Remediation Summary & Soil Closure Request

Mewbourne Oil Company Red Hills West 22 4" SWD Line

Lea County, New Mexico
Unit Letter "D", Section 22, Township 26 South, Range 32 East
Latitude 32.035169 North, Longitude 103.671224 West
NMOCD Reference No. nAPP2222238377

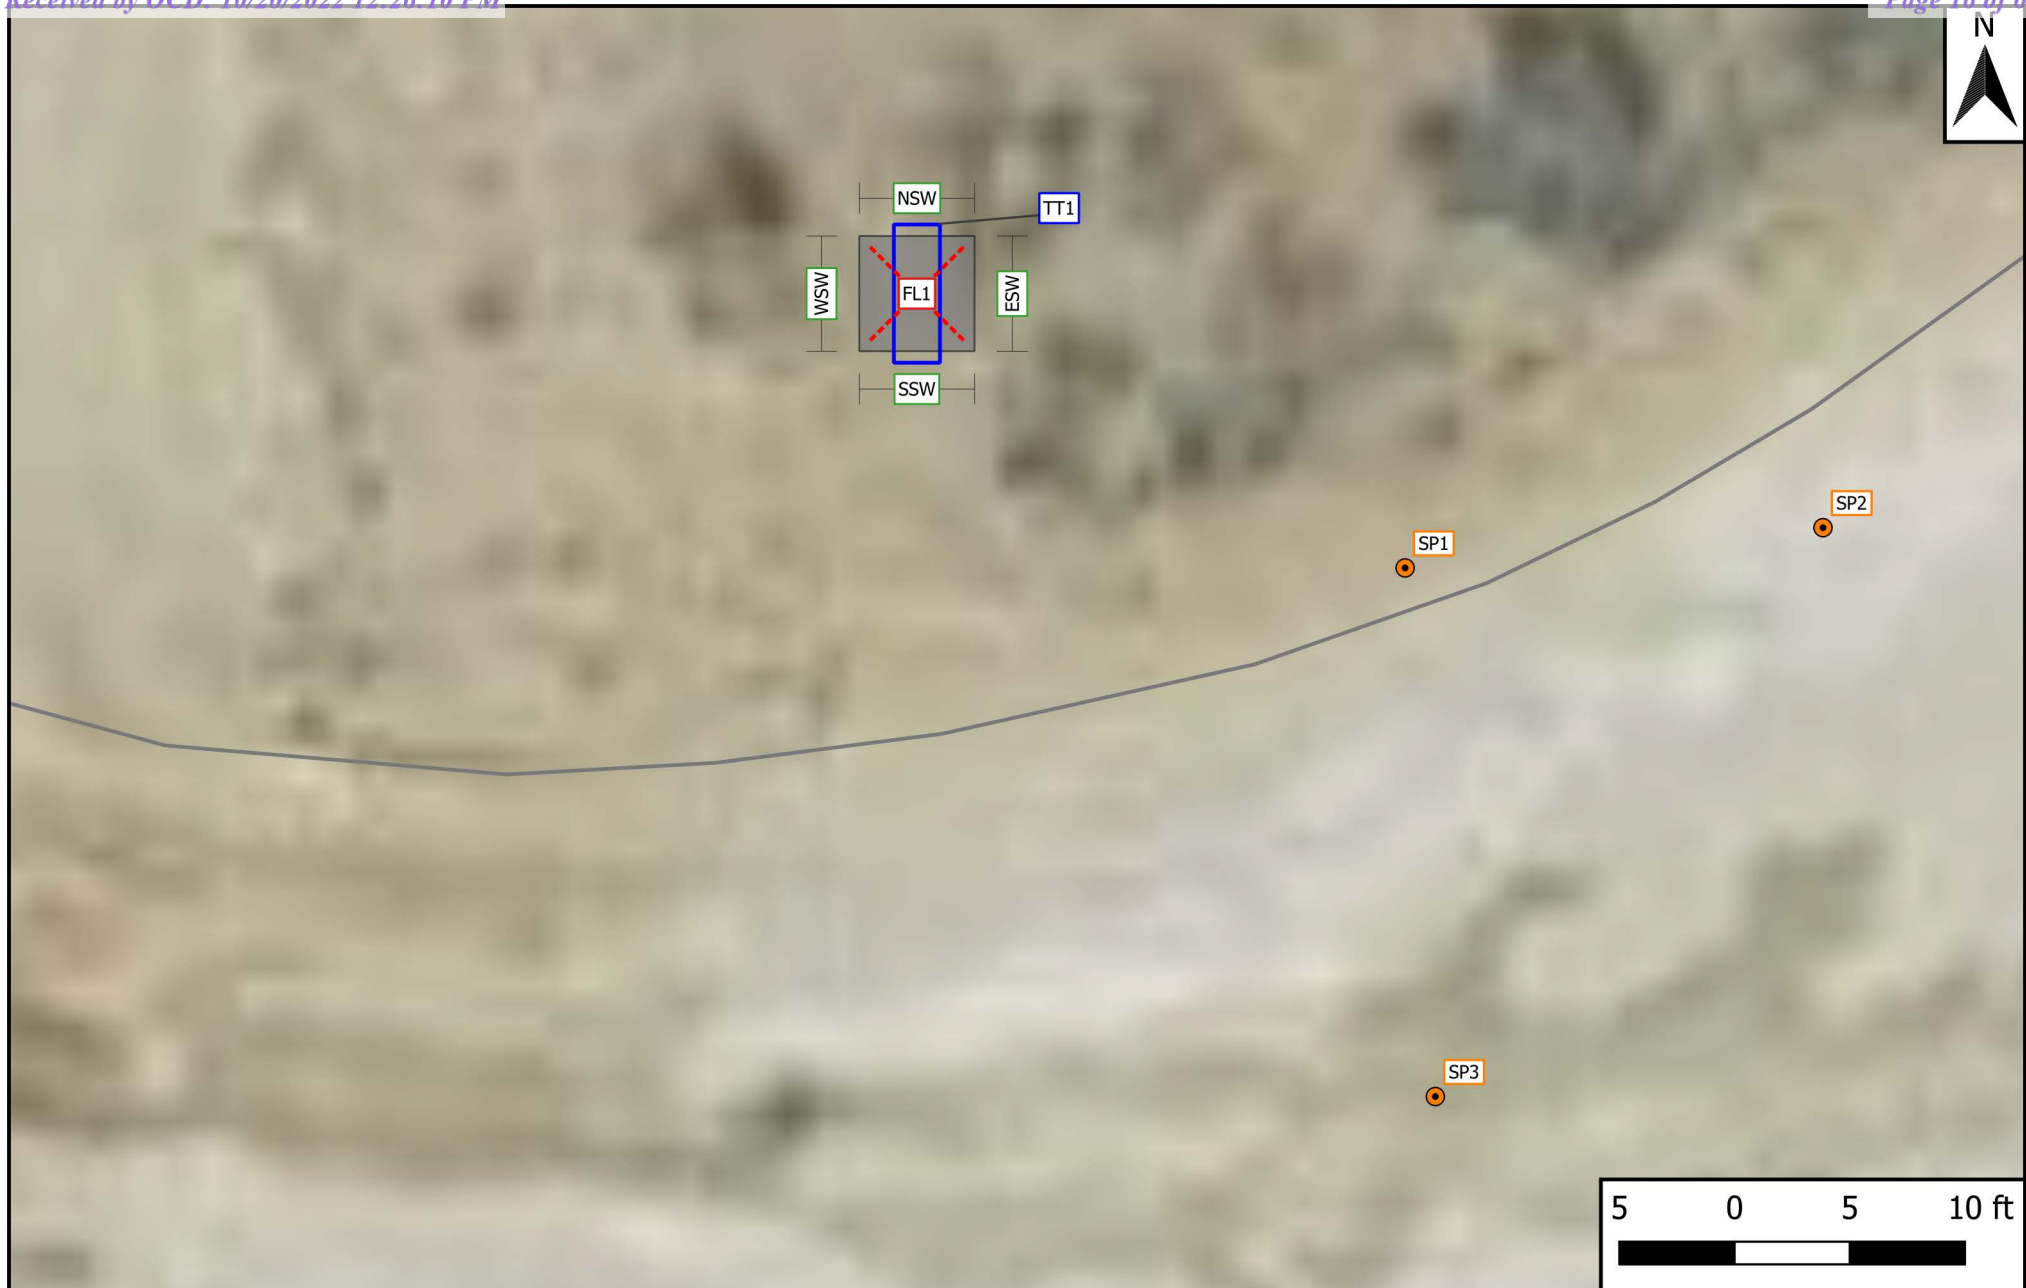
Figure 3

The location of the test trench is depicted in Figure 3, "Site & Sample Location Map".

Site & Sample Location Map

Soil sample locations and the extent of the excavated area are depicted in Figure 3, "Site & Sample Location Map". Soil chemistry data is summarized in Table 1. Field data and a soil profile log are provided in Appendix B. Laboratory analytical reports are provided in Appendix C. General photographs of the release site are provided in Appendix D.

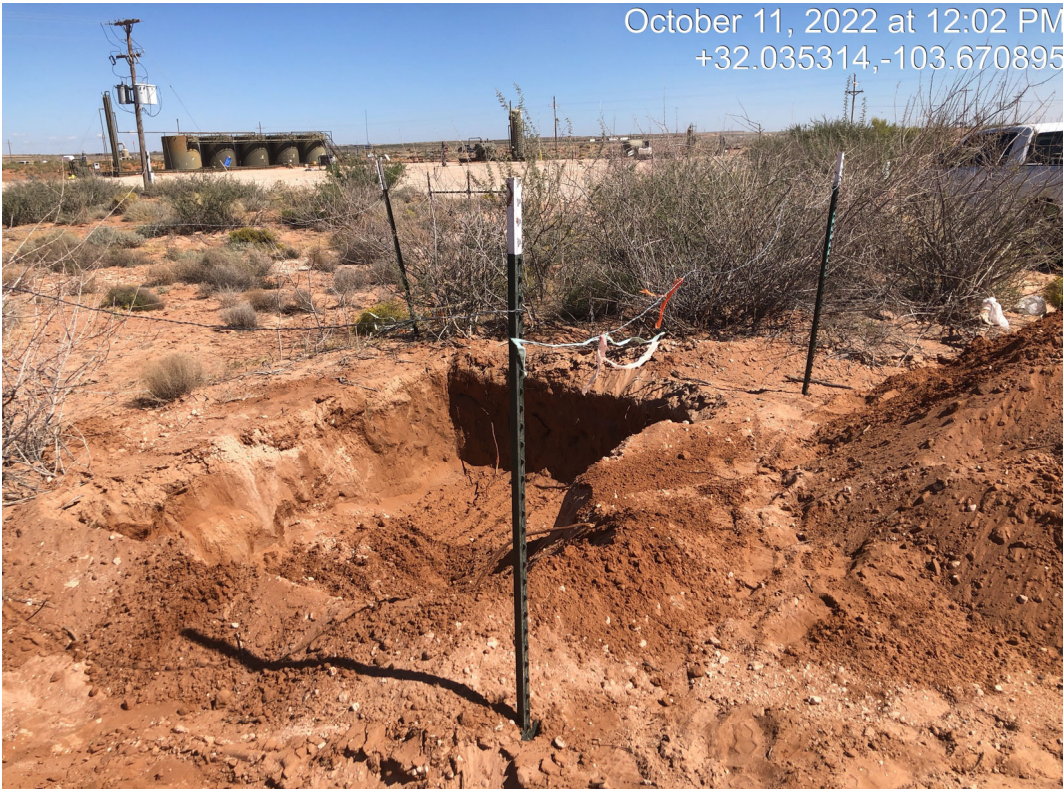
Photo Number: 3

Photo Direction: Northeast	
Photo Description: View of the excavated area.

The final dimensions of the excavated area were approximately five (5) feet in length, five (5) feet in width, and two (2) feet in depth. During the course of remediation activities, Etech transported approximately 20 cubic yards of impacted soil to an NMOCD-permitted surface waste facility for disposal and imported approximately 20 cubic yards of locally sourced, non-impacted material to the site for use as backfill.
