## Release Notification

Site Name Ameredev South Facility	Site Type Idle Gas Treatment Facility
Date Release Discovered 07/08/2022	API# (if applicable)

**Re: Site Assessment, Remediation, and Closure Report  
 Ameredev South Facility  
 API No. N/A  
 GPS: Latitude 32.02735 Longitude -103.27593  
 UL "L", Sec. 21, T26S, R36E  
 Lea County, NM  
 NMOCD Ref. No. NAPP2219631614**

Pima Environmental Services, LLC (Pima) has been contracted by SCM Operations, LLC to perform a spill assessment, remediation activities, and submit this closure report for an oil release that occurred at the Ameredev South Facility. The initial C-141 was submitted on July 15<sup>th</sup>, 2022 (Appendix C). This incident was assigned Incident ID NAPP2219631614, by the New Mexico Oil Conservation Division (NMOCD).

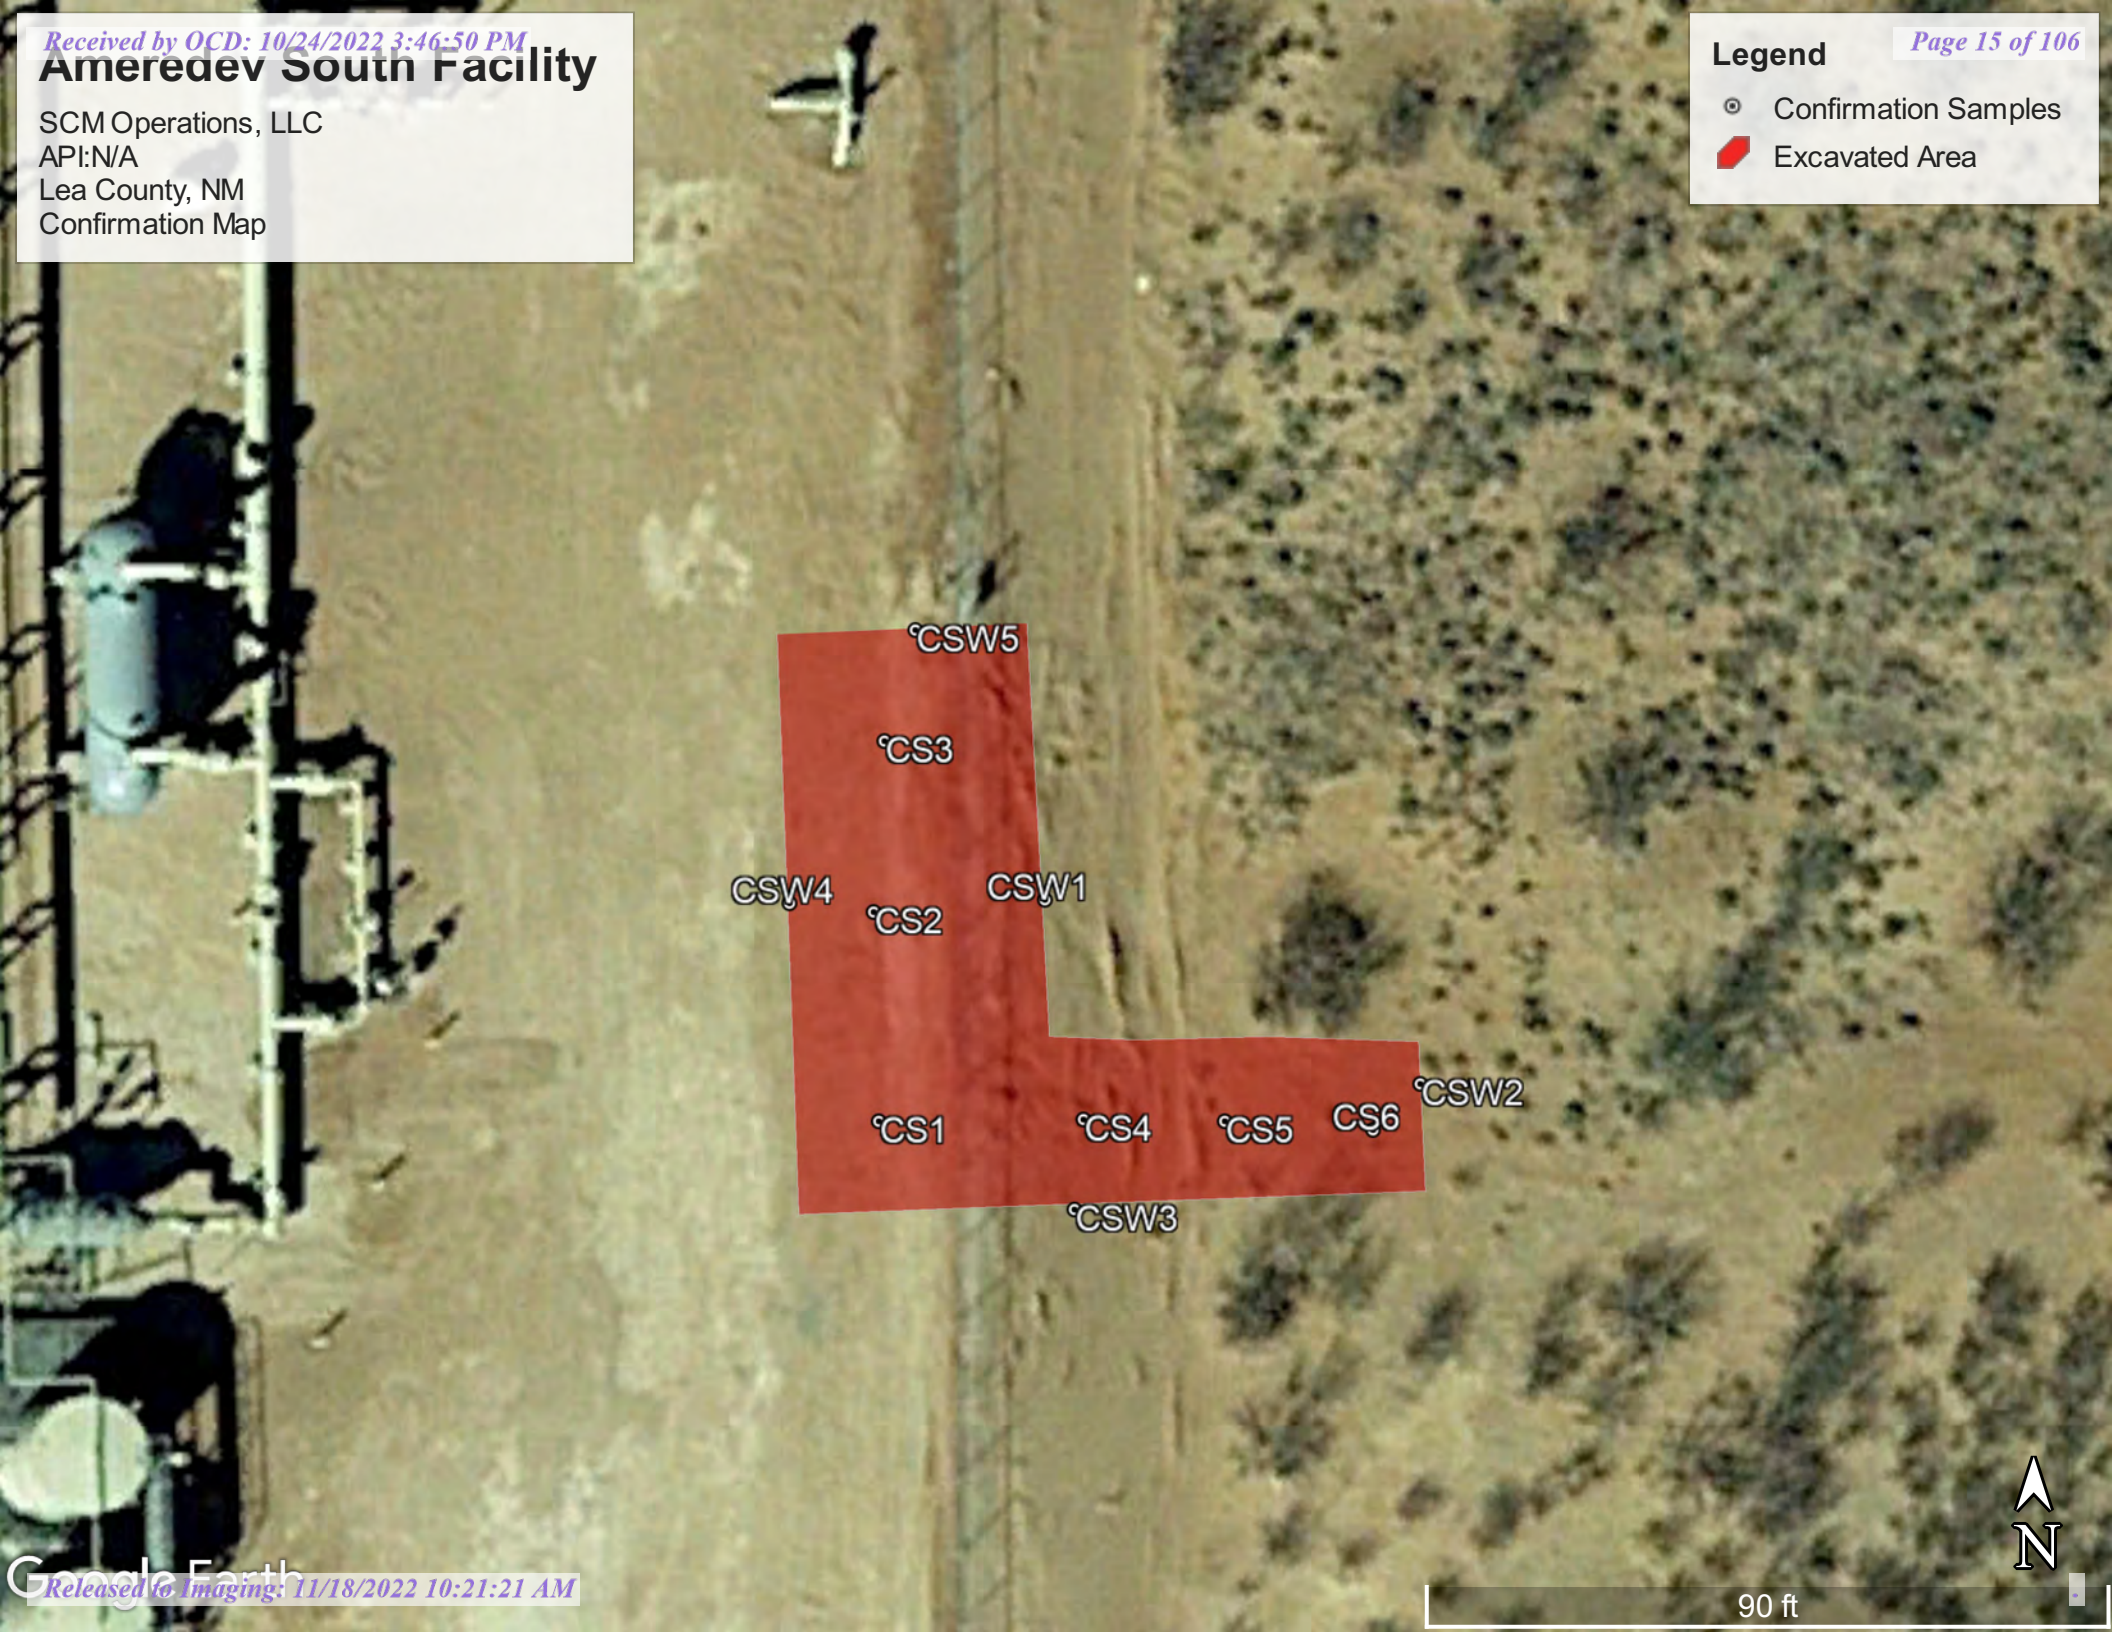
SCM Operations, LLC  
API:N/A  
Lea County, NM  
Confirmation Map

On September 29<sup>th</sup>, 2021, after submitting a 48-hour notification (Appendix C), Pima returned to the site to collect confirmation samples. The laboratory results of this sampling event can be found in the following data table.

°CSW5  
°CS3  
CSW4 °CS2 CSW1  
°CS1 °CS4 °CS5 CS6 °CSW2  
°CSW3

On September 28<sup>th</sup>, 2022, Pima mobilized personnel and equipment to conduct remedial activities. Pima excavated the area overlapping soil samples (BH1-BH6) and (SW1-SW5) to a depth of one (1) foot bgs. Photographic documentation can be found in Appendix D.

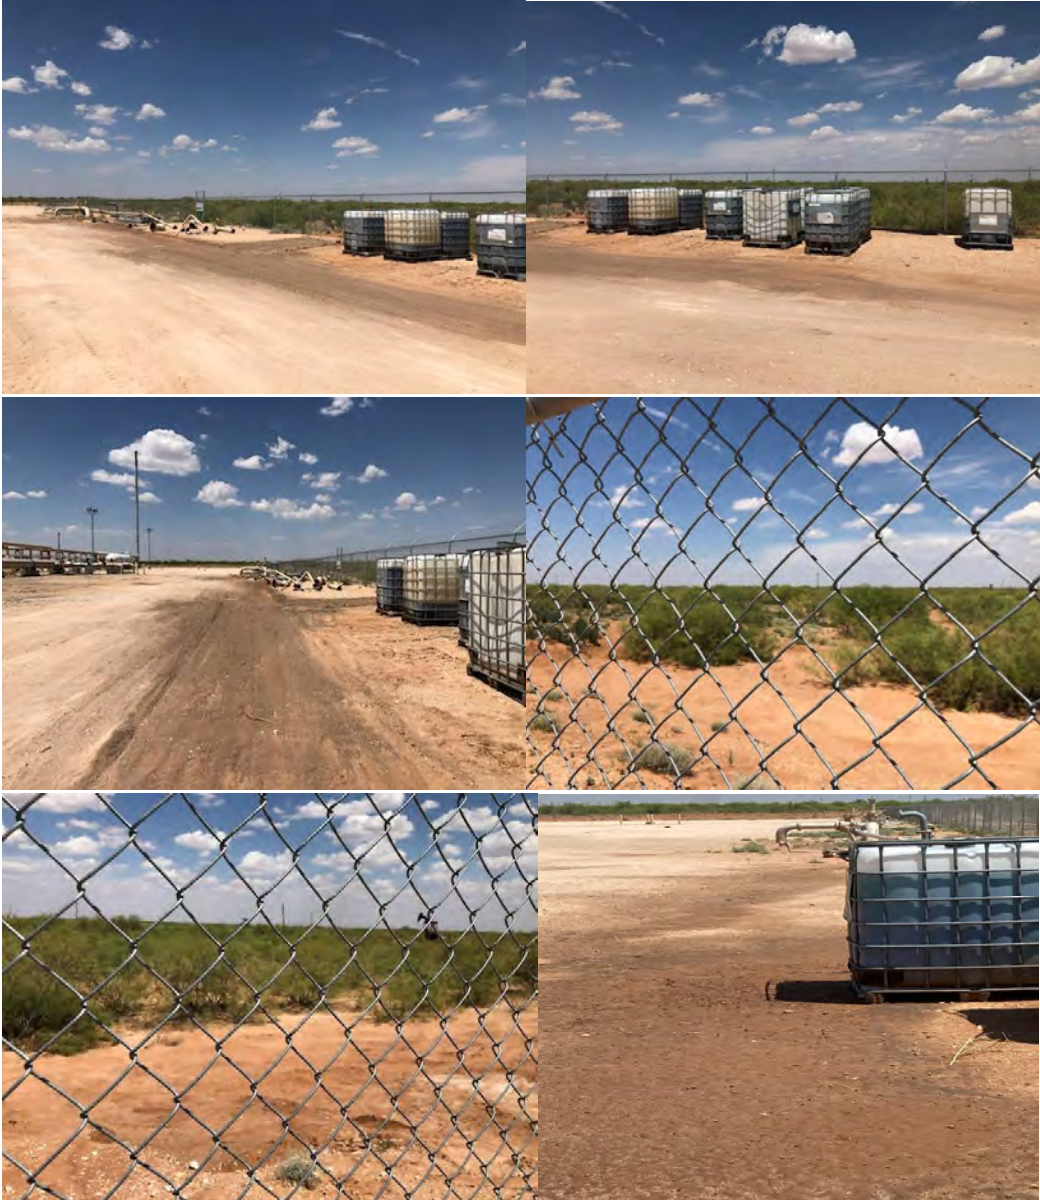
Pre-Treatment

**Background:**  
 One 275-gal HDPE tote filled with lube oil was found cracked on site. Its entire contents were released onto the ground. The cause of the crack and the time of the incident is unknown. Since the tote was full prior to the incident and is completely empty after, the spill volume was determined to be 275 gal / 6.55 bbl.
