## Release Notification and Corrective Action

## FINAL REPORT

### **CENTRAL VACUUM UNIT #342 RESERVE PIT CLOSURE REPORT (RP #2672)**

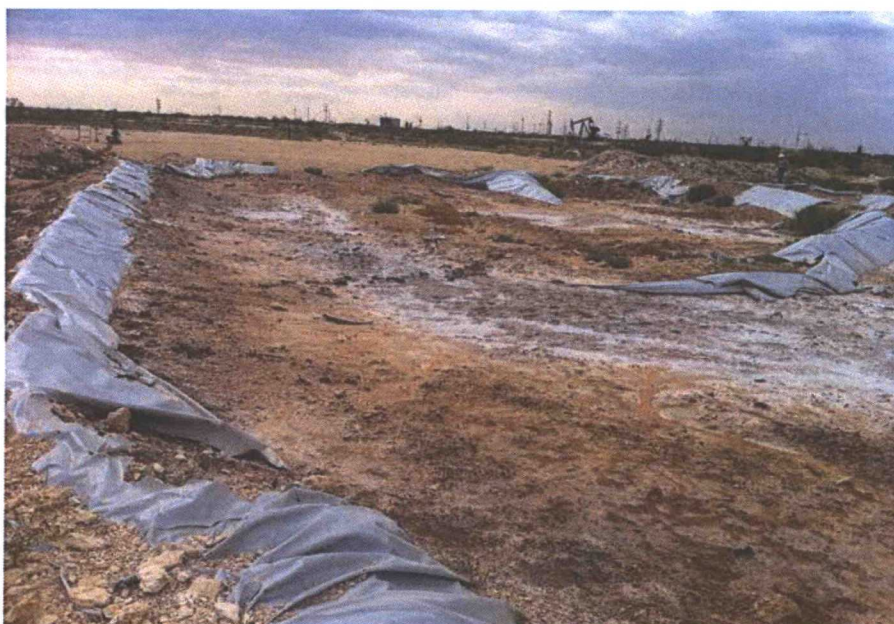
PHOTO 1: View of reserve pit facing west before any remedial work activities

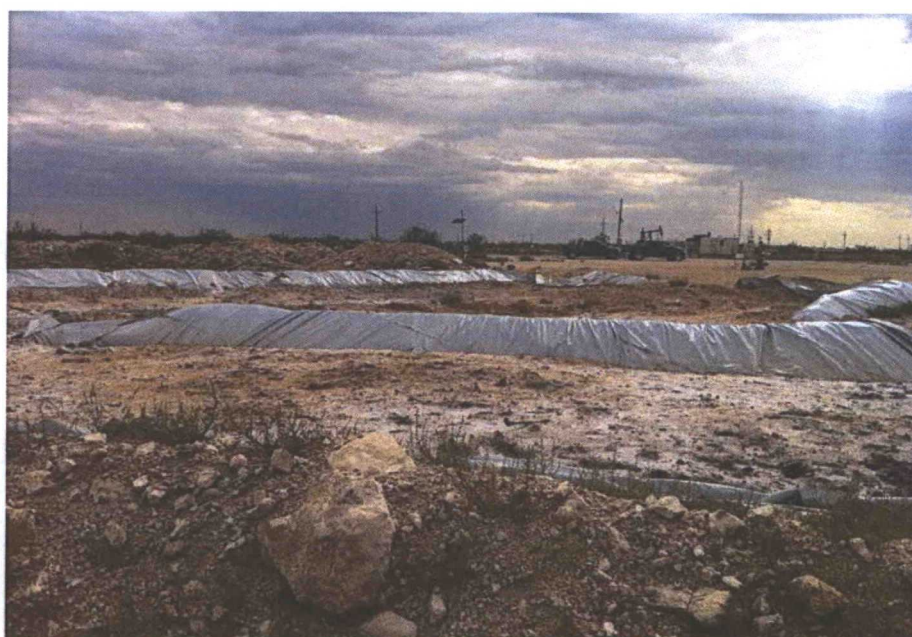
PHOTO 2: View of reserve pit facing southwest before any remedial work activities

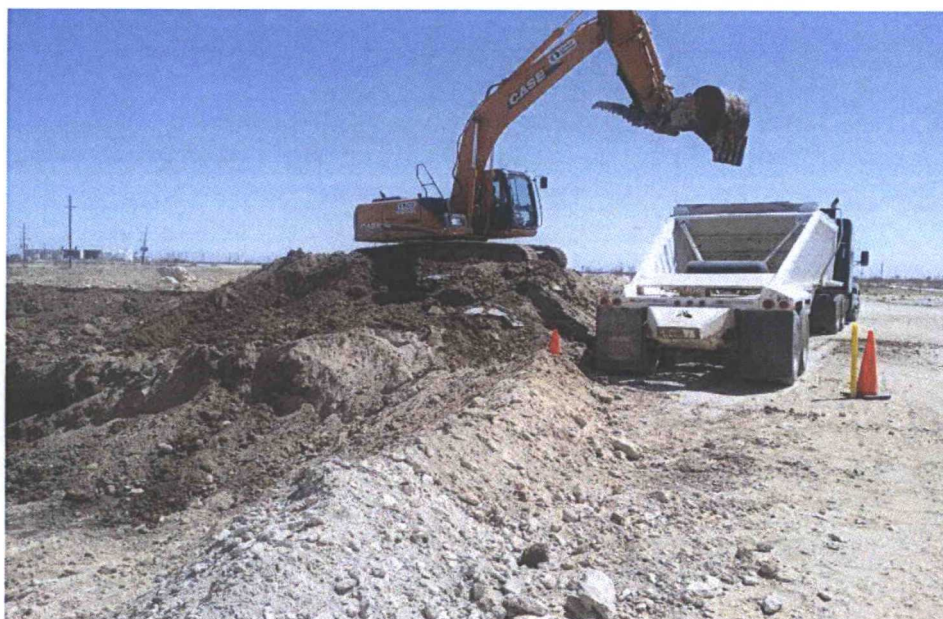
PHOTO 4: View of excavation/waste removal activities

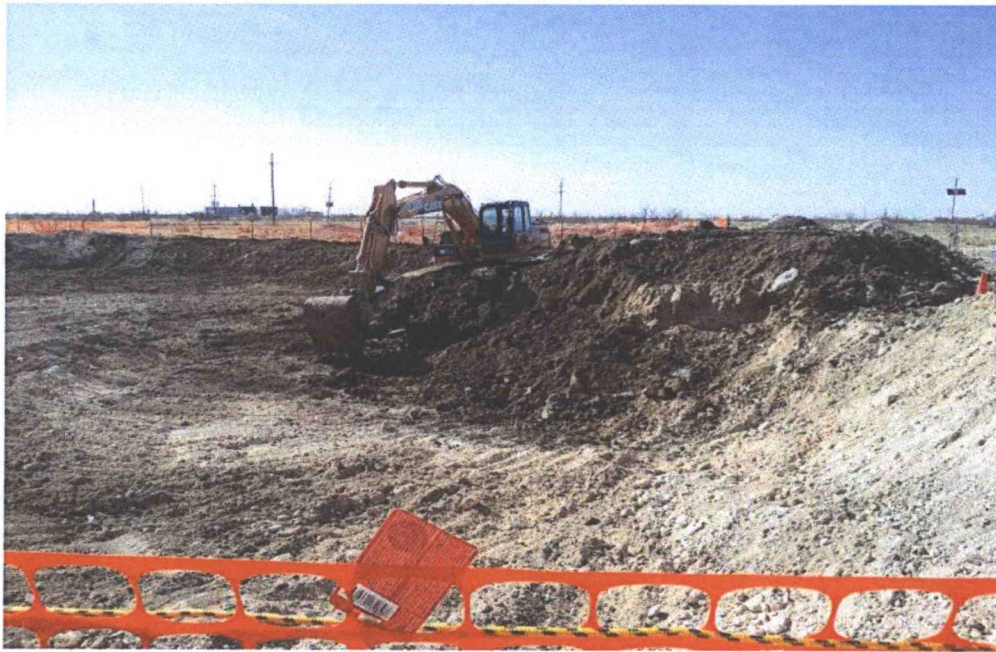
PHOTO 5: View of excavation activities

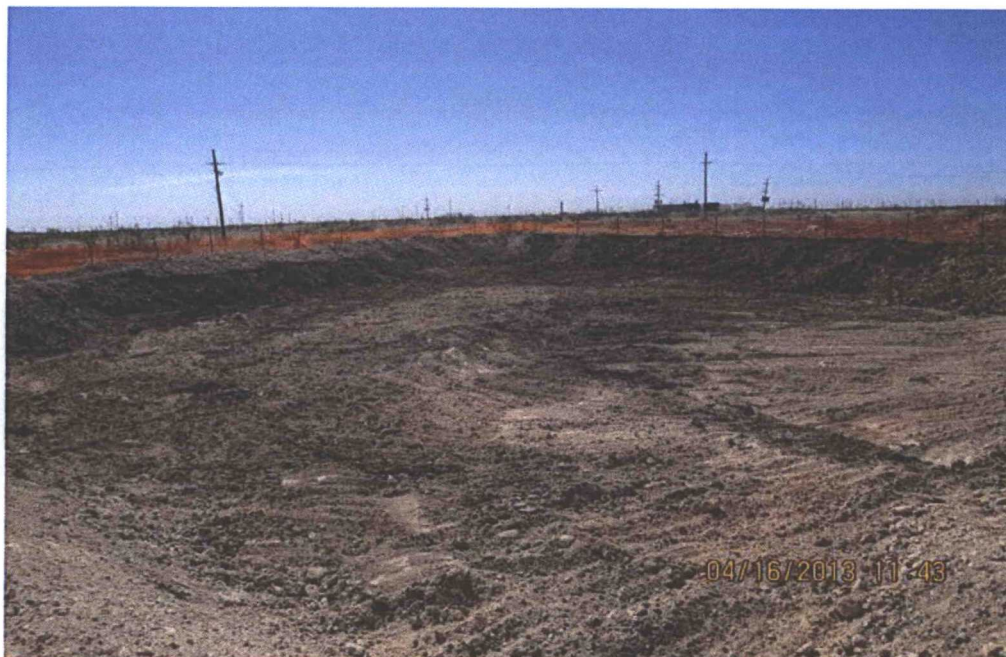
PHOTO 6: View of excavated reserve pit facing southeast

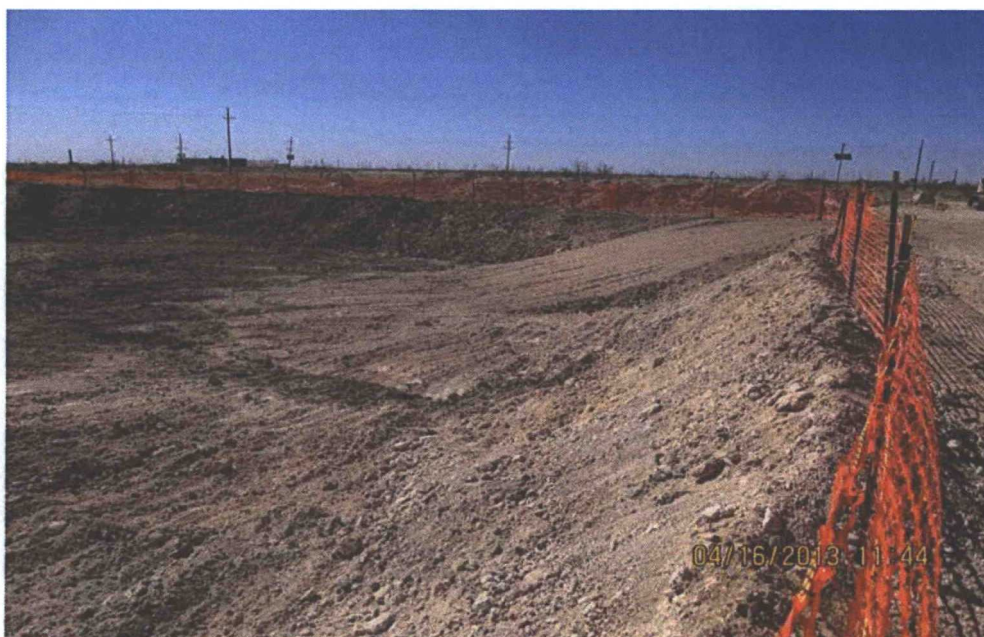
PHOTO 7: View of excavated pit and entrance ramp facing southeast

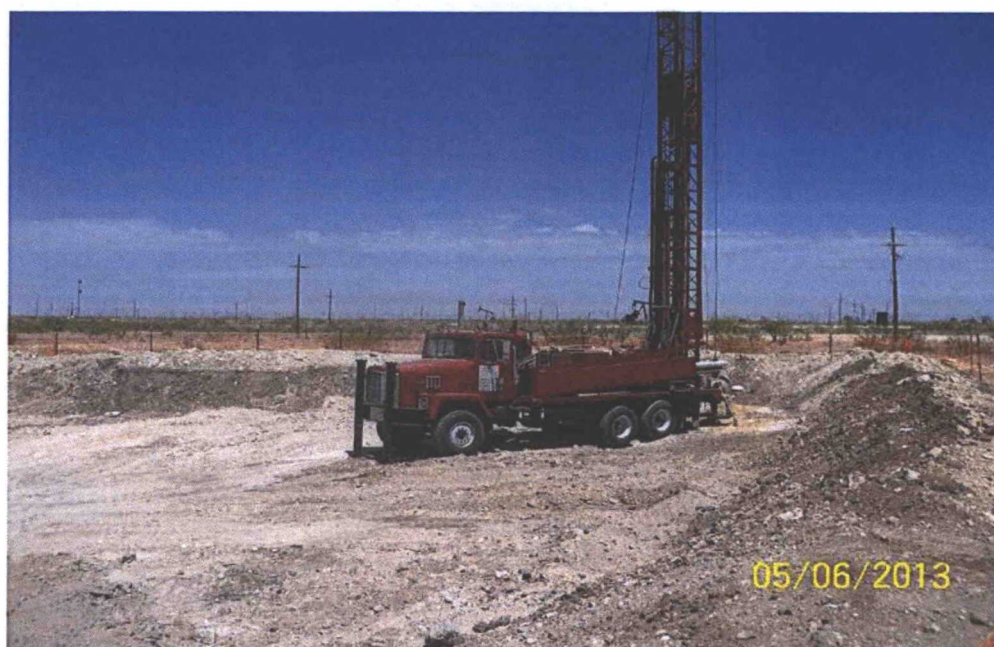
PHOTO 8: View of drill rig inside excavated reserve pit facing east

In May 2013, after discussions and approval from the NMOCD Hobbs District I office, three soil borings (SB-1, SB-2 and SB-3) were installed within the existing remedial excavation to a depth of 100 feet bgs. Soil samples were collected at 5 to 10 foot intervals in an effort to horizontally and vertically evaluate the extent of chloride impacts. All three soil borings SB-1 (75'-4.94 mg/kg), SB-2 (80'-4.22 mg/kg), and SB-3 (90'-209 mg/kg) demonstrated decreasing chloride levels with depth to well below recommended remediation and delineation levels. A soil cross section depicting subsurface conditions is provided in Figure 2. Certified Laboratory Reports for the 2013 soil sampling events are provided in Appendix E.

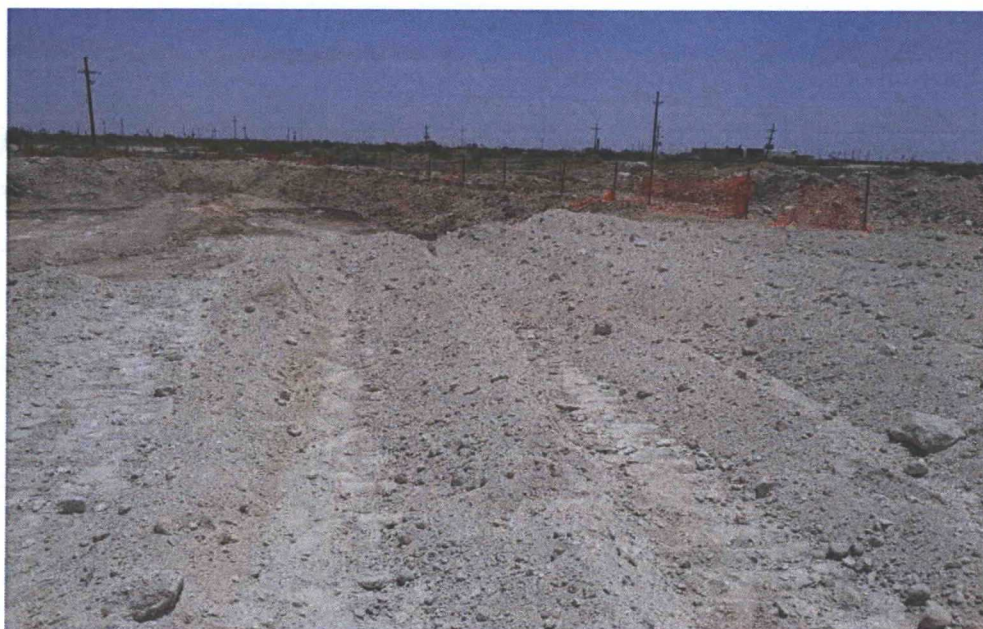
PHOTO 9: View of backfill activities facing northeast

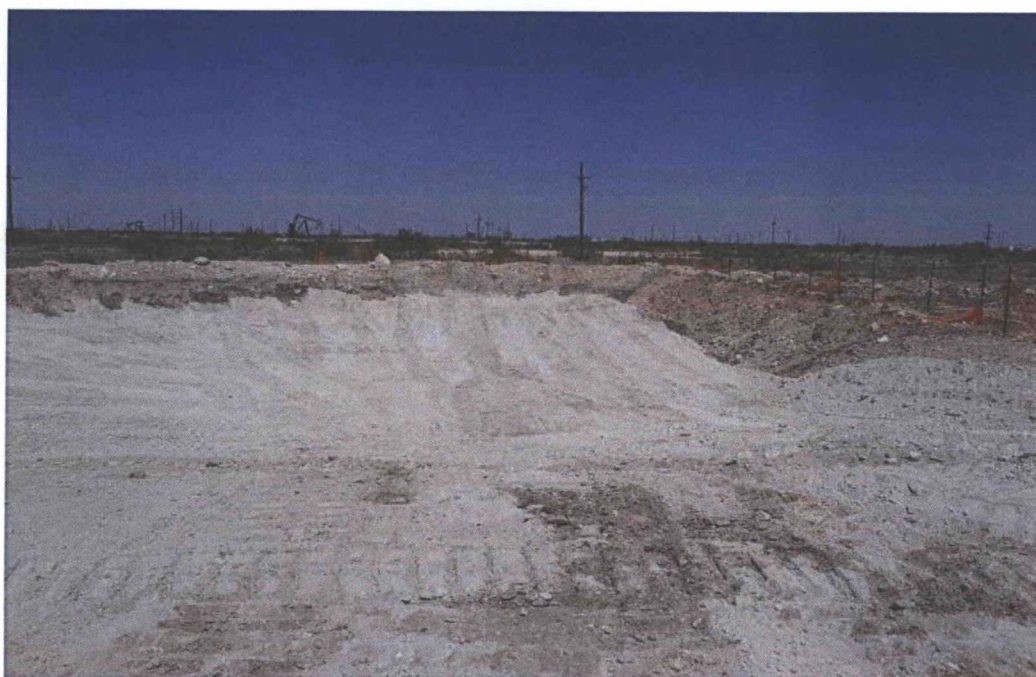
PHOTO 10: View of backfilling activities facing northeast, ready for liner material

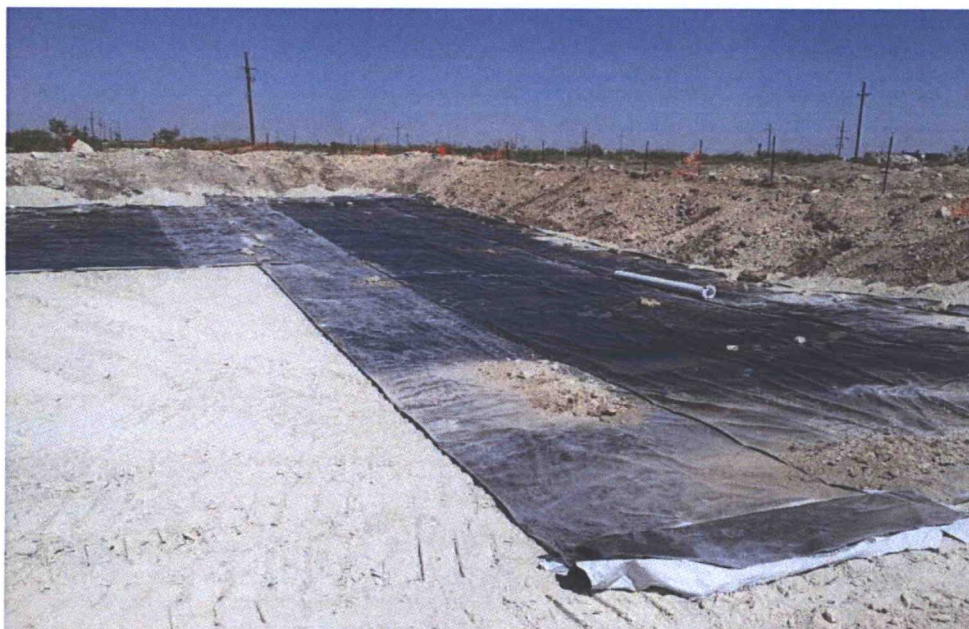
PHOTO 11: View of 20 mil poly liner installation facing northeast

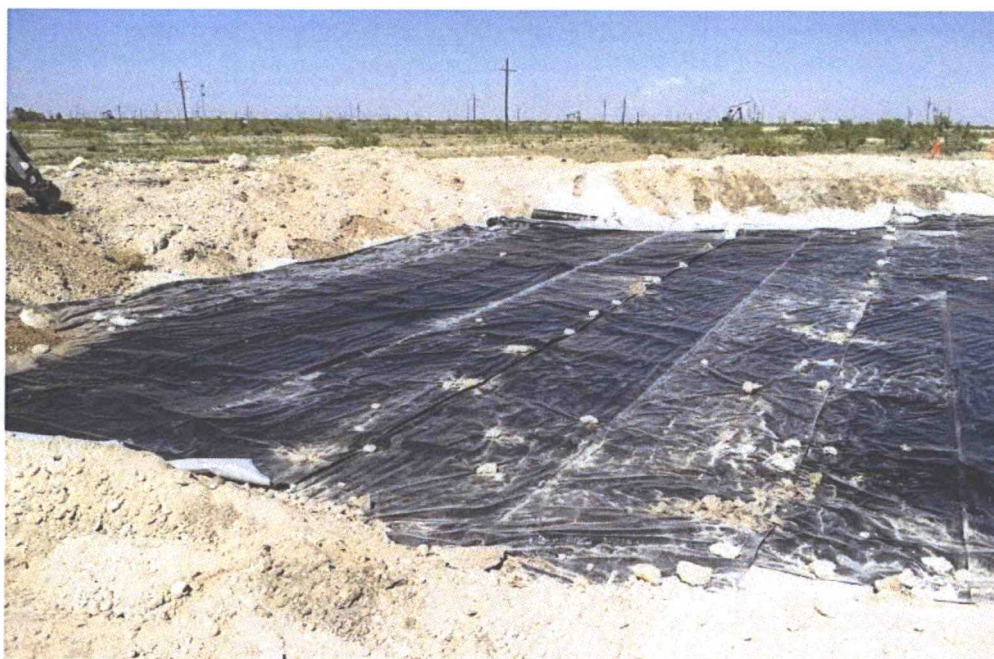
PHOTO 12: View of 20 mil poly liner installation facing northwest

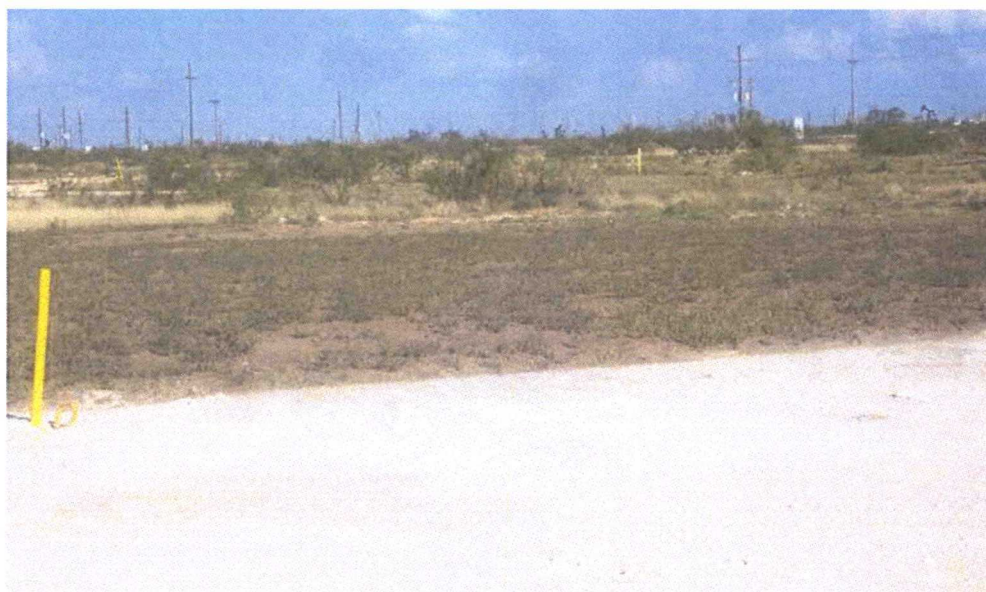
PHOTO 13: View of final grading and seeding activities completed with new vegetative growth already taking place - facing southeast.

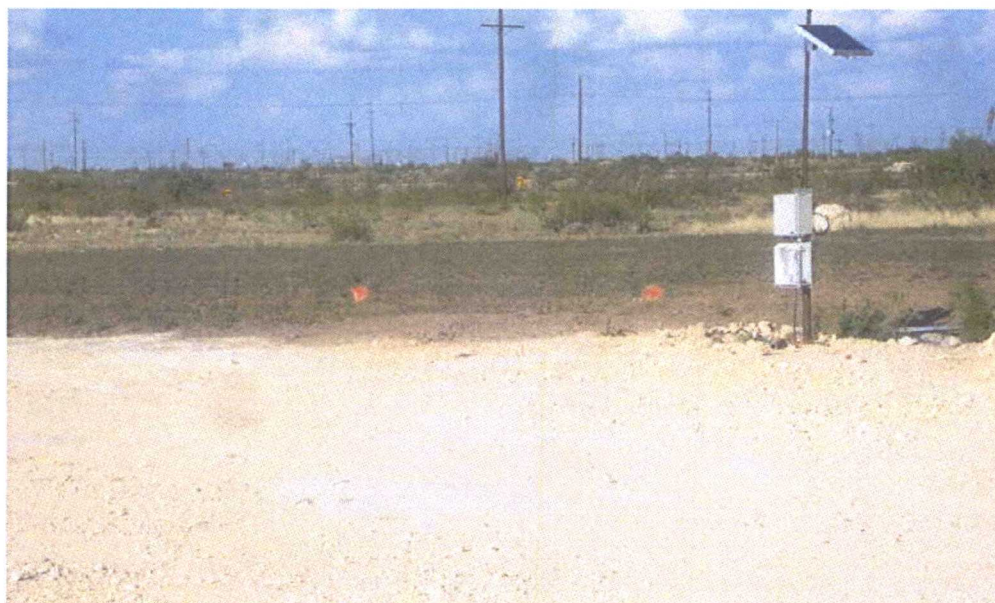
PHOTO 14: View of final grading and seeding activities completed facing northeast. Flags are representative of entrance ramp location during remedial activities for the Site.
