**Re: Closure Letter
Barn Owl Federal #002H
API #: 30-015-42472
RP#: 2RP-4128
Unit Letter B, Section 19, Township 26S, Range 27E
Eddy County, NM**

COG Operating, LLC (COG) is pleased to submit for your consideration the following closure report for the Barn Owl Federal #002H. This release occurred on February 23, 2017. Following the release an assessment of impacted soils was conducted. A remediation work plan was submitted to and subsequently approved by the New Mexico Oil Conservation Division (NMOCD) and the Bureau of Land Management (BLM). A copy of the approved work plan is attached in Appendix IV.

Re: Work Plan for the COG Operating LLC., Barn Owl Federal #2H, Unit B, Section 19, Township 26 South, Range 27 East, Eddy County, New Mexico. 2RP-4128.

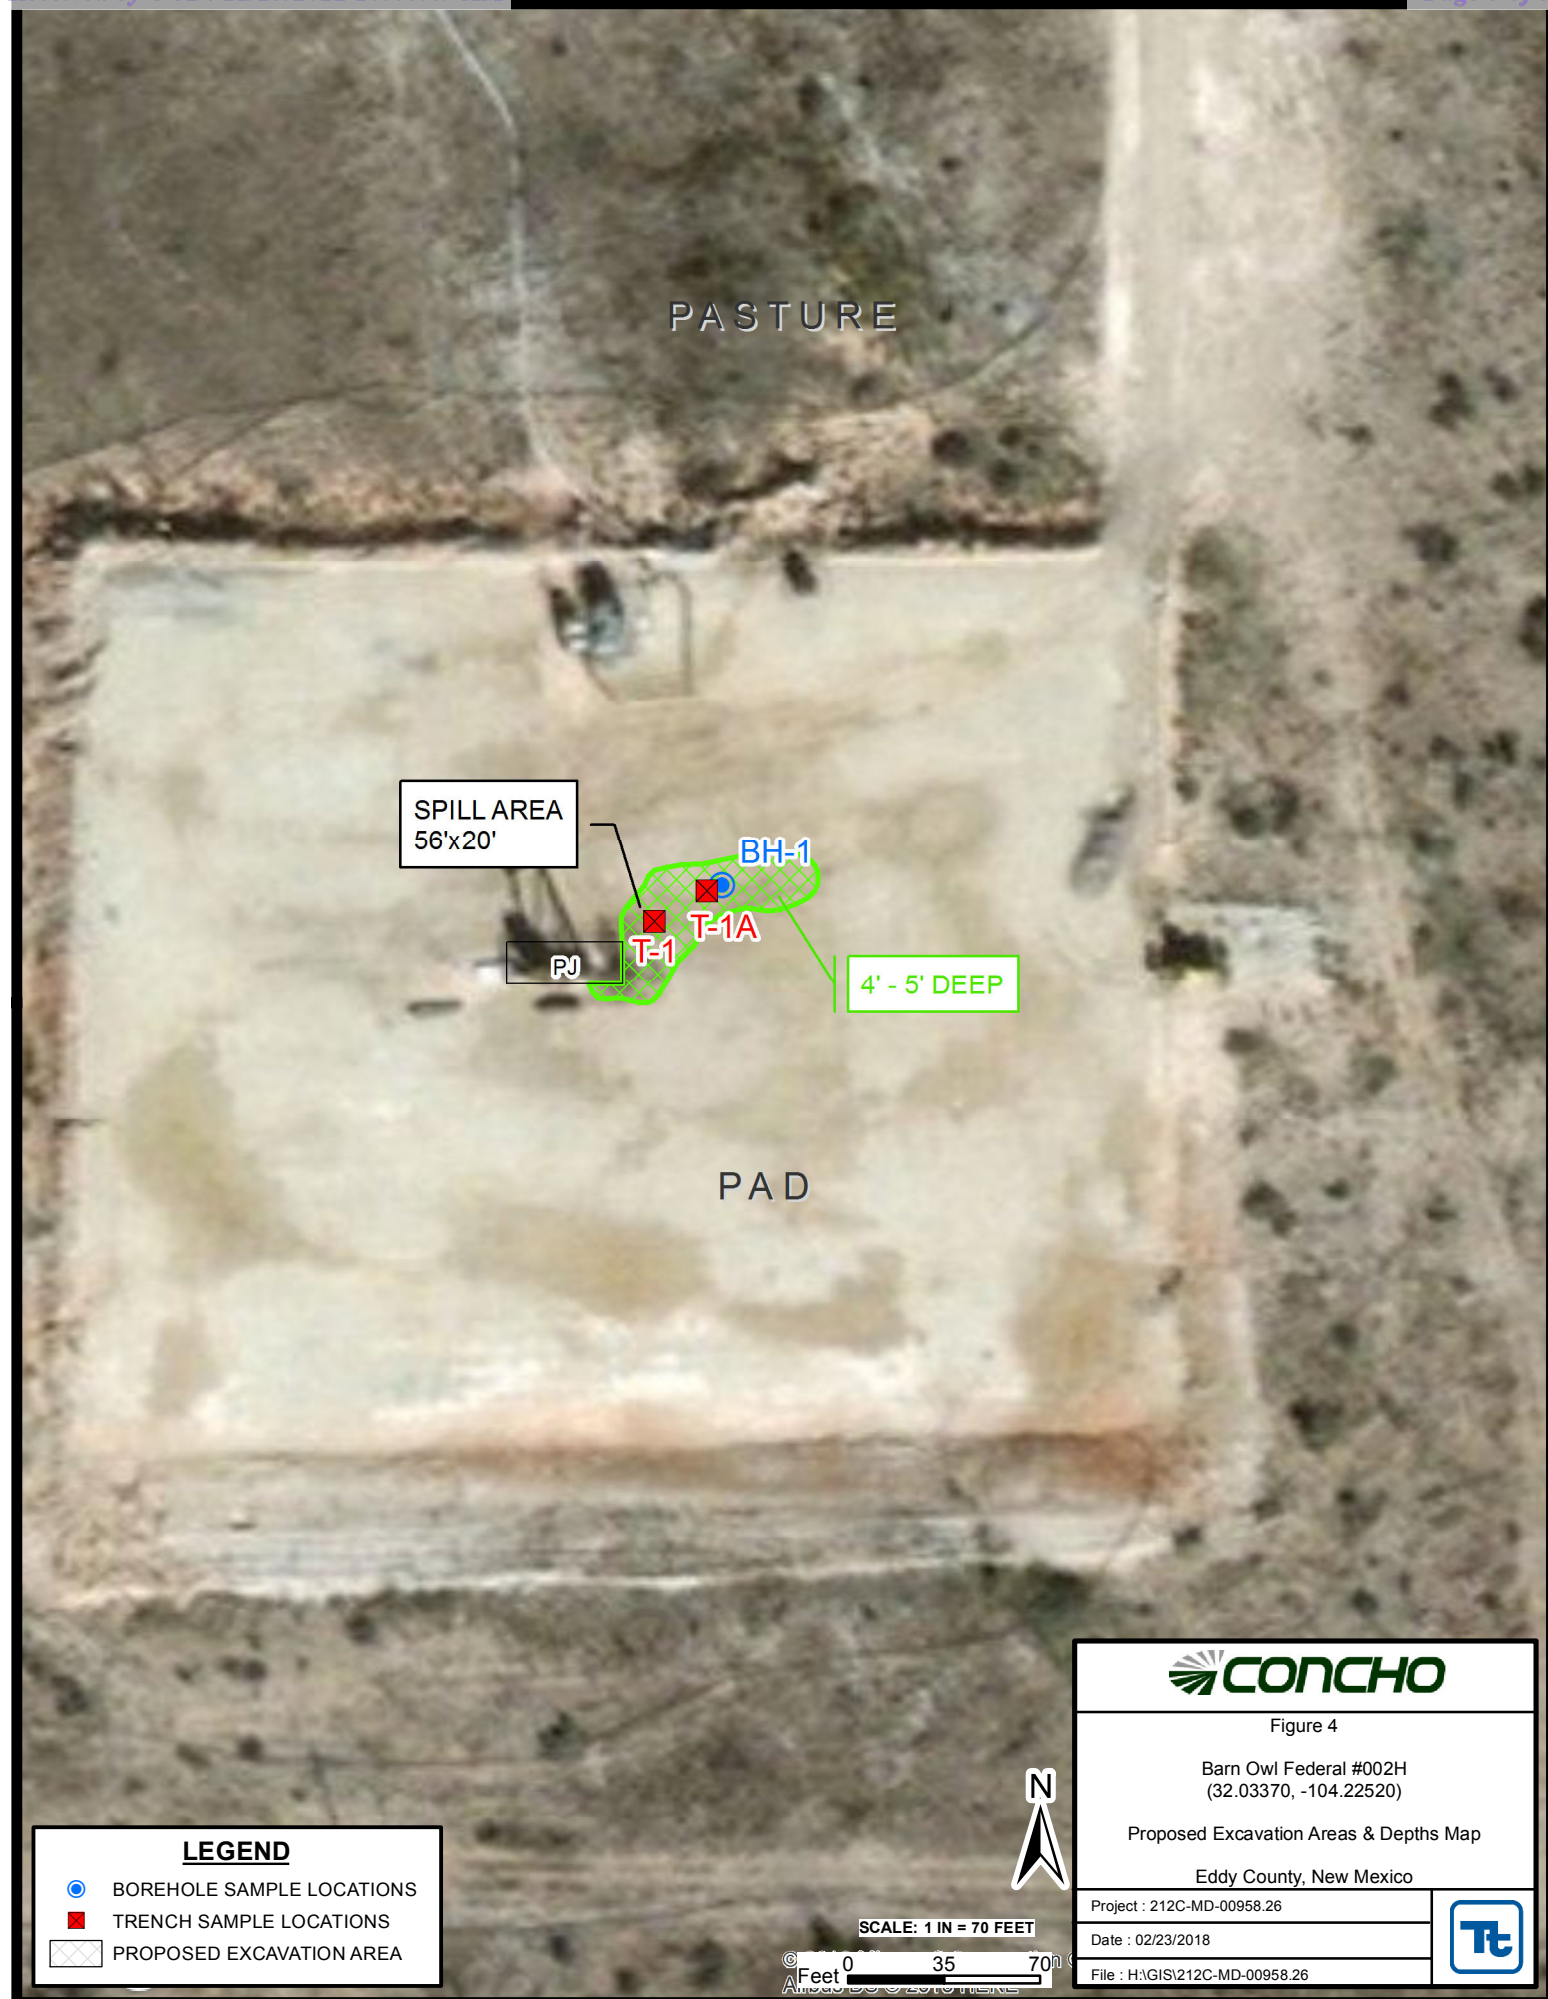
APPENDIX I

Remediation activities were conducted in accordance with the approved work plan. Confirmation soil samples were not required by NMOCD or BLM. A site diagram of the excavated area is presented in Appendix I.

- The impacted area was excavated to a depth of five (5) feet BGS.
- All of the excavated material was hauled to an NMOCD approved solid waste disposal facility.
- The excavation was backfill with clean “like” material and contoured to match the surrounding terrain.

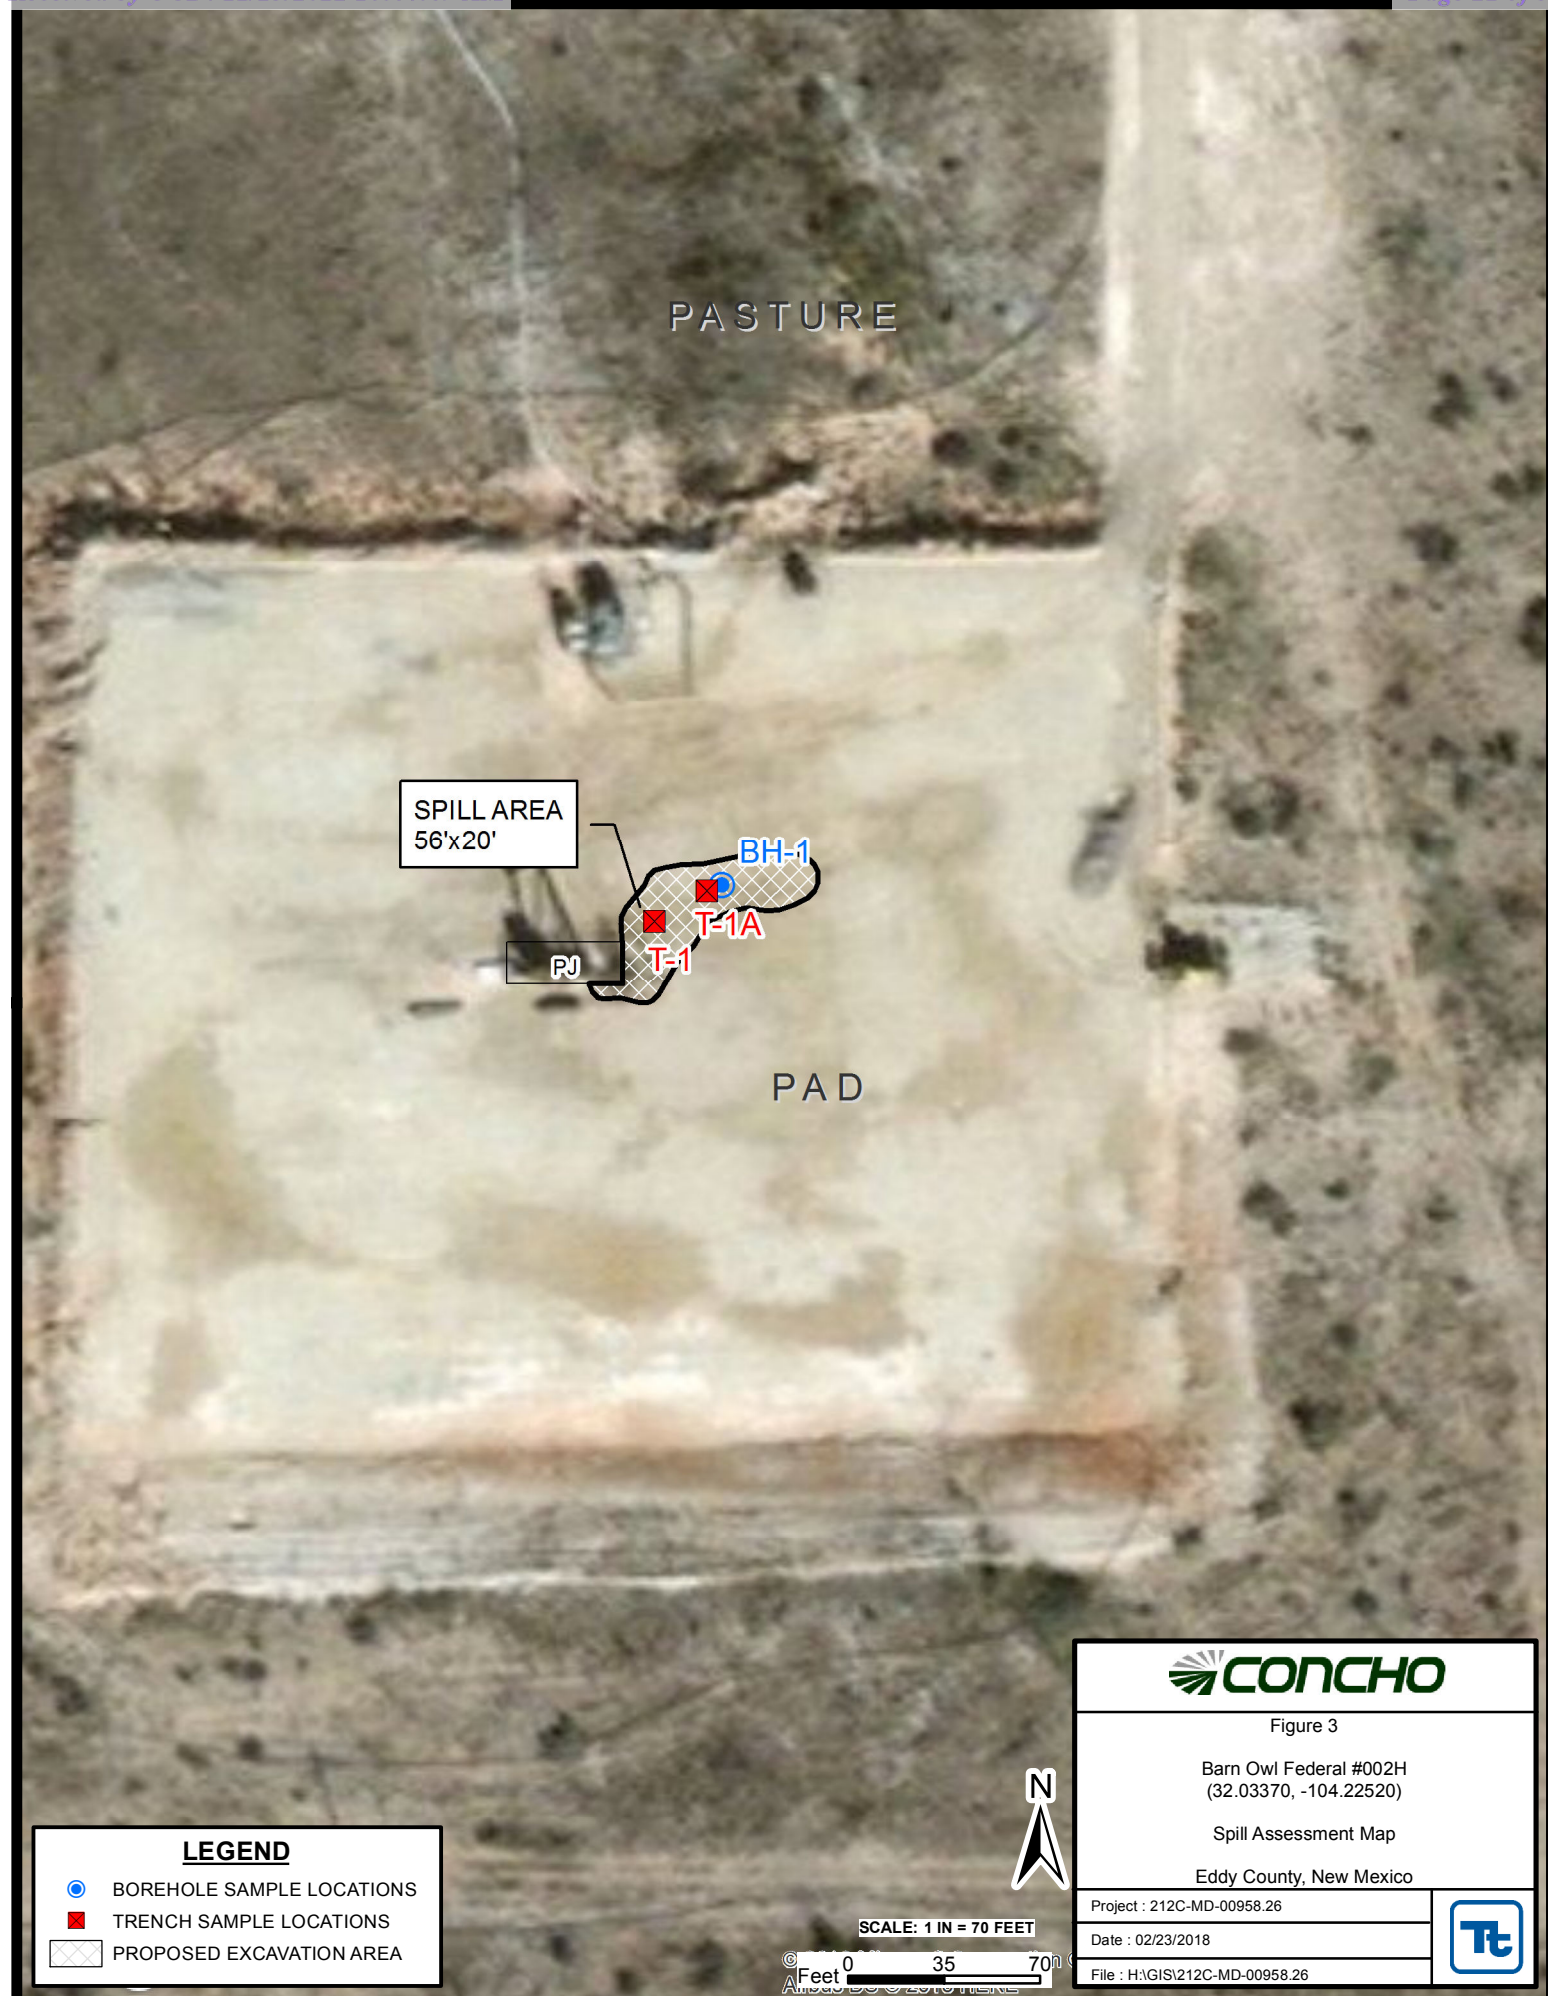
On March 21, 2017, COG personnel were onsite to evaluate and sample the release area. One sample trench (T-1) was installed in the release area to a total depth of 7.0' below surface. For horizontal extents, four (4) sample trenches (North, South, East, and West) were installed outside of the release footprint to total depths between 3.0' and 4.0' below surface. Selected samples were analyzed for TPH analysis by EPA method 8015 modified, BTEX by EPA Method 8021B and chloride by EPA method 300.0. Copies of laboratory analysis and chain-of-custody documentation are included in Appendix C. The sampling results are summarized in Table 1. The trench locations are shown on Figure 3.

Based on the laboratory data, ASSI personnel were onsite on October 12, 2017, to confirm and attempt to define the chloride concentrations in the areas of trenches (T-1 and South). ASSI personnel installed one sample trench (T-1A) in the area of T-1 to a total depth of 6.0' below surface. A confirmation surface sample (South 1A) was also collected in trench (South). Additionally, one background trench (Background) was installed in the adjacent pasture to a total depth of 4.0' below surface to evaluate the native soils. The samples were analyzed for chlorides by EPA method 300.0. Copies of laboratory analysis and chain-of-custody documentation are included in Appendix C. The sampling results are summarized in Table 1. The trench locations are shown on Figure 3.

Based on the laboratory data, Tetra Tech personnel were onsite on November 20, 2017, to install one borehole (BH-1) in the area of trench (T-1) to a total depth of 29'-30' below surface in order to vertically define the chloride concentrations. Selected samples were analyzed for TPH analysis by EPA method 8015 modified, BTEX by EPA Method 8021B and chloride by EPA method 300.0. Copies of laboratory analysis and chain-of-custody documentation are included in Appendix C. The sampling results are summarized in Table 1. The borehole location is shown on Figure 3.

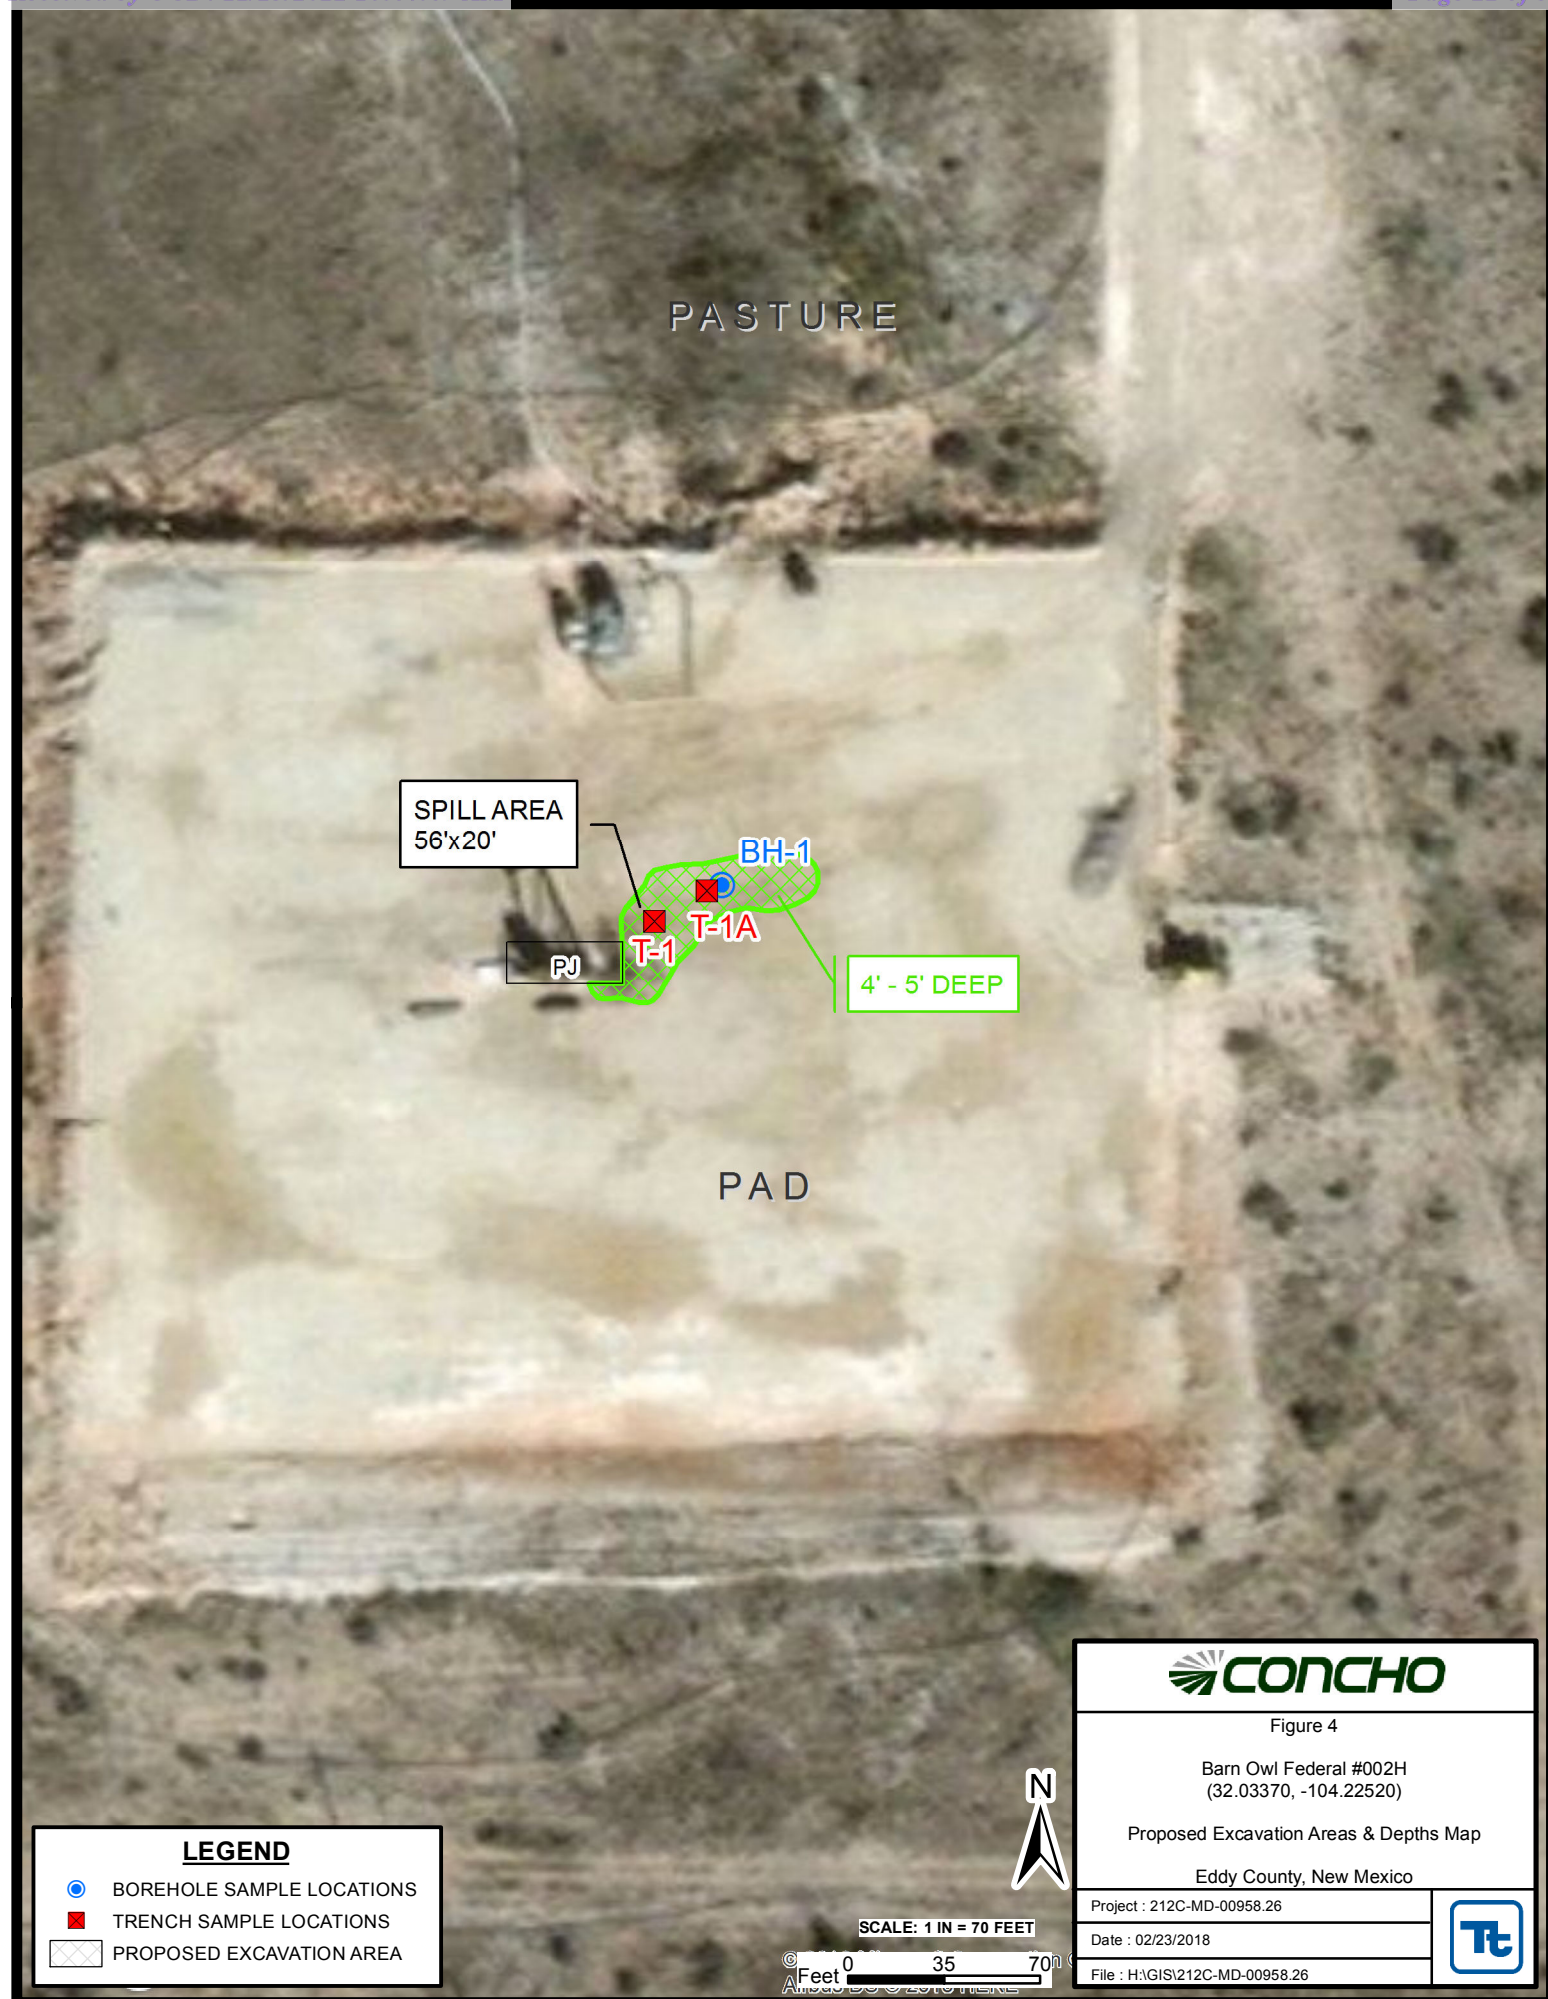
Based on the laboratory results, COG proposes to remove the chloride impacted soils as shown on Figure 4 and highlighted (green) on Table 1. The area of trench (T-1) will be excavated to approximately 4.0' below surface to remove the chloride impacted soils. The excavation will then be backfilled with clean material to surface grade. All of the excavated material will be transported offsite for proper disposal.

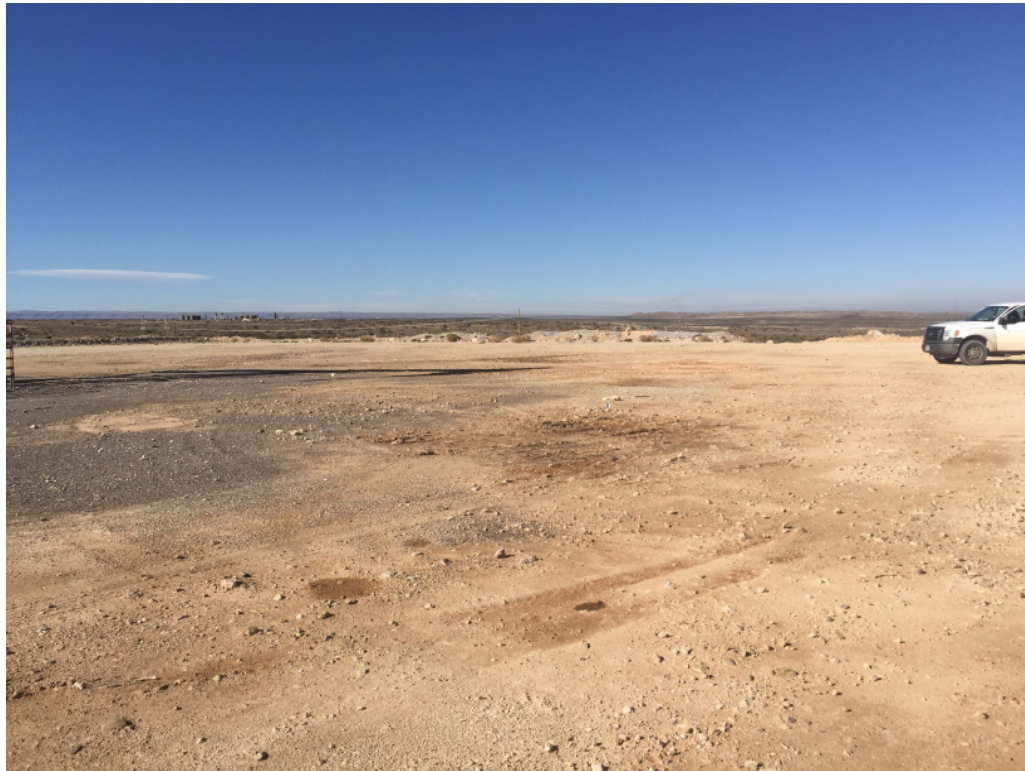
View North – Area of BH-1

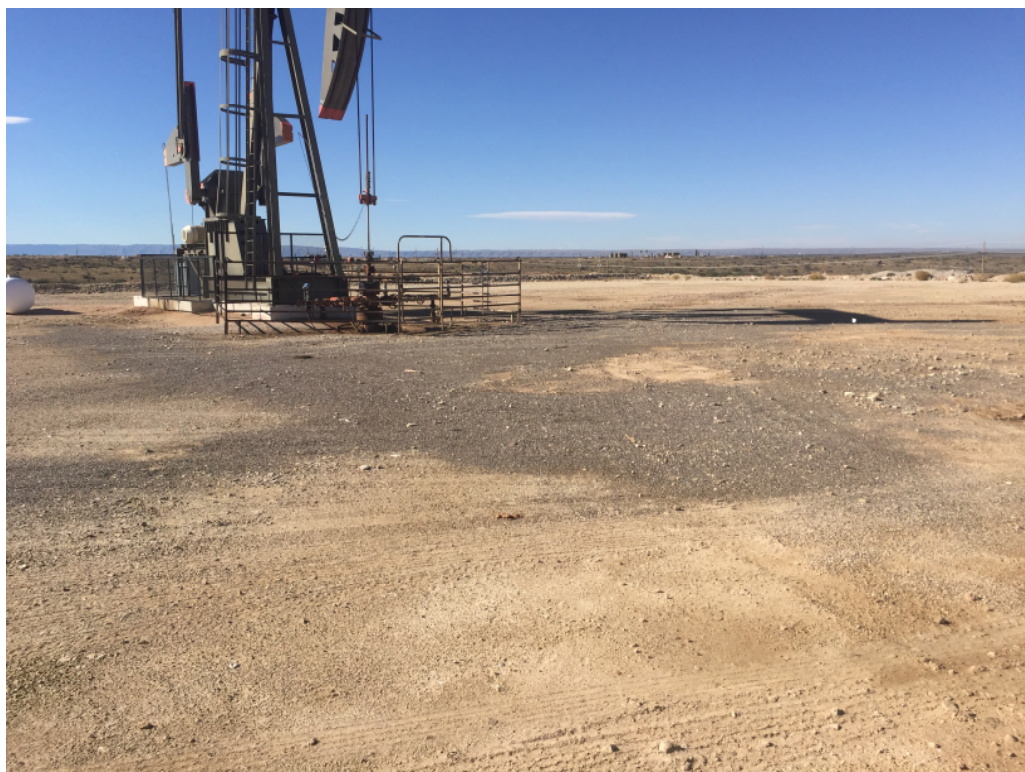
View West – Area of BH-1
