## Release Notification

Site Name	Gold NC 29 CTB	Site Type	E & P Tank Battery
Date Release Discovered	05/25/2022	API#	(if applicable)

Re: **Request for Approval of Work Plan**  
**Gold NC 26 CTB**  
**Tracking #: NAPP2214733218**

## RELEASE BACKGROUND

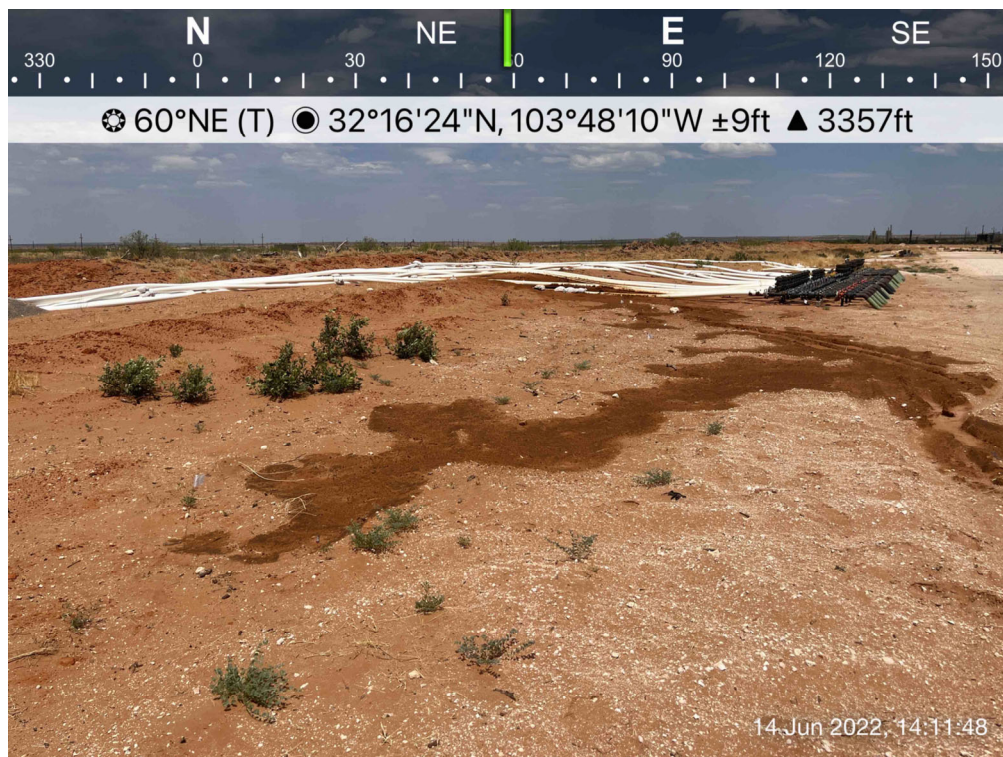
Pasture:

On 5/27/2022, OXY USA, Inc. reported a release at the Gold NC 26 CTB. The release was caused when a flowline ruptured while in service. Approximately 2,740 sqFt of the Pasture was found to be damp upon initial inspection.
