**Re: Remediation Summary, Deferral Request and Closure Report
Canvasback 13 Federal #002H
API No. 30-015-40538
GPS: Latitude 32.214831 Longitude -103.722968
UL "I", Sec. 13, T24S, R31E
Eddy County, NM
NMOCD Ref. No. 2RP-4813**

TRC Environmental Corporation (TRC), on behalf of COG Operating, LLC (COG), has prepared this *Remediation Summary, Deferral Request and Closure Report* for the Release Site known as the **Canvasback 13 Federal #002H**. Details of the Release are summarized below:

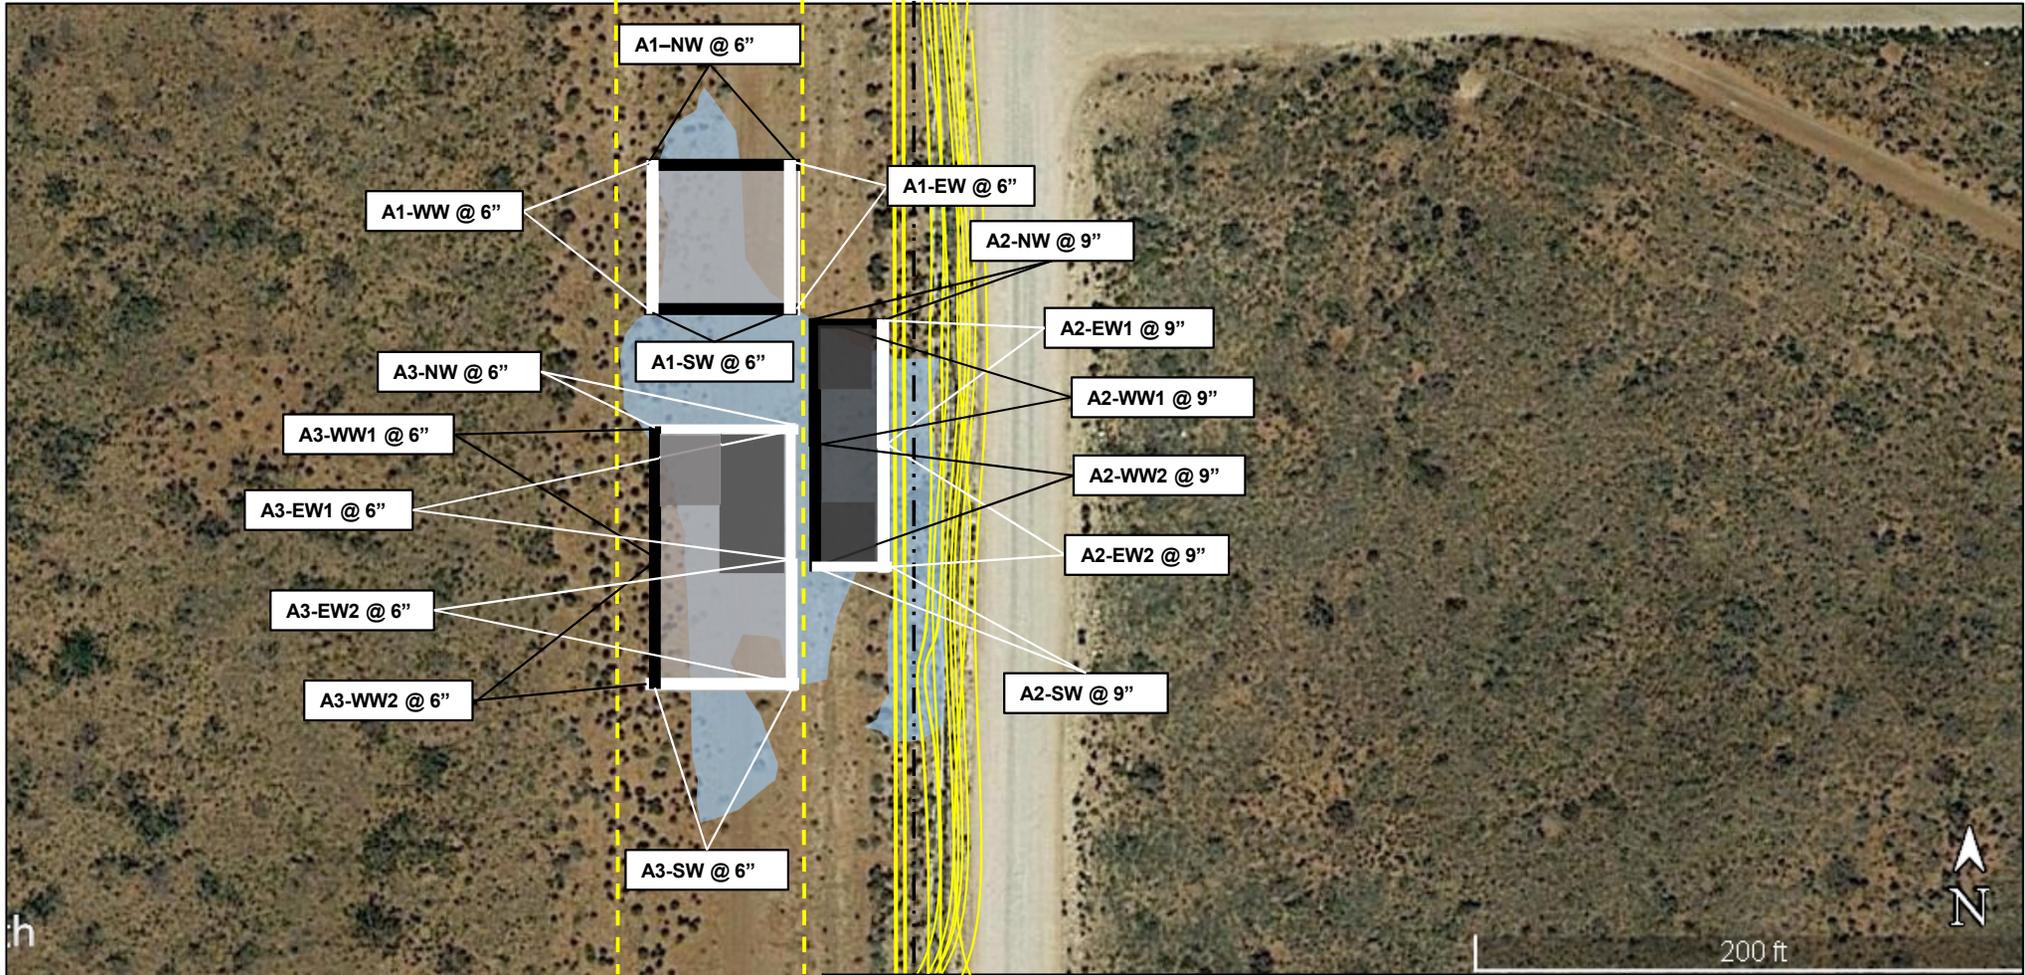
Figure 4A

Excavation & Confirmation Sample Location
 COG Operating, LLC
 Canvasback 13 Federal #002H
 Eddy County, New Mexico

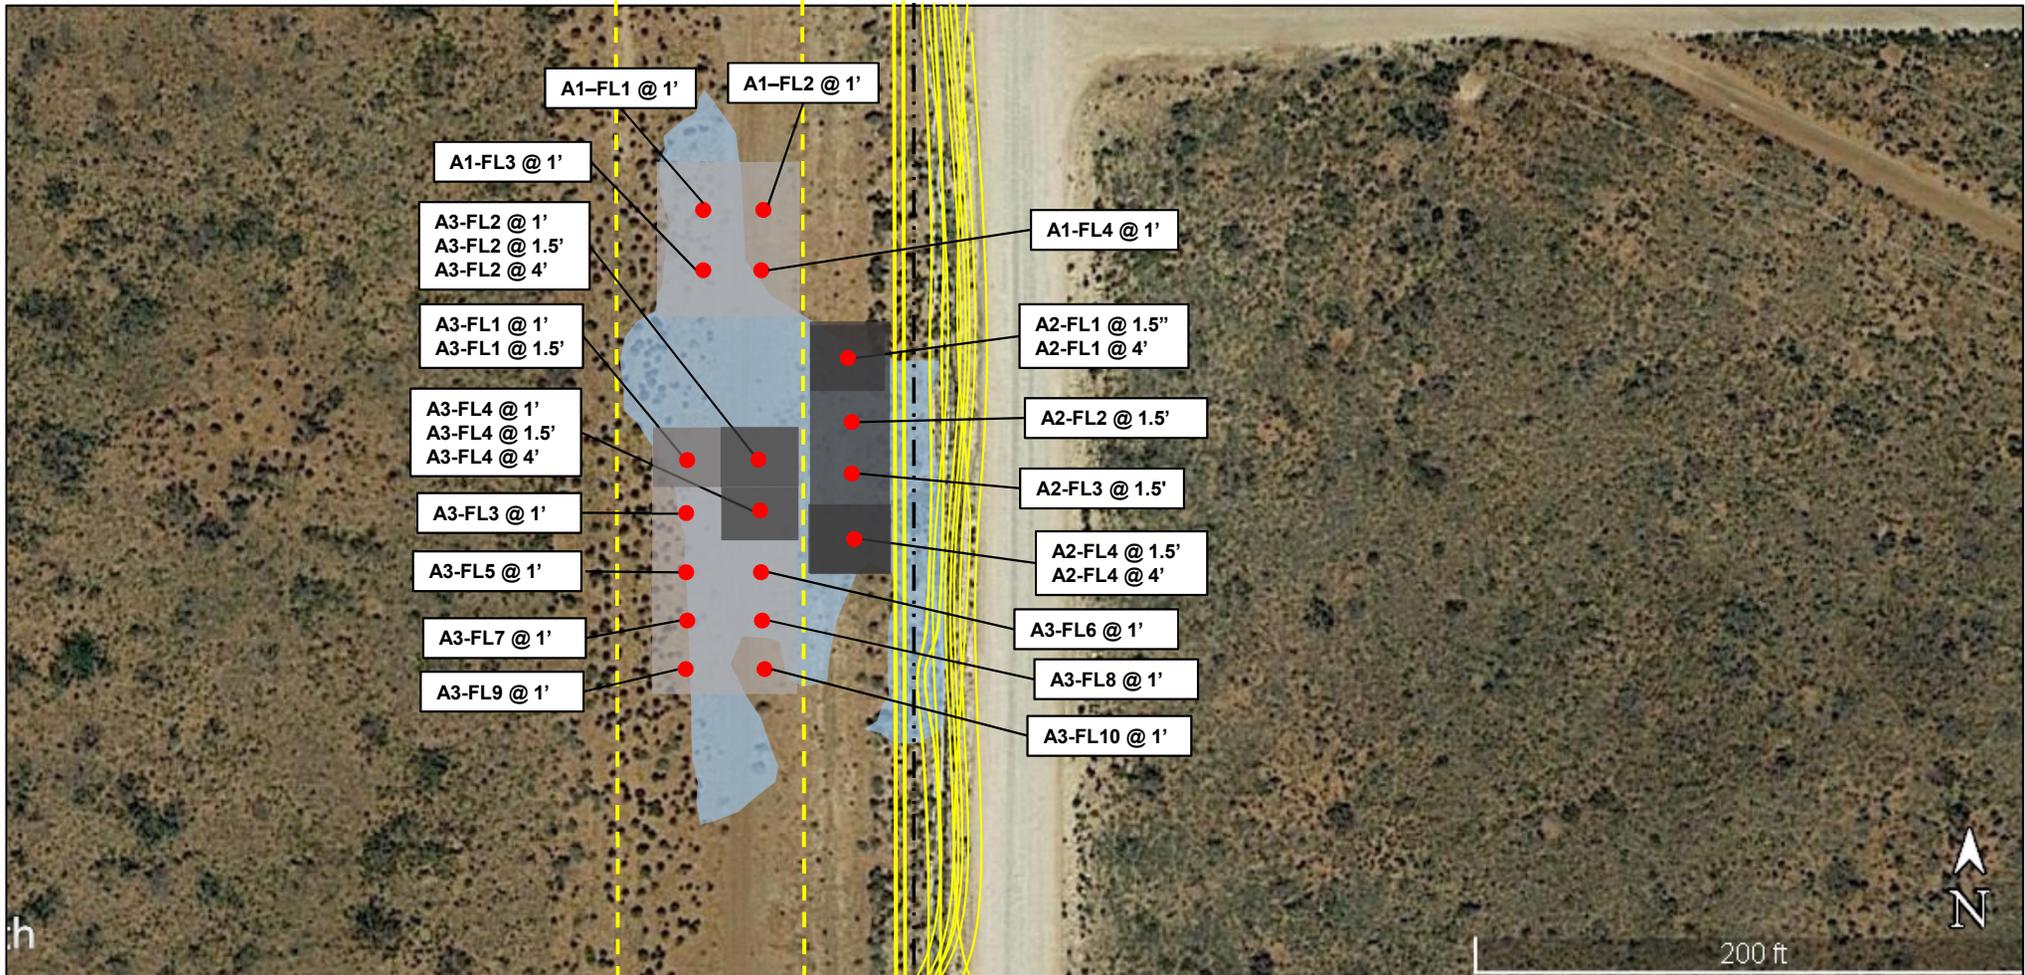
Figure 4B
 Excavation & Confirmation Sample Location
 COG Operating, LLC
 Canvasback 13 Federal #002H
 Eddy County, New Mexico

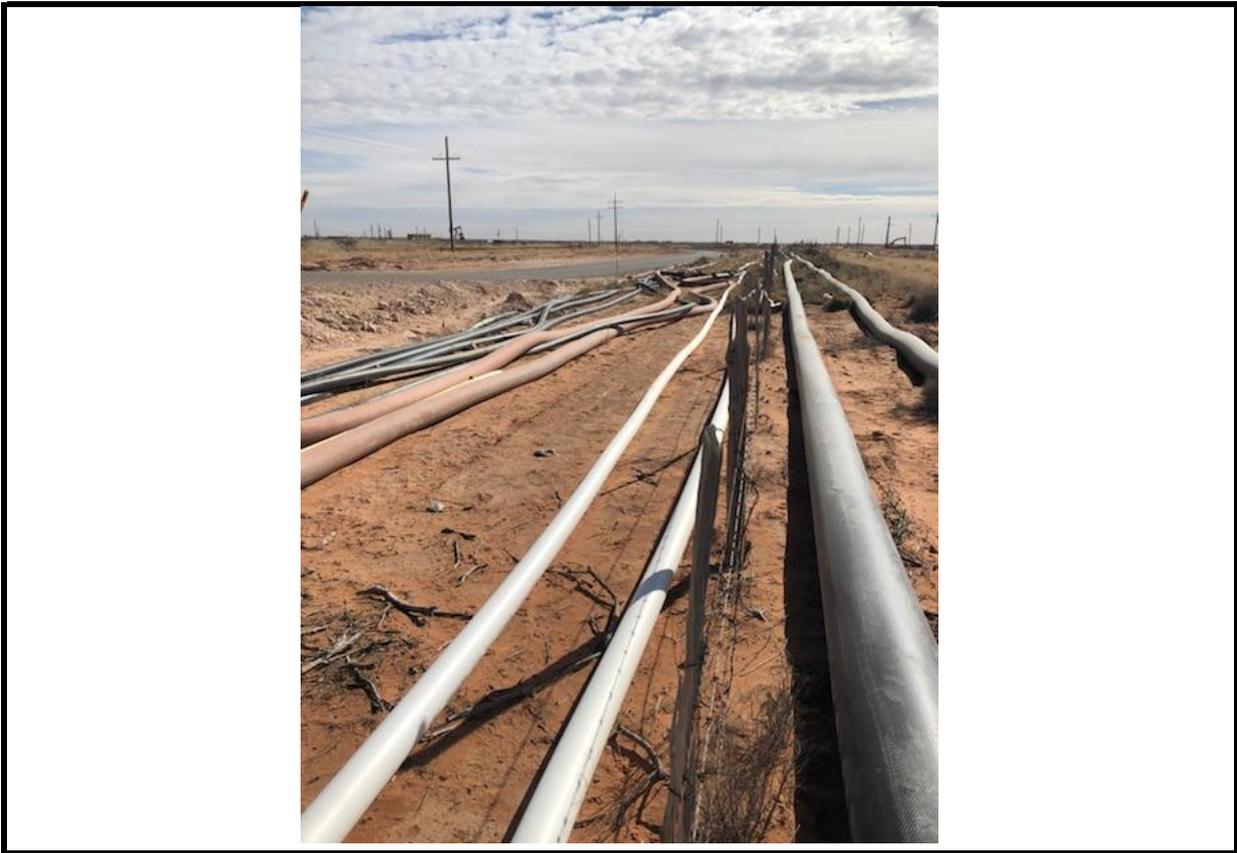
Photo 1 - View of affected area and above ground pipelines, facing South.

COG maintains excavation and backfilling of the affected area represented by soil sample location HA-7 @ 1' underlying above-ground pipelines would pose a risk which could result in potentially hazardous conditions and property damage. The area represented by soil sample location HA-7 does not exceed NMOCD and BLM regulatory guidelines at any other sampled depths except the one (1) foot bgs interval. Based on laboratory analytical results, site characteristics, and field observations made during the initial site visit and subsequent visits, COG requests remediation, restoration and reclamation of the area represented by soil sample HA-7 @ 1' be deferred until the equipment is removed during other operations and/or at time abandonment, whichever occurs first.

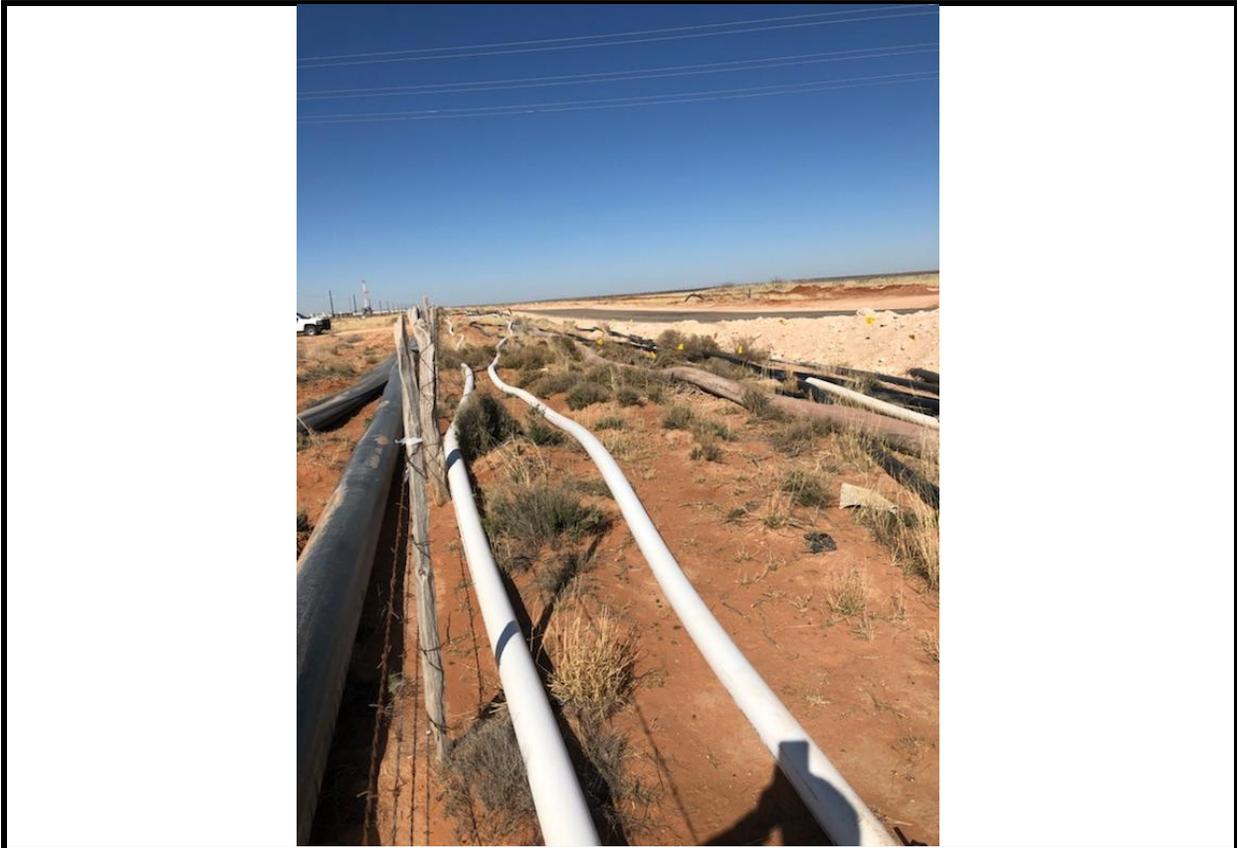
Photo 2- View of affected area and above ground pipelines, facing North.

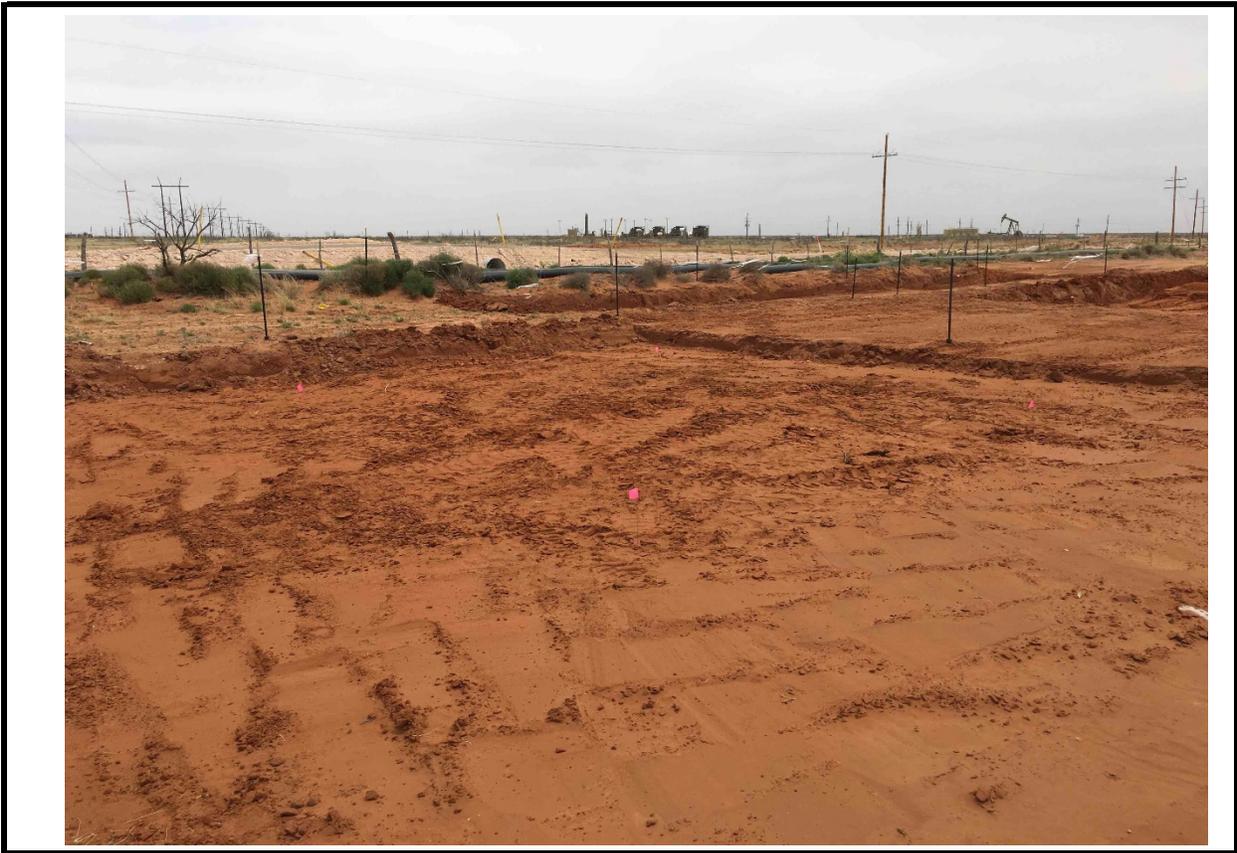
Photo 3 - View of excavated area A1 facing east (4/16/19).

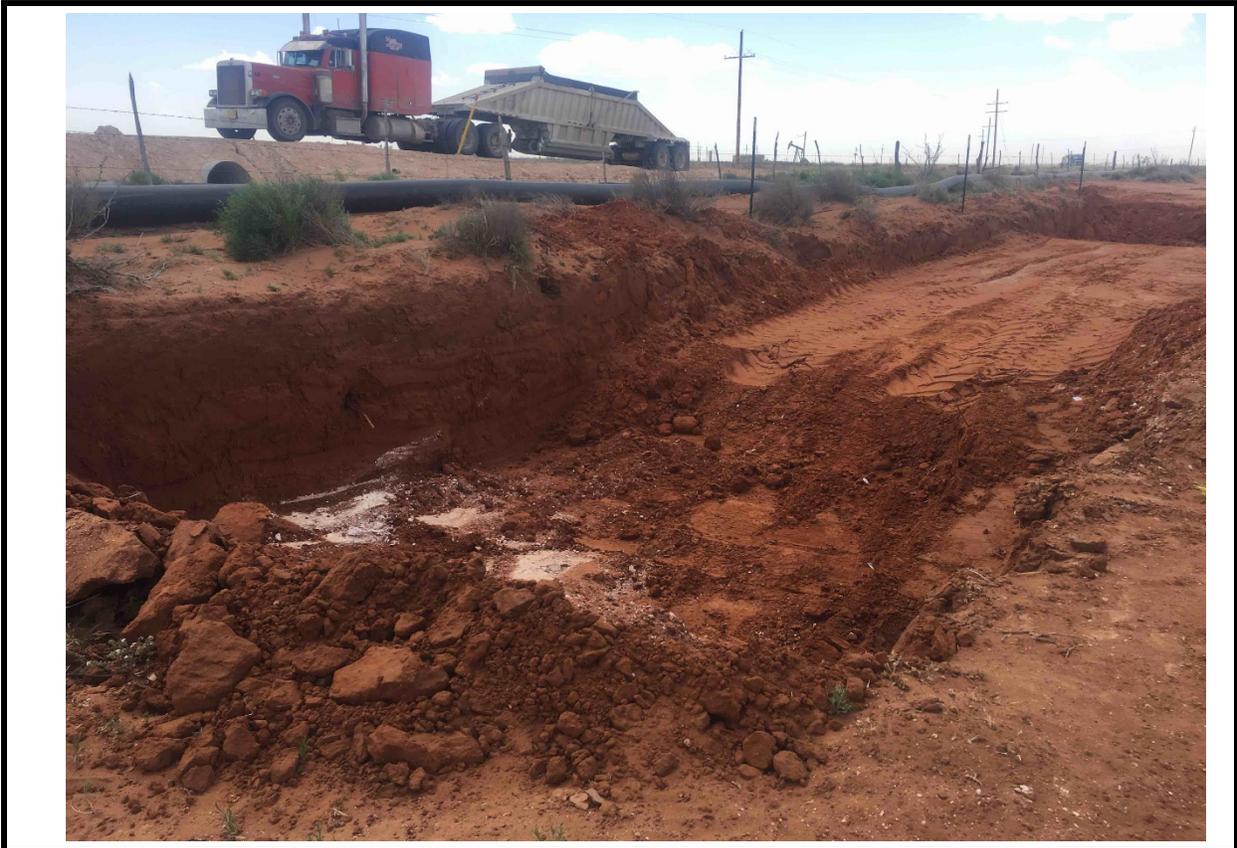
Photo 4 - View of excavated area A2 facing southeast (4/17/19).

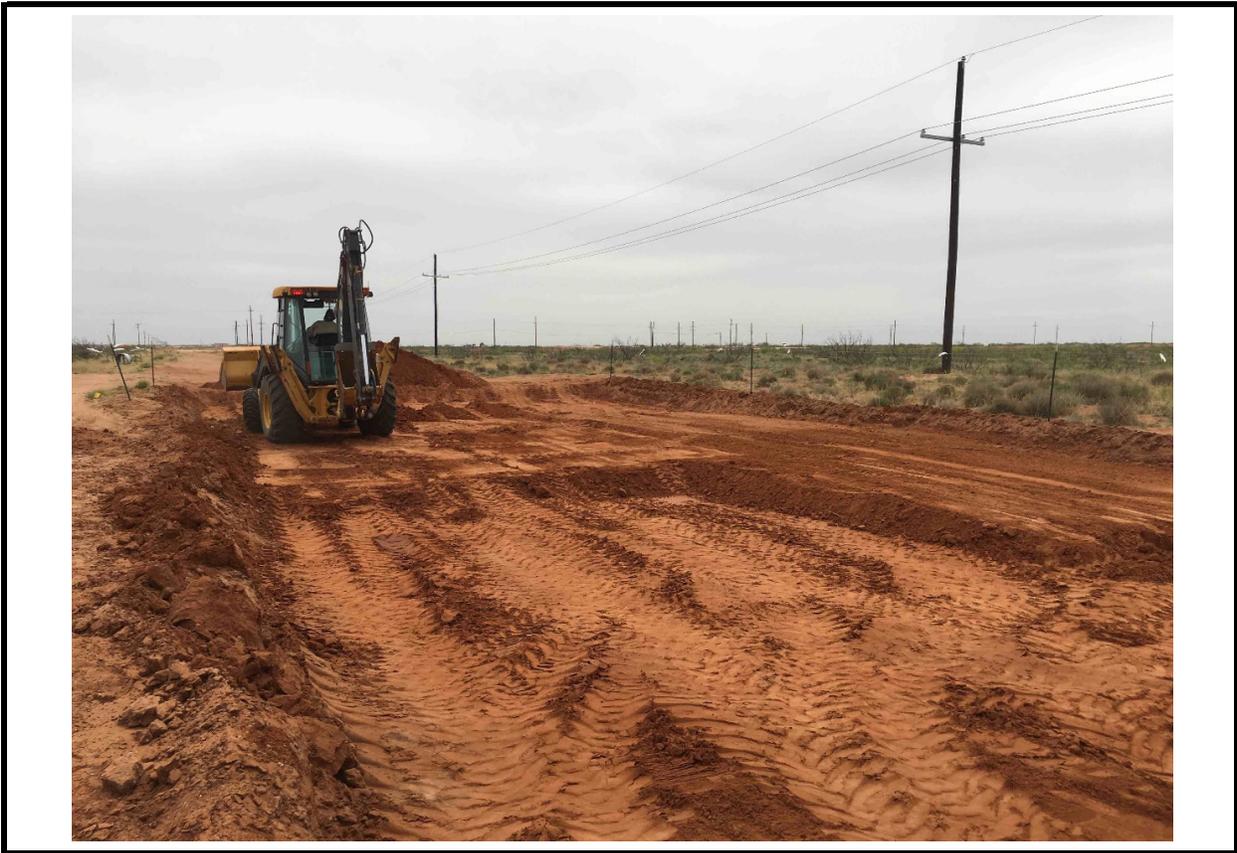
Photo 5 - View of excavated area A3 facing southwest (4/16/19).

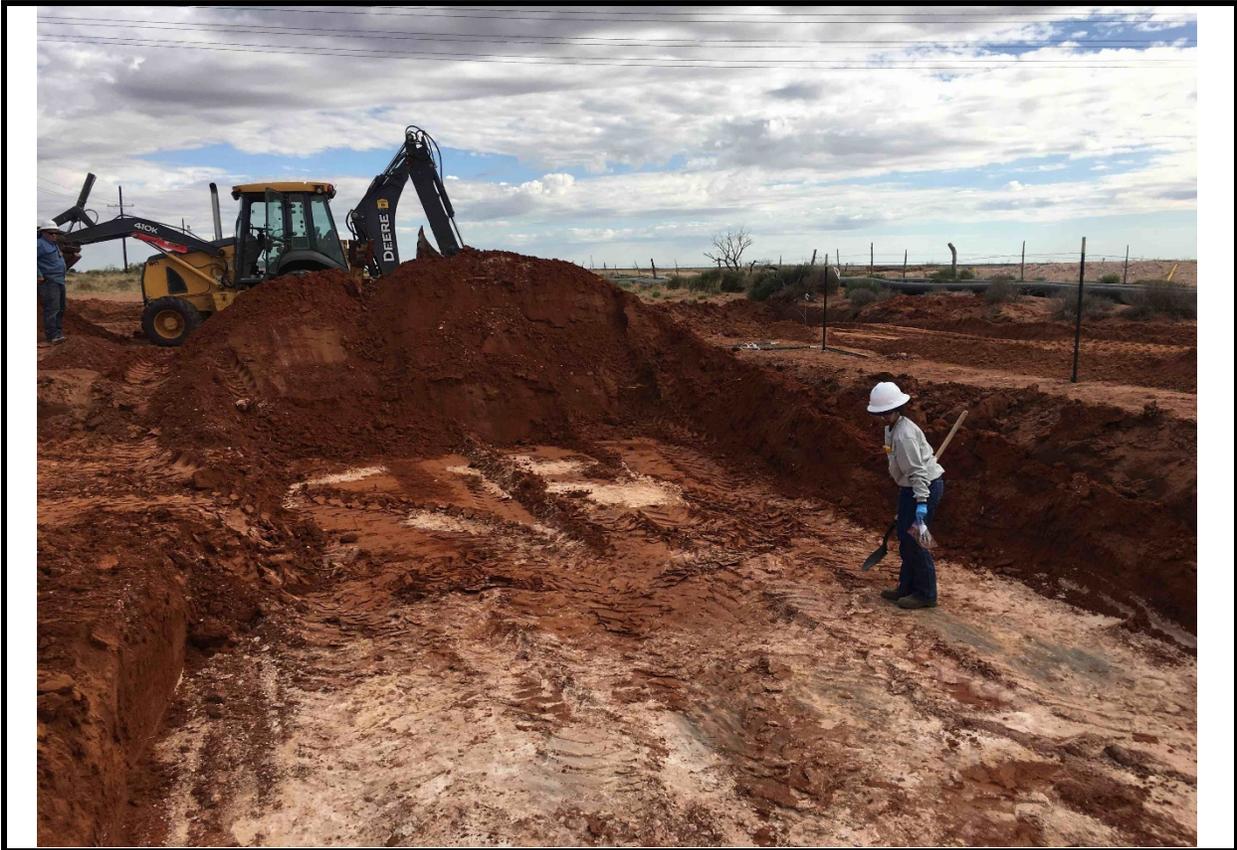
Photo 6 - View of excavation to four ft. bgs in area A3 facing northeast (4/18/19).

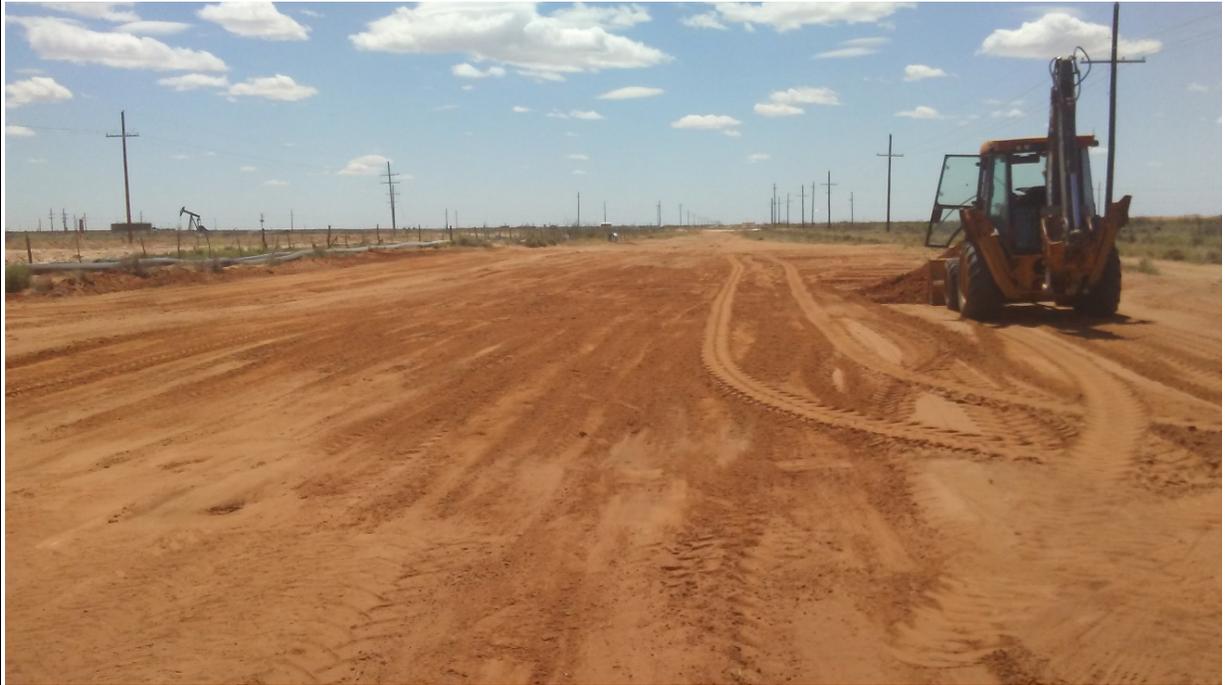
Photo 7 - View of the remediated area facing south (4/18/19).

Areas affected by the Release were substantially restored to the condition which existed prior to the release to the maximum extent practicable.

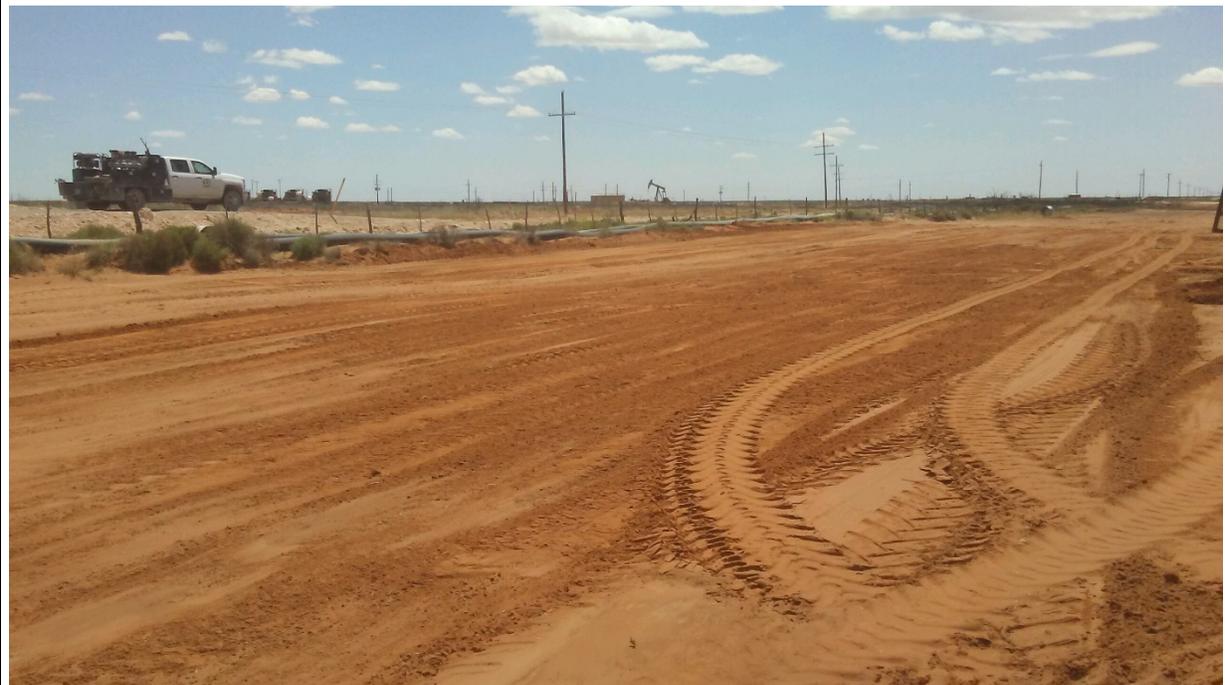
Photo 8 - View of remediated area facing southeast (4/18/19).
