SUBJECT: Remediation Closure Report for the B-6 360 Pipeline Release (nAPP2215229801), Eddy County, New Mexico

On behalf of Enterprise Field Services LLC (Enterprise), Souder, Miller & Associates (SMA) has prepared this Remediation Closure Report that describes the remediation of a natural gas and condensate release related to oil and gas gathering activities at the B-6 360 Pipeline Release (nAPP2215229801). The release site is located in Unit M, Section 29, Township 20S, Range 27E, Eddy County, New Mexico, on public land administered by the Bureau of Land Management (BLM). Figure 1 illustrates the vicinity and site location on a United States Geological Survey (USGS) 7.5-minute quadrangle map.

## B-6 360 Release Closure Report August 25, 2022

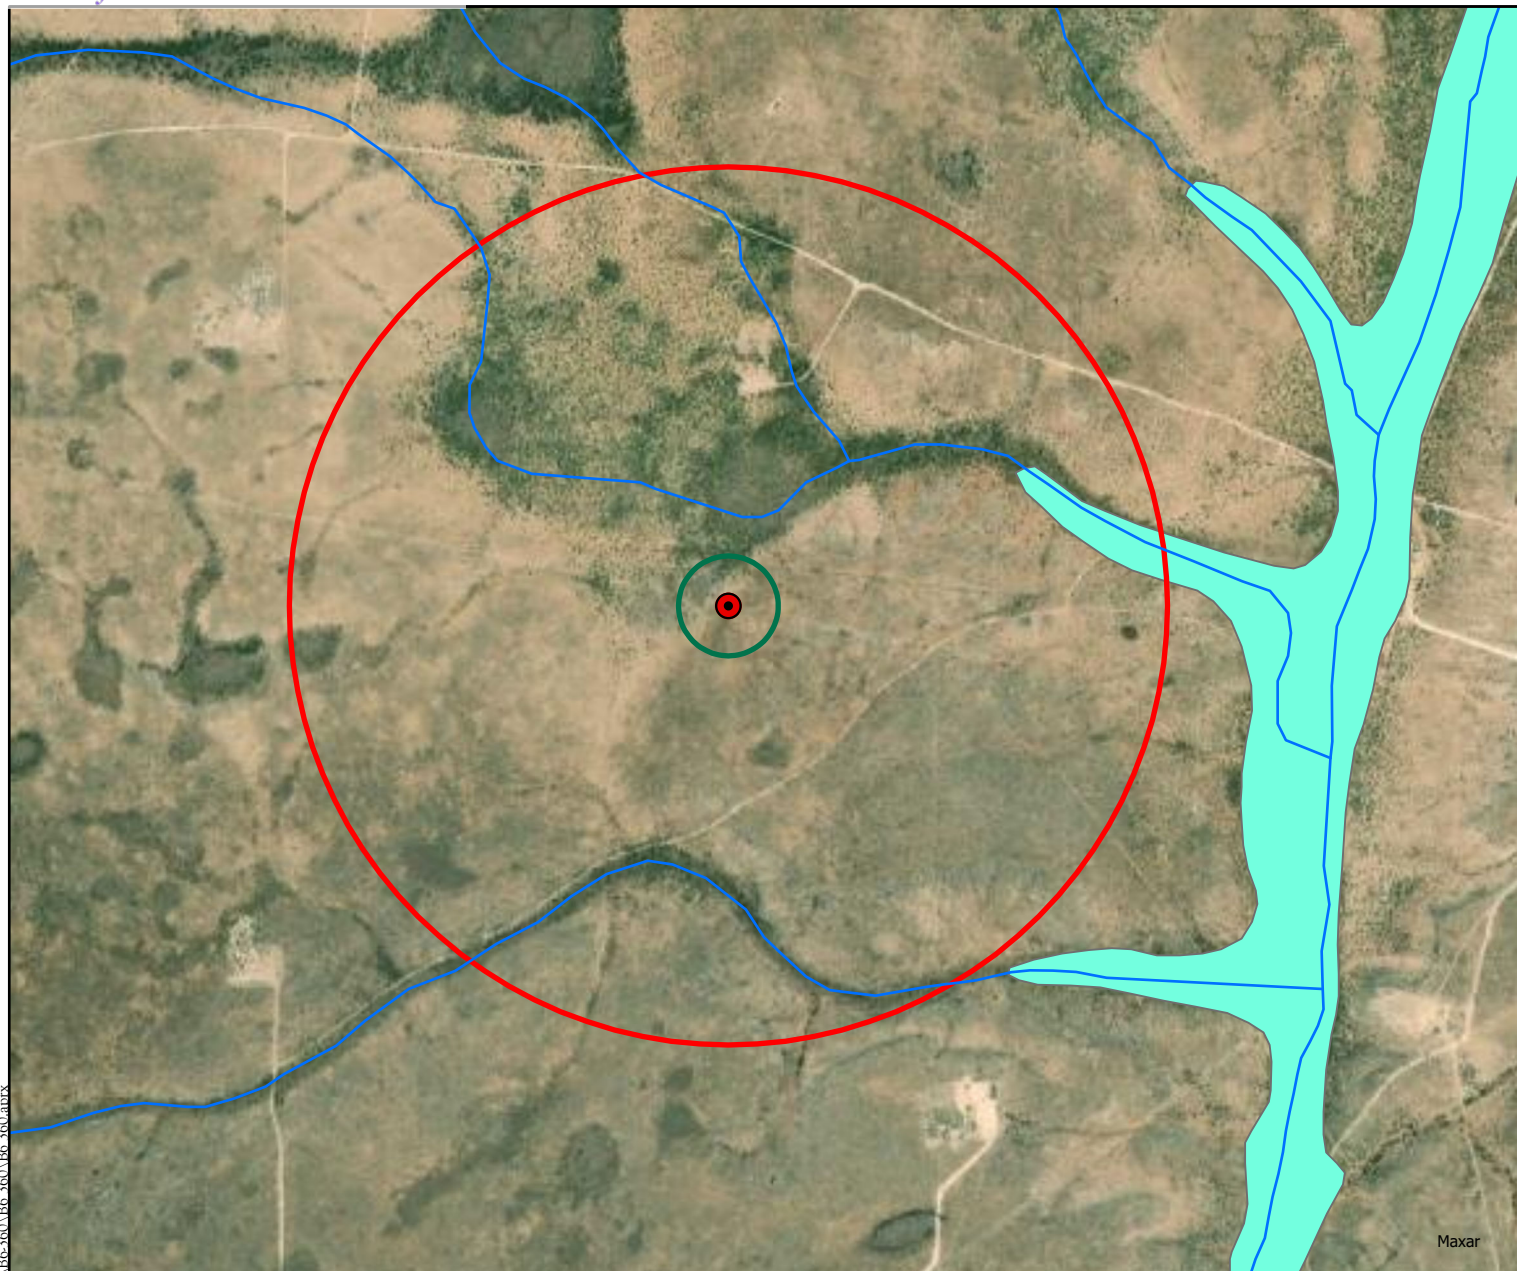
Figure 2

Table 2 demonstrates the Closure Criteria applicable to this location. Figures 1 and 2 illustrate the 200 and 300-foot radii which indicate that the site does not lie within a sensitive area as described in Paragraph (4) of Subsection (C) of 19.15.29.12 NMAC.

Aerial Site Map  
 B-6 360 - Enterprise Field Services LLC  
 S: 29 T: 20S R: 27E, Eddy County, New Mexico

The nearest significant watercourse is a tributary to Dagger Draw, located approximately 380 feet to the north.

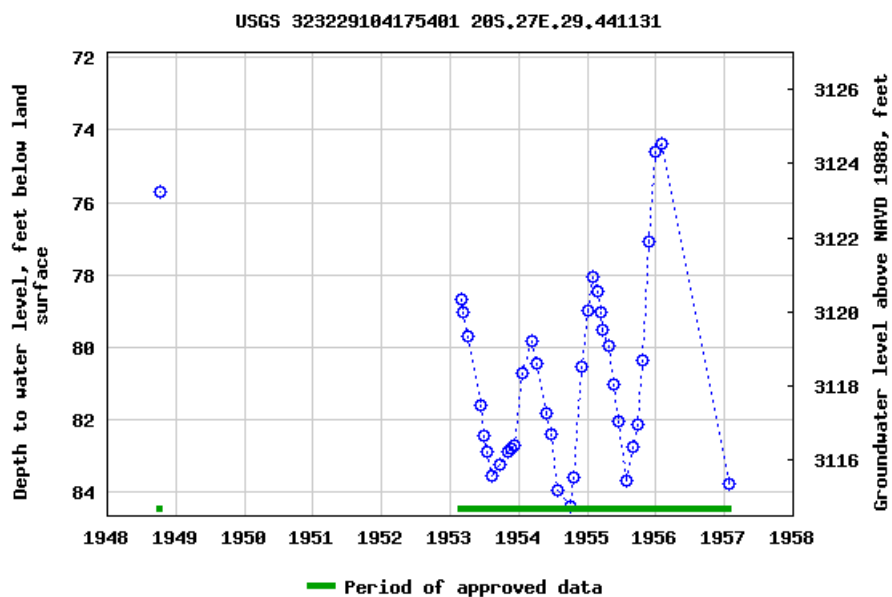
### USGS 323229104175401 20S.27E.29.441131

This well is completed in the Rustler Formation (312RSLR) local aquifer.

Breaks in the plot represent a gap of at least one year between field measurements.
