Re: Closure Report
Blondie 15-3 FED COM 6H
Unit G, S15, T26S, R34E
Site Coordinates: 32.046273, -103.454998
Lea County, New Mexico
Incident ID: nAPP2209837669

On behalf of Devon Energy Production Company (Devon), New Tech Global Environmental, LLC (NTGE) has prepared this letter to document site assessment and remedial action activities at the Blondie 15-3 FED COM 6H (Site). The Site is located approximately 16.2 miles west-southwest of Jal, New Mexico in Lea County (Figures 1 and 2).

**SITE LOCATION MAP
CLOSURE REPORT**
BLONDIE 15-3 FED COM 6
DEVON ENERGY PRODUCTION COMPANY
EDDY COUNTY, NEW MEXICO

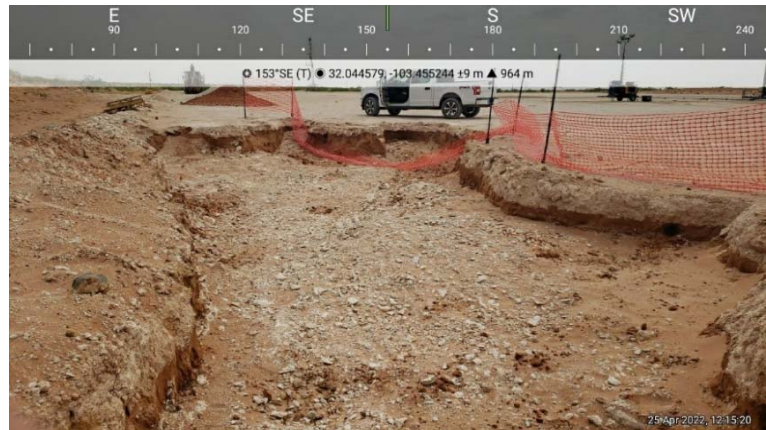
View Southeast, View of south spill area excavated.

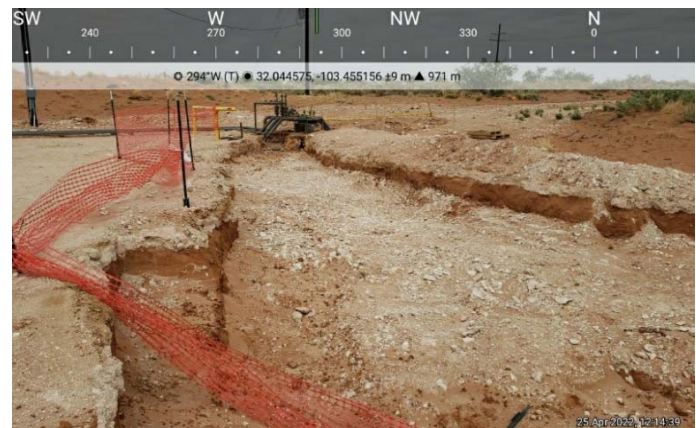
Photograph No. 2

View West, View of excavated northern spill area.

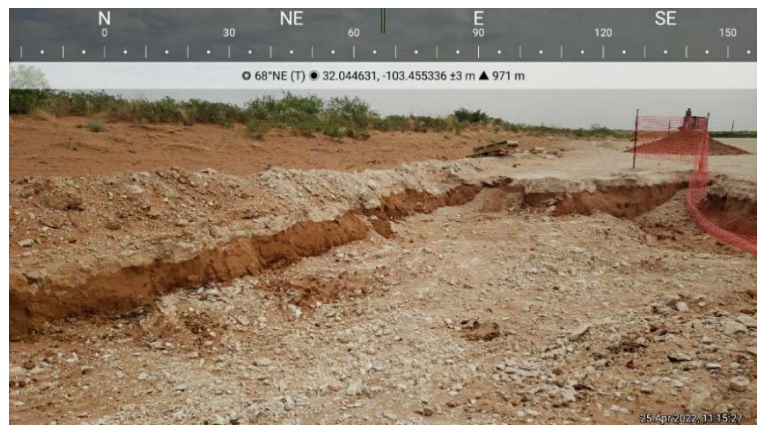
Photograph No. 3

View Northeast, View of northern sidewall.

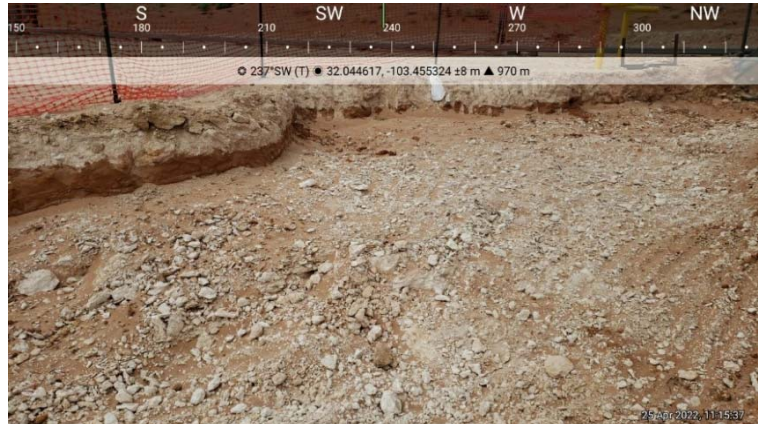
View Southwest, View of western sidewall.

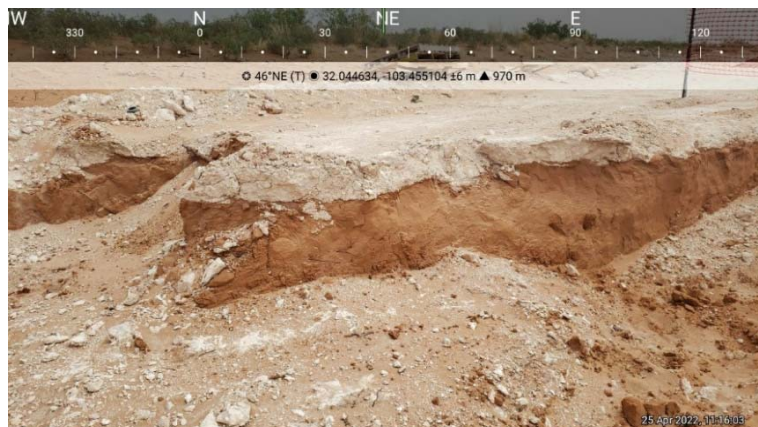
Photograph No. 6

View Northeast, View of northeastern sidewall.
