RE: Liner Inspection and Closure Report
Mean Green 27 Fed 1H Battery
API No. N/A
GPS: Latitude 32.022119 Longitude -103.450923
UL P, Section 22, Township 26S, Range 34E
NMOCD Reference No. NAPP2214628682

Devon Energy Production Company (Devon) has contracted Pima Environmental Services, LLC (Pima) to perform a liner inspection and prepare this closure report for a produced water release that happened at the Mean Green 27 Fed 1H Battery (Mean Green). An initial C-141 was submitted on June 7, 2022, and can be found in Appendix B. This incident was assigned Incident ID NAPP2214628682, by the New Mexico Oil Conservation Division (NMOCD).

**SITE PHOTOGRAPHS
DEVON ENERGY
MEAN GREEN 27 FED 1H**

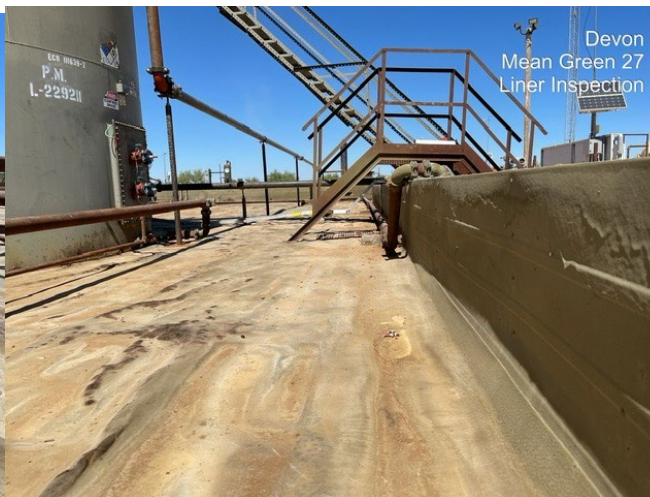
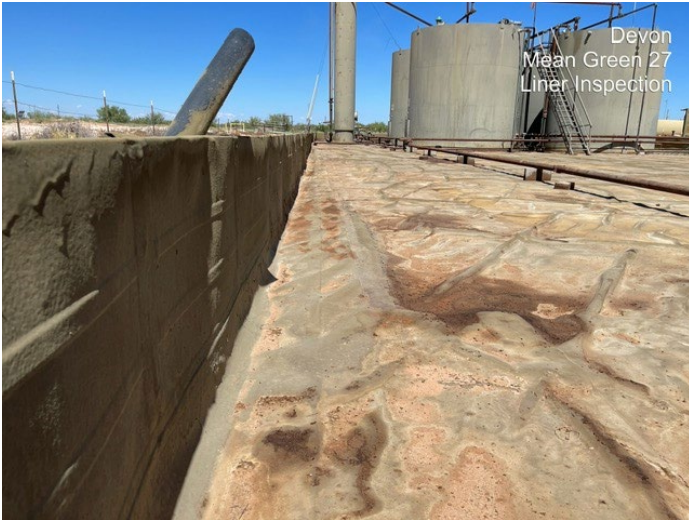
Liner Inspection

On September 23, 2022, after sending the 48-hour notification email, Pima Environmental conducted a liner inspection at this location. We concluded that this liner and containment maintained its integrity and was able to retain the fluids. The liner inspection form and photographic documentation can be found in Appendix C.
