Site Name: Canyon 1 SWD	Site Type: Saltwater Disposal Facility
Date Release Discovered: 9/1/2022	API# (if applicable) 30-045-34454

Executive Summary – Incident #nAPP2225752449

Scaled Site Map

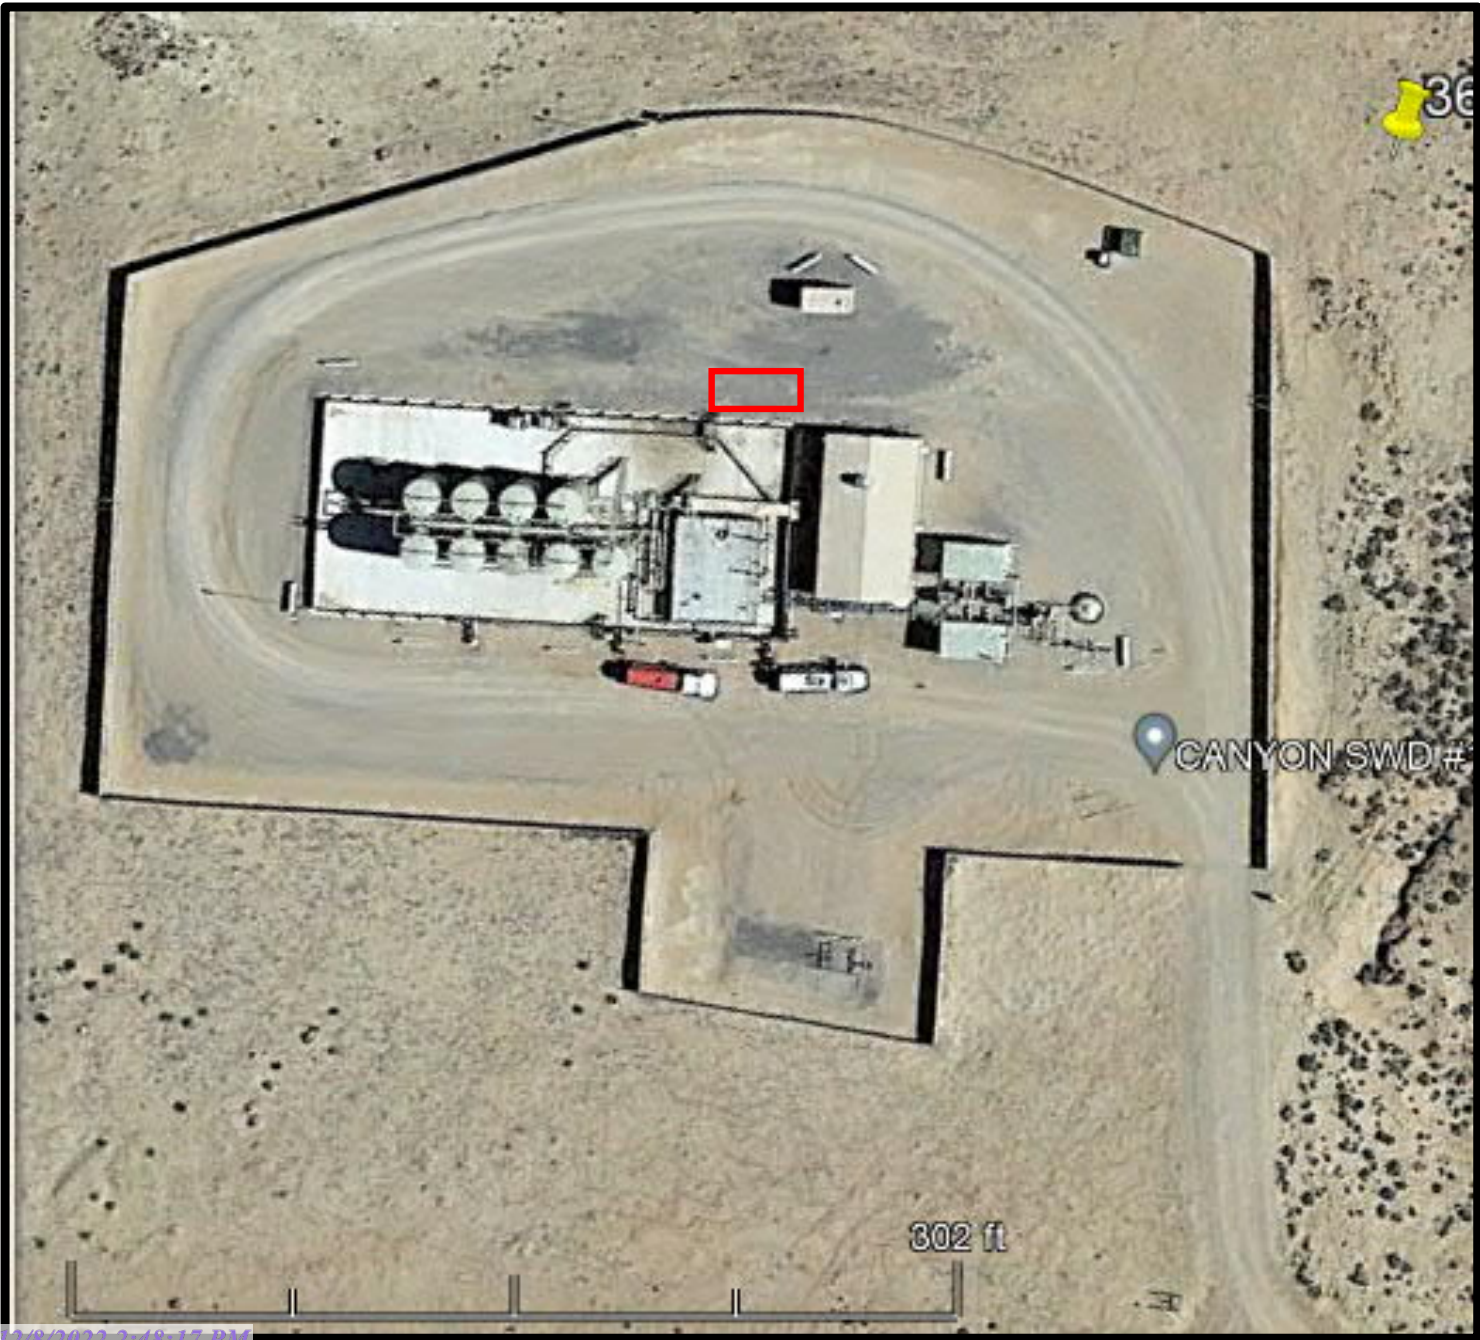
Release Area

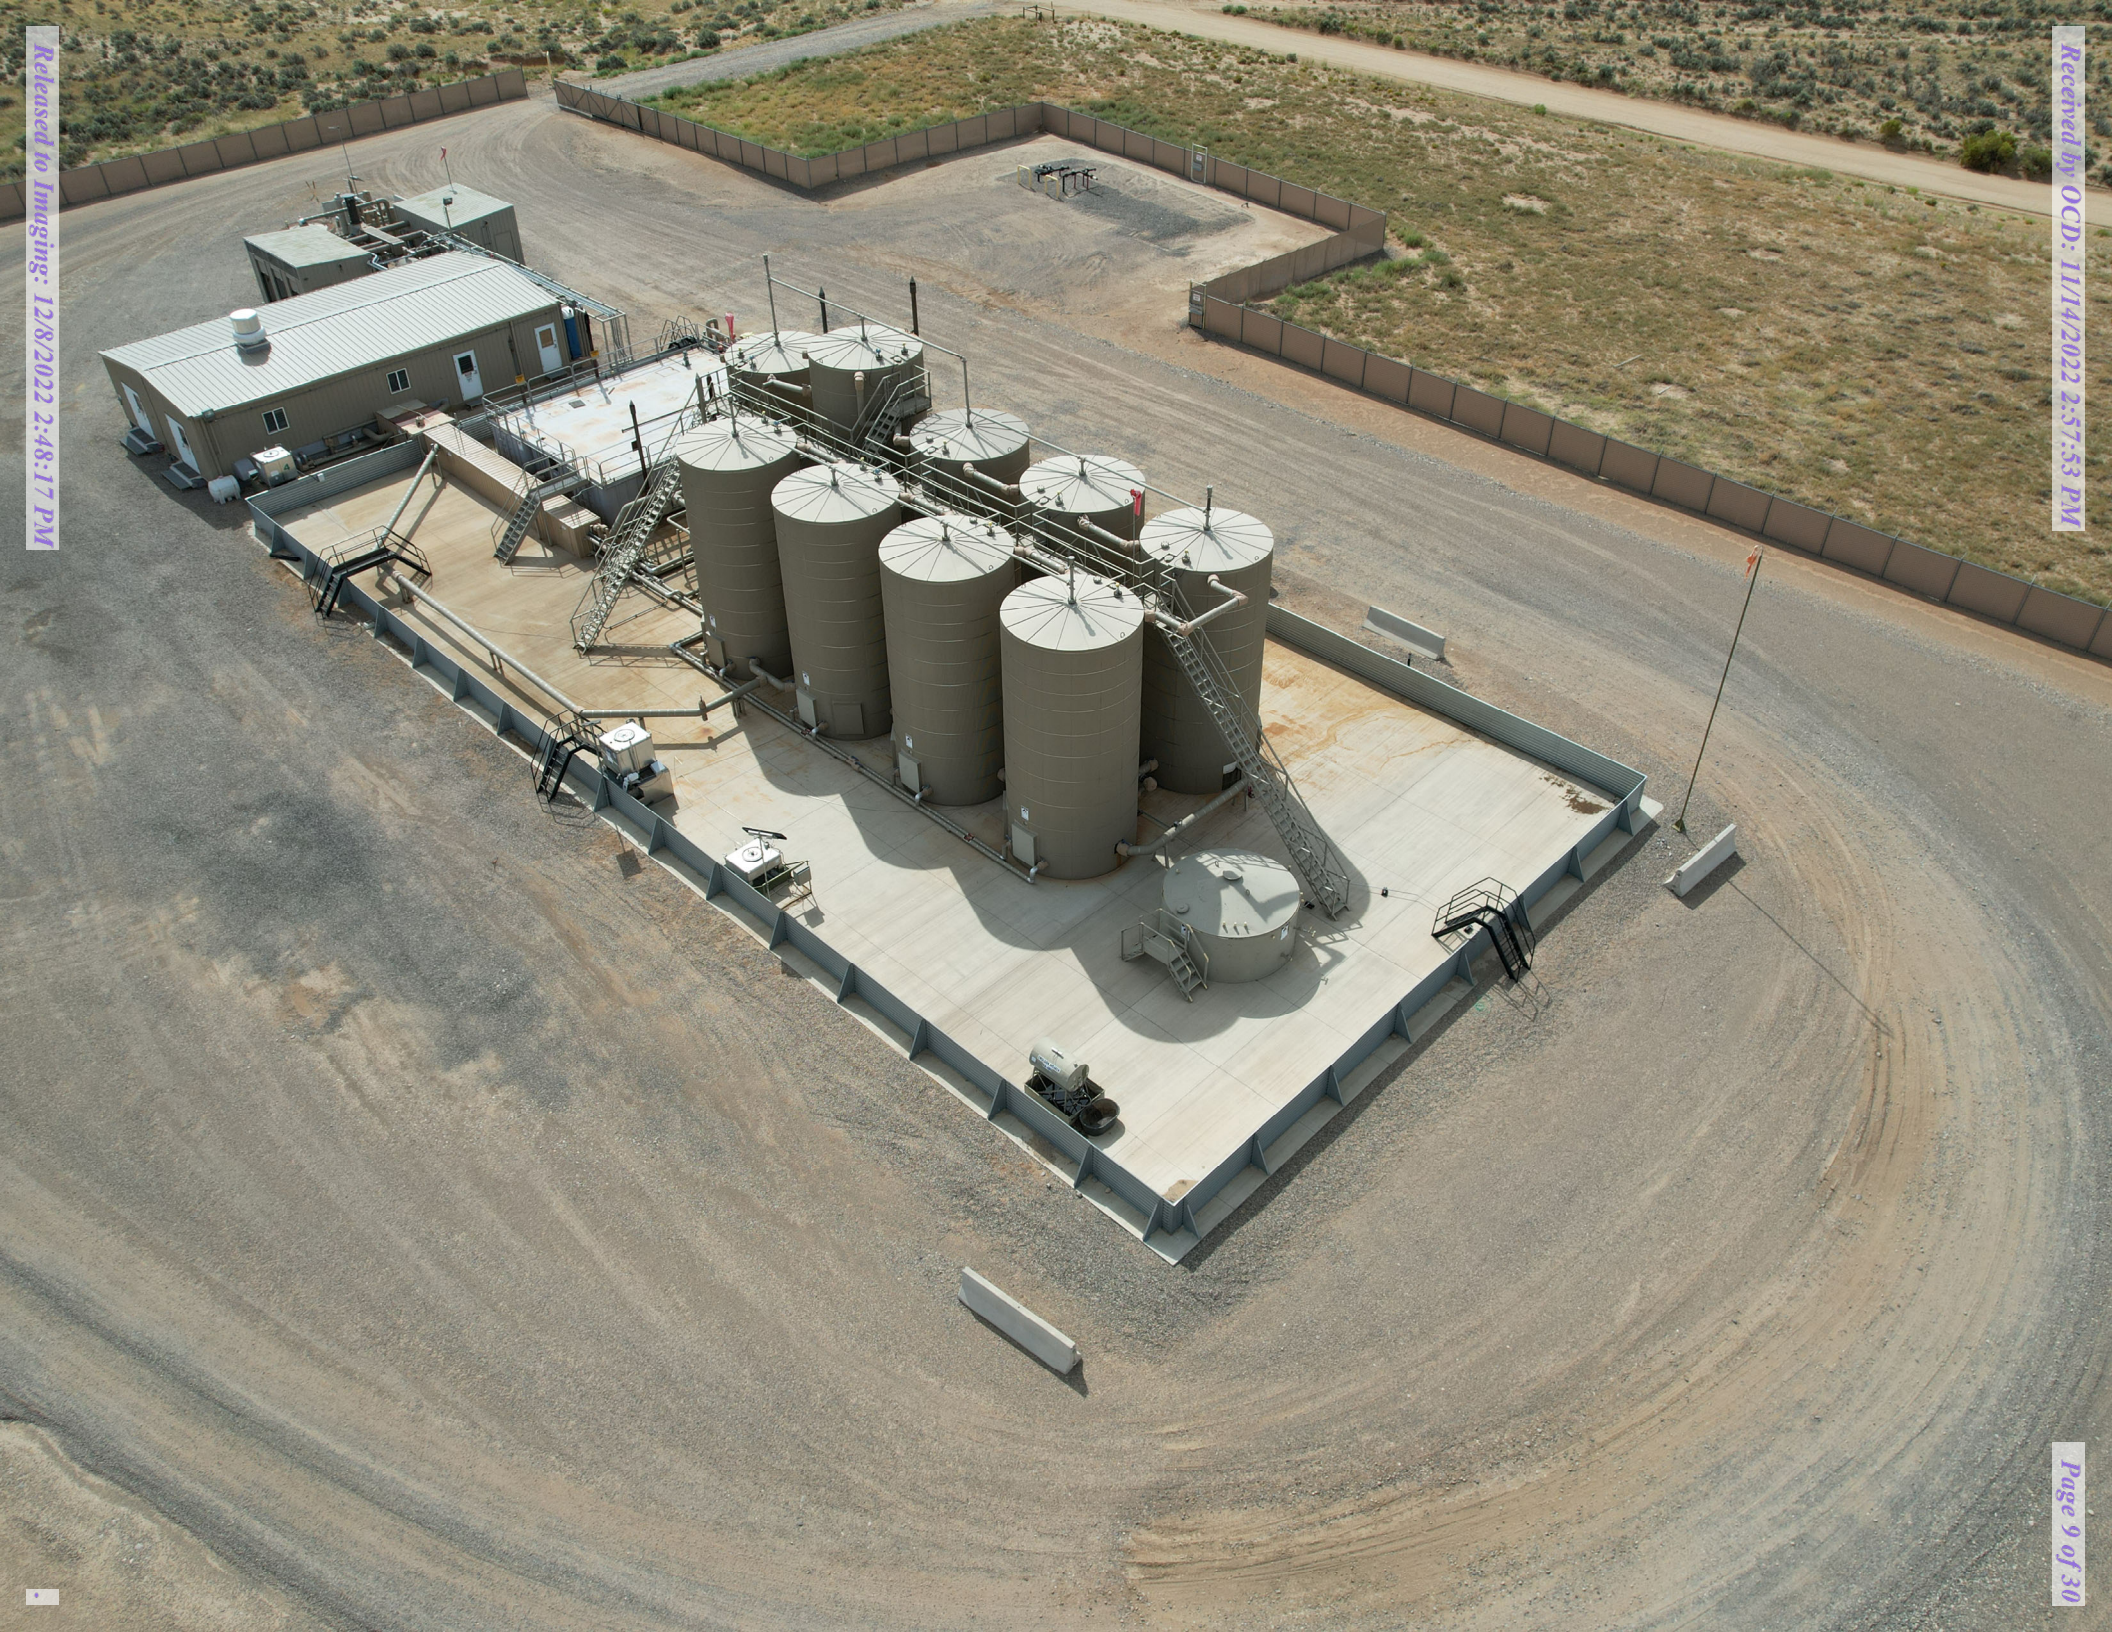
The tank is fully insulated with a capacity of 500 bbls. Approximately 200 bbls was released to the containment area comprised of a steel berm and concrete pad. Approximately 4 gallons impacted gravel outside the berm, via a bolt hole missing a bolt in the steel sidewall. The tank was isolated, and the remaining fluids removed. A vac truck was used to recover fluid from the containment area, and the impacted soil was removed and disposed of offsite.

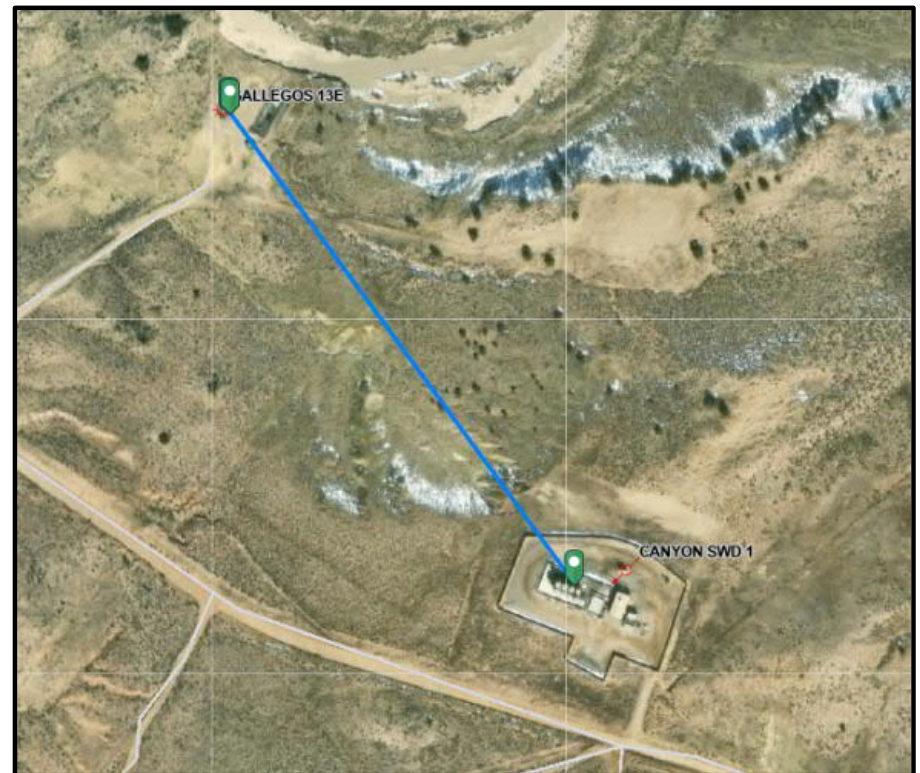
BGT Siting Criteria for Gallegos 13E – 0.25 miles northwest of the Canyon 1 SWD.

Estimated depth to groundwater is greater than 100'.

Groundwater data available from the NM State Engineer's iWaters Database for wells near the proposed site are attached. A map showing the locations of wells in reference to the proposed pit location is also attached. Water drops show locations of wells and the labels for each water drop indicate depth to groundwater in feet. The closest well to the site is an elevation of approximately of 6,355 feet and is located 3,225 feet to the southeast this well puts groundwater at 165 feet below the surface. The observations made within this report suggest that groundwater is greater than 100 feet deep at the proposed location.

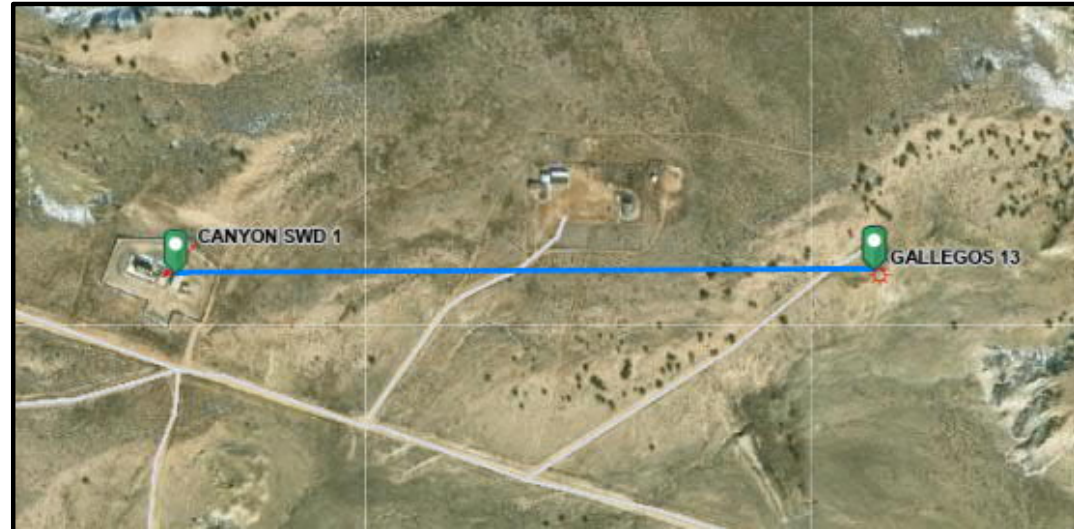
BGT Siting Criteria for Gallegos 13 – 0.5 miles east of the Canyon 1 SWD.

Estimated depth to groundwater is greater than 100'.

Groundwater data available from the NM State Engineer's iWaters Database for wells near the proposed site are attached. A map showing the locations of wells in reference to the proposed pit location is also attached. Water drops show locations of wells and the labels for each water drop indicate depth to groundwater in feet. The closest well to the site is an elevation of approximately of 6,356 feet and is located 786 feet to the northwest this well puts groundwater at 165 feet below the surface. The observations made within this report suggest that groundwater is greater than 100 feet at the proposed location.

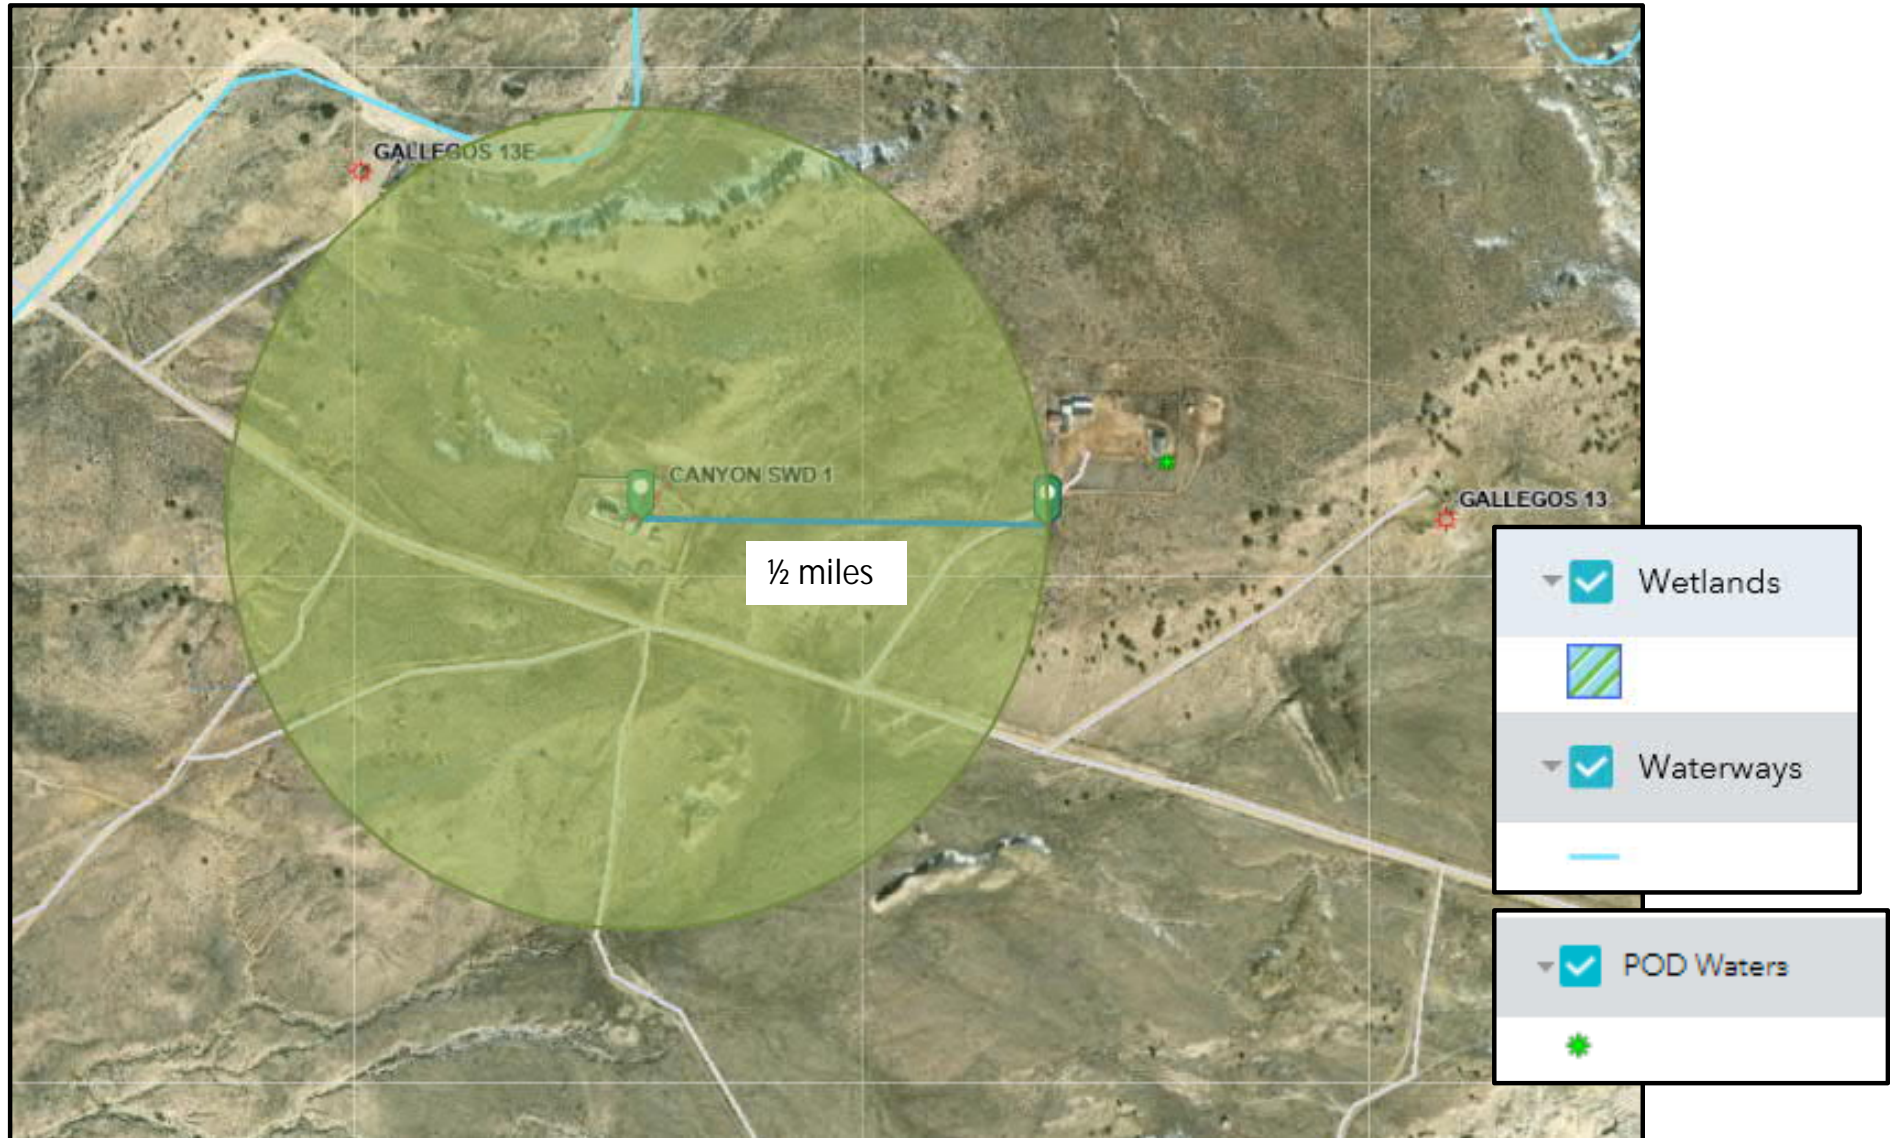
Determination of water sources and significant watercourses within ½ mile of the lateral extent of the release

Note 1: Release point is not shown to be within 300 ft of any continuously flowing watercourse or any other significant water course.

Note 2: The lateral extents of the release point are not shown to be within 300 feet of a mapped wetland.

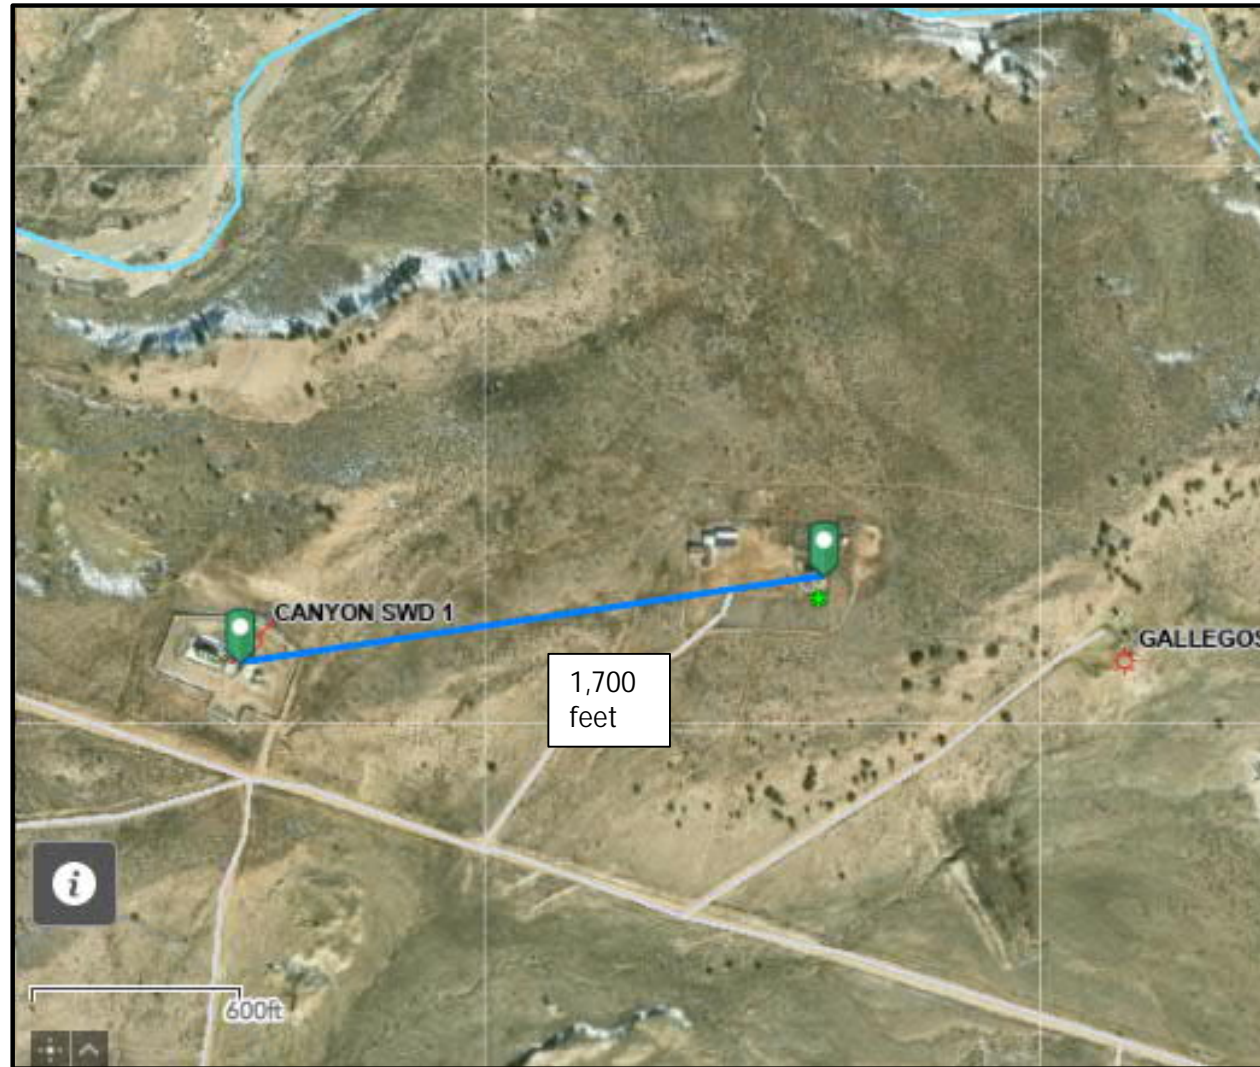
Distance to mapped water wells.

Note: The lateral extents of the release point are not shown to be within 500 ft of a spring or domestic freshwater well used by less than 5 households (or stock watering) or within 1,000 ft of any freshwater water well or spring.

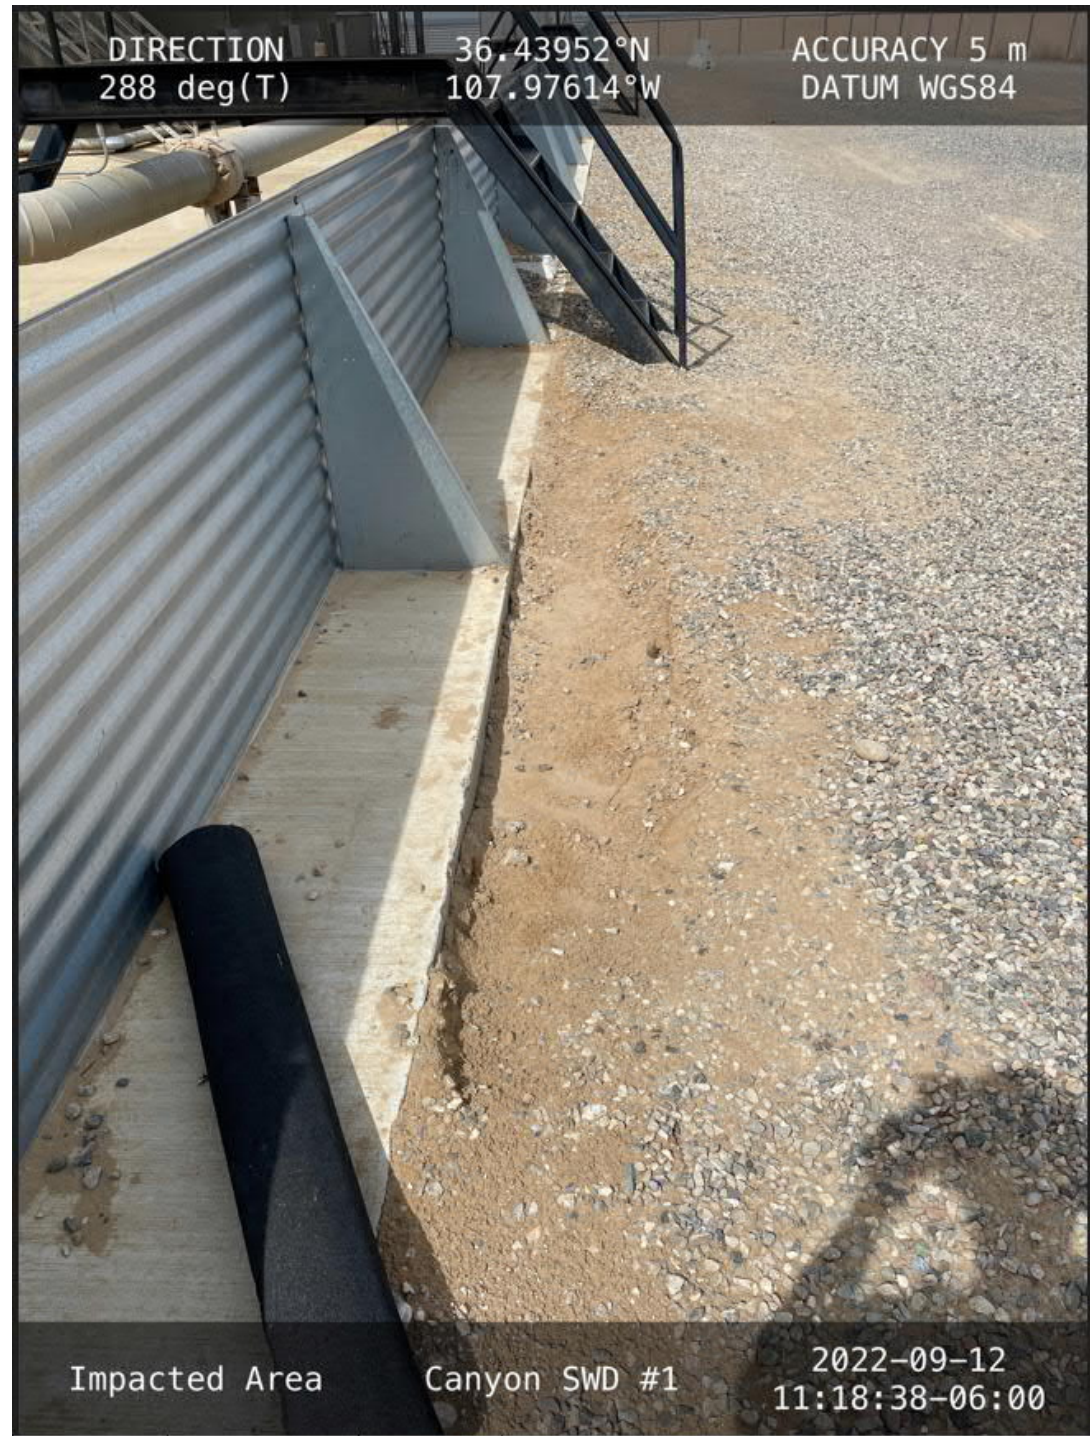
Sample Locations/Field Notes - 10/4/2011

- Impacted area approximately 16' L x 1' W x 5" D
- Total area: 16 sq. ft.
- One 5-pt composite sample collected
