**Re: Site Assessment Summary and Proposed Remediation Plan**  
**Mas Federal Com #002H**  
**API No. 30-015-44214**  
**GPS: Latitude 32.53632 Longitude -103.54164**  
**UL "A", Sec. 34, T20S, R34E**  
**Lea County, NM**  
**NMOCD Ref. No. 1RP-5138**

TRC Environmental Corporation (TRC), on behalf of COG Operating, LLC (COG), has prepared this *Site Assessment Summary and Proposed Remediation Plan* for the Release Site known as the **Mas Federal Com #002H**. Details of the release are summarized below:

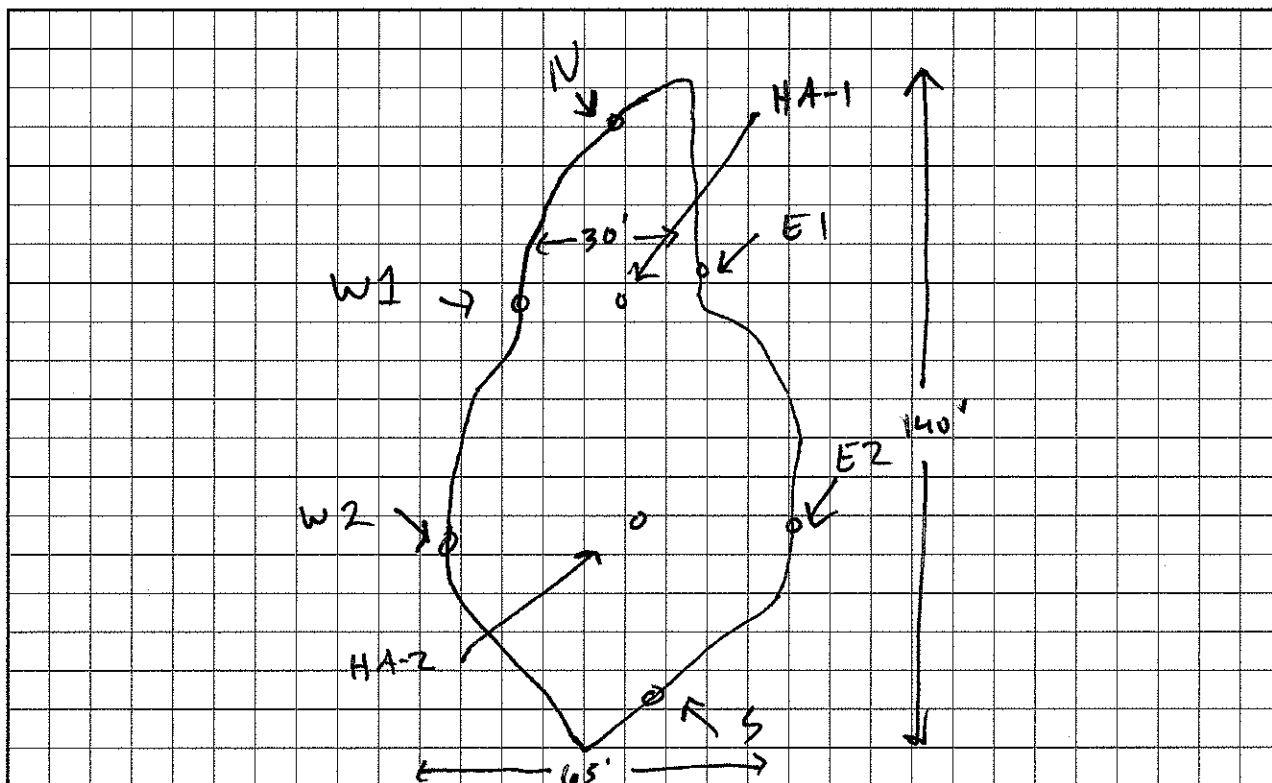
## Field Observation Log

ID	CI-	Odor/PID
HA-1-0'	798	Slight
HA-1-1'	76.4	None
HA-1-2'	17.0	None
GPS:

ID	CI-	Odor/PID
HA-2-0'	2,910	Moderate
HA-2-1'	141	Slight
HA-2-2'	28.7	None
GPS:

ID	CI-	Odor/PID
N01'	76.0	None
GPS:

ID	CI-	Odor/PID
E101'	20.6	None
GPS:

ID	CI-	Odor/PID
E201'	58.5	None
GPS:

ID	CI-	Odor/PID
S01'	13.3	None
GPS:

ID	CI-	Odor/PID
W101'	93.3	None
GPS:

ID	CI-	Odor/PID
W201'	165	None
GPS:
