Remediation and Closure Report

West Shugart 30 Federal #001
Eddy County, New Mexico
30-015-29166
Incident #NAB1631955174

Subject: **Remediation and Closure Report**
West Shugart 30 Federal #001
Eddy County, New Mexico
Incident #NAB1631955174

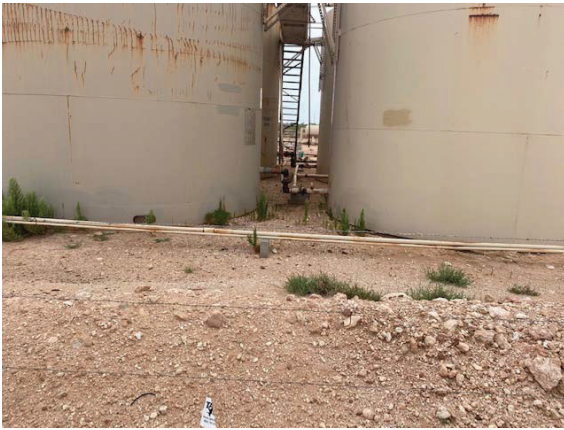
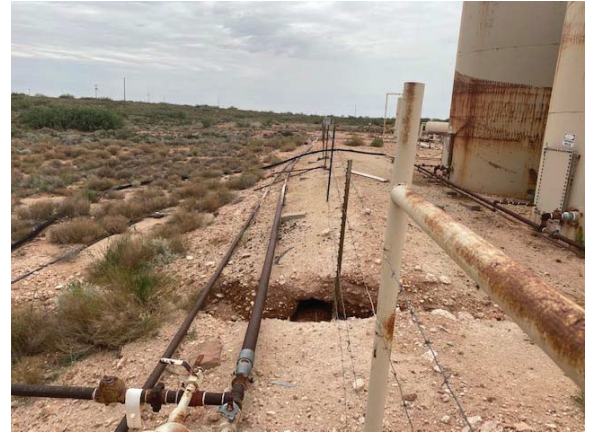
S. side of containment

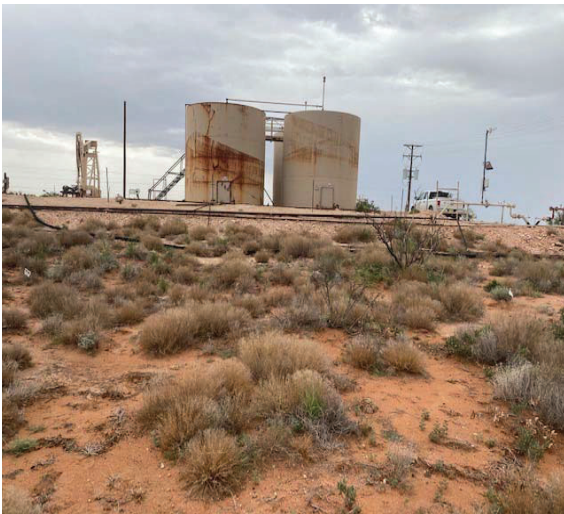
Pasture Area

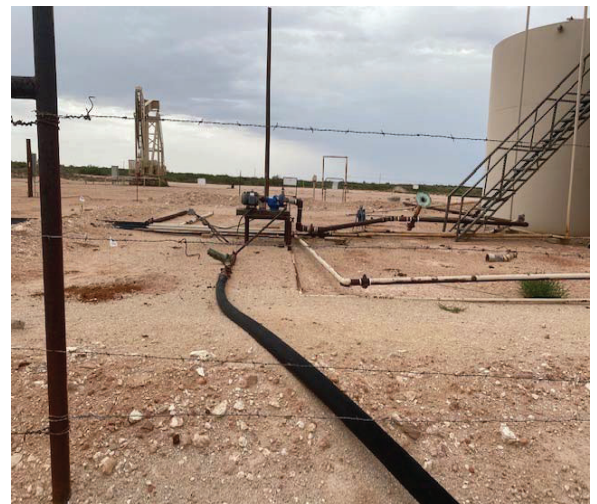
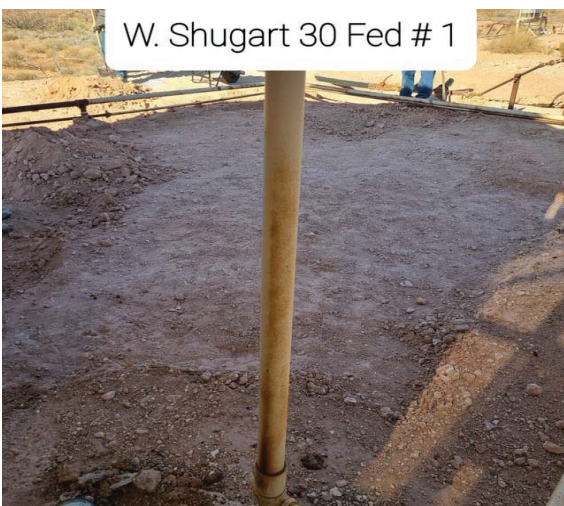
W. Shugart 30 Fed # 1

Interior of containment hand excavated @ (S1 and S2)

On December 03, 2020 Talon mobilized equipment and personnel to the West Shugart 30 Federal #001. The areas of sample positions 1 (S-1) thru S-2 were hand excavated to a depth of 1' BGS. Utilizing mechanized equipment, the south background area was also excavated to a depth of 1' bgs. Composite samples were retrieved and transported to hall Laboratories for analysis of total Chloride, TPH, and BTEX. The confirmation results are tabled below.

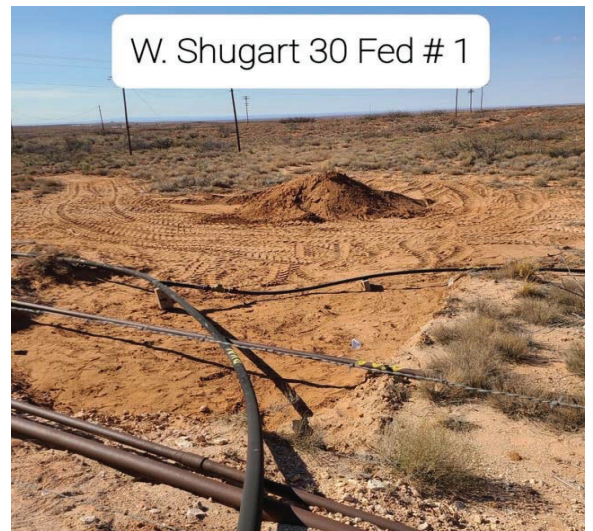
W. Shugart 30 Fed # 1

Pasture Excavation

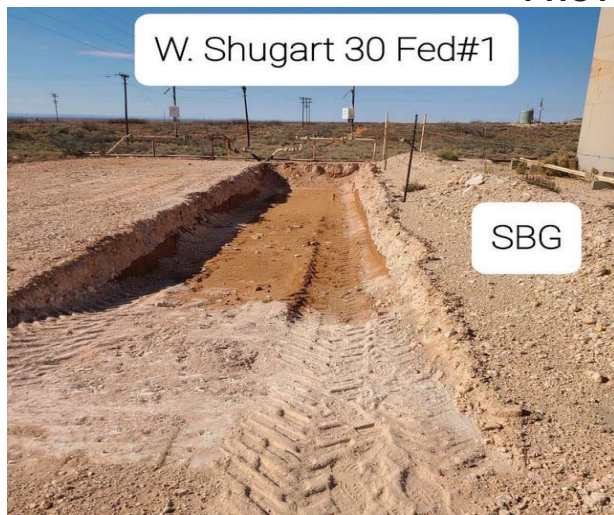
Excavated area South of containment

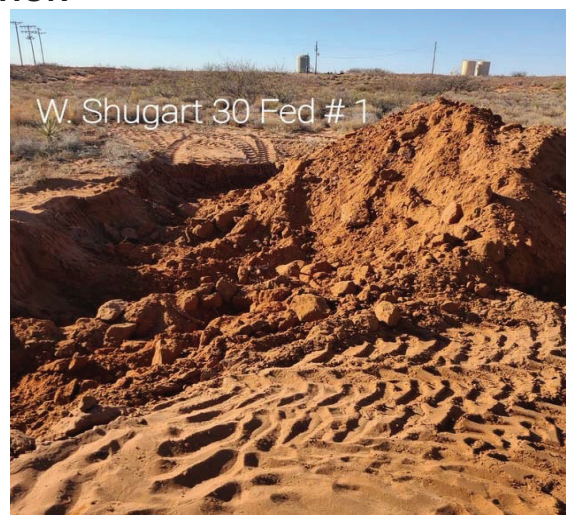
Pature Area

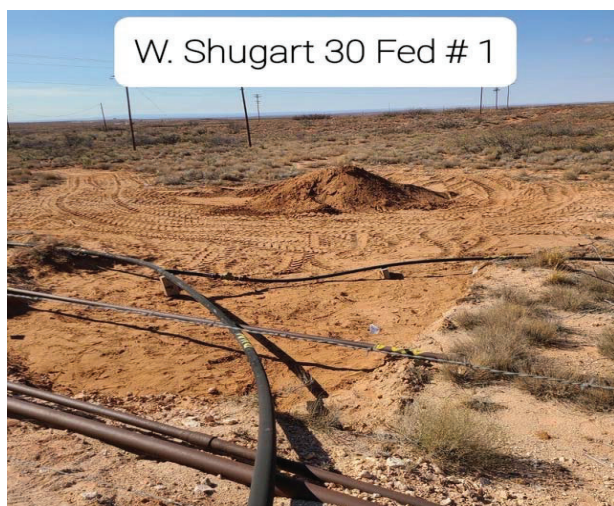
Pasture Backfilled

- The West Shugart 30 Federal #001 was remediated in accordance with the approved work plan.
- The impacted soil was excavated and disposed of at a NMOCD approved solid waste disposal facility.
- Confirmation soil samples were collected and verified analyte levels were below NMOCD and BLM remediation guidelines.
- Fresh caliche, similar in grade was used to backfill the location. The containment area was packed and restored to surrounding grade.
- The pasture area has been reseeded in accordance with BLM guidelines.

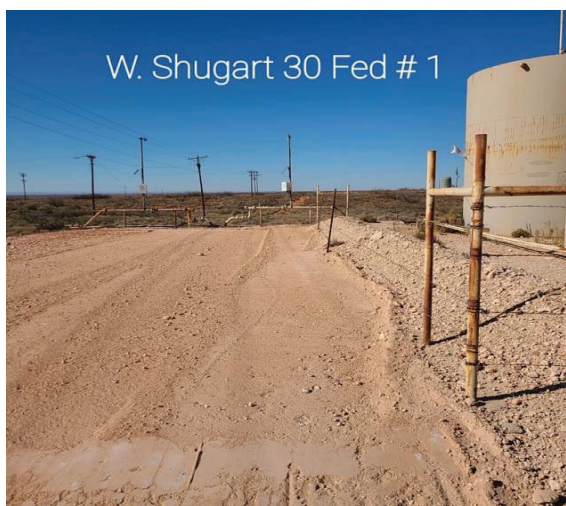
Restored Pad Area S. of containment

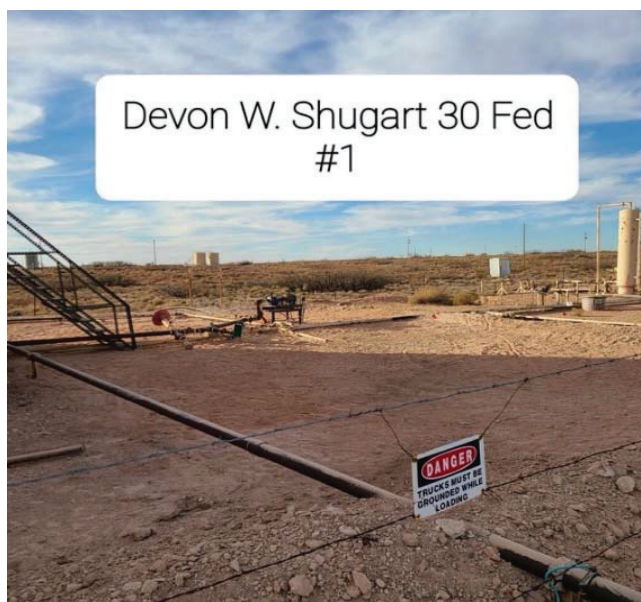
Interior of containment (Area of S1 and S2)
