CLOSURE REPORT

Federal 31-11-28 #3 (8/18/22)
Unit Letter O, S28 T31N R11W
San Juan County, New Mexico

New Mexico EMNRD OCD Incident ID No. NAPP2223126700

Ensolum Project No. 05A1226204

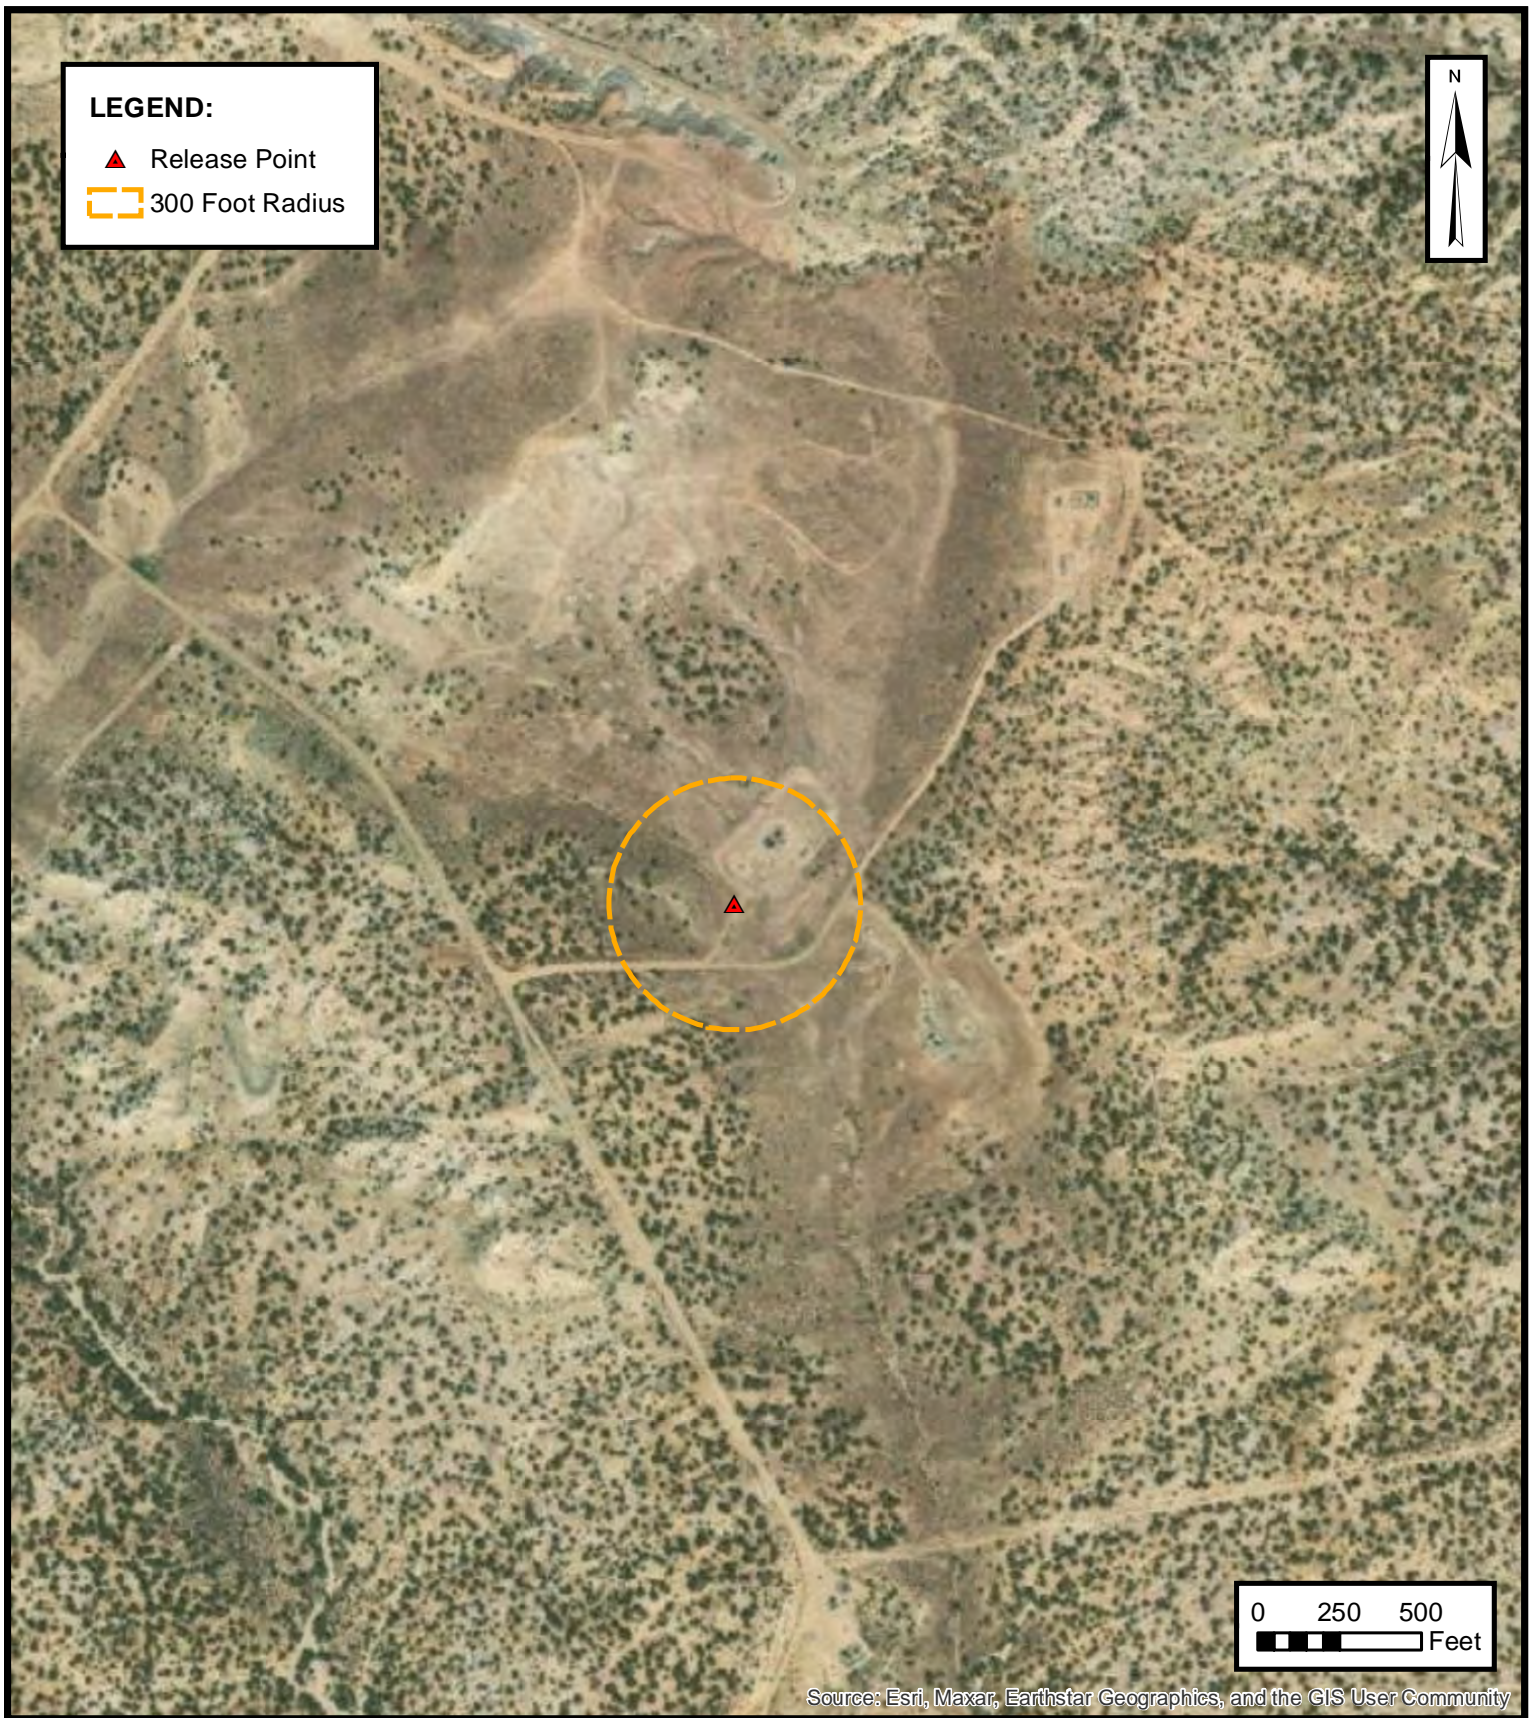
C

- The Site is located within 300 feet of a NM EMNRD OCD-defined continuously flowing watercourse or significant watercourse (**Figure C, Appendix B**).

**300 FOOT RADIUS
WATERCOURSE AND DRAINAGE IDENTIFICATION**

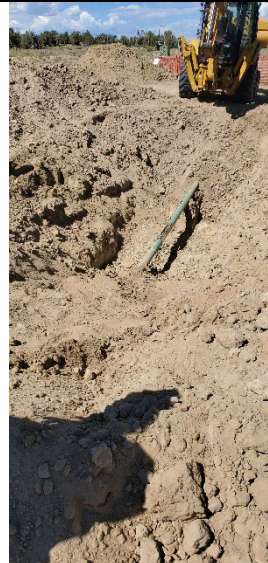
**Photograph 1**

Photograph Description: View of the in-process excavation activities.

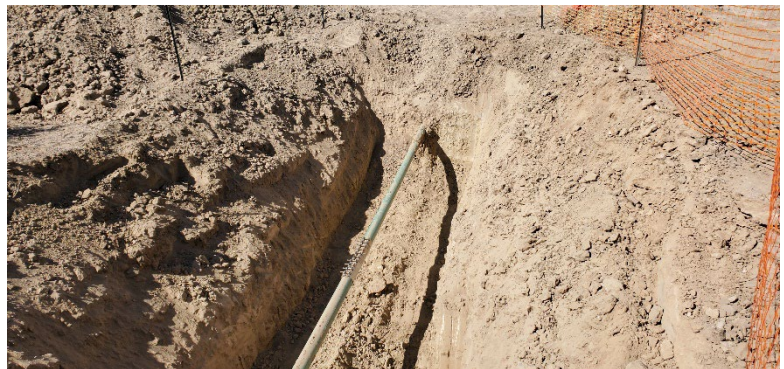
**Photograph 2**

Photograph Description: View of the in-process excavation activities.

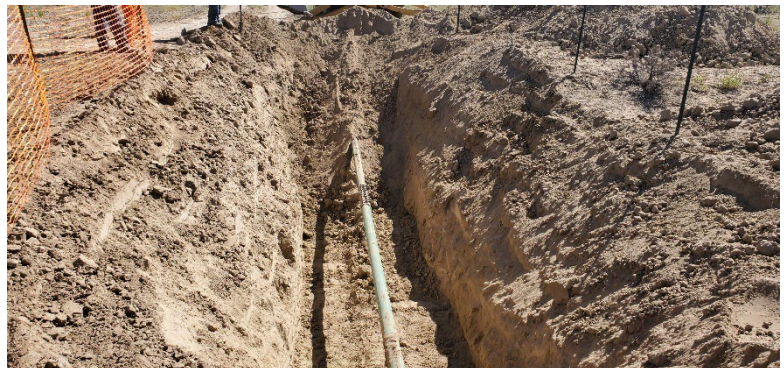
**Photograph 3**

The final excavation measured approximately 20 feet long and 11 feet wide at the maximum extents. The maximum depth of the excavation measured approximately seven feet bgs. The lithology encountered during the completion of remediation activities consisted primarily of unconsolidated silty sandy clay.

Photograph Description: View of the final excavation.

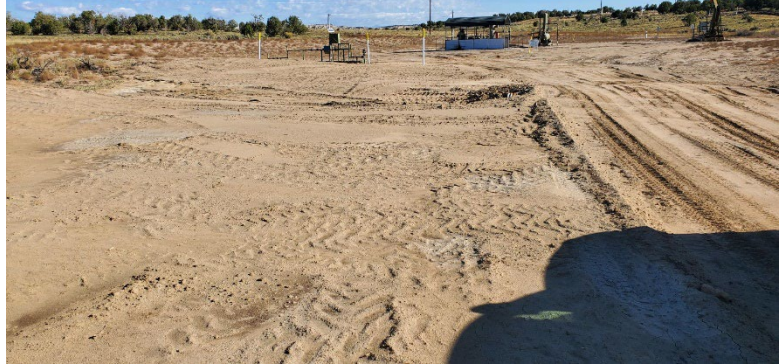
Photograph 4

Photograph Description: View of the site after initial restoration.

The excavation was backfilled with imported fill and then contoured to the surrounding topography. Enterprise will re-seed the Site with an approved seeding mixture.
