Remediation Plan

Our ref: 11230055-LTR-1

Updated Site Remediation Work Plan
Roden GD Federal #3 Release Site
EOG Resources Inc.
Incident ID: nAPP2116941928
F-24-19S-24E, Eddy County, New Mexico

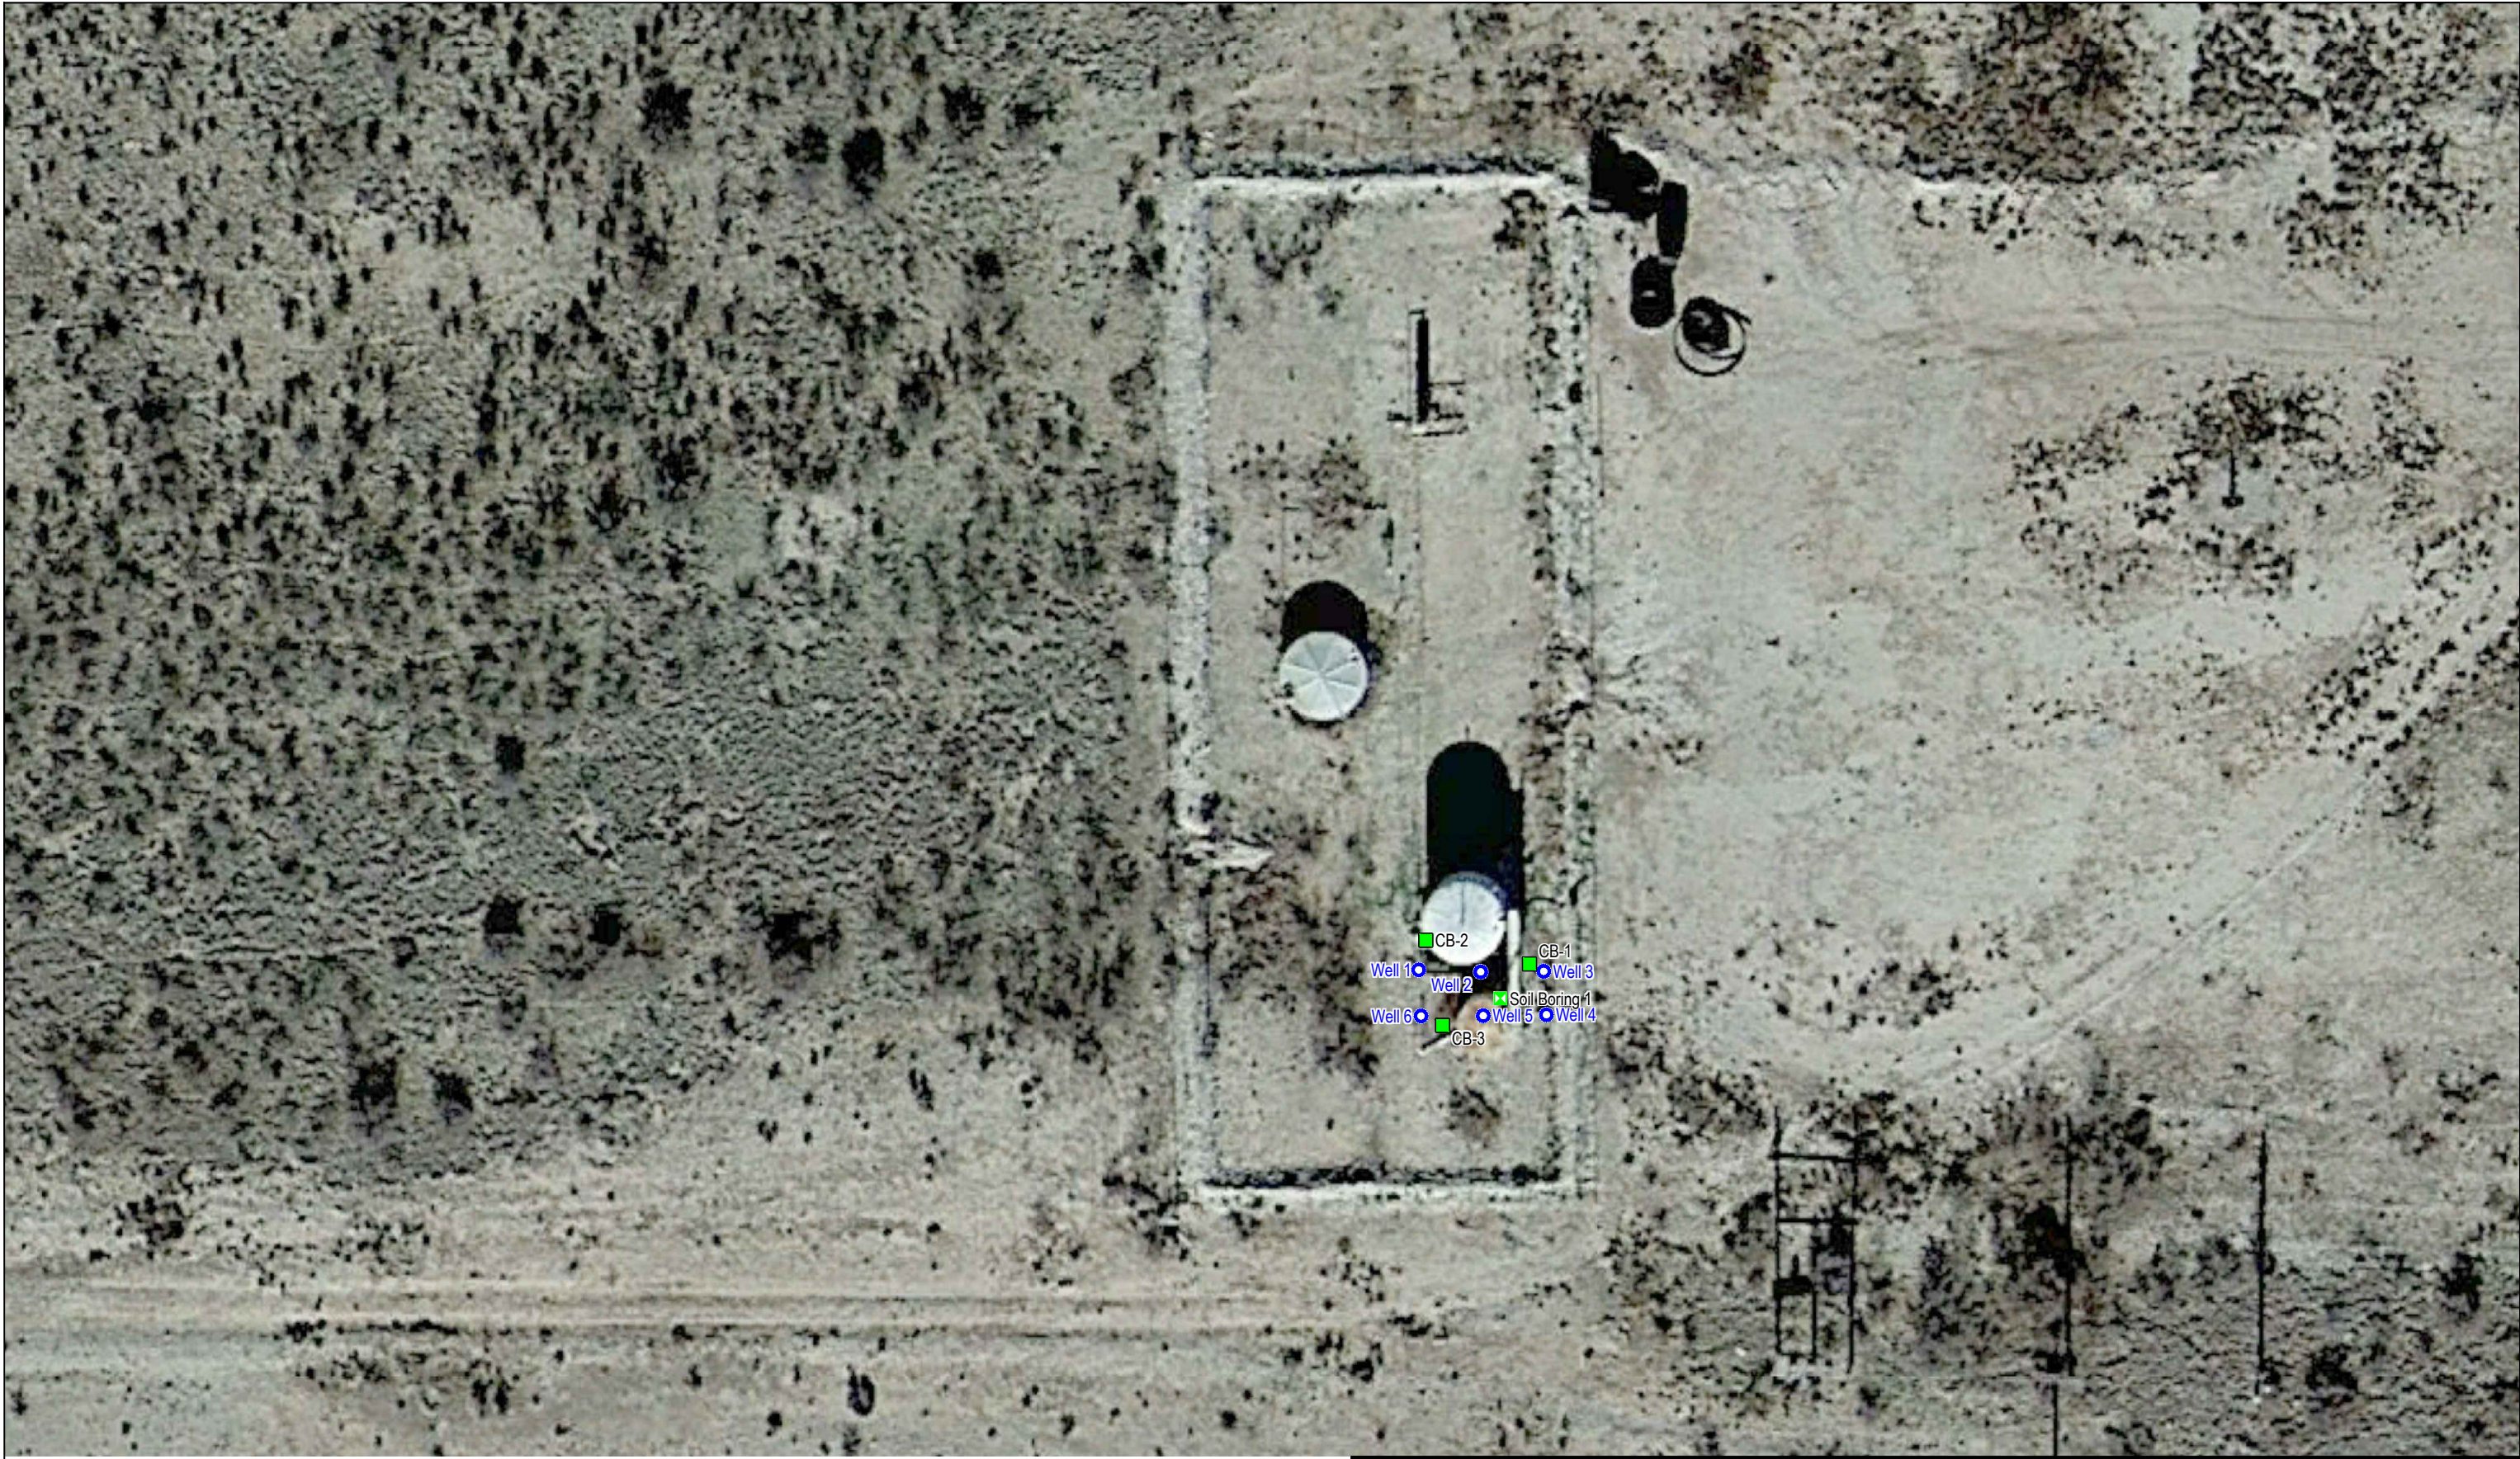
FIGURE 2

GHD Services Inc. (GHD), on behalf of EOG Resources (EOG), submits this Updated Site Remediation Work Plan to the New Mexico Oil Conservation Division (NMOCD) District 2 Office. This Report provides documentation of remedial activities, sampling, and analyses in the affected area at the EOG Roden GD Federal #3 Release Site (Site). The Site is located in Unit Letter F Section 24 of Township 19 South and Range 24 East in Eddy County, New Mexico. The GPS coordinates for the release site are 32.64837 N latitude and 104.54375 W longitude. The release occurred on land managed by the Bureau of Land Management (BLM). Figure 1 depicts the Site location. The EOG production facility and other site details are depicted on Figure 2, Site Details Map.

SITE DETAILS MAP

Two of the three borings had samples exceeding applicable NMAC Table 1 Closure Criteria for groundwater greater than 100 feet: CB-1 and CB-3. Figure 2, Site Details Map, depicts the locations of the confirmation boring samples. The CB-1, CB-2, and CB-3 soil boring logs are provided as Attachment A. Analytical results are provided in Table 1, on Figure 3, and in the Laboratory Analytical Reports provided in Attachment B.

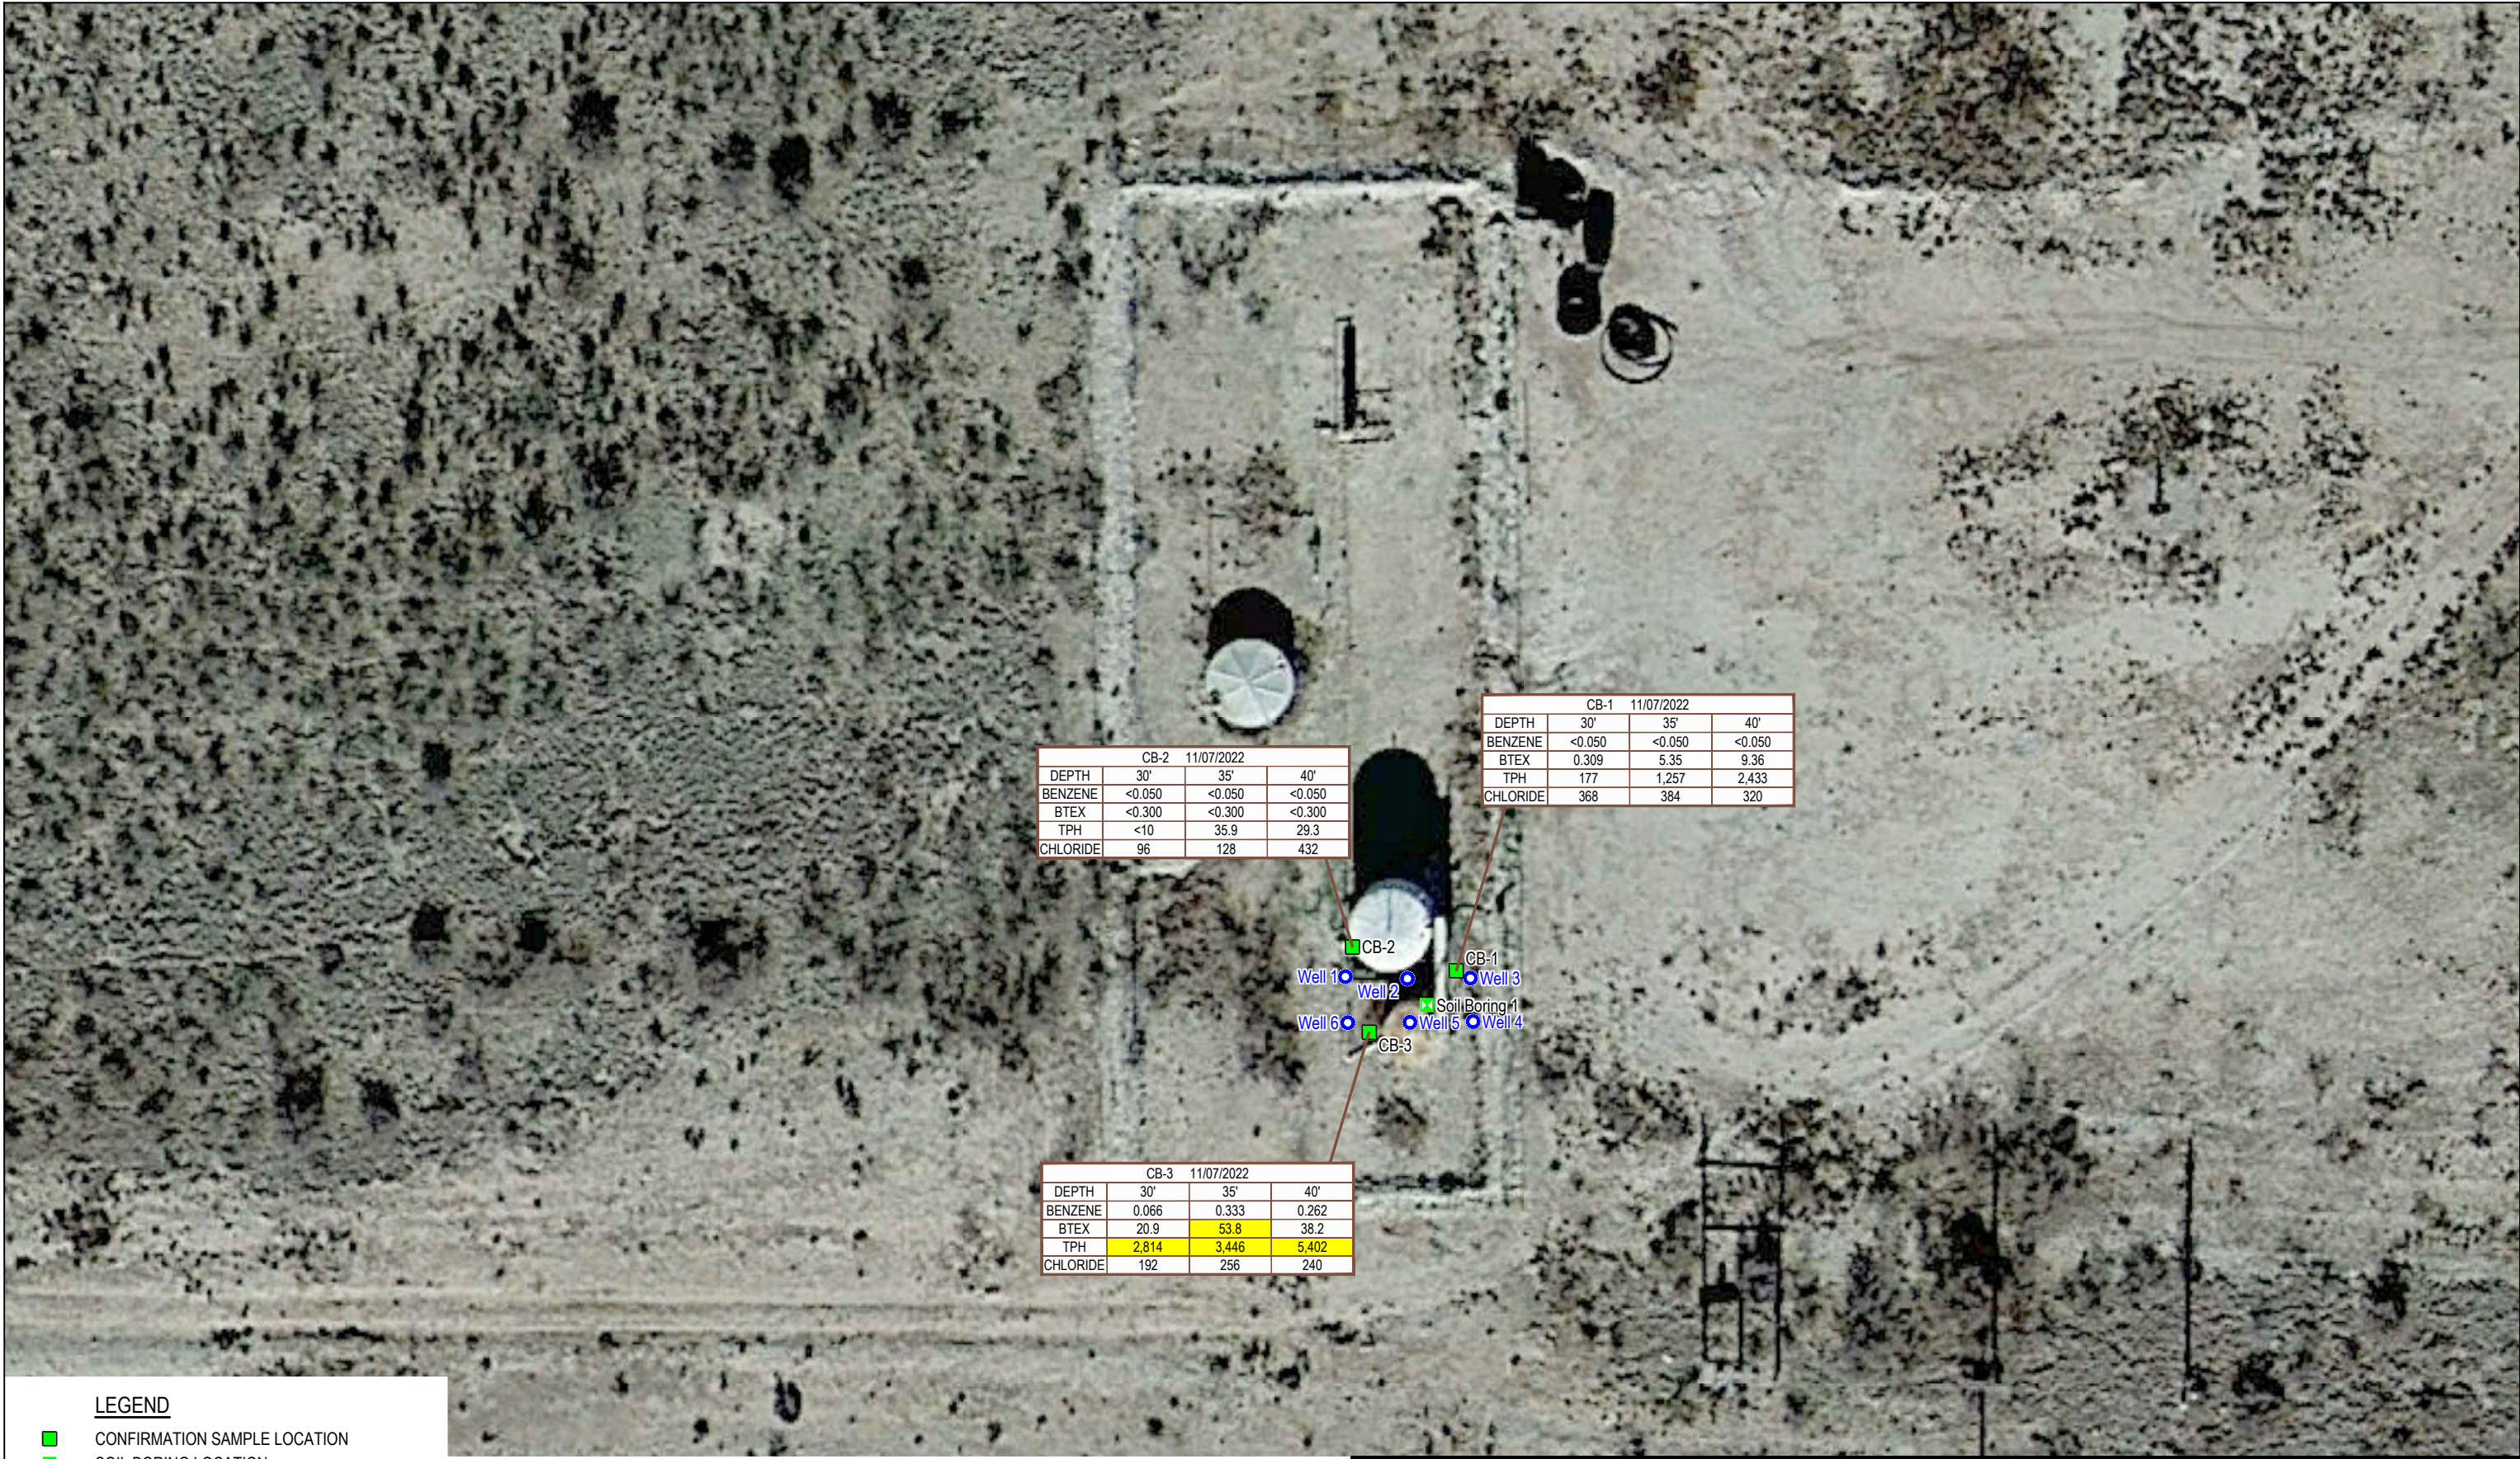
FIGURE 3

CONFIRMATION SOIL ANALYTICAL

CB-1 exhibited TPH GRO and DRO above Table 1 closure criteria to a depth of 35 and 40 feet bgs. CB-3 exhibited exceedances above Table 1 closure criteria for BTEX and TPH from 30 feet bgs to 40 feet bgs. None of the other samples submitted for analysis exhibited exceedances above Table 1 closure criteria. Based on results from the confirmation soil borings further treatment injections are required to adequately breakdown the hydrocarbon within the impacted soils. Continued injections are proposed to the speed of bioremediation.
