Remediation Summary and Closure Request

6" Santo Nino

Eddy County, New Mexico

NMOCD Incident # nAPP2214330261

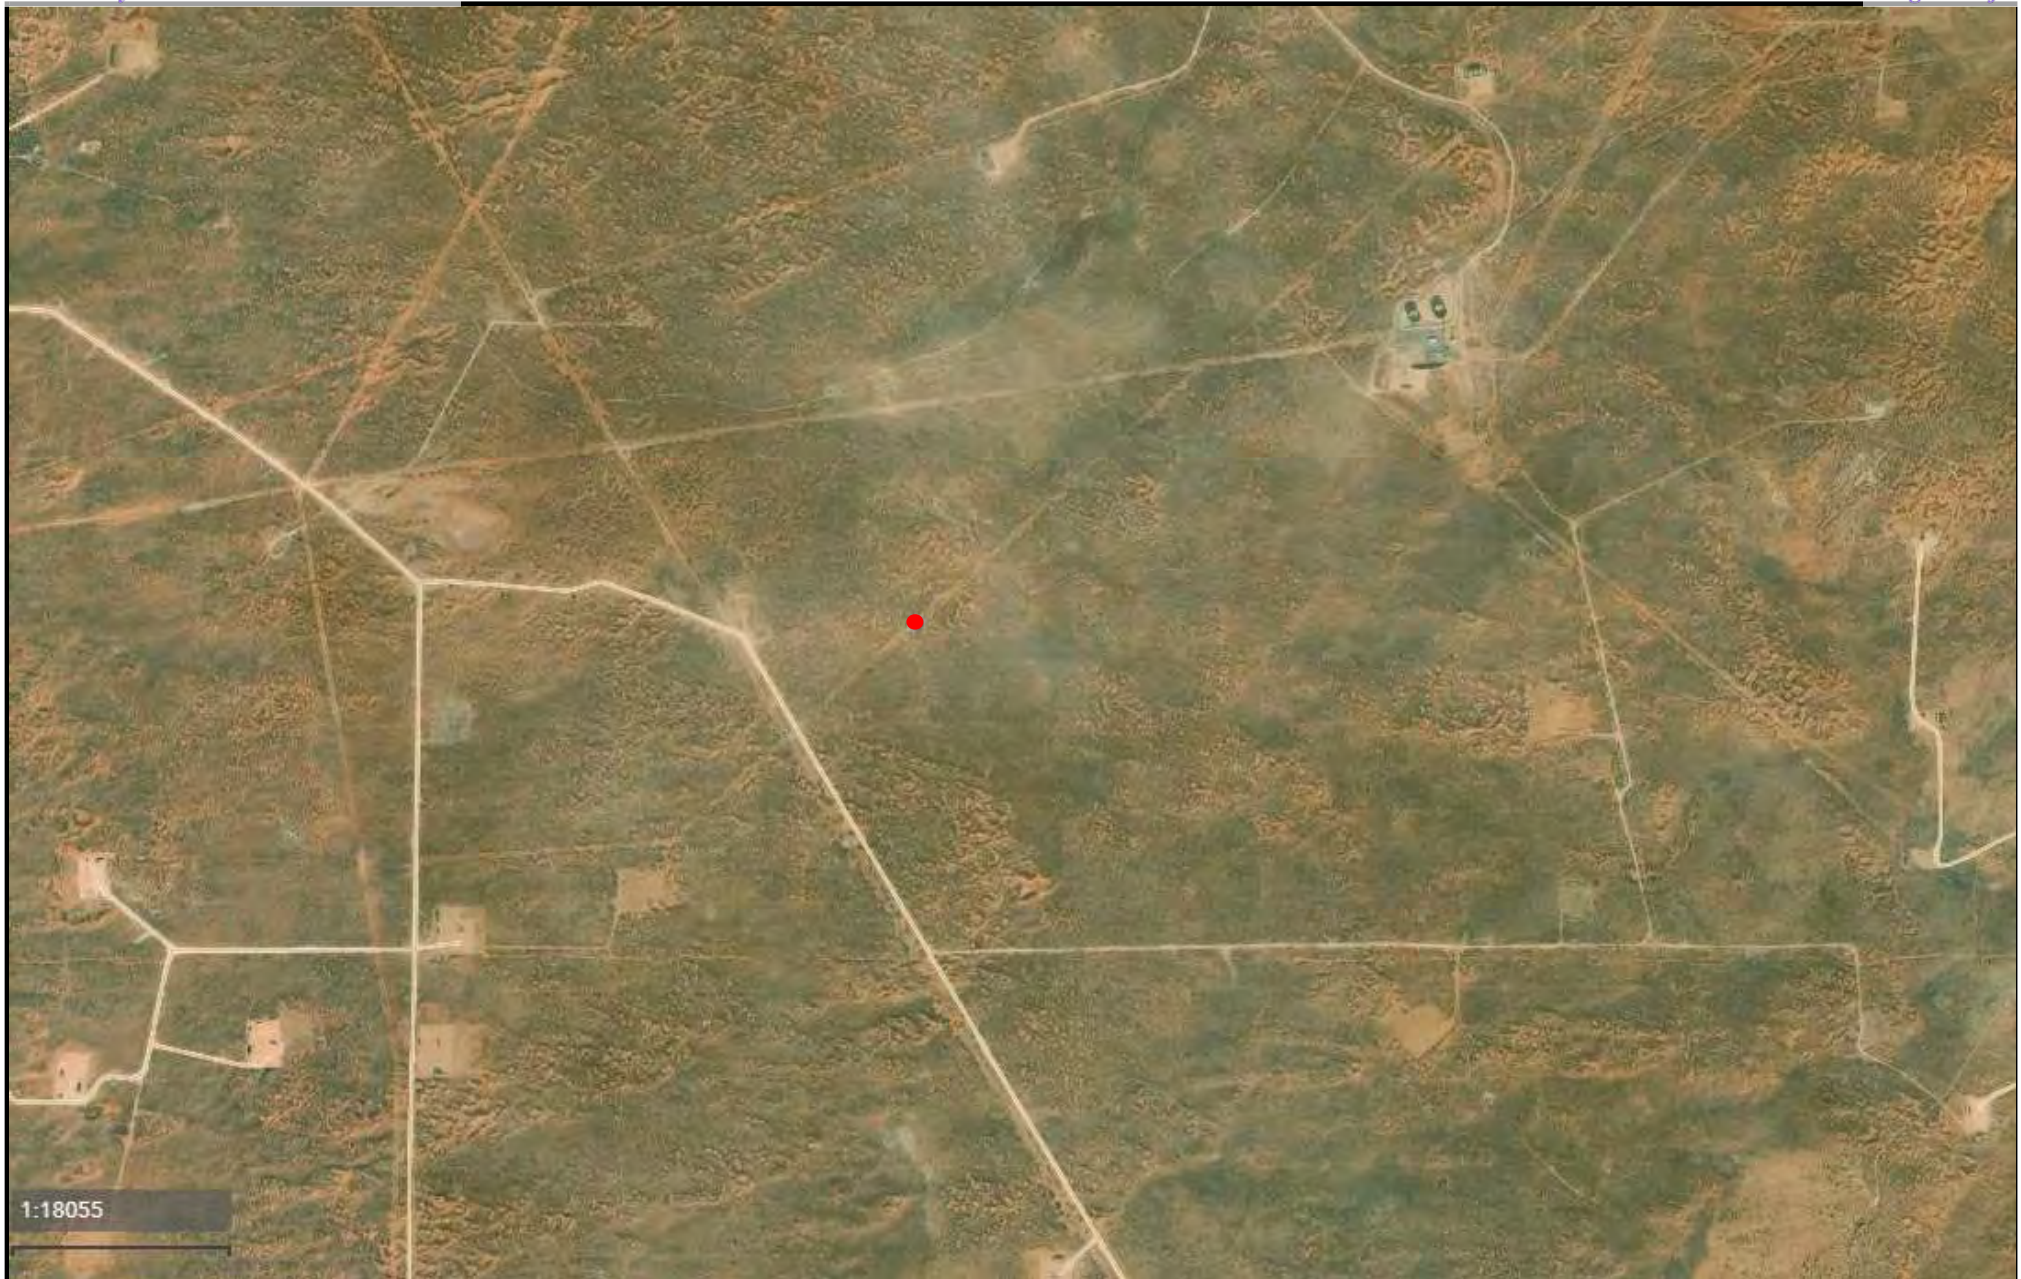
**Figure 2**

OSE POD Locations Map
Frontier Field Services, LLC
6" Santo Nino
GPS: 32.776513, -103.97263
Eddy County

A search of the New Mexico Office of the State Engineer (NMOSE) and United States Geological Survey (USGS) groundwater databases was completed in an effort to determine the horizontal distance to known water sources within a half mile radius of the Release Site. Approximate depth to groundwater was determined using maintained and published water well data. Karst mapping indicates the site is not located in a Karst designated area. Karst and Wetland Maps are provided as Attachment I. Depth to groundwater information is provided as Attachment IV and the results are depicted on Figures 2 & 3.

No water wells were located within a half mile of the release area, therefore depth to groundwater could not be determined. Consequently, the site was delineated and further remediated according to the strictest NMOCD Closure Criteria. Utilizing this information, the NMOCD Closure Criteria for the Site were determined as follows:

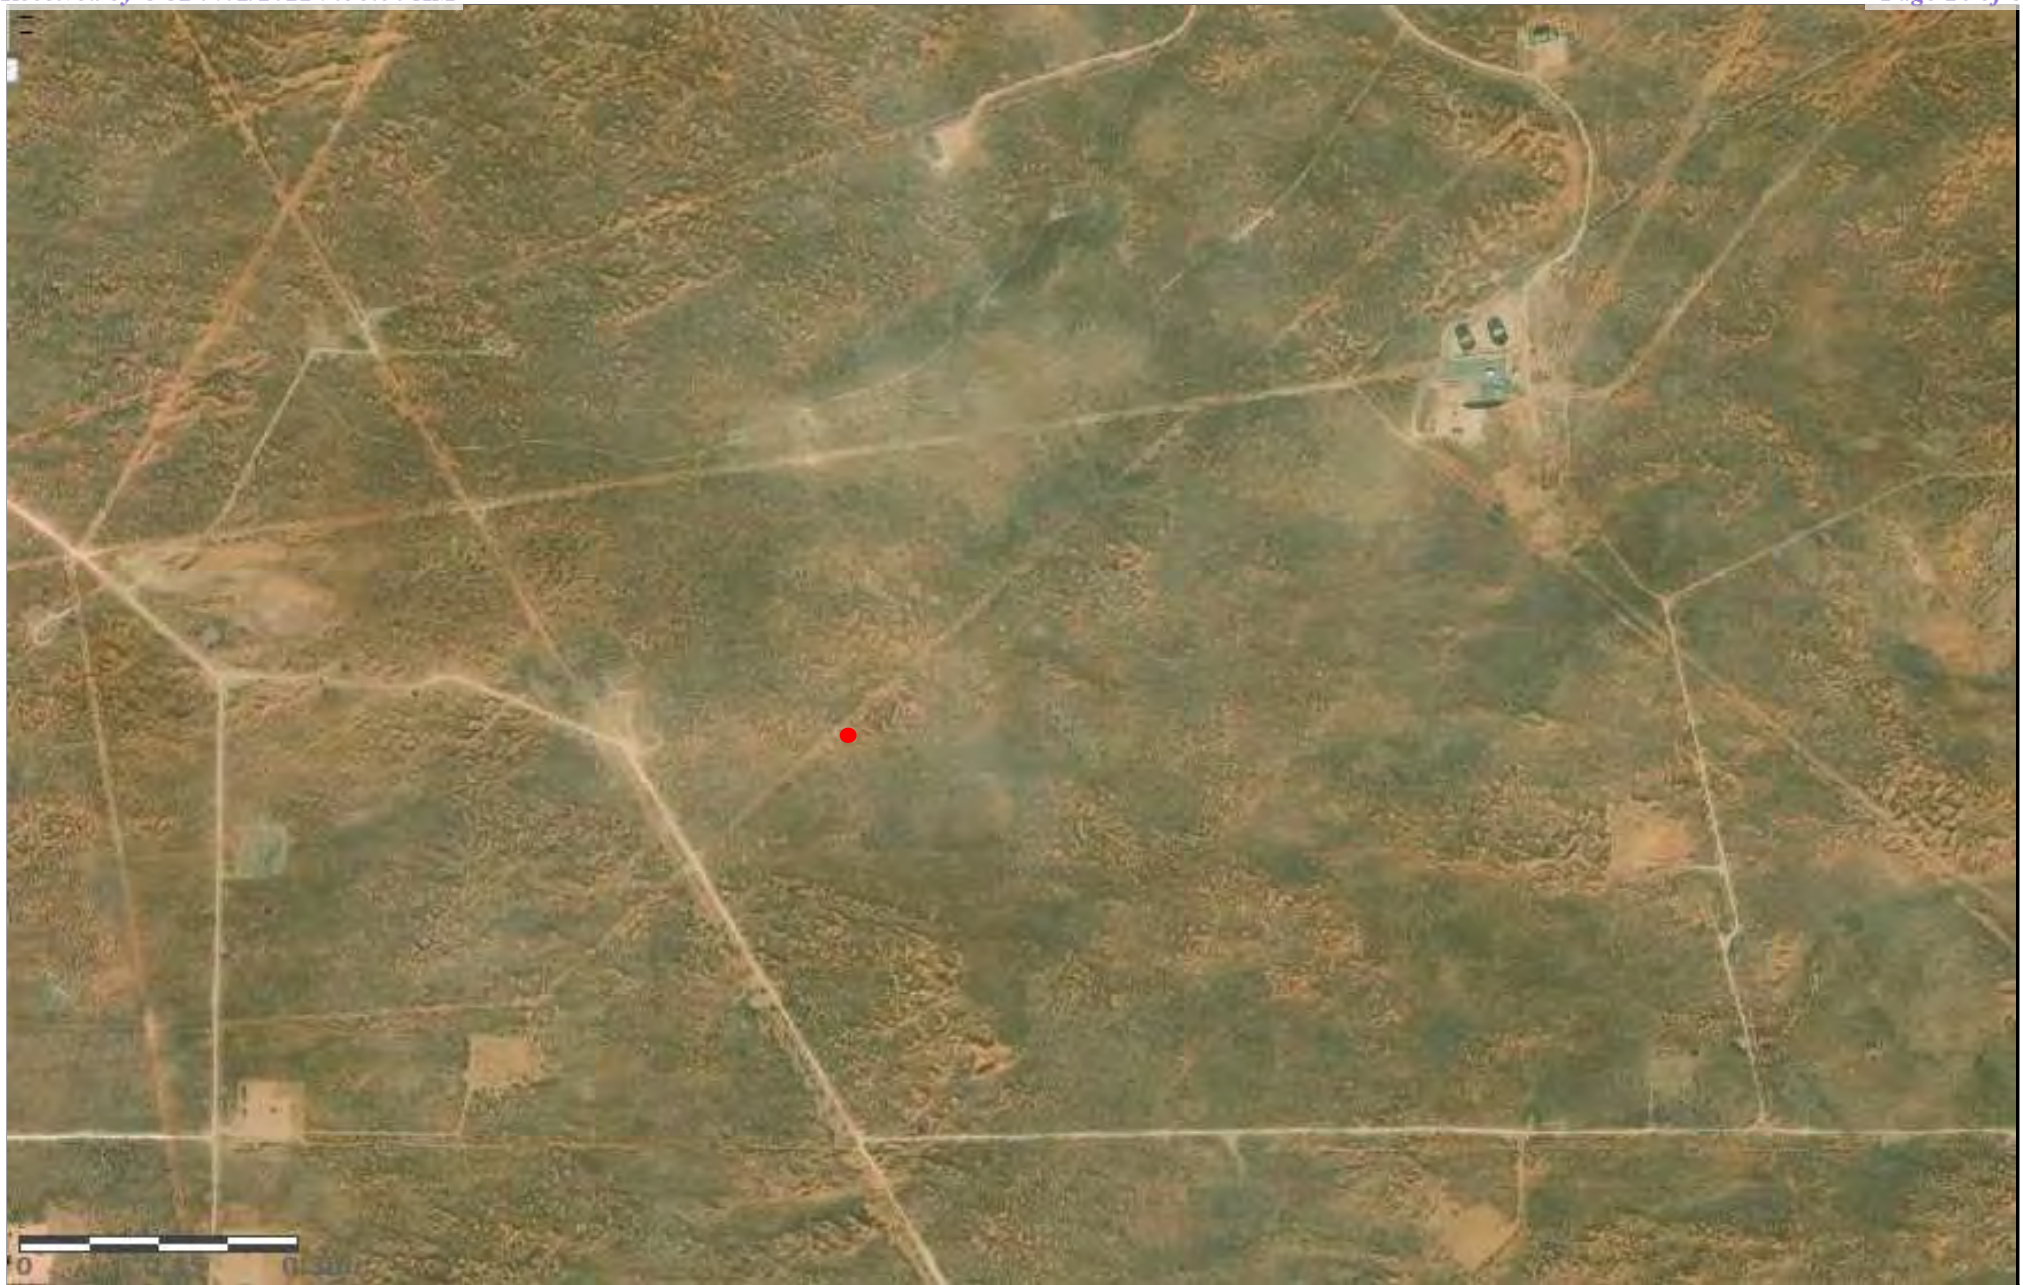
**Figure 3**

USGS Well Locations Map
Frontier Field Services, LLC
6" Santo Nino
GPS: 32.776513, -103.97263
Eddy County

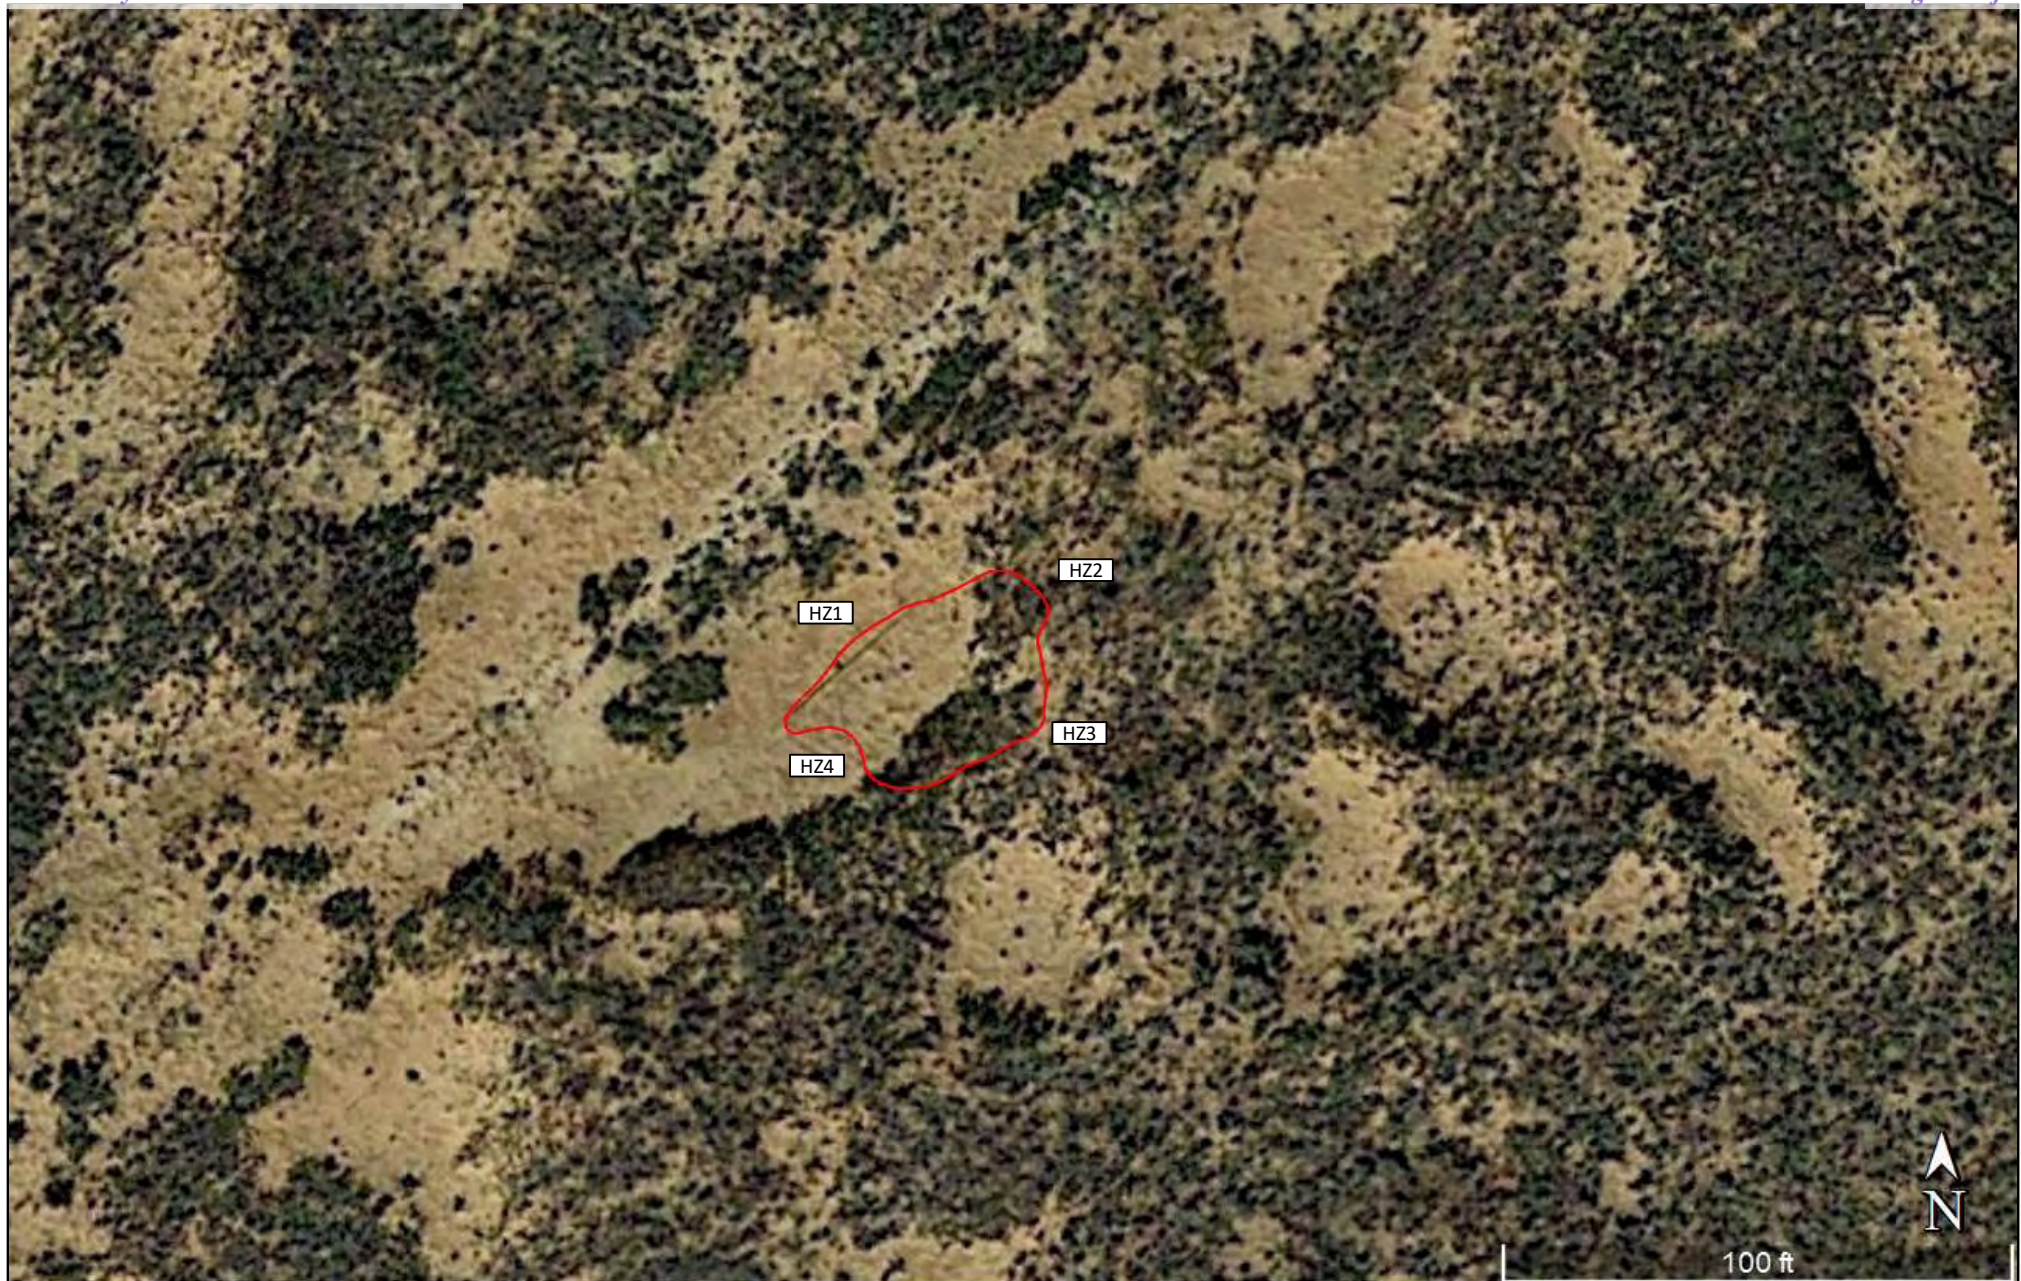
**Figure 4**

Delineation Sample Map
Frontier Field Services, LLC
6" Santo Nino
GPS: 32.776513, -103.97263
Eddy County

A Delineation Sample Map and Excavation Sample Map are provided as Figure 4 and Figure 5, respectively. A Summary of Soil Sample Laboratory Analytical Results is provided as Table 1 and Laboratory Analytical Reports are provided as Attachment VI.

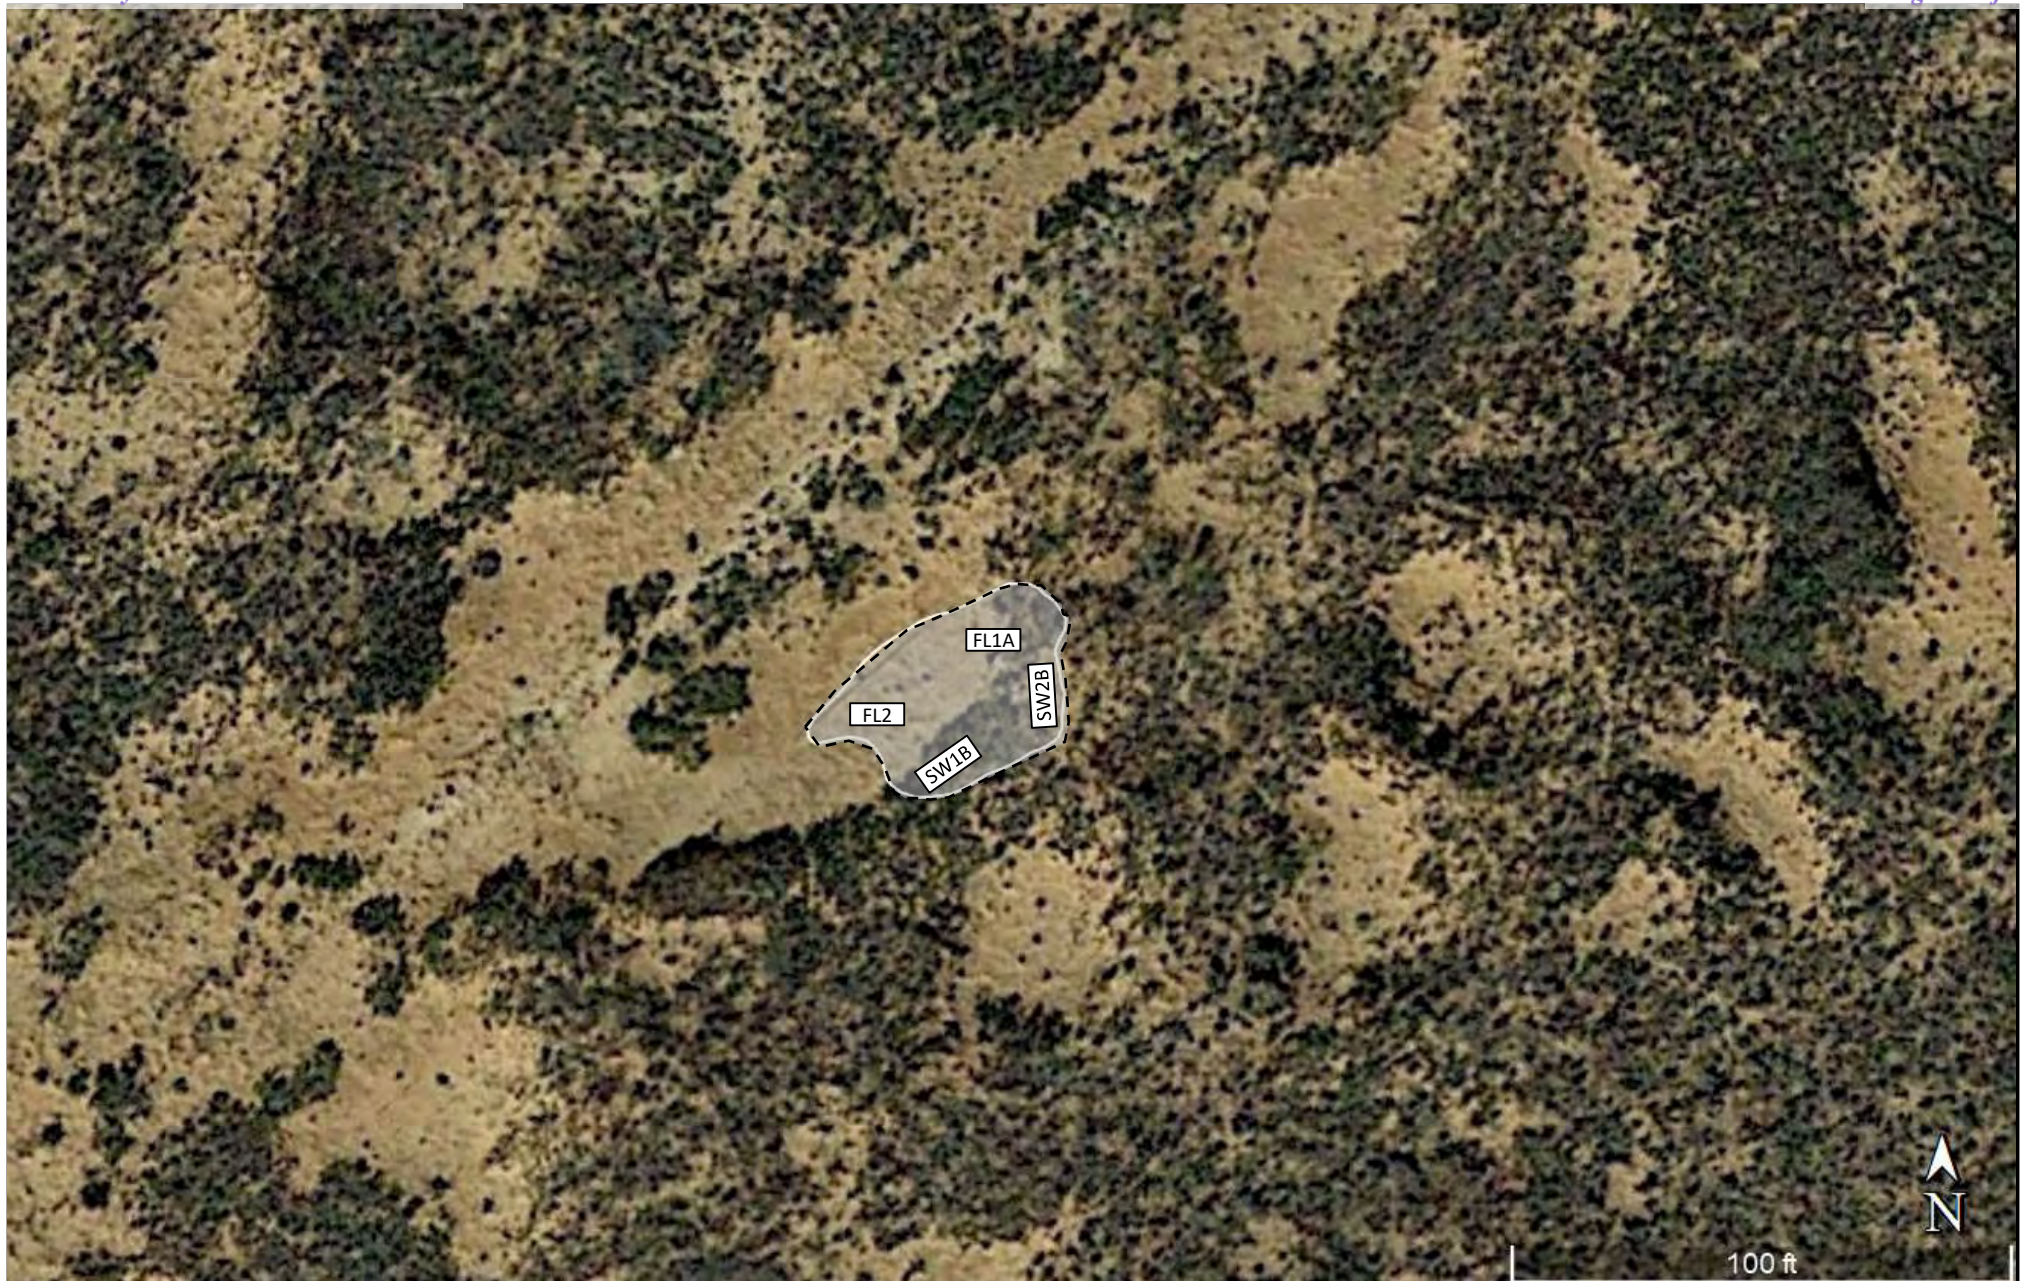
**Figure 5**

Excavation Sample Map
Frontier Field Services, LLC
6" Santo Nino
GPS: 32.776513, -103.97263
Eddy County

On August 15, 2022, the sidewalls were excavated laterally approximately one foot and re-sampled. Soil impacted above the NMOCD Closure Criteria was excavated and transported to an NMOCD approved disposal facility. Manifests can be provided upon request. Closure samples SW1B and SW2B were collected and submitted to the laboratory for analysis of BTEX, TPH, and chloride. Laboratory analytical results indicated contaminant concentrations were below the NMOCD Closure Criteria in each of the submitted samples.

The excavated area measured approximately fifty-five feet in length, thirty-five feet in width, and two to three feet in depth. During remediation activities approximately 144 cubic yards of impacted soil were excavated and hauled to an NMOCD approved disposal facility. Manifests can be provided upon request.

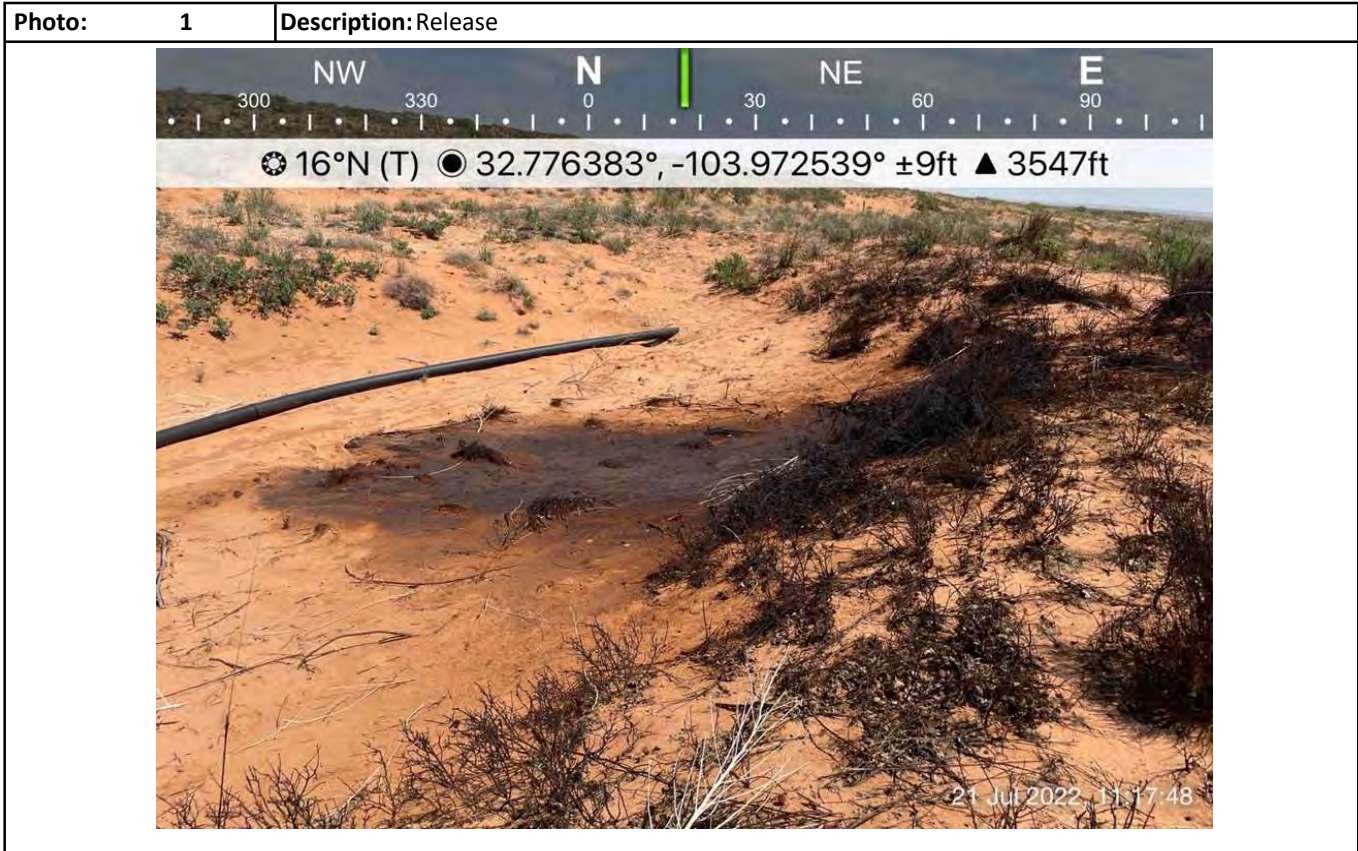
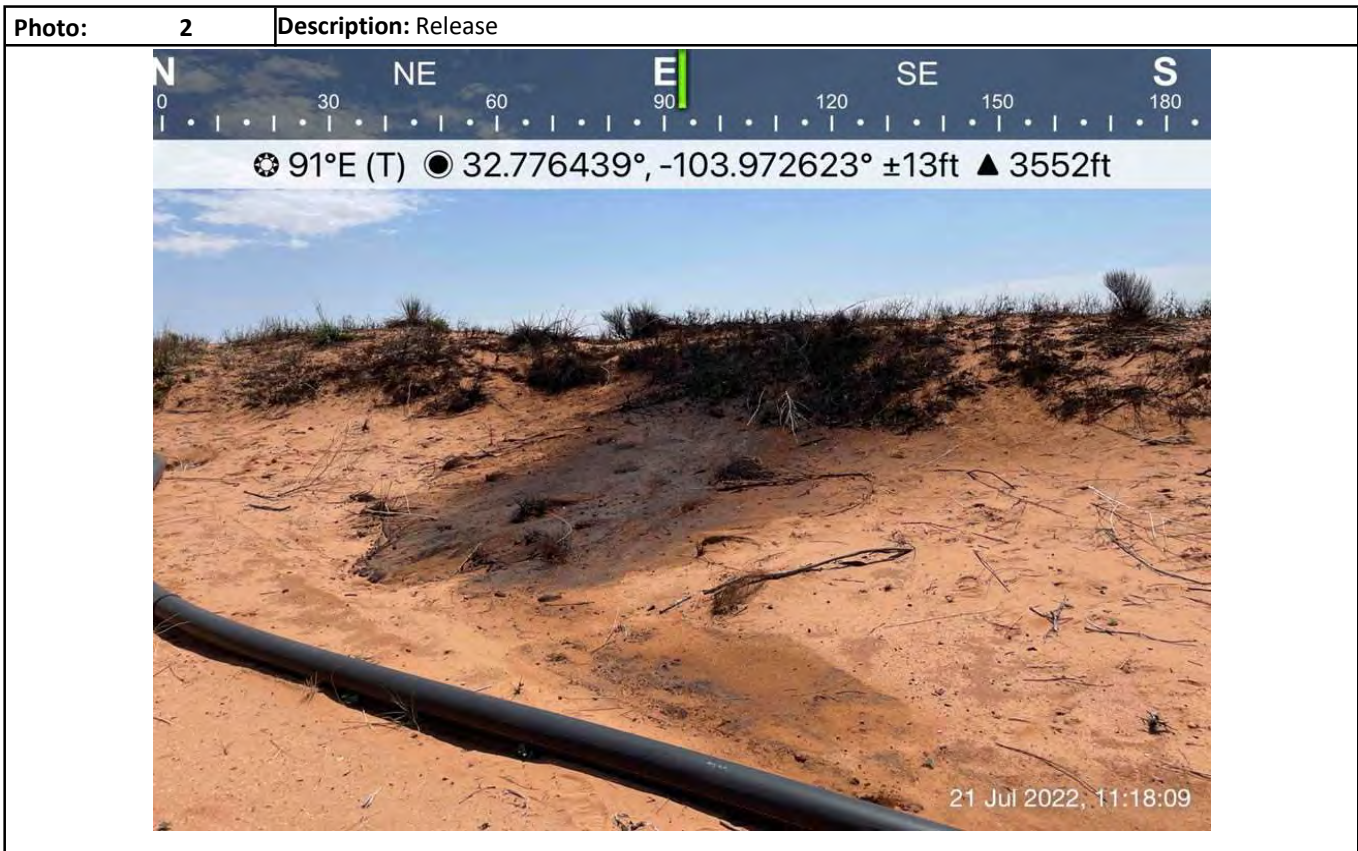
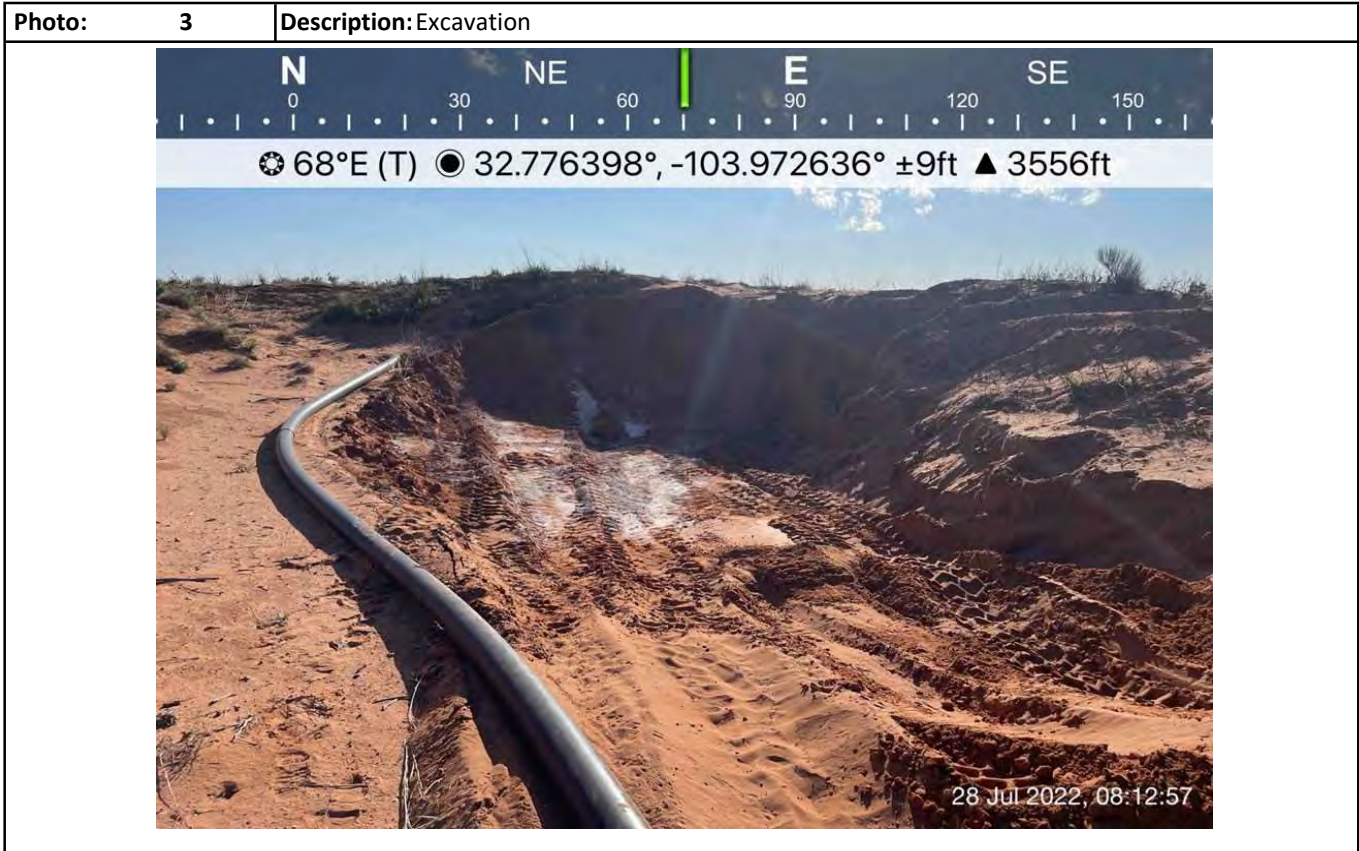
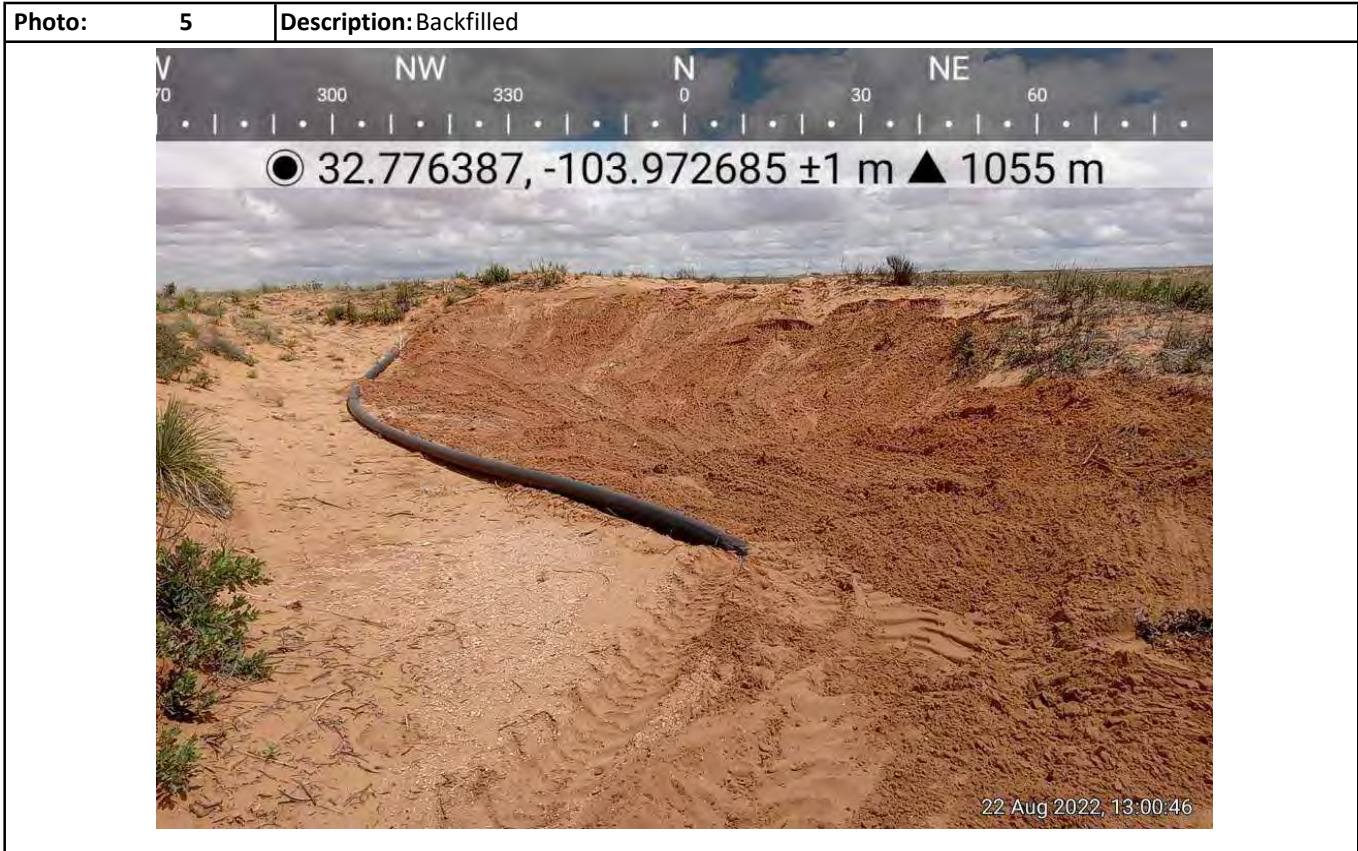
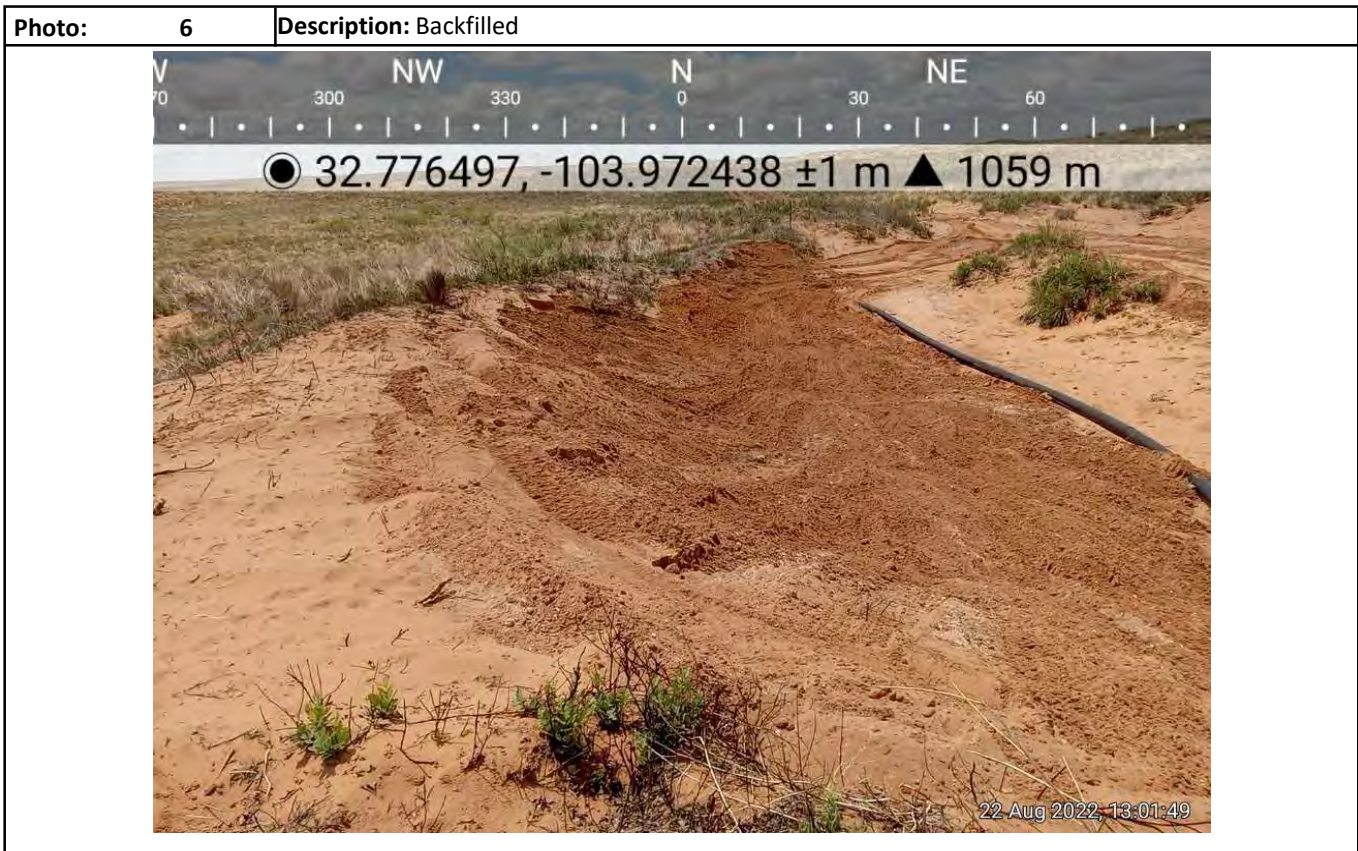
Attachment III Site Photographs

On July 21, 2022, Hungry Horse conducted an initial site assessment consisting of photographing and mapping the release area. On July 28 and 29, 2022 the release area was excavated and contaminated soil hauled to an NMOCD approved facility for disposal.
