Durango Midstream, LLC
18 Inch Skelly Inlet
32.8401°, -103.92338°
NMOCD Reference # nAPP2217429521
Terracon Project # AR227092

RE: **Release Investigation and Closure Documentation**
18 Inch Skelly Inlet
NW 1/4 of the NE 1/4, Section 13, Township 17 South, Range 30 East
32.8401°, -103.92338°
Eddy County, New Mexico
Terracon Project No. AR227092

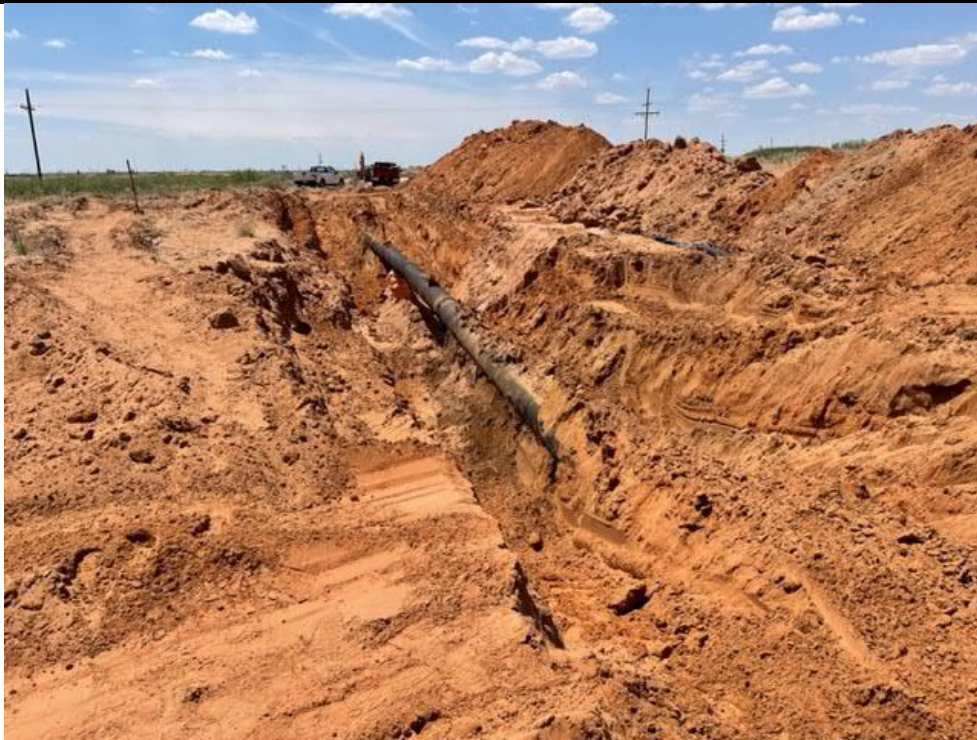
PHOTO 1: View of excavation, facing west. / GPS: 32.8401 -103.9232

On July 1, July 5, July 6, July 26, July 27, August 2, August 3 and August 9, 2022, Terracon mobilized to the site to meet Gandy Corporation (Gandy) personnel. Gandy performed excavation activities in support of soil remediation, collection of 14 confirmation samples of the excavation floor and sidewalls every 200 square feet. Samples were placed in laboratory provided sample containers, preserved with ice, and transported under chain of custody to Cardinal Laboratories in Hobbs, New Mexico for analysis of benzene, toluene, ethylbenzene, and total xylenes (collectively known as BTEX), total petroleum hydrocarbons (TPH), and chlorides.

In total, approximately 1,200 cubic yards were excavated during remedial activities. Excavated material was stockpiled on-site atop a polyethylene liner pending waste characterization and disposal under an approved Form C-138. Waste manifests are available upon request.

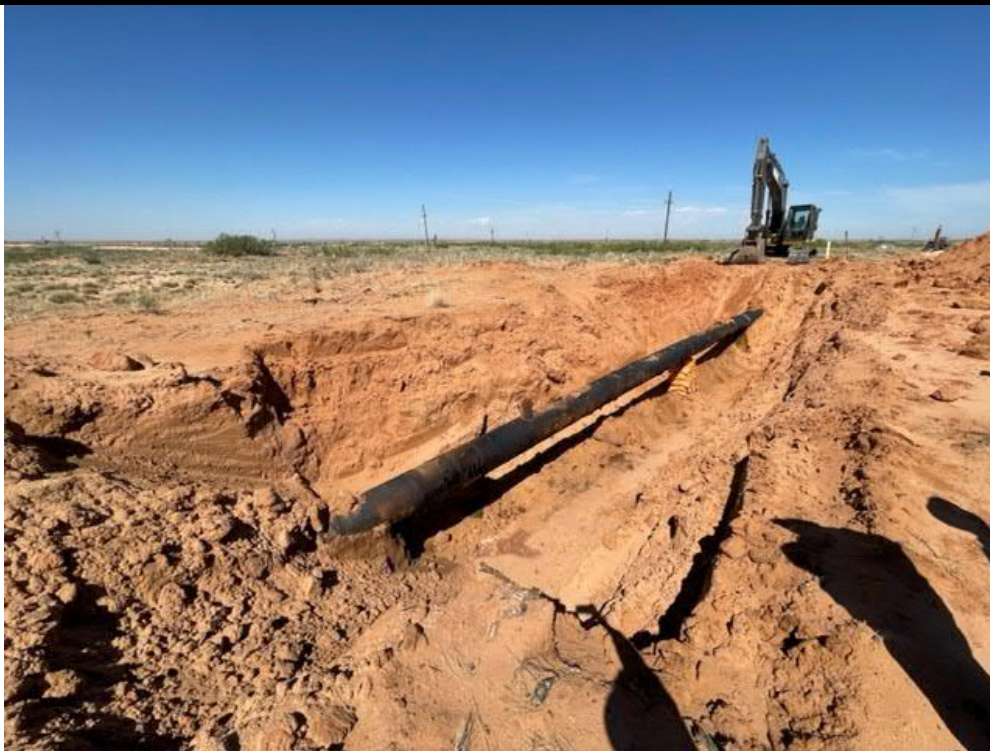
PHOTO 2: View of excavation, facing east / GPS: 32.8401 -103.9232
