## Release Notification

Site Name Cypress Compressor Station	Site Type Gas Compressor Station
Date Release Discovered 07/06/2022	API# (if applicable)

**Re: Site Assessment, Remediation, and Closure Report**  
**Cypress Compressor Station**  
**API No. N/A**  
**GPS: Latitude 32.25861 Longitude -103.97361**  
**UL "K", Sec. 34, T23S, R29E**  
**Eddy County, NM**  
**NMOCD Ref. No. NAPP2218767546**

# Cypress Compressor Station

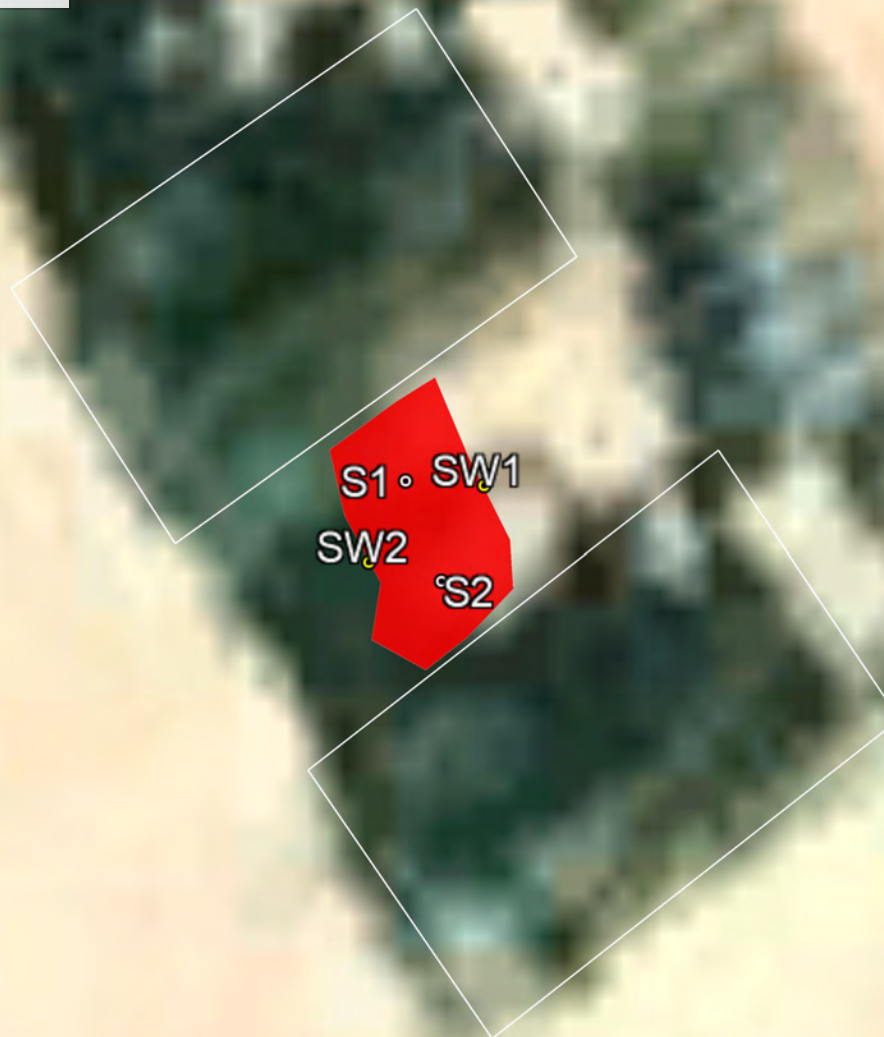
Site Map

On July 12<sup>th</sup> and July 25<sup>th</sup>, 2022, Hurlburt Construction and Environmental Services mobilized personnel to the site to assess the area. Hurlburt sampled the area between both compressors located on the Cypress Compressor Station pad. Laboratory results of this sampling event can be found in the following data table.

On September 6<sup>th</sup>, 2022, Pima mobilized personnel and equipment to conduct remedial activities. We excavated the area overlapping soil samples (S1-S2) and (SW1-SW2) to a depth of six (6) inches bgs. Photographic documentation can be found in Appendix D.

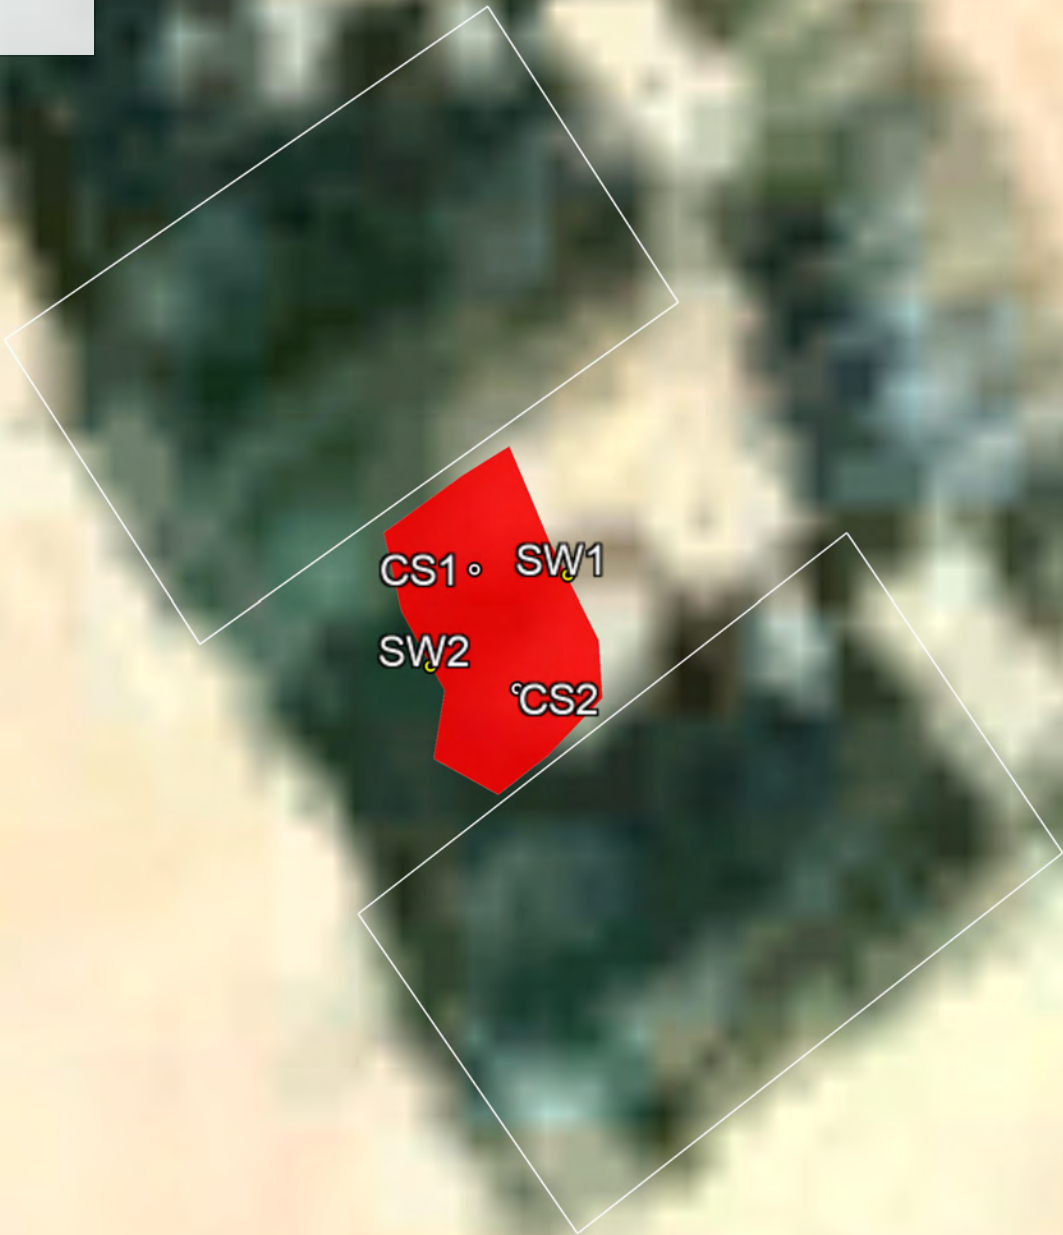
SCM Operations, LLC  
Eddy County, NM  
Confirmation Map  
Incident Number: nAPP2218767546

On September 7<sup>th</sup>, 2021, after submitting a 48-hour notification (Appendix C), Pima returned to the site to collect confirmation samples. The laboratory results of this sampling event can be found in the following data table.

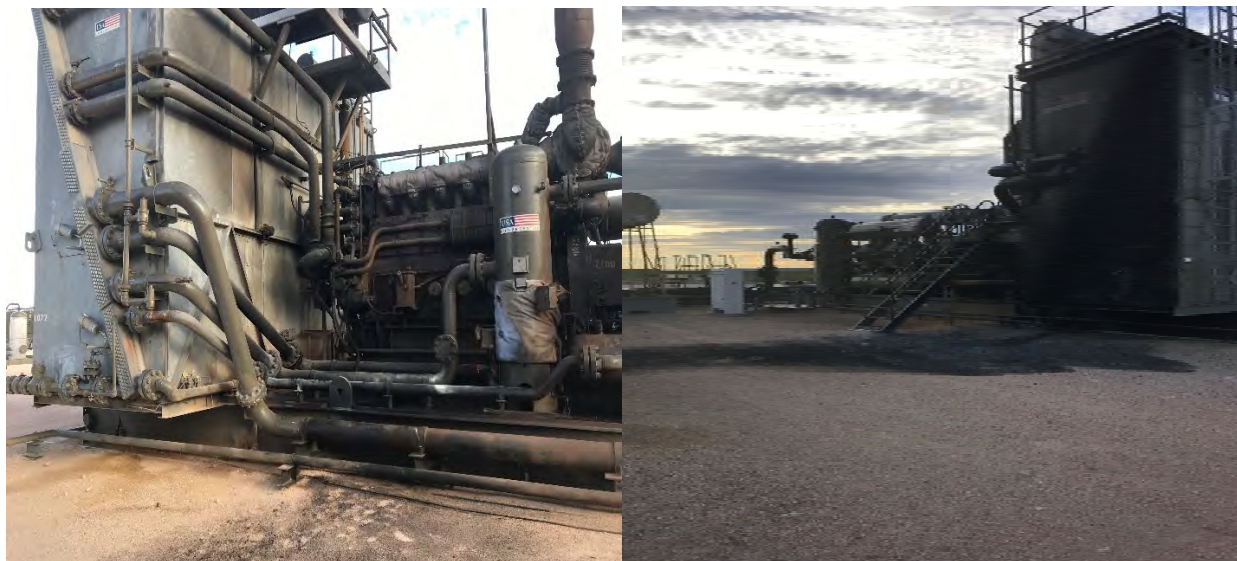
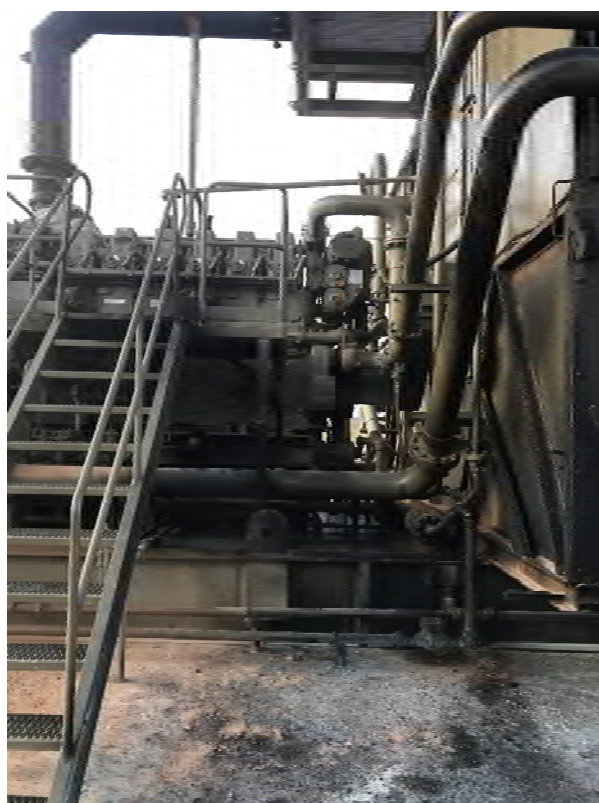
Pre-Excavation

**nAPP2218767546:** On July 6<sup>th</sup>, 2022, while starting up the Unit 4 Compressor, condensate spewed out of the blowdown line onto the Unit 3 Compressor and the ground. When the fluid hit the exhaust on the Unit 3 Compressor it ignited. The operator immediately hit the ESD and used a fire extinguisher to put out the remaining fire. The burned area is approximately 36 feet squared on the surface of the hard pack caliche soil. Approximately 1.35 gallons fluid was released, all remained on pad.
