Rajin Cajun 13 Fed 1H

Site Map w/ Confirmation Samples

**Devon Energy Production Company
Ragin Cajun 13 Fed 1H**

**Closure Report
N-13-26S-34E
nAPP2131358531
Eddy County, New Mexico
February 1, 2022**

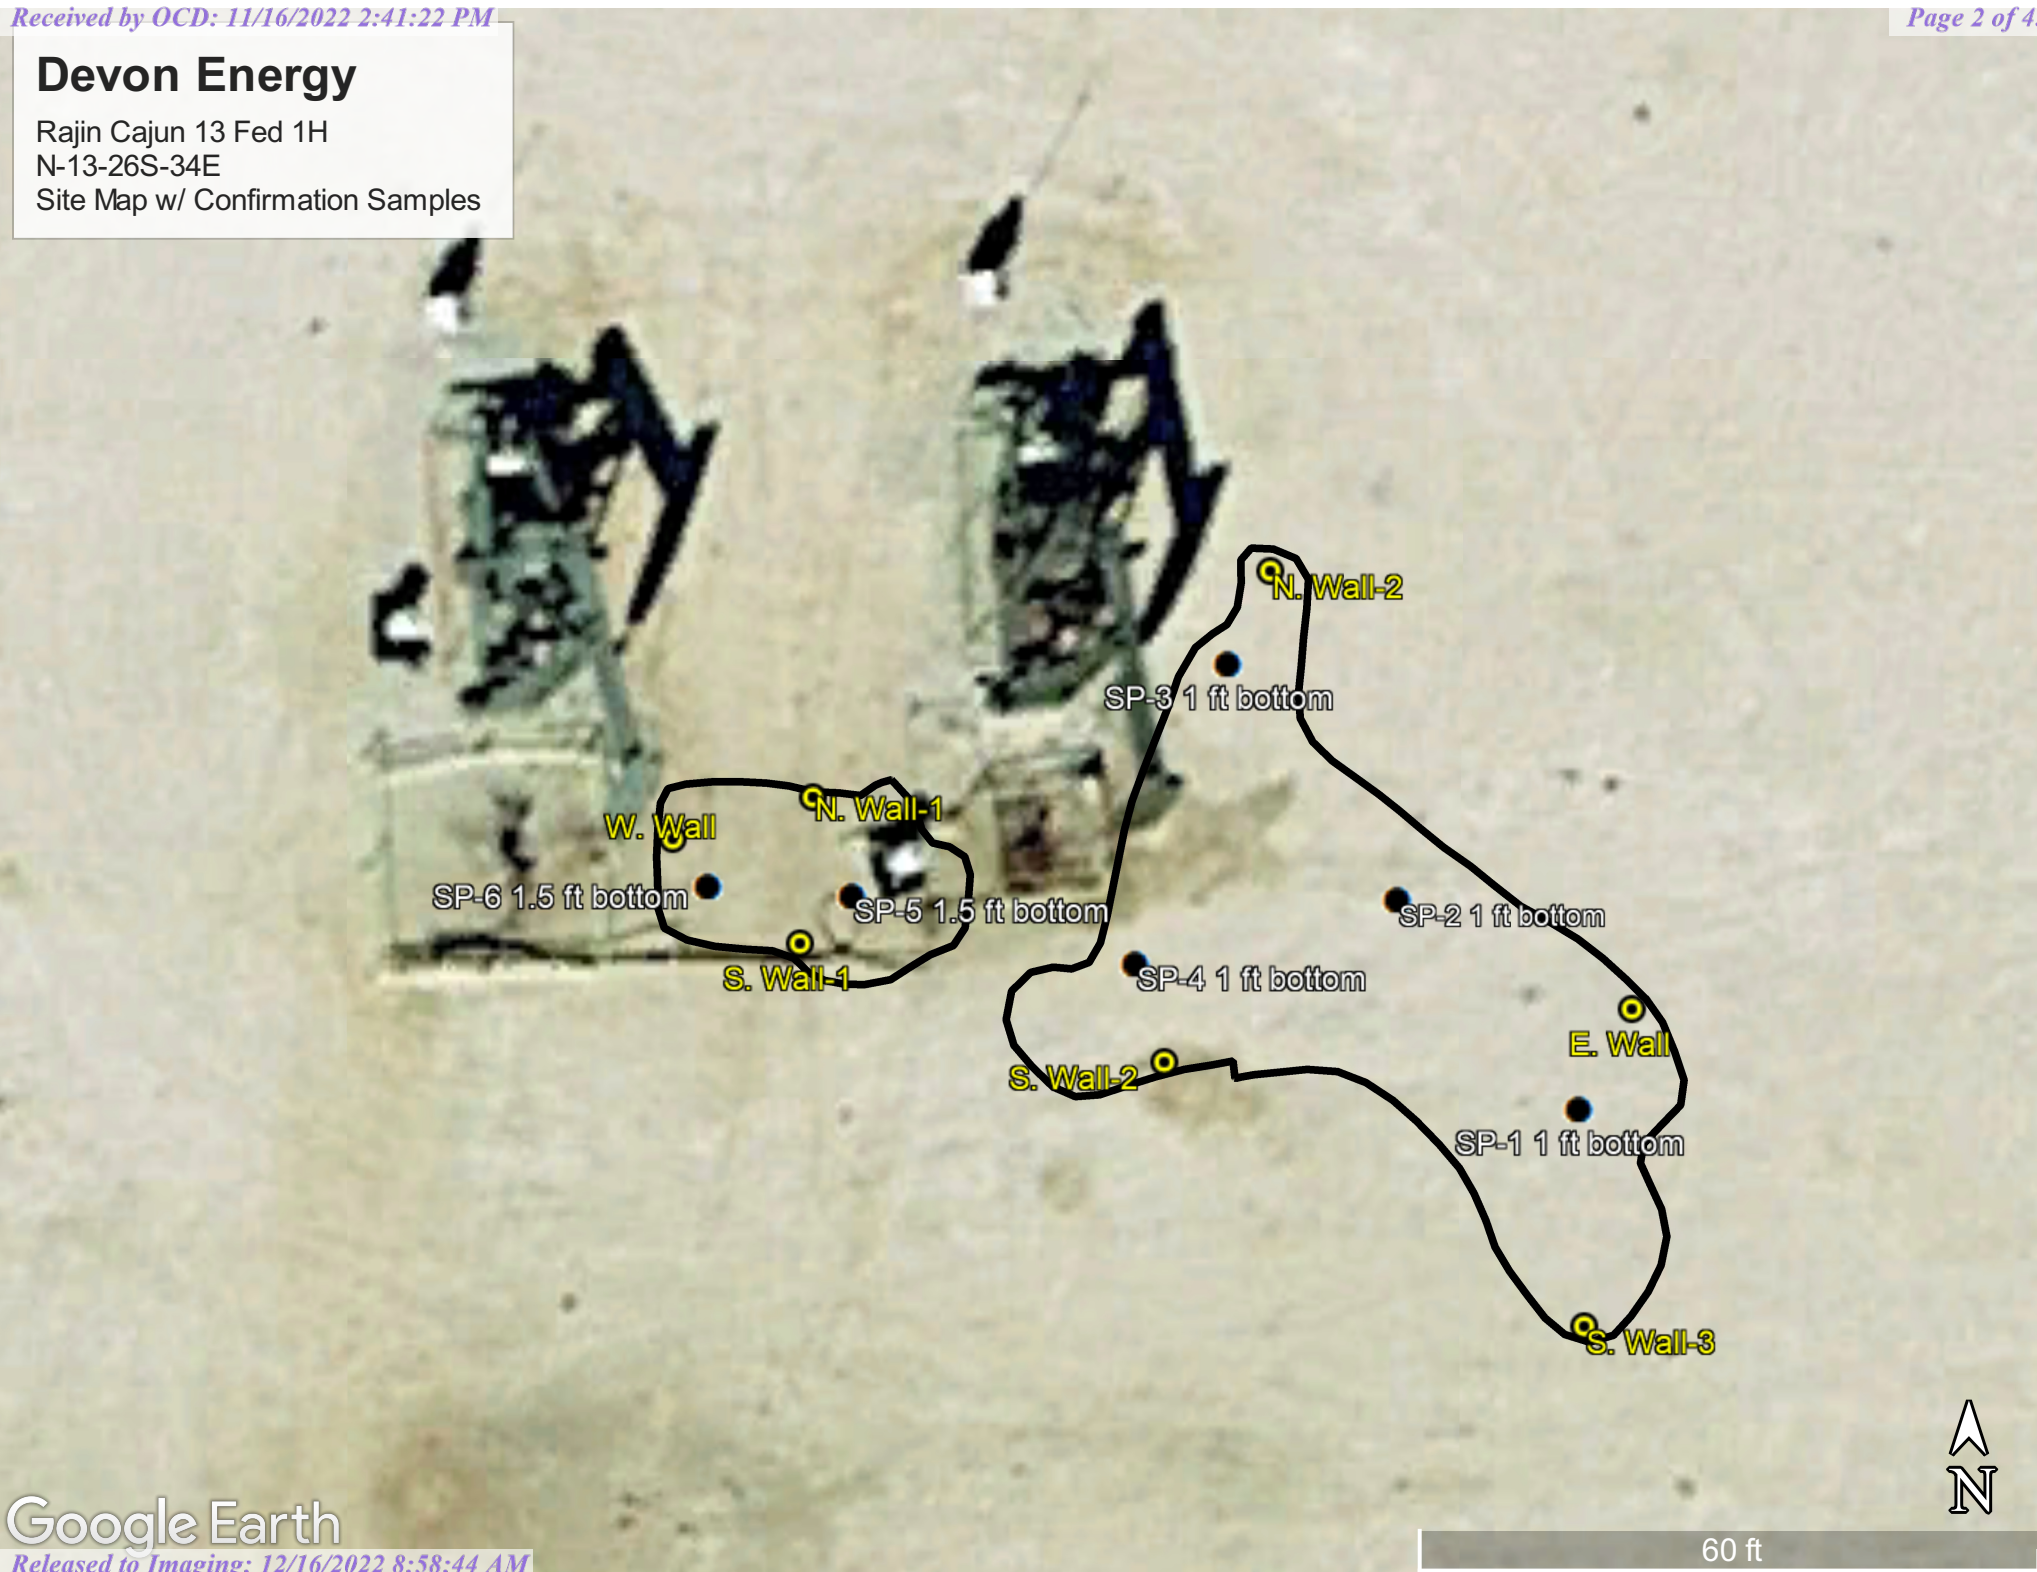
SESI personnel tracked and mapped the release and sampled the area to achieve both vertical and horizontal delineation. Samples were taken at the surface and 1-foot intervals until field testing indicated the samples to meet target levels. The horizontal extent samples are denoted on the map with an H beside the sample number. The results of the analytical are captured in the summary table below.

Based on the results of the delineation, SESI, determined the best course of action is to excavate the contaminated soil to a depth of 1 to 1.5 feet as applicable. In November of 2021, contaminated material was removed by excavating the affected area. Confirmation samples were taken to ensure remediation was successful and that the vertical and horizontal extent of the release area had been established. The samples were properly preserved and packaged then sent to Hall Laboratories for analysis. The results of the sampling is captured in the table below.

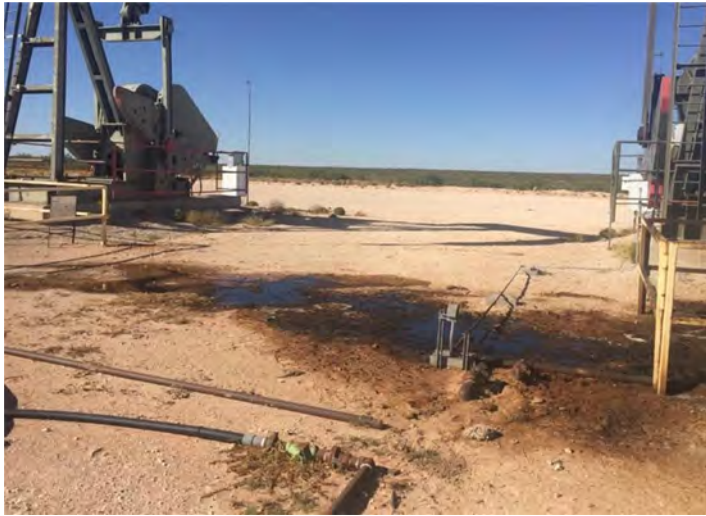
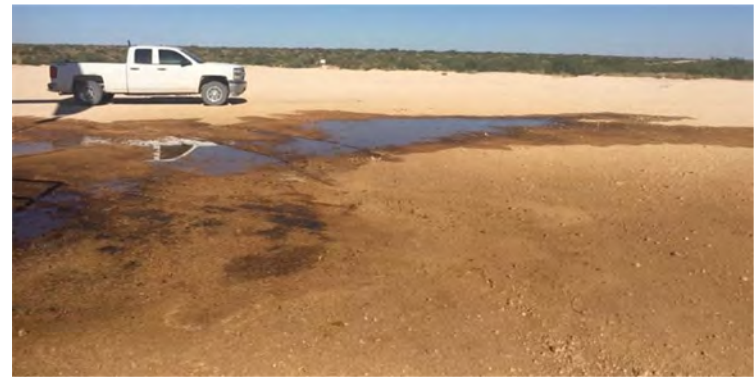
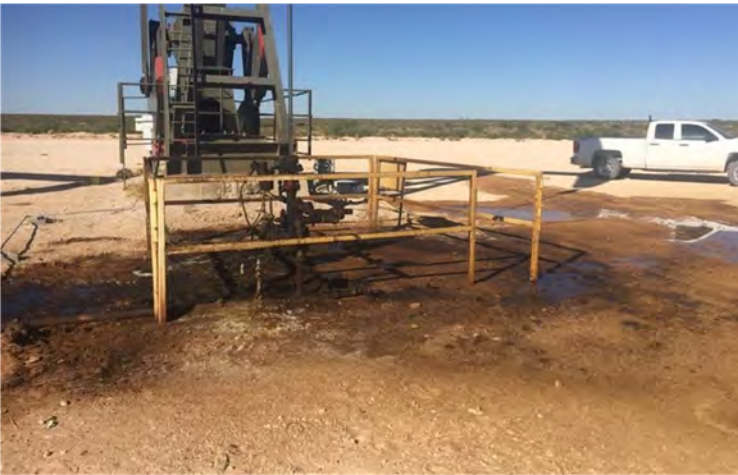
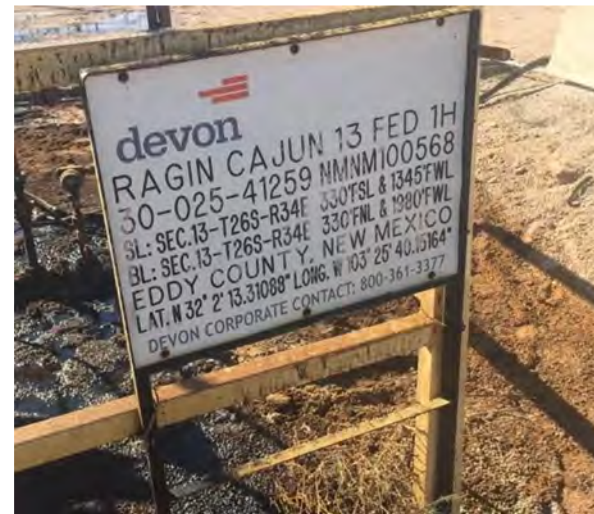
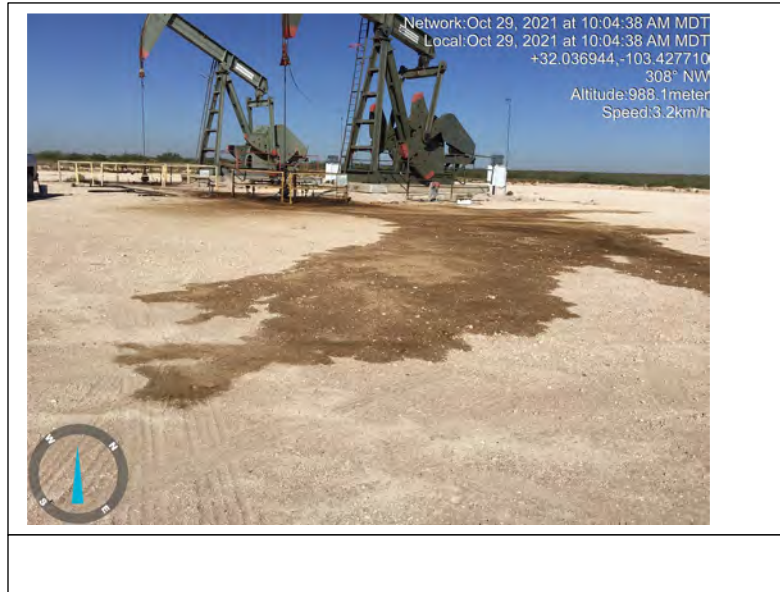
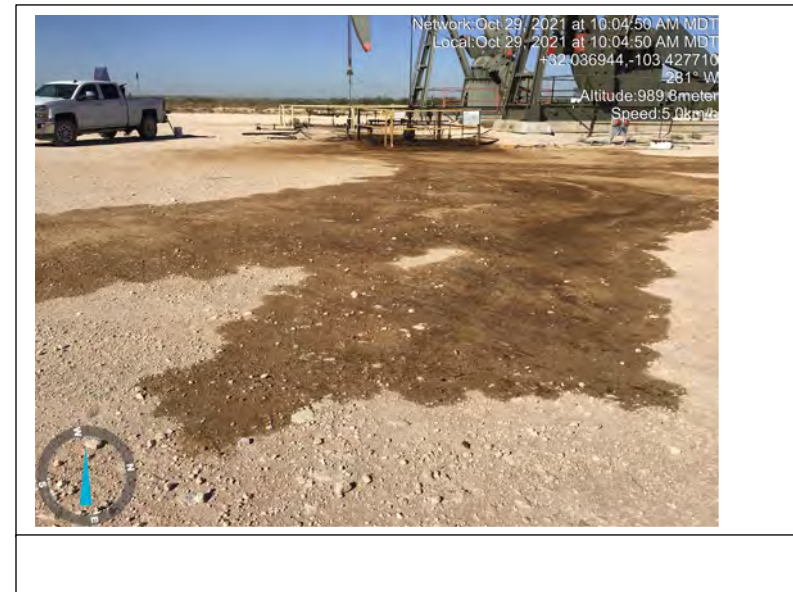
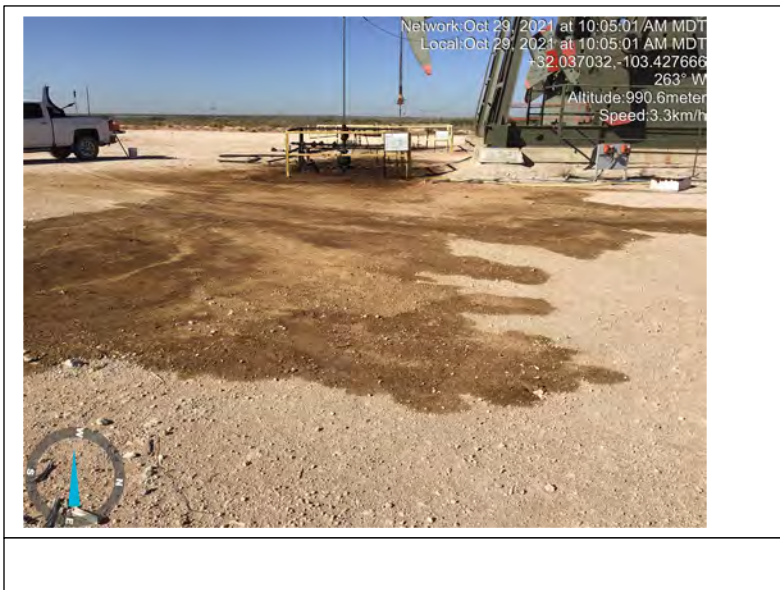
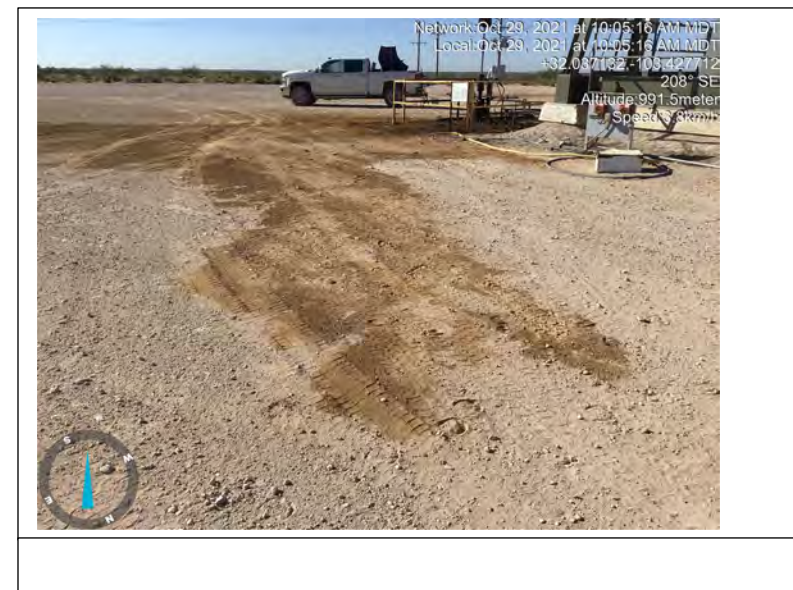
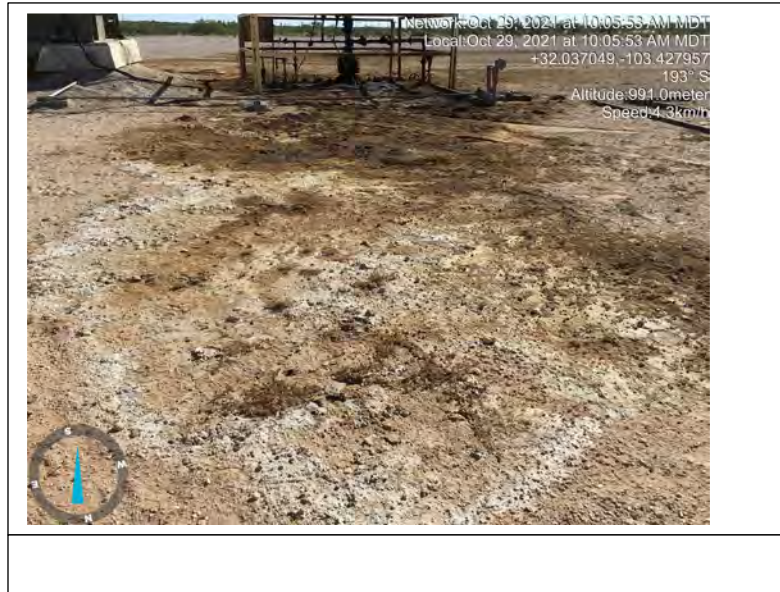
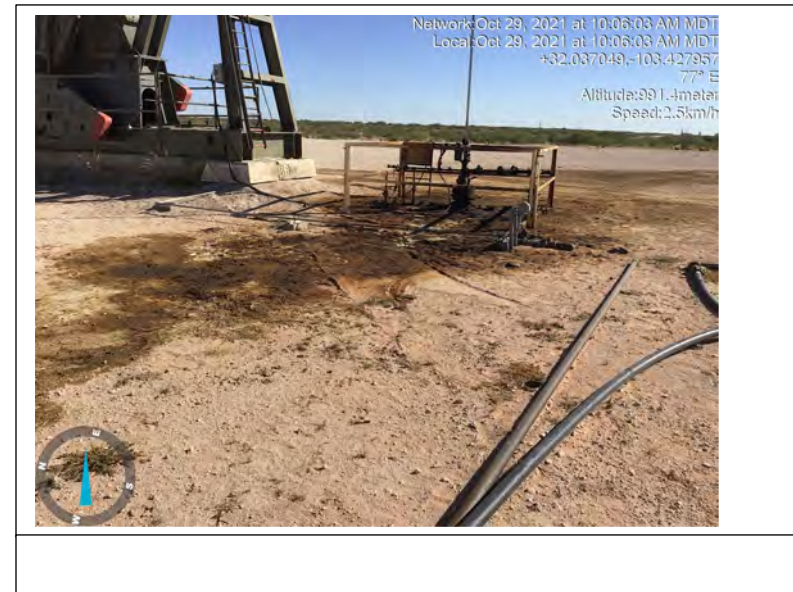
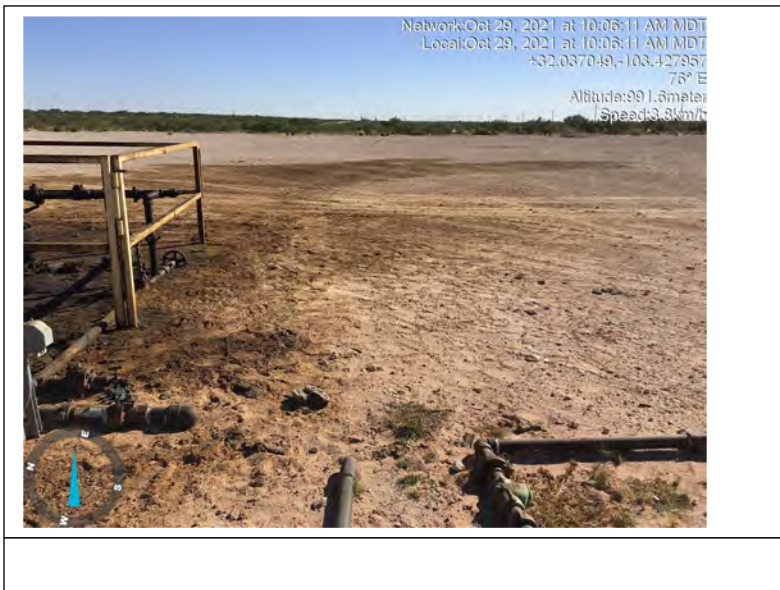
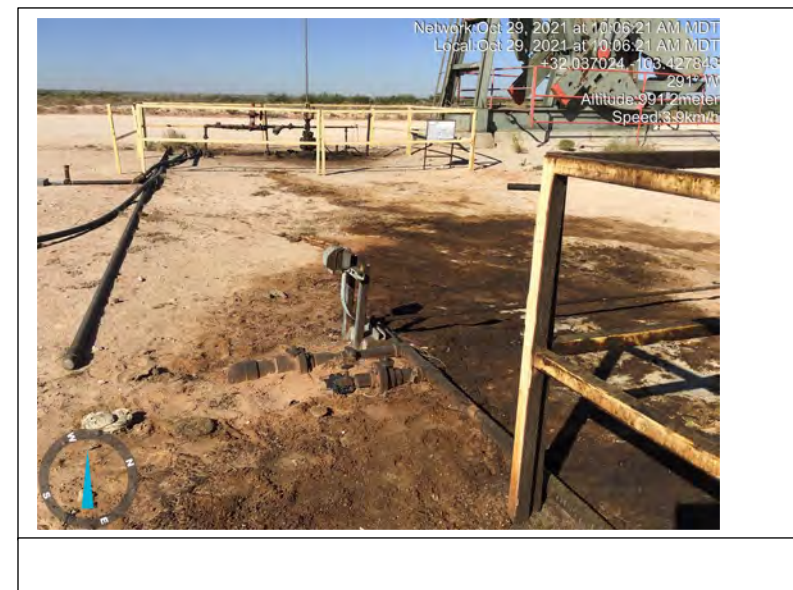
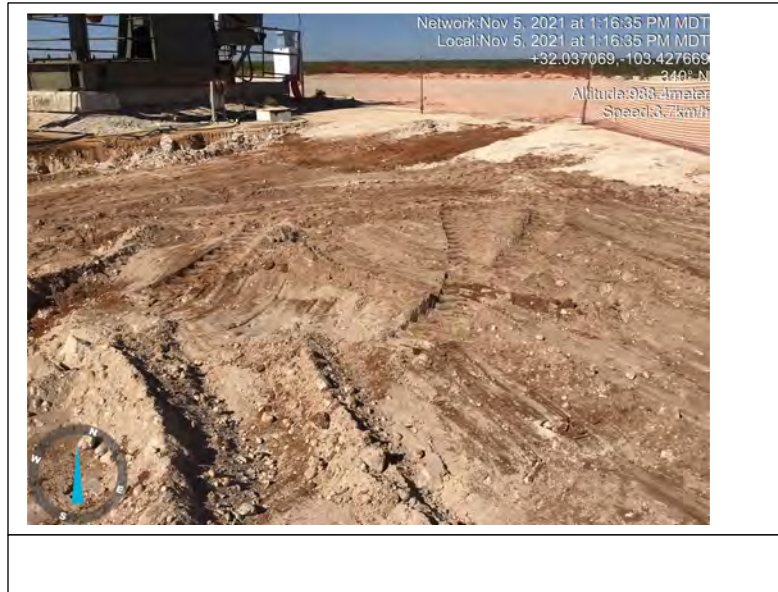
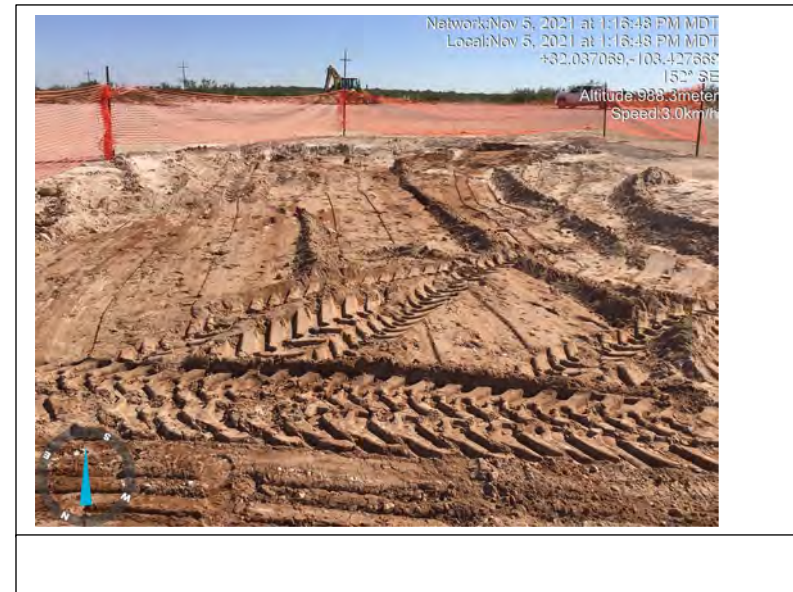
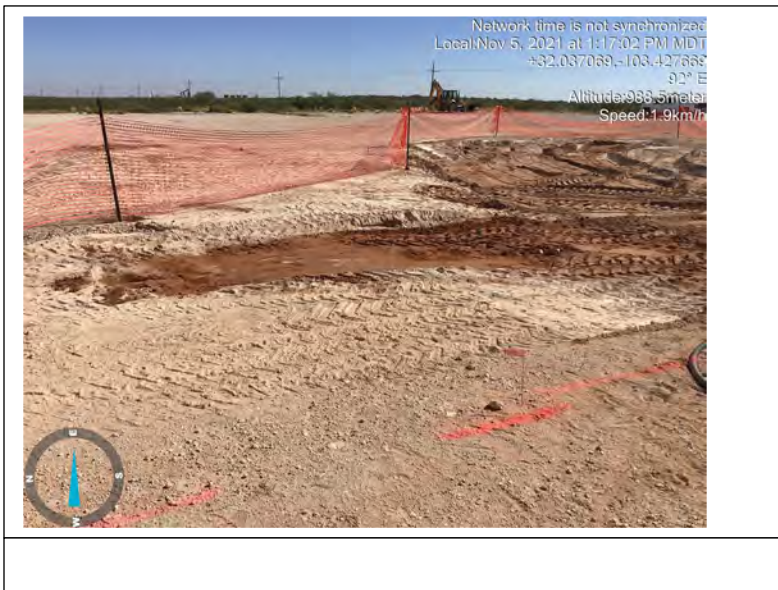
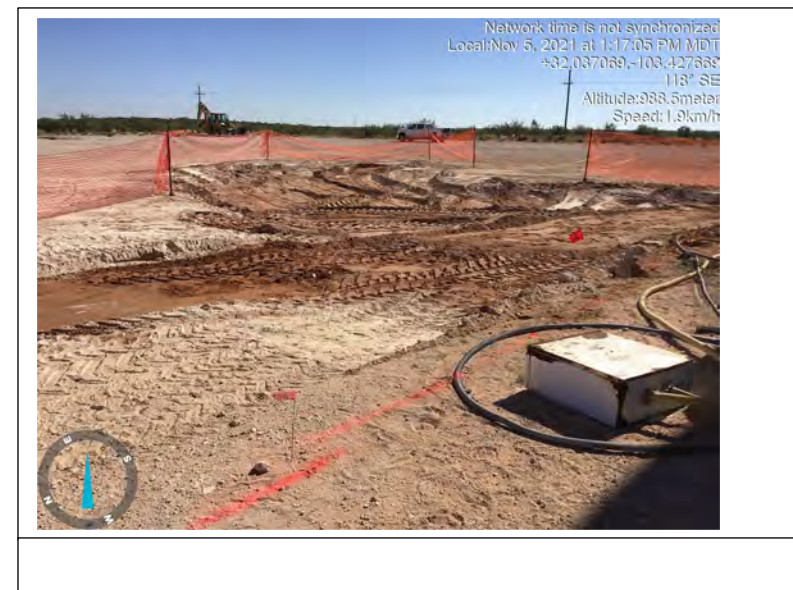
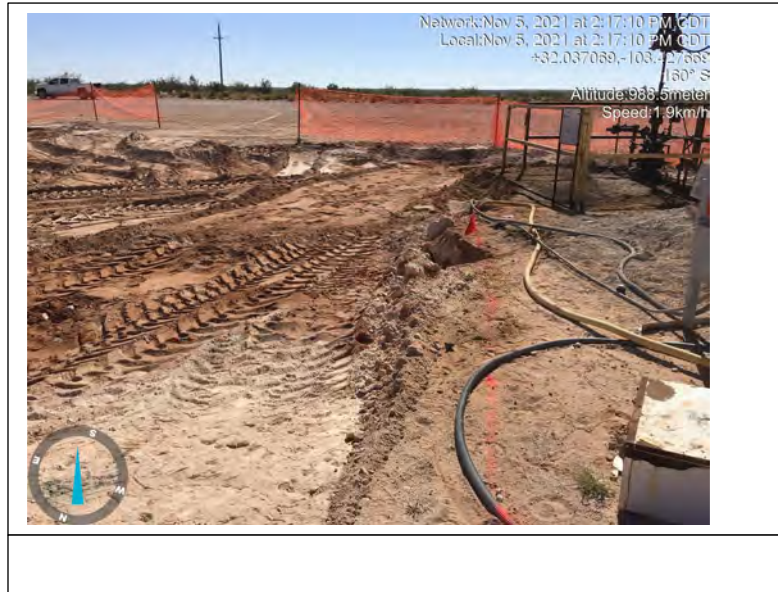
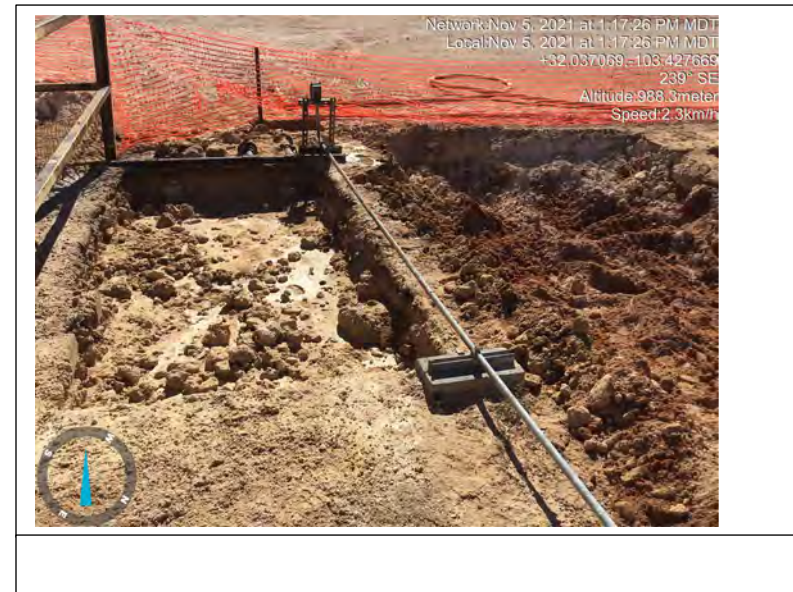
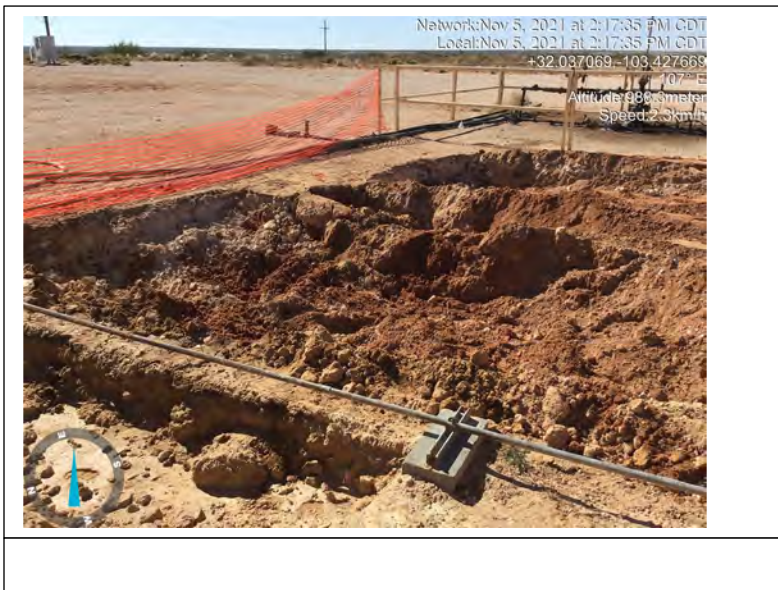
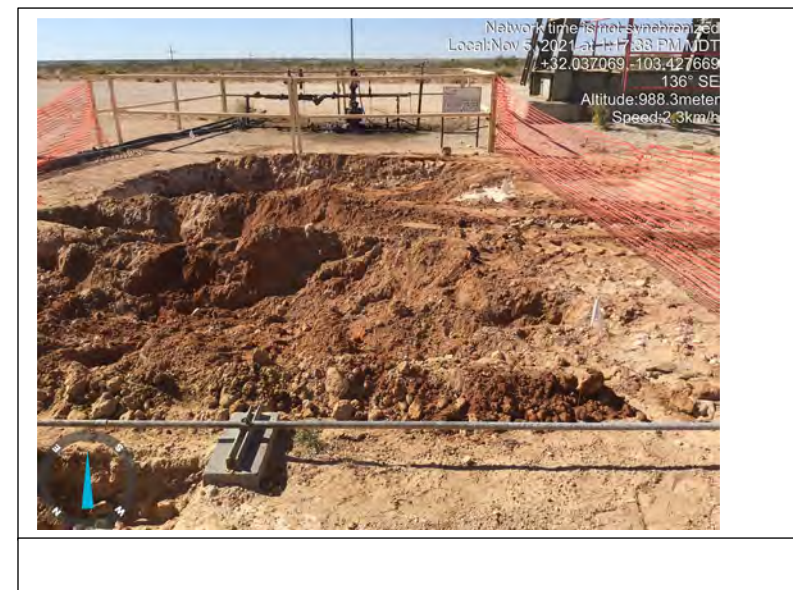
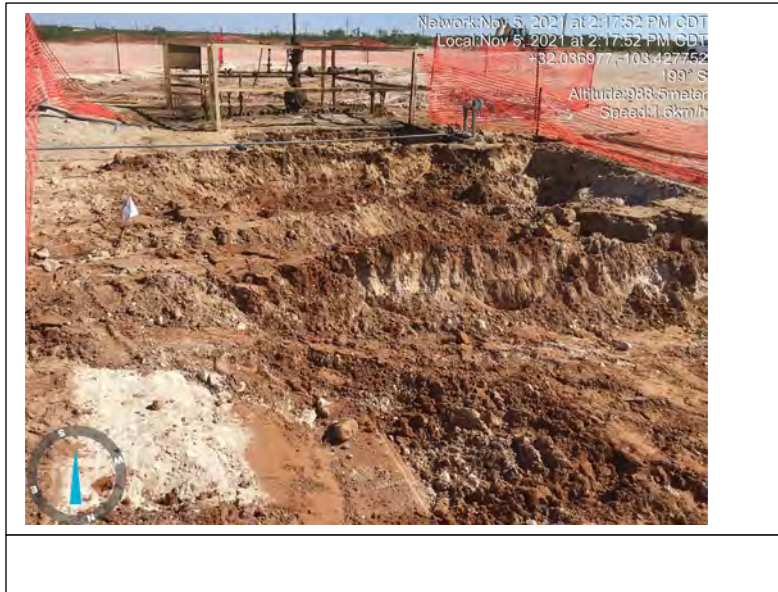
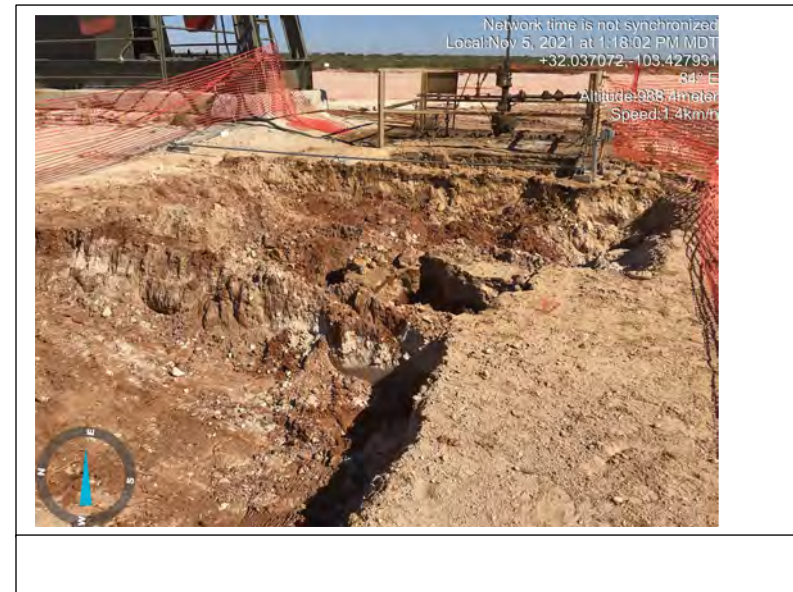
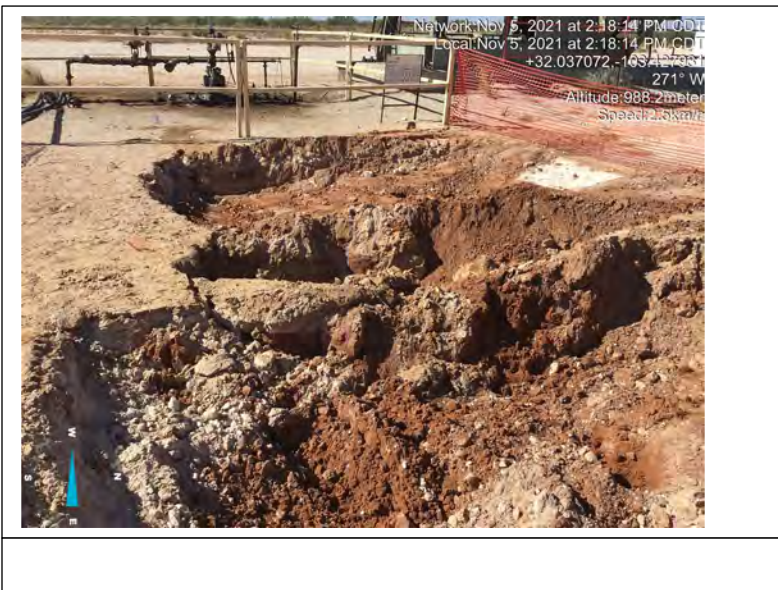
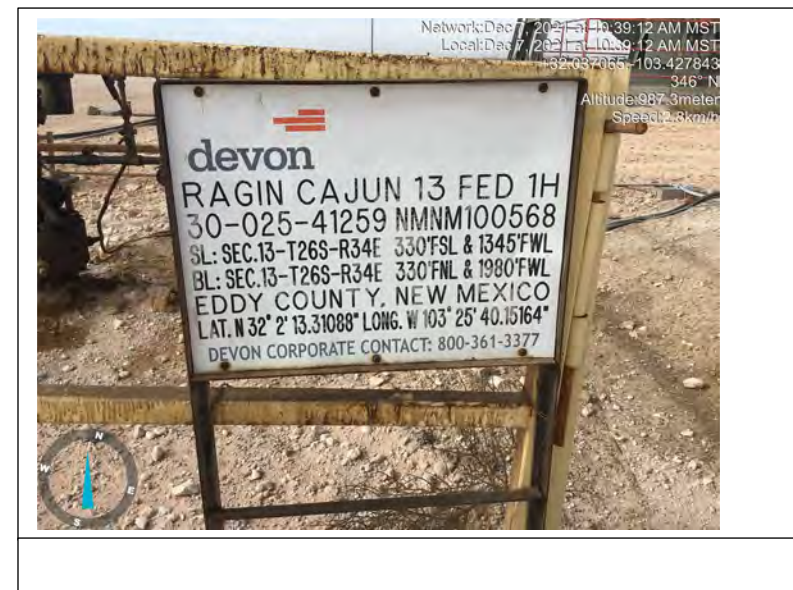
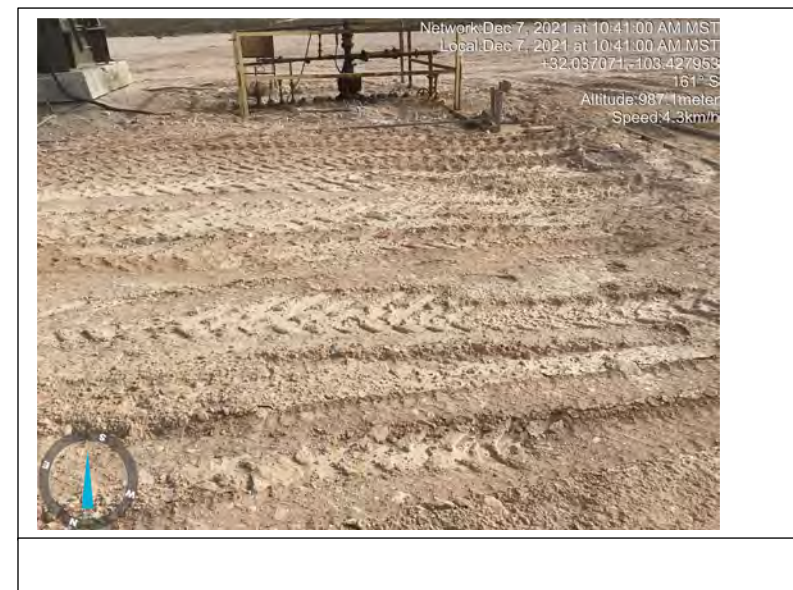
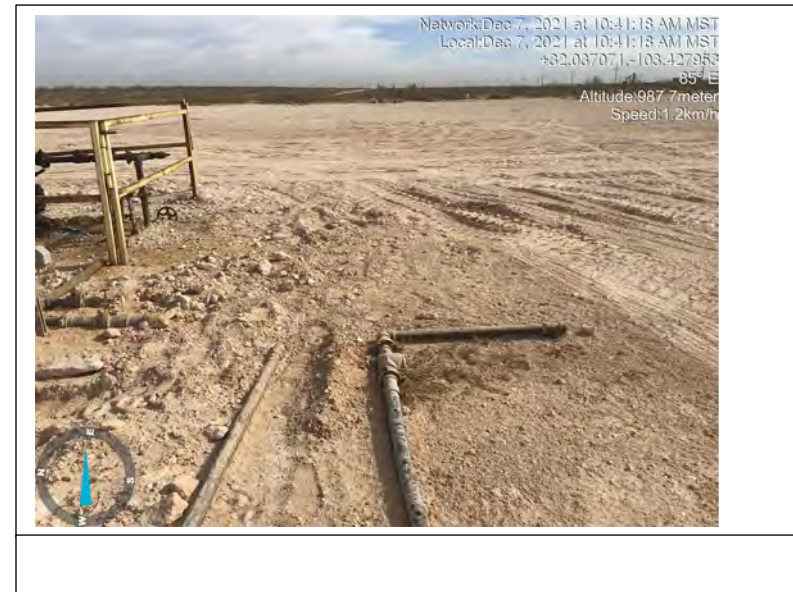
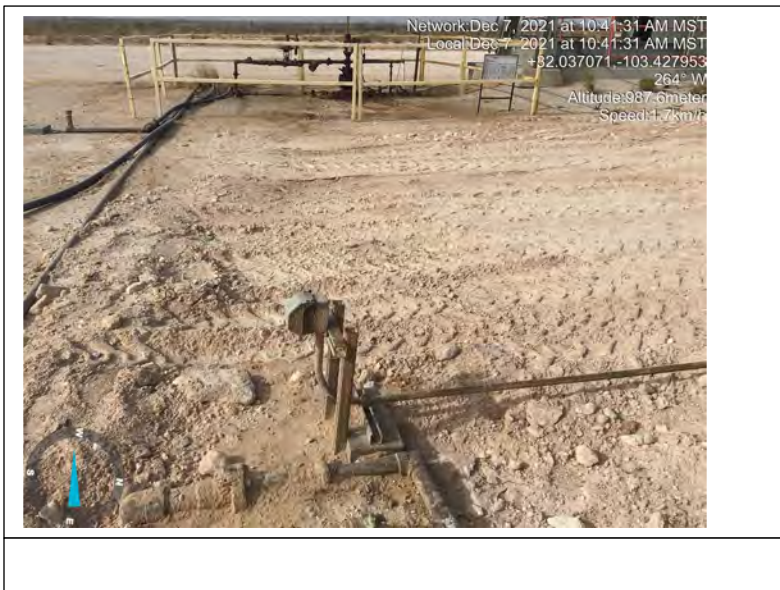
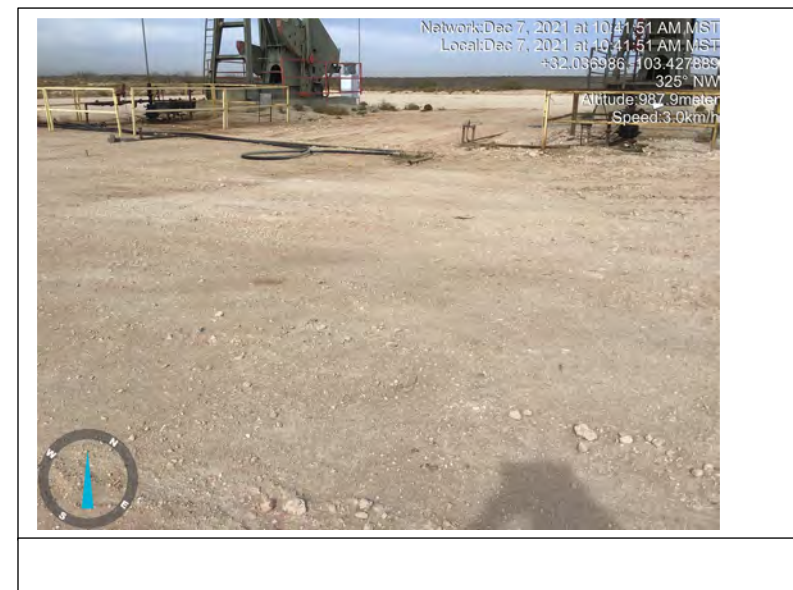
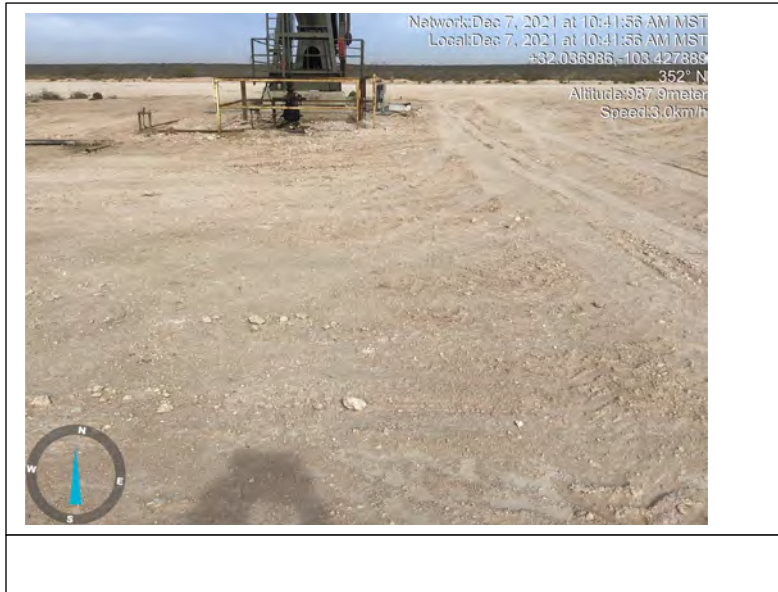
Devon Energy – Ragin Cajun 13 Fed 1H Excavation & Remediation Photos

Once sample results verified both successful remediation and horizontal extent, the site was backfilled with clean soil. Pictures of the remediation are included in this report.
