**Re: Closure Request  
Big Sinks 2-24-30 Battery  
Incident Numbers NAPP2219644709 and NAPP2220224382  
Eddy County, New Mexico**

Ensolum, LLC (Ensolum) on behalf of XTO Energy, Inc. (XTO), has prepared this Closure Request to document site assessment and soil sampling activities performed at the Big Sinks 2-24-30 Battery (Site). The purpose of the site assessment and soil sampling activities was to assess the presence or absence of impacts to soil resulting from a release of crude oil and produced water within lined containment at the Site. Based on field observations, field screening activities, and laboratory analytical results, XTO is submitting this Closure Request, describing remediation that has occurred and requesting no further action for Incident Numbers NAPP2219644709 and NAPP2220224382.

XTO ENERGY, INC  
 BIG SINKS 2-24-30 BATTERY  
 NAPP2219644709 & NAPP2220224382  
 Unit E, Sec 02, T24S, R30E  
 Eddy County, New Mexico

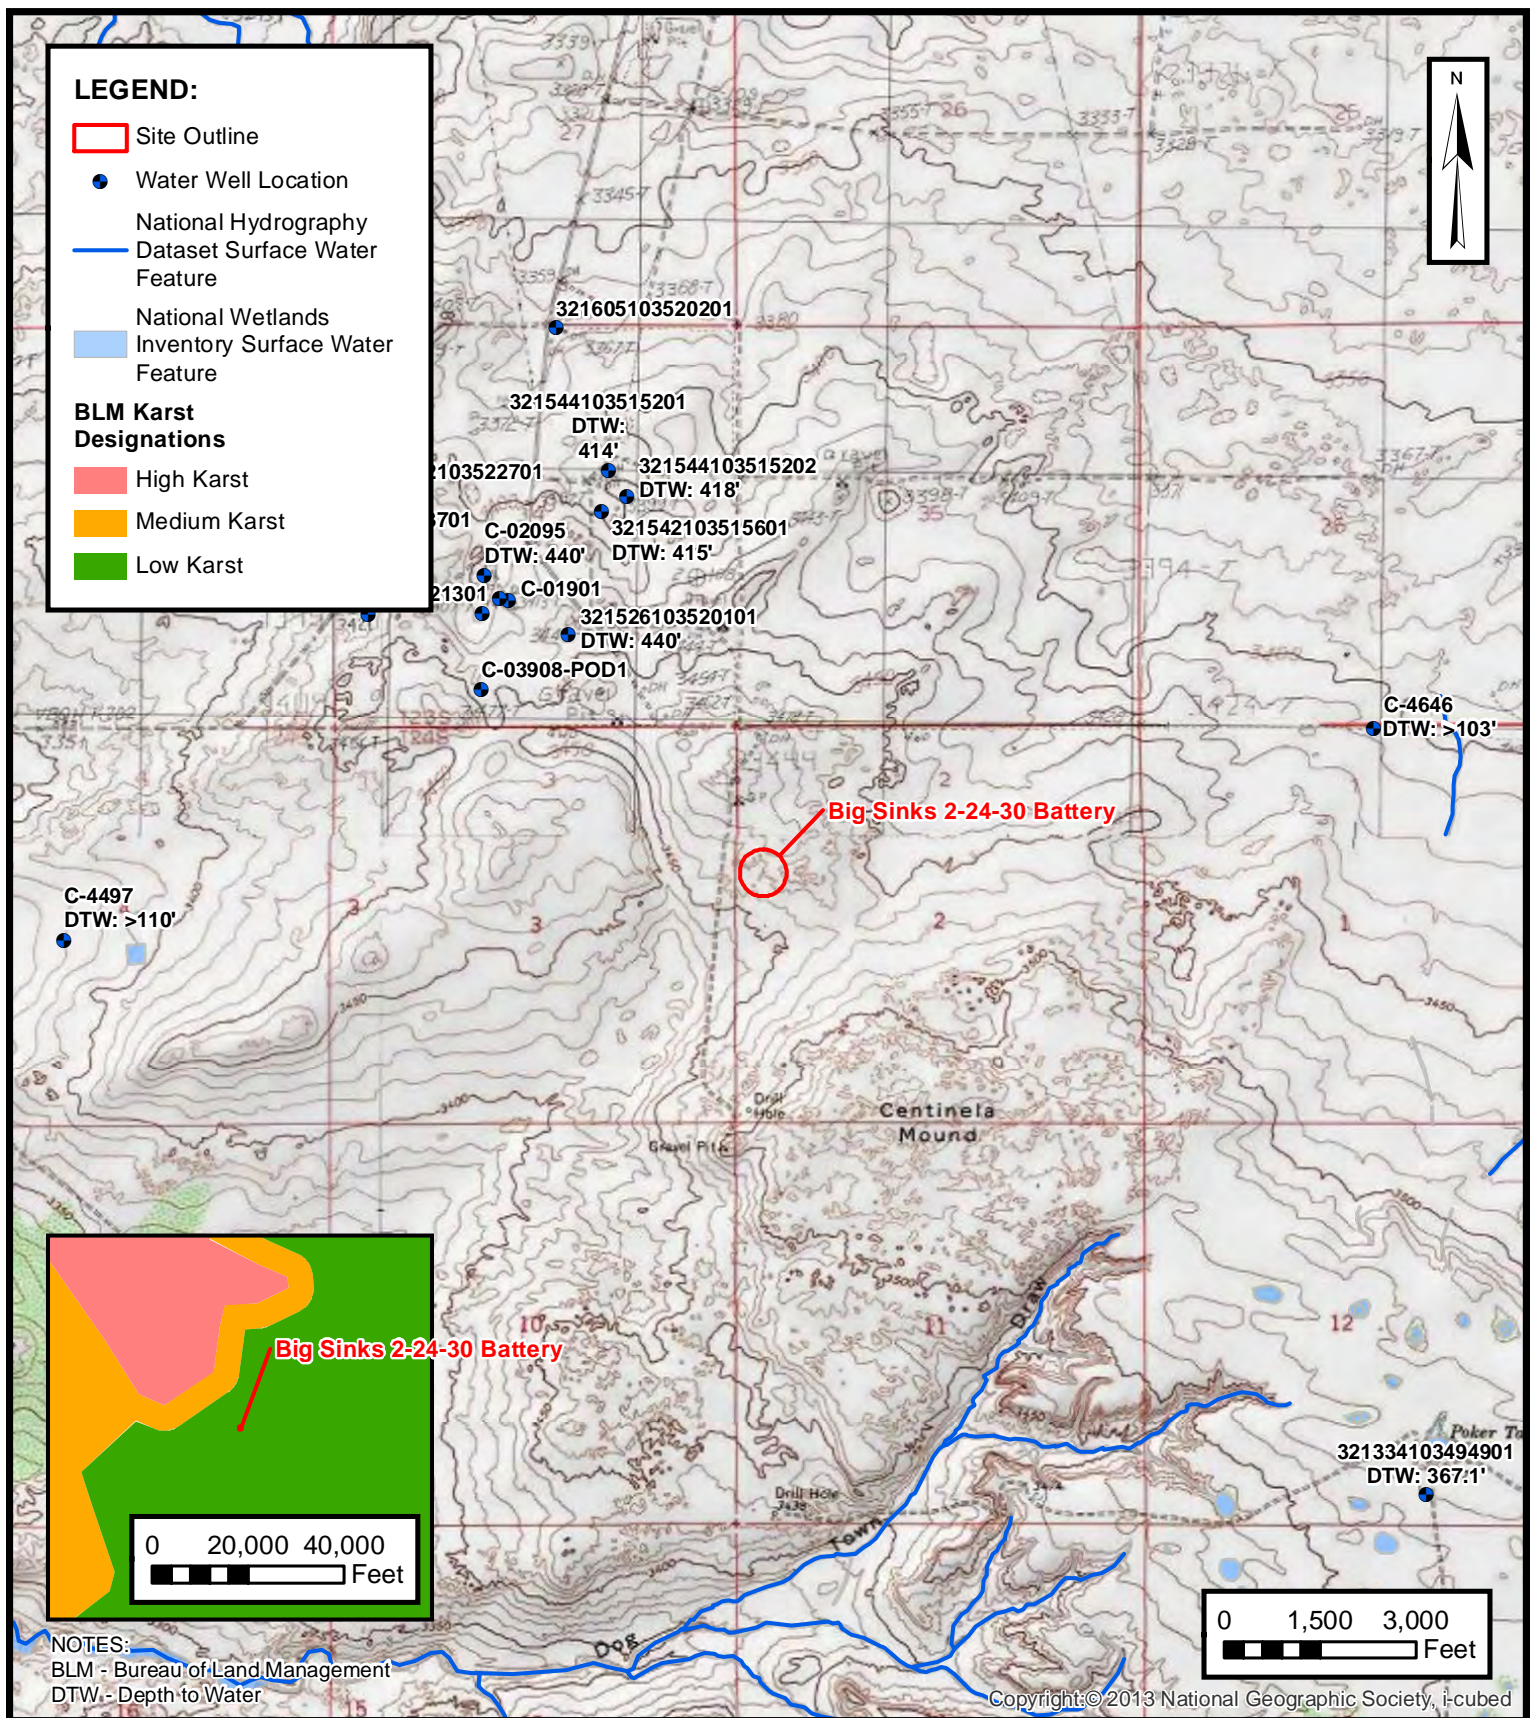
**FIGURE****1**

**SITE RECEPTOR MAP**

The Site is located in Unit E, Section 02, Township 24 South, Range 30 East, in Eddy County, New Mexico (32.24849° N, 103.85958°W) and is associated with oil and gas exploration and production operations on state land managed by the New Mexico State Land Office (SLO; Figure 1).

Code (NMAC). Results from the characterization desktop review are presented on page 3 of the Form C-141, Site Assessment/Characterization. Potential site receptors are identified on Figure 1.

The closest continuously flowing or significant watercourse to the Site is Dog Town Draw, located approximately 6,575 feet south of the Site. The Site is greater than 200 feet from a lakebed, sinkhole, or playa lake and greater than 300 feet from an occupied residence, school, hospital, institution, church, or wetland. The Site is greater than 1,000 feet to a freshwater well or spring and is not within a 100-year floodplain or overlying a subsurface mine. The Site is not underlain by unstable geology (low potential karst designation area). Site receptors are identified on Figure 1.

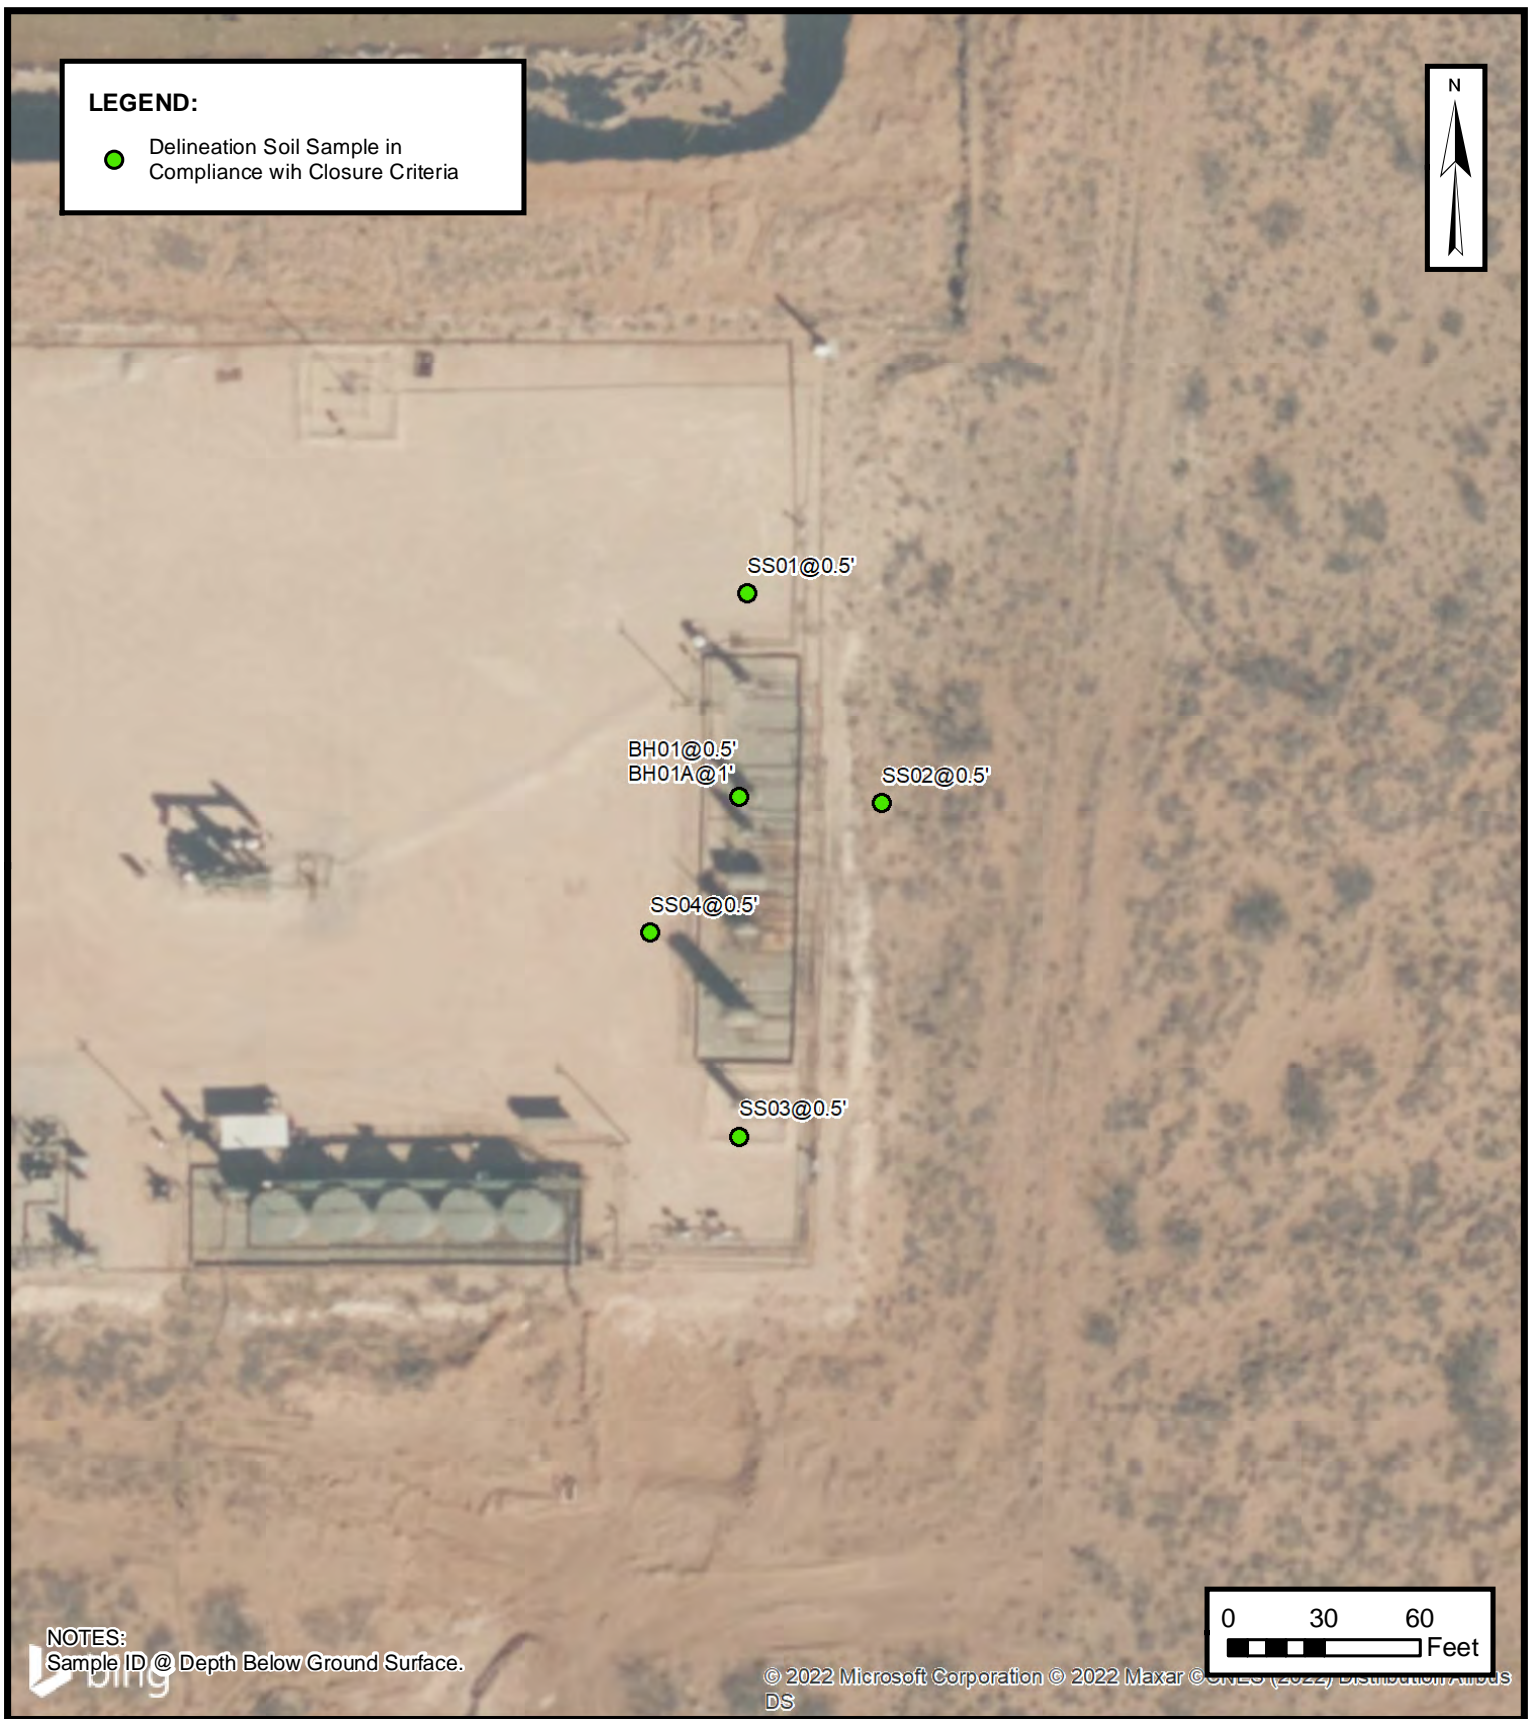
FIGURE

### DELINEATION SOIL SAMPLE LOCATIONS

XTO ENERGY, INC  
BIG SINKS 2-24-30 BATTERY  
NAPP2219644709 & NAPP2220224382  
Unit E, Sec 2, T24S, R30E  
Eddy County, New Mexico

On August 23, 2022 and August 29, 2022, site assessment activities were conducted to evaluate the release extent based on information provided on the Form C-141 and visual observations. Ensolum personnel advanced one borehole (BH01) via hand-auger at the location of the tear in the liner identified during the liner integrity inspection. Two discrete delineation soil samples (BH01 and BH01A) were collected from the borehole at depths of approximately 0.5 feet and 1 foot bgs. Soil from the delineation samples was field screened for volatile organic compounds (VOCs) utilizing a calibrated photoionization detector (PID) and chloride using Hach® chloride QuanTab® test strips, respectively. Field screening results and observations from the borehole were documented on a lithologic/soil sampling log, which is included as Appendix B. The borehole was backfilled with soil removed and the tear in the liner was repaired. Four assessment samples (SS01 through SS04) were collected around the lined containment from a depth of 0.5 feet bgs to confirm the lateral extent of any release. The soil sample locations are depicted on Figure 2. Photographic documentation was conducted during the Site visit. A photographic log is included in Appendix C.

Laboratory analytical results for the delineation soil samples from borehole BH01 indicated that benzene, BTEX, TPH-GRO/TPH-DRO, TPH, and chloride concentrations were compliant with the Site Closure Criteria. Laboratory analytical results for soil samples SS01 through SS04, collected around the containment, were compliant with the Site Closure Criteria and compliant with the most stringent Table 1 Closure Criteria. Laboratory analytical results are summarized in Table 1 and the complete laboratory analytical reports are included as Appendix D.

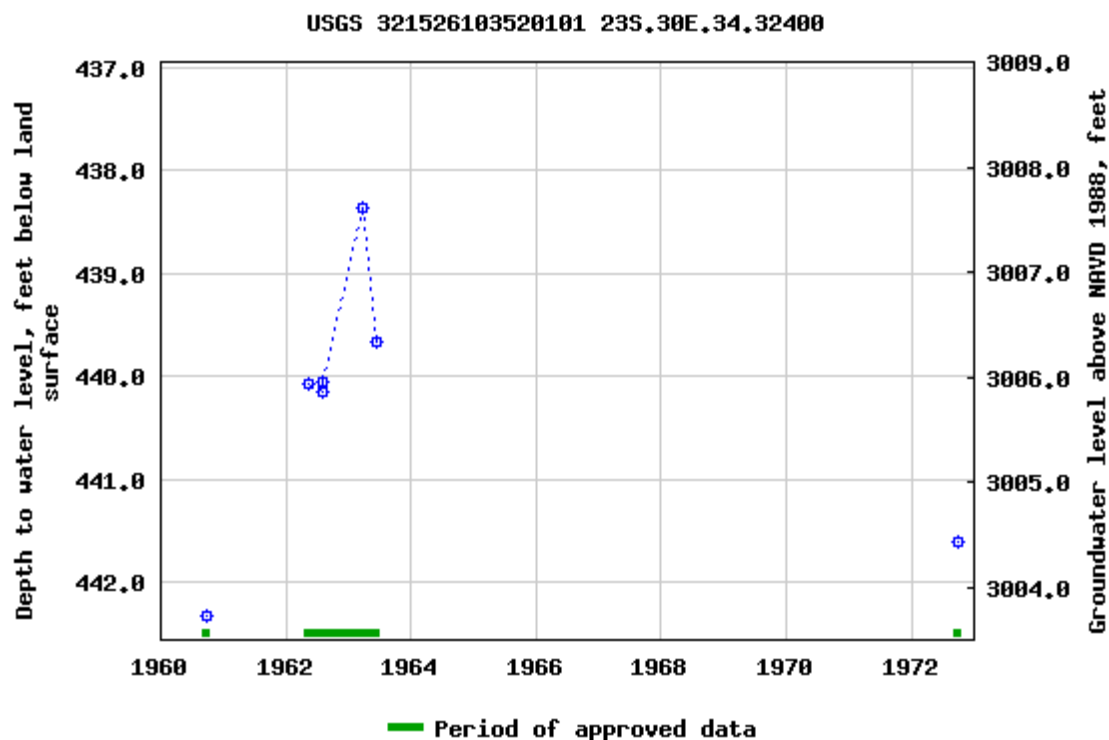
## USGS 321526103520101 23S.30E.34.32400

The depth of the well is 567 feet below land surface.

Breaks in the plot represent a gap of at least one year between field measurements.  
[Download a presentation-quality graph](#)

Depth to groundwater at the Site is estimated to be greater than 100 feet below ground surface (bgs) based on the nearest groundwater well data. The closest permitted groundwater well with depth to groundwater data is USGS well 321526103520101, located approximately 0.69 miles northwest of the Site. The groundwater well has a reported depth to groundwater of 440 feet bgs and a total depth of 567 feet bgs. Although the nearest water well with depth to water data is greater than ½ mile away, NMOCD guidance indicates the agency will review additional information on a case-by-case basis. Ensolum requests NMOCD consider regional groundwater trends to evaluate groundwater at this Site. In addition to the referenced water well, there are eight permitted wells within a 2-mile radius of the Site, all of which indicate depth to groundwater is greater than 100 feet bgs. In fact, most of the wells document groundwater near 400 feet bgs. The water wells exist in all directions around the Site. The Site is not located near any surface water features and is well within the low-karst potential area, which likely rules out any pathway to shallow groundwater. All wells used for depth to groundwater determination are presented on Figure 1. The referenced well records are included in Attachment 1.

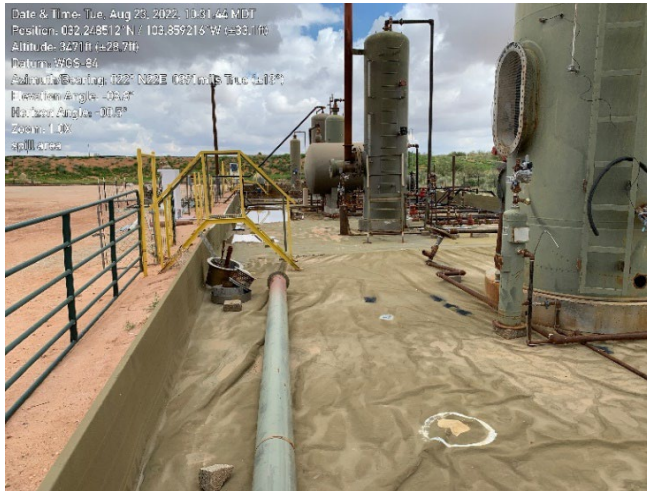
Photograph 1

Description: View northeast of tears in the liner marked with white paint.

Following the failed liner integrity inspection at the Site, Ensolum personnel advanced one borehole (BH01) at the location of the tear in the liner to assess for the presence or absence of impacted soil resulting from the July 5, 2022 and July 16, 2022, crude oil and produced water releases within lined containment. The release was contained laterally by the lined containment and all released fluids were recovered during initial response activities. The tear in the liner was subsequently repaired.

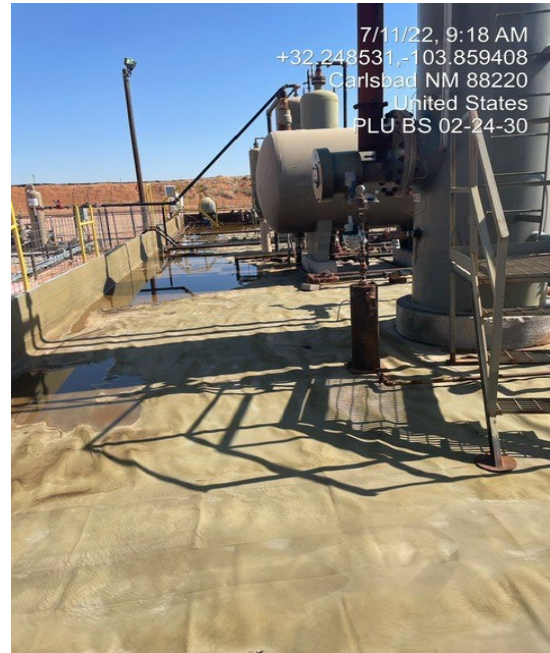
Photograph 2

Description: View of liner facing south.

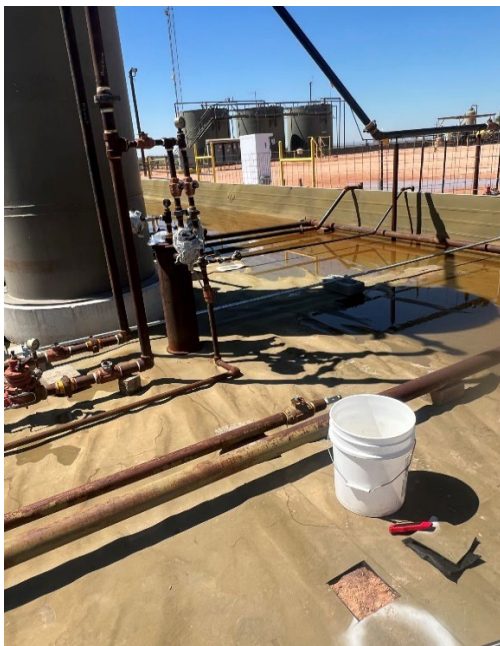
Photograph 3

Description: View of location of BH01 during liner delineation.
