| Site Name Big Sinks 2-24-30 State Battery | Site Type Tank Battery |

**Re: Closure Request  
Big Sinks 2-24-30 Battery  
Incident Numbers NAPP2219644709 and NAPP2220224382  
Eddy County, New Mexico**

Ensolum, LLC (Ensolum) on behalf of XTO Energy, Inc. (XTO), has prepared this Closure Request to document site assessment and soil sampling activities performed at the Big Sinks 2-24-30 Battery (Site). The purpose of the site assessment and soil sampling activities was to assess the presence or absence of impacts to soil resulting from a release of crude oil and produced water within lined containment at the Site. Based on field observations, field screening activities, and laboratory analytical results, XTO is submitting this Closure Request, describing remediation that has occurred and requesting no further action for Incident Numbers NAPP2219644709 and NAPP2220224382.

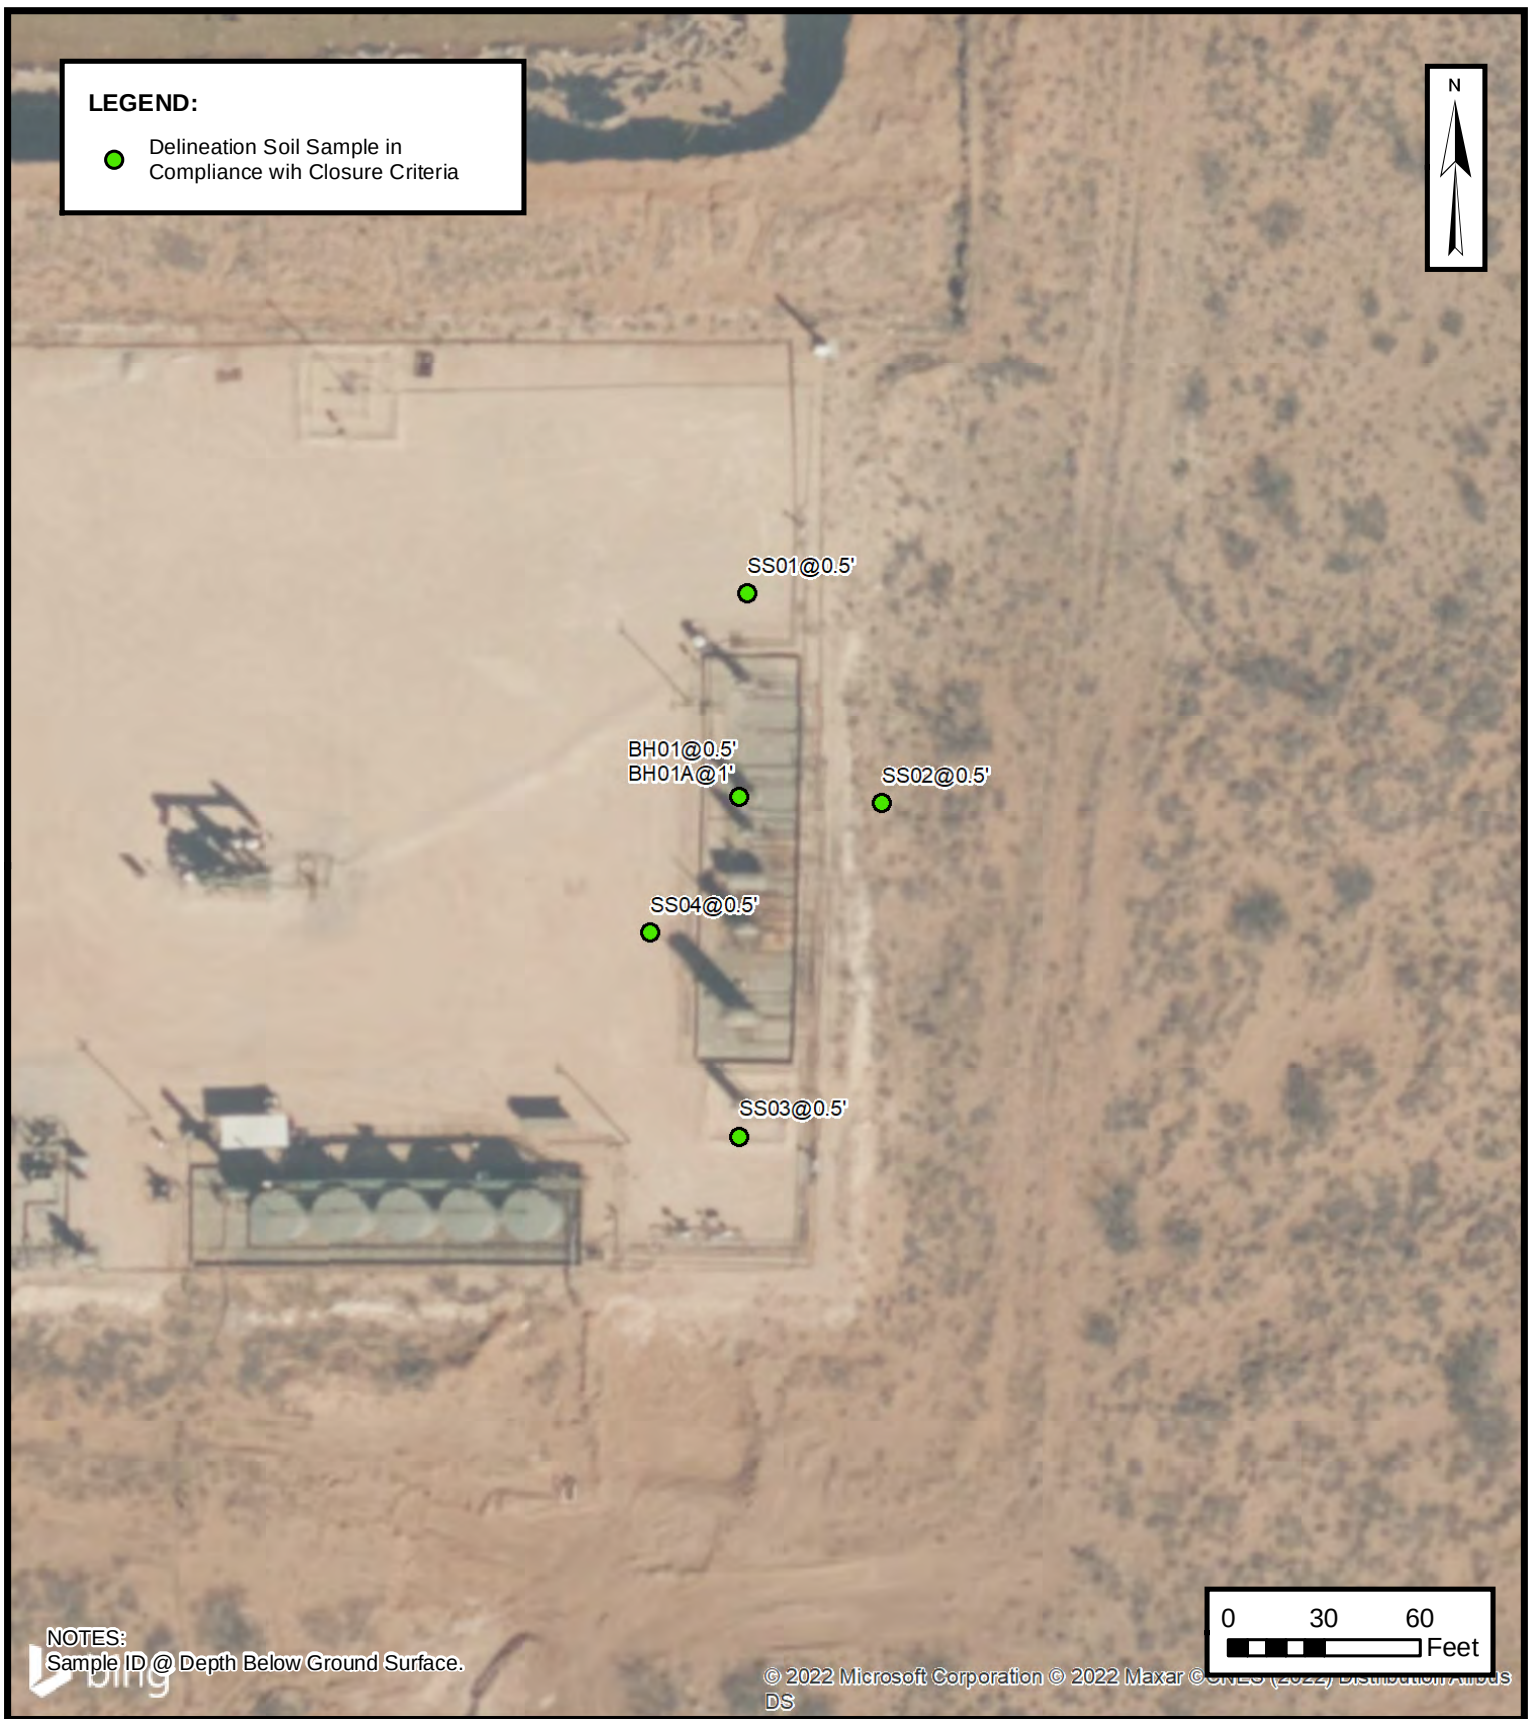
FIGURE

### DELINEATION SOIL SAMPLE LOCATIONS

On August 23, 2022 and August 29, 2022, site assessment activities were conducted to evaluate the release extent based on information provided on the Form C-141 and visual observations. Ensolum personnel advanced one borehole (BH01) via hand-auger at the location of the tear in the liner identified during the liner integrity inspection. Two discrete delineation soil samples (BH01 and BH01A) were collected from the borehole at depths of approximately 0.5 feet and 1 foot bgs. Soil from the delineation samples was field screened for volatile organic compounds (VOCs) utilizing a calibrated photoionization detector (PID) and chloride using Hach® chloride QuanTab® test strips, respectively. Field screening results and observations from the borehole were documented on a lithologic/soil sampling log, which is included as Appendix B. The borehole was backfilled with soil removed and the tear in the liner was repaired. Four assessment samples (SS01 through SS04) were collected around the lined containment from a depth of 0.5 feet bgs to confirm the lateral extent of any release. The soil sample locations are depicted on Figure 2. Photographic documentation was conducted during the Site visit. A photographic log is included in Appendix C.

Laboratory analytical results for the delineation soil samples from borehole BH01 indicated that benzene, BTEX, TPH-GRO/TPH-DRO, TPH, and chloride concentrations were compliant with the Site Closure Criteria. Laboratory analytical results for soil samples SS01 through SS04, collected around the containment, were compliant with the Site Closure Criteria and compliant with the most stringent Table 1 Closure Criteria. Laboratory analytical results are summarized in Table 1 and the complete laboratory analytical reports are included as Appendix D.
