**Closure Report**  
**Michalada Federal #3D**  
**API#: 30-015-35157**  
**RP#: 2RP-4246**  
**DOR: June 9, 2017**  
**GPS: 32.4255753, -104.3826447**  
**Unit Letter B, Section 03, Township 22 South, Range 25 East**  
**Eddy County, New Mexico**

# Michalada Federal #3D

**Re: Work Plan for the COG Operating LLC., Michalada Federal #3D, Unit B, Section 03, Township 22 South, Range 25 East, Eddy County, New Mexico. 2RP-4246.**

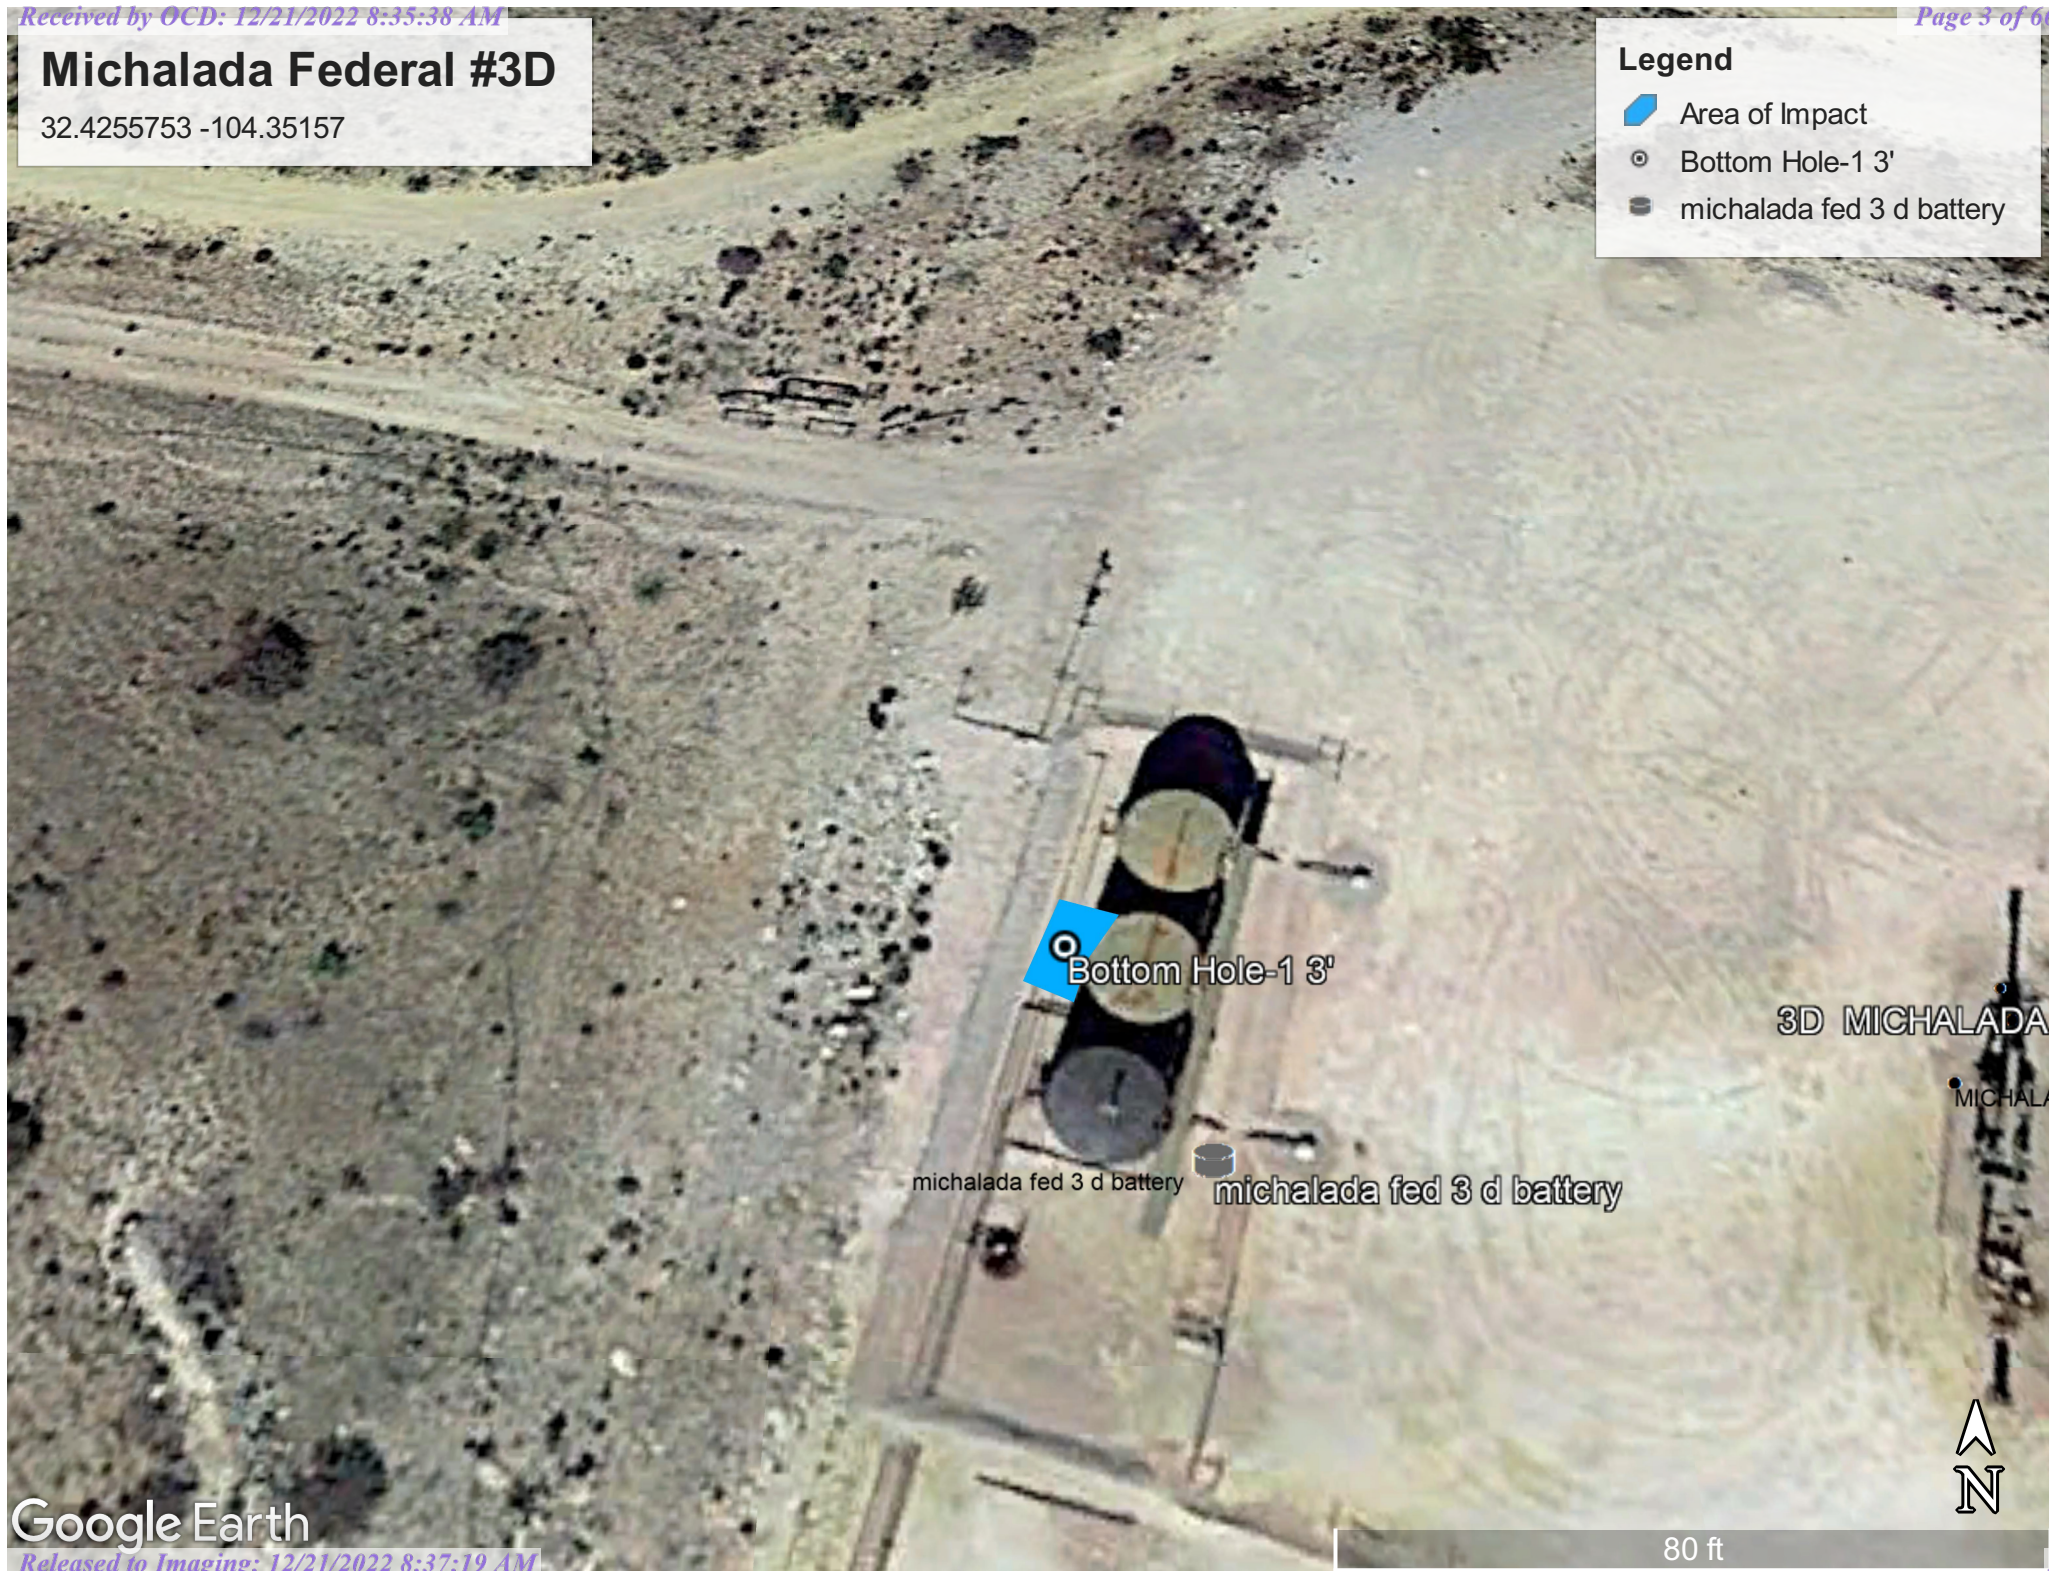
Area of Impact
-

Bottom Hole-1 3'
-

michalada fed 3 d battery

- The impacted area was excavated to a depth of three (3) feet BGS.
- On September 11, 2018, one confirmation sample was collect from the floor of the excavation and analyzed for benzene, toluene, ethylbenzene and xylene (BTEX) by EPA Method 8021B, total petroleum hydrocarbons (TPH) by EPA Method 8015 modified and chloride SM4500 Cl B. Bottom Hole-1 3' exhibited BTEX concentrations below the method detection limit of <0.300 mg/kg, TPH concentrations of 36.6 mg/kg, and a chloride concentration of 1,260 mg/kg.
- All of the excavated material was hauled to an NMOCD approved solid waste disposal facility.
- The excavation was backfilled with clean "like" material and contoured to match the surrounding terrain.

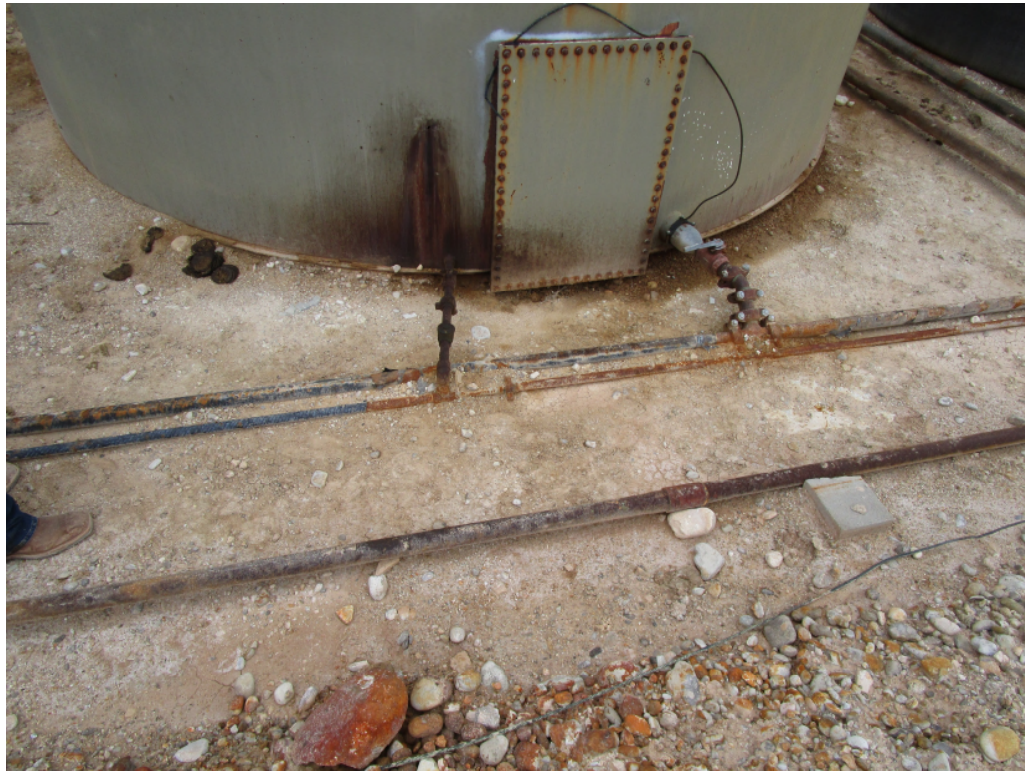
View North – Release Area

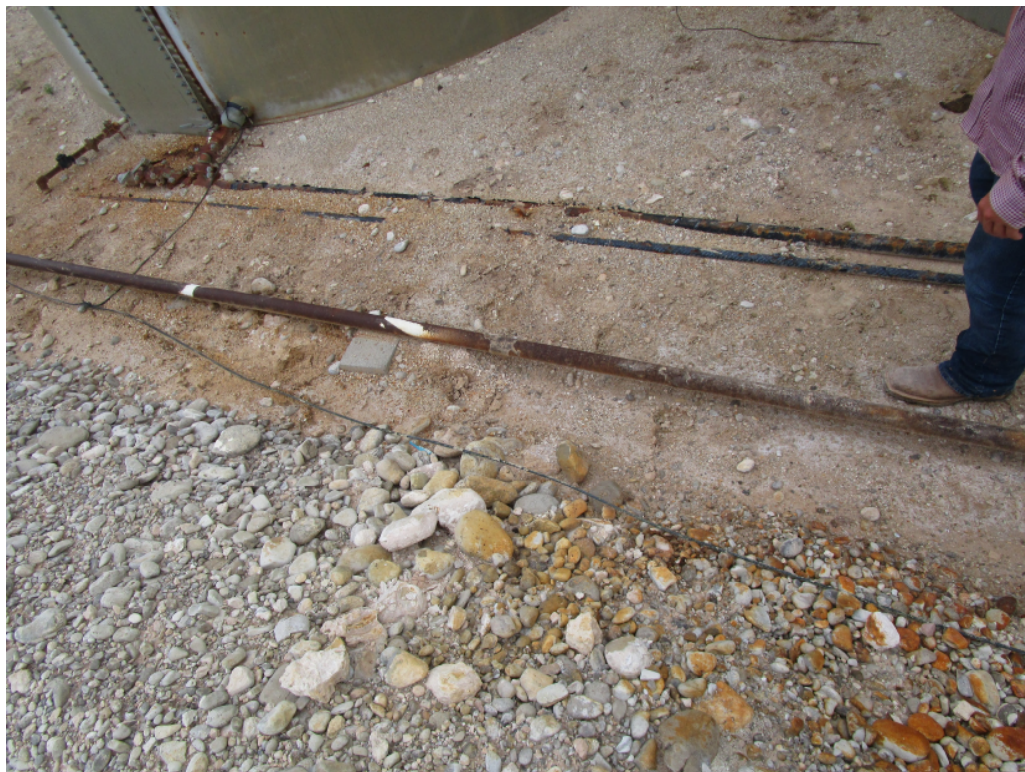
View Northwest – Release Area

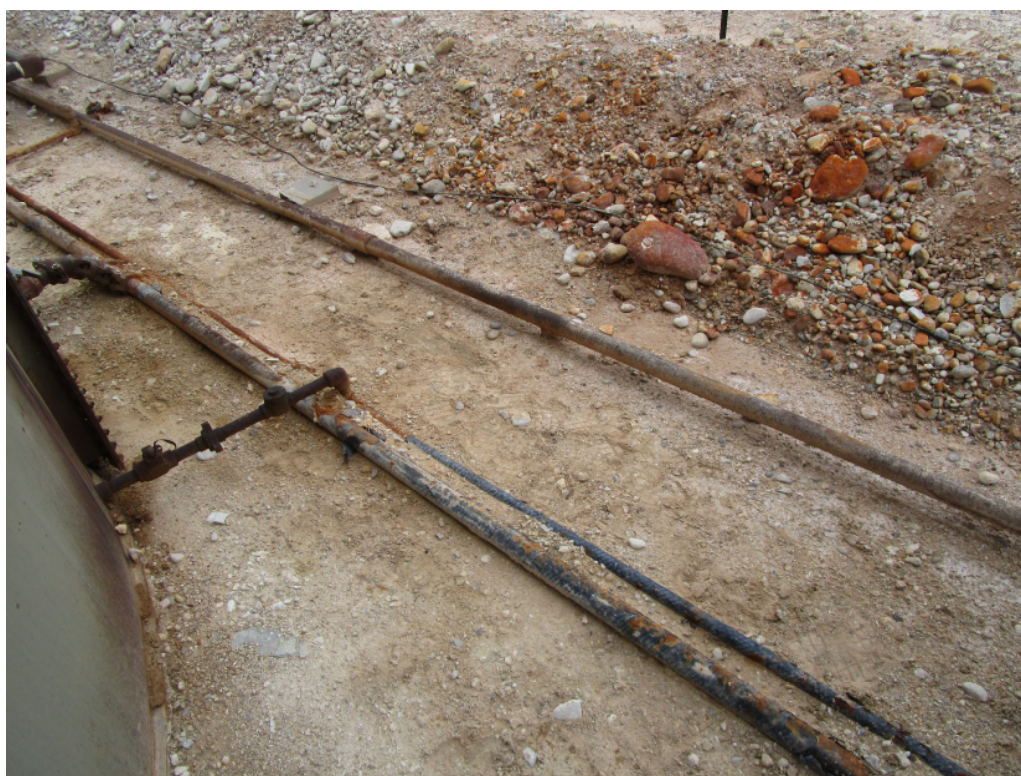
View Southeast – Release Area

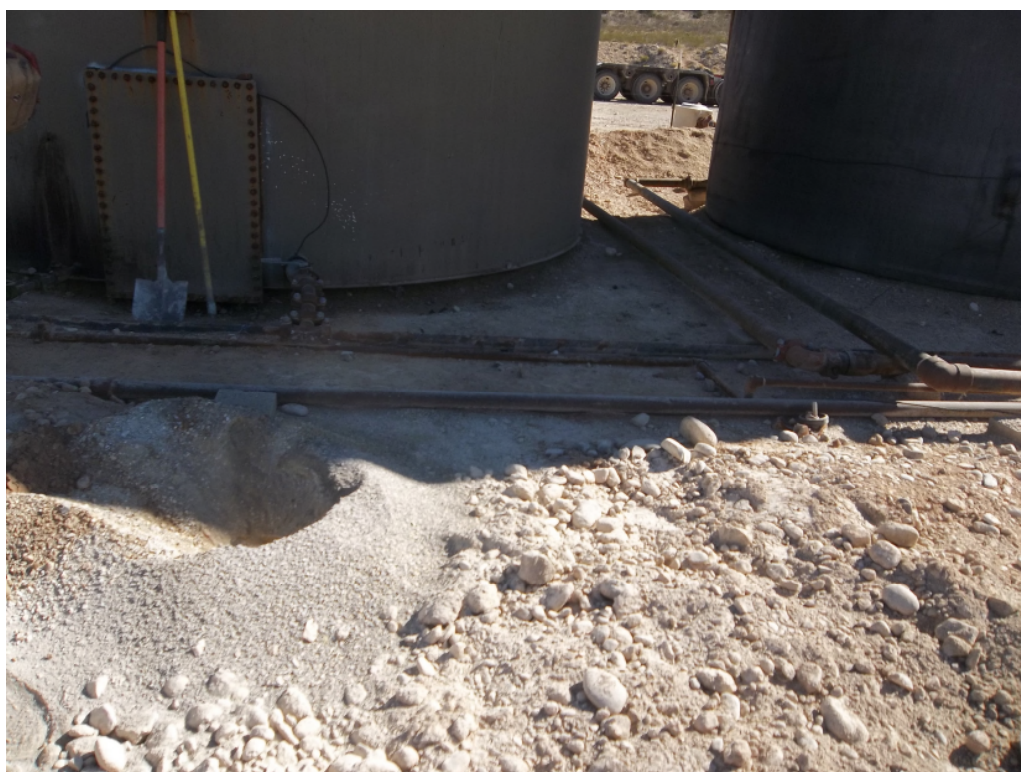
View North – Area of BH-1
