Remediation Summary and Closure Request

Devon Energy Corporation

Peridot 13 State #3H

NMOCD Incident # nAB1535131213

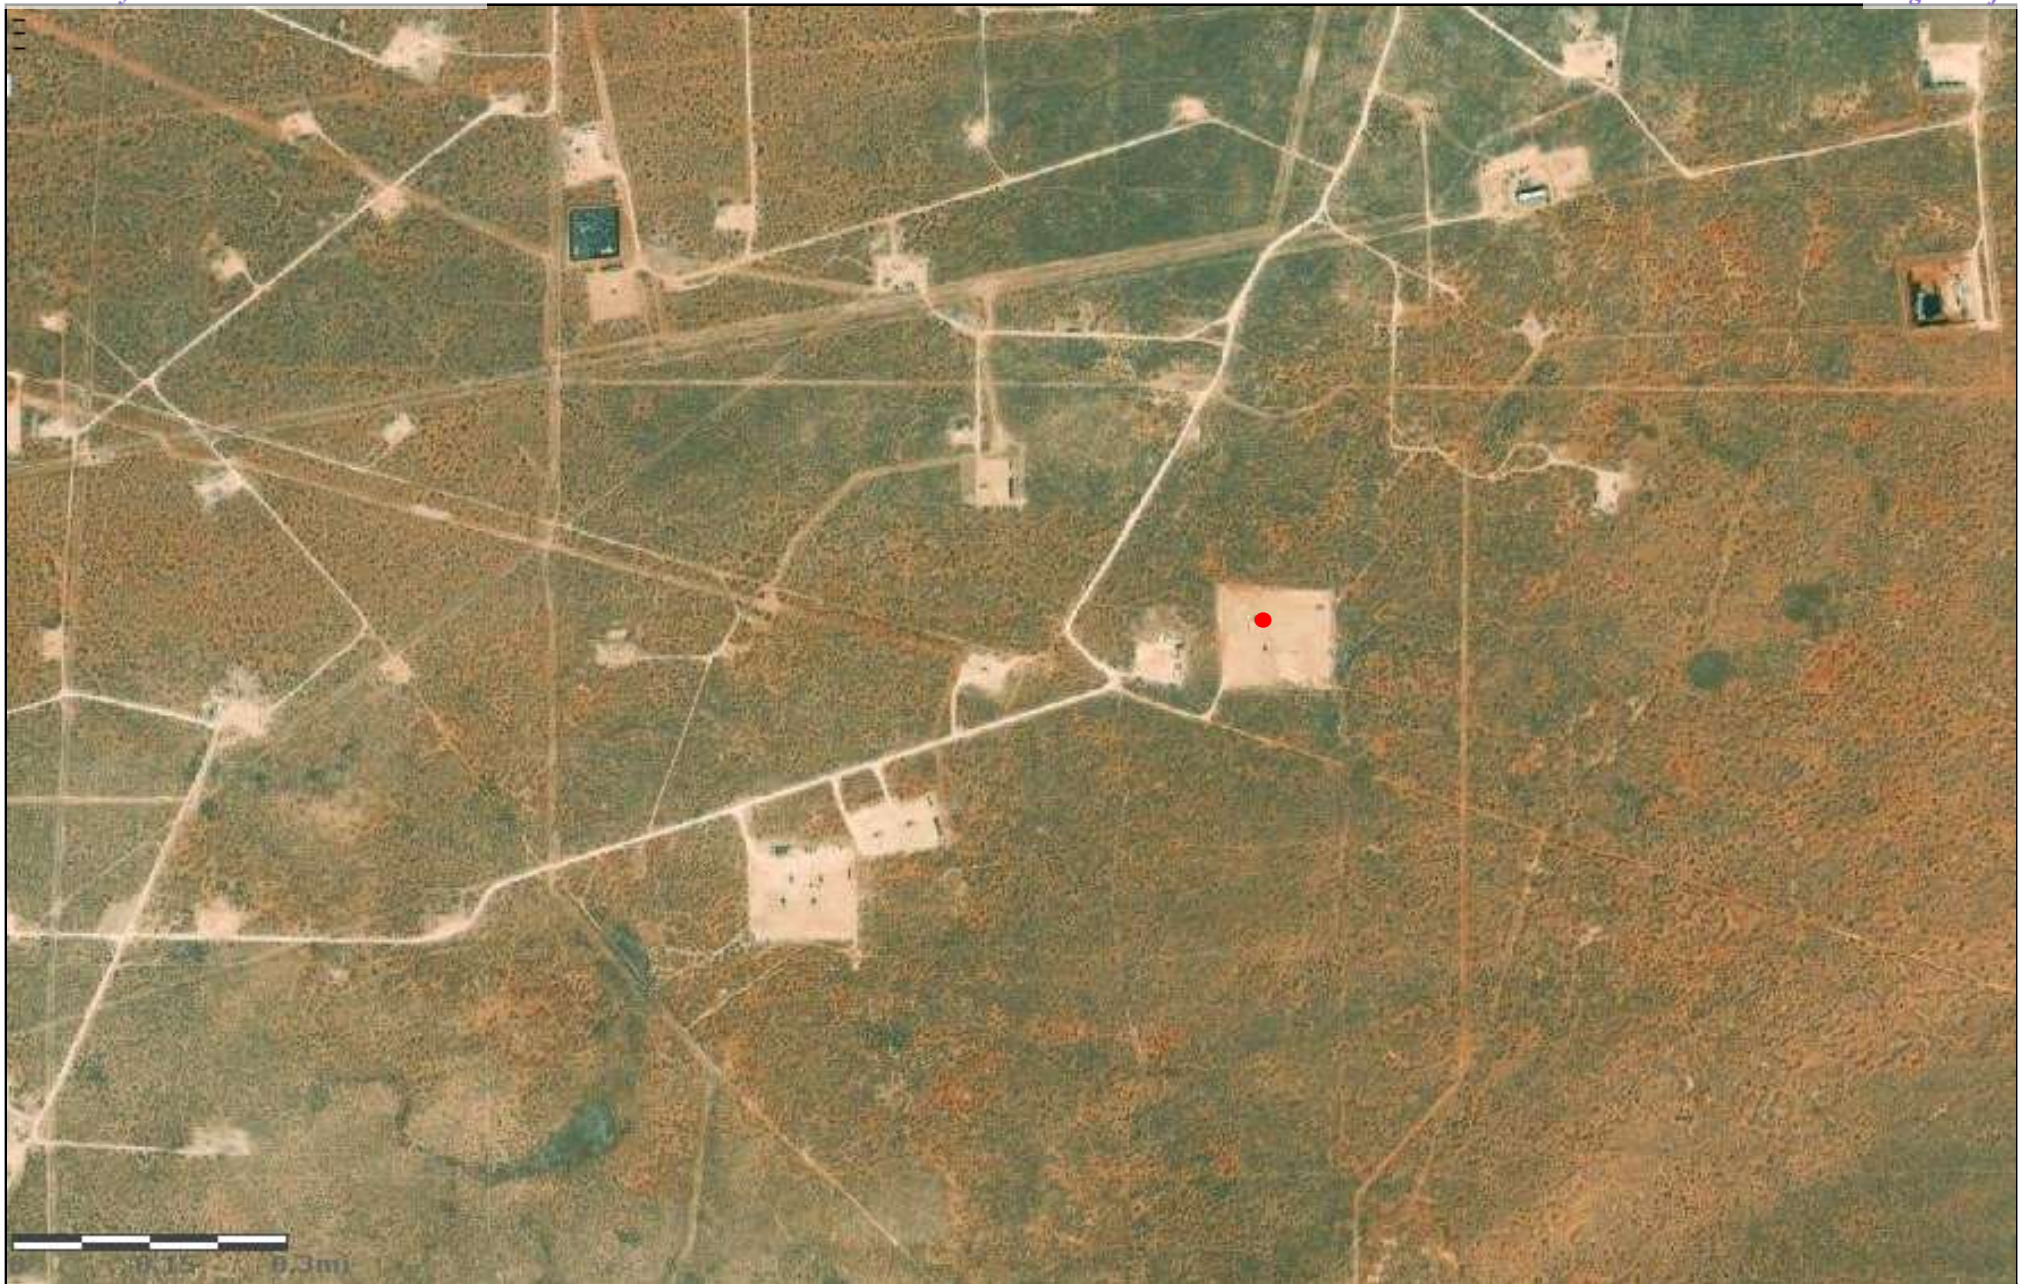
**Figure 3**

A search of the New Mexico Office of the State Engineer (NMOSE) and United States Geological Survey (USGS) groundwater databases was completed in an effort to determine the horizontal distance to known water sources within a half mile radius of the release site. Approximate depth to groundwater was determined using maintained and published water well data. Karst mapping indicates the site is not located in a Karst designated area. Depth to groundwater information is provided as Attachment III and the results are depicted on Figures 2 & 3.

No water wells could be located within a half mile of the release area, however, depth to water was estimated to be approximately one hundred-fifty feet bgs based upon the Eddy County Depth to Ground Water map. At that time the NMOCD allowed use of these maps to estimate depth to water. Utilizing this information, the NMOCD Recommended Remedial Action Levels for the Site were determined as follows:

USGS Well Locations Map
Devon Energy Corporation
Peridot 13 State #3H
GPS: 32.678207, -104.023742
Eddy County

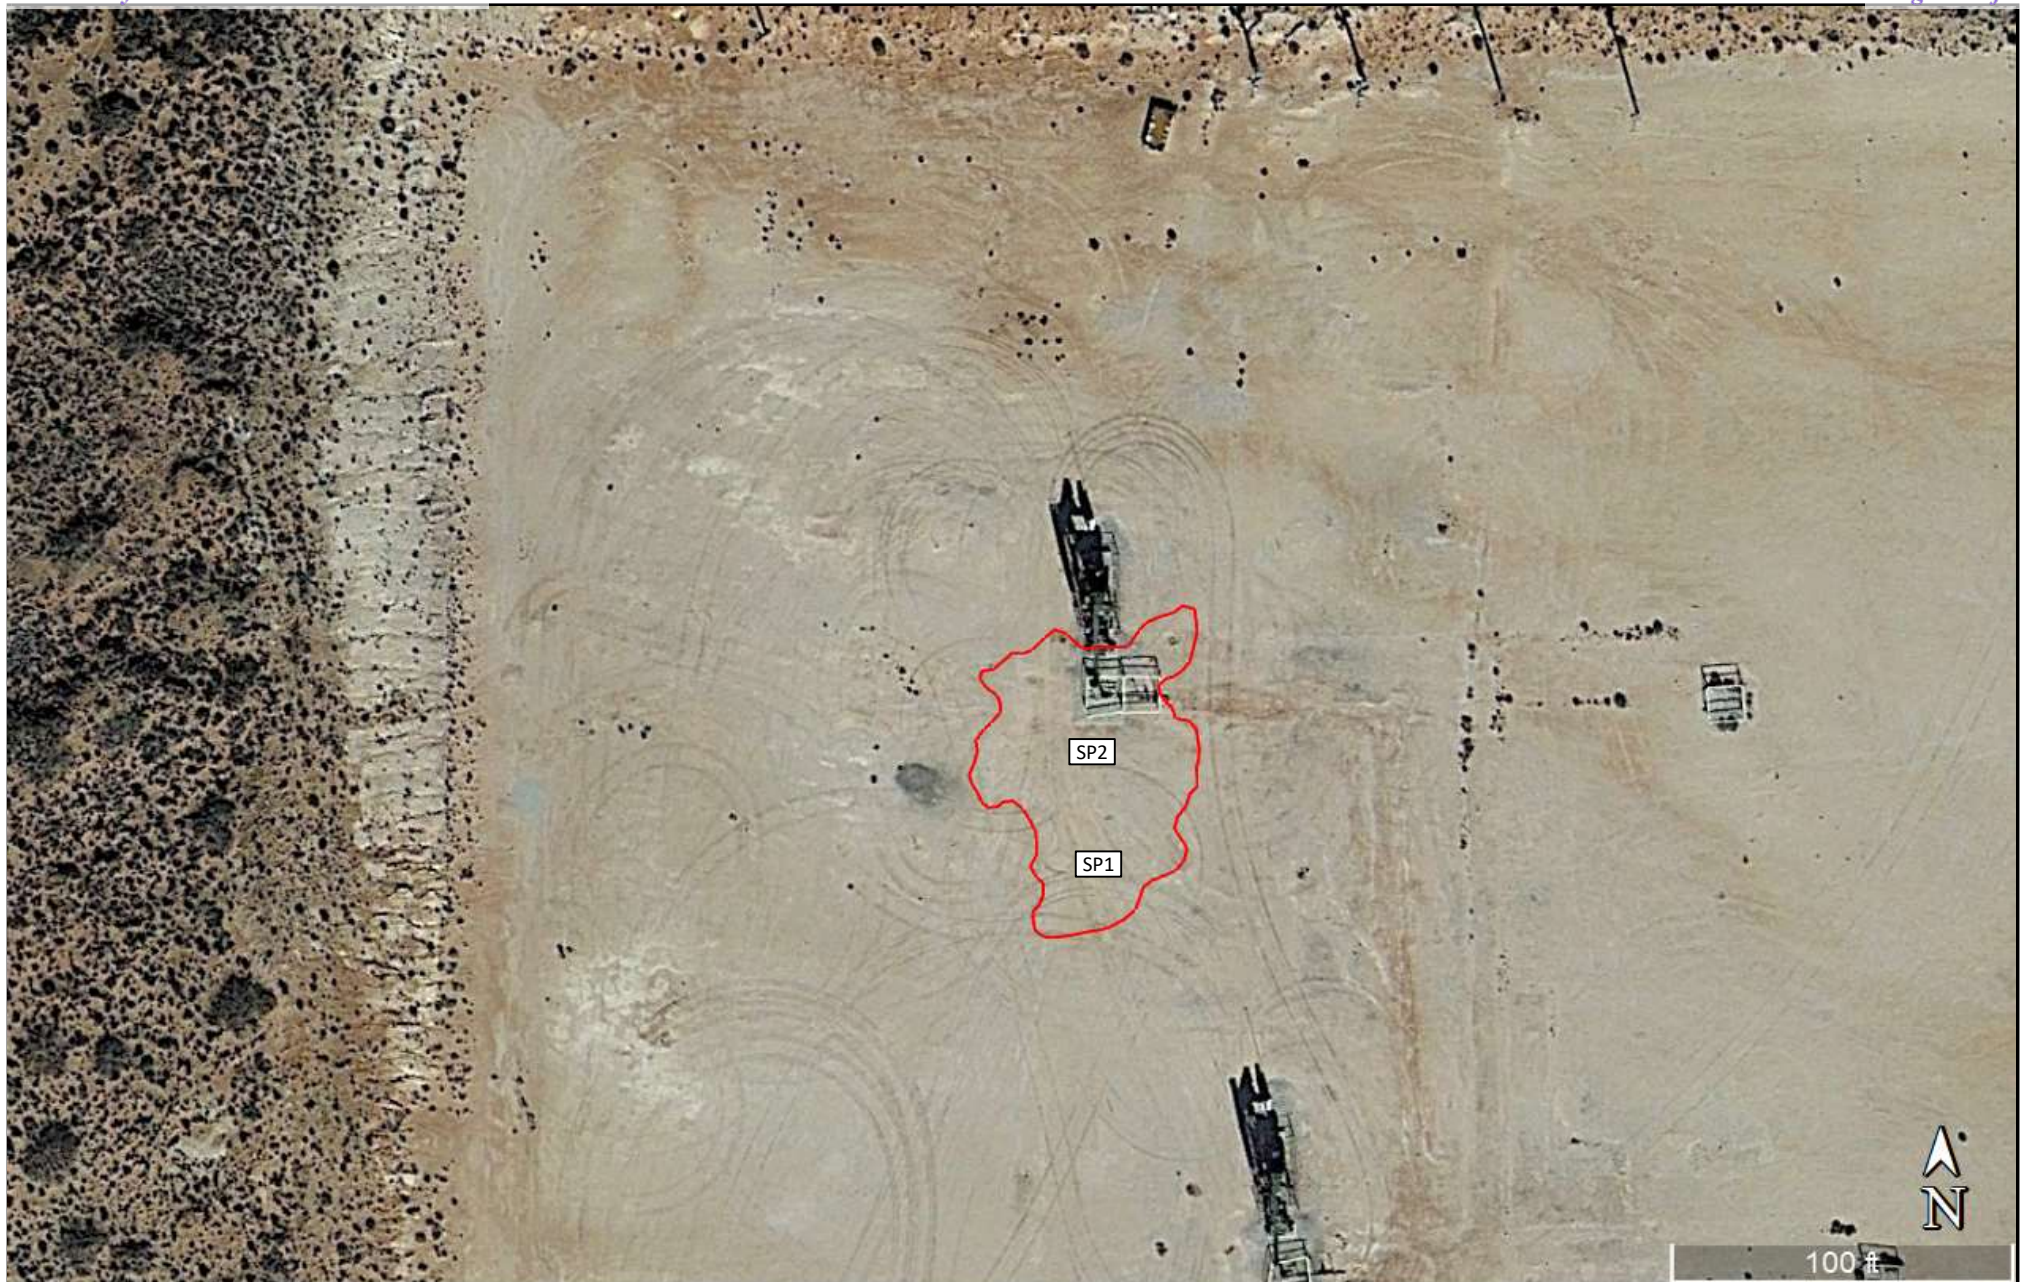
**Figure 4**

Laboratory analytical results indicated contaminant concentrations were below the NMOCD RRAL's in each of the submitted samples, with the exception of SP1 and SP2 at surface, which exhibited TPH concentrations in excess of NMOCD RRAL's.

Laboratory analytical results indicated contaminant concentrations were below the NMOCD RRAL's in each of the submitted samples, with the exception of SP2 at one foot, which exhibited TPH concentrations in excess of NMOCD RRAL's.

Sample Location Map
Devon Energy Corporation
Peridot 13 State #3H
GPS: 32.678207, -104.023742
Eddy County

During the first week of March 2016, according to the approved work plan, the release area was heavily tilled to loosen the hardened caliche crust and treated with MicroBlaze. On June 6 and 22, 2016, the area was sampled again at surface and one-foot bgs. Four confirmation soil samples, SP1 at surface and one foot, and SP2 at surface and one foot, were submitted to the laboratory for analysis of TPH.
