**EOG Resources, Inc.
Sara AHA #2 Battery**

Closure Report

**H-15-20S-24E
Eddy County, New Mexico**

nAPP2223032387

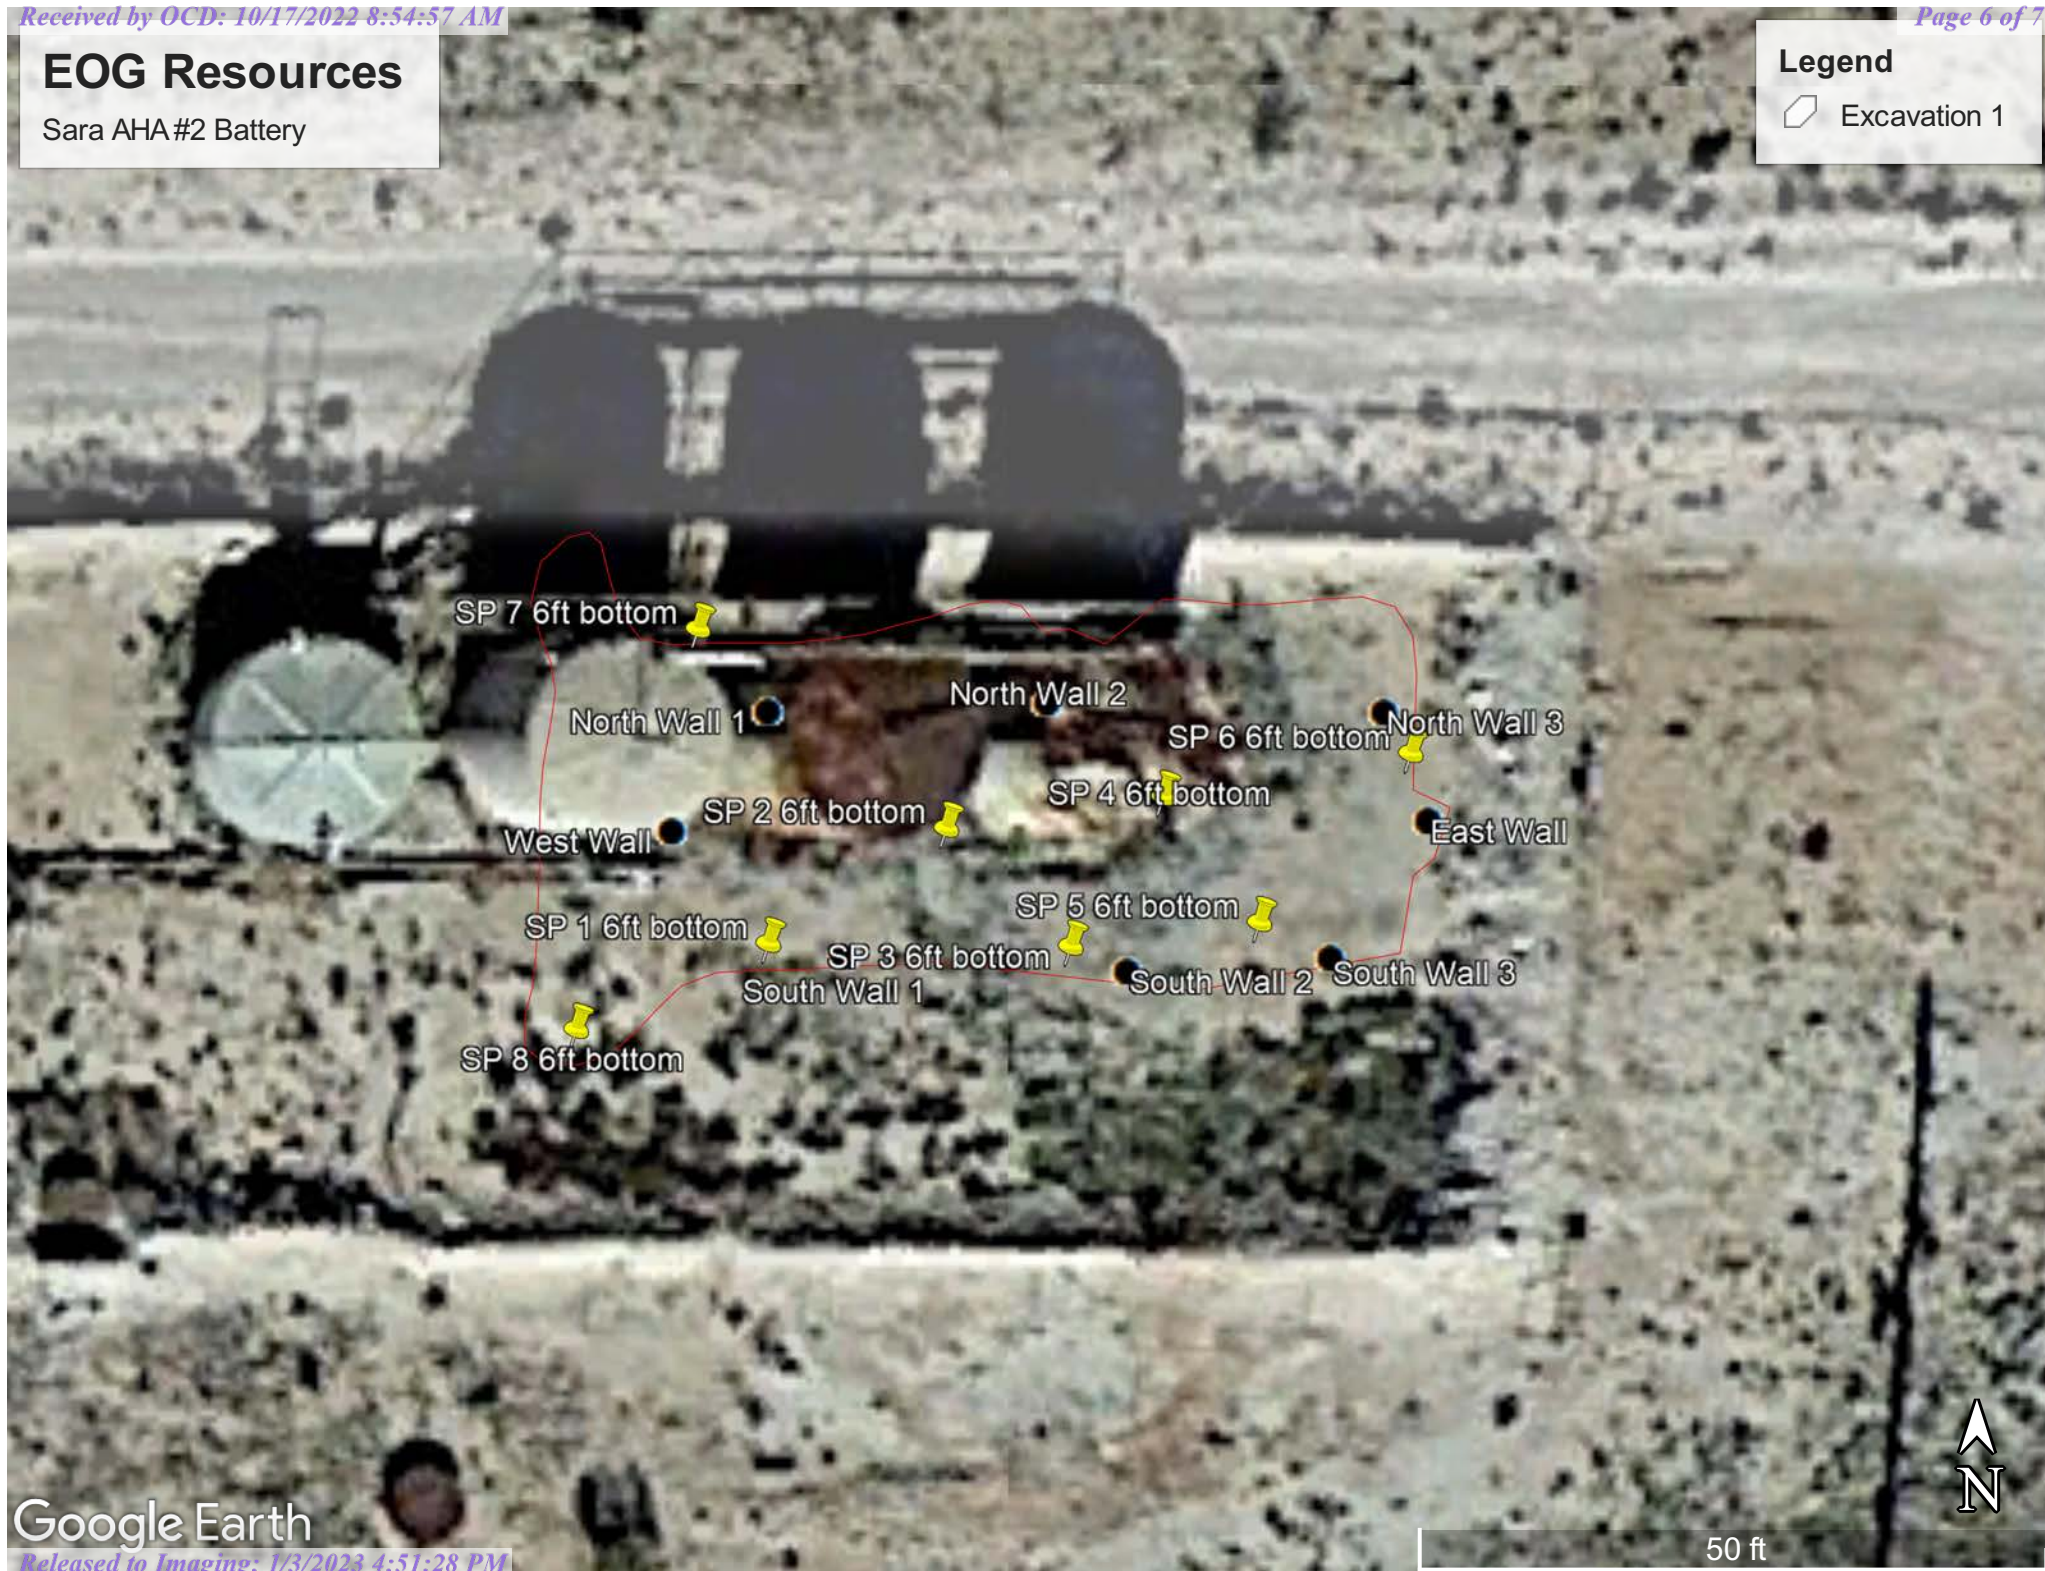
Excavation 1

The site has been fully delineated according to the NMOCD NMAC 19.15.29 published guidelines. Vertical delineation was established by advancing 12 test trenches at various locations and depths. Horizontal delineation was achieved during remediation. All vertical samples were conducted at the surface and one-foot increments until the most stringent criteria of 600 mg/Kg for chlorides, 100 mg/kg for TPH, 10 mg/kg for Benzene, and 50 mg/kg for BTEX was reached.

On September 6-8, 2022, SESI personnel performed sampling to determine vertical and horizontal extent of the release. SESI advanced a total of twelve (12) test trenches within the release area. The field results are recapped as follows:

Based on the results of the delineation, The release area was excavated to a depth ranging from of 1ft to 6ft bgs.

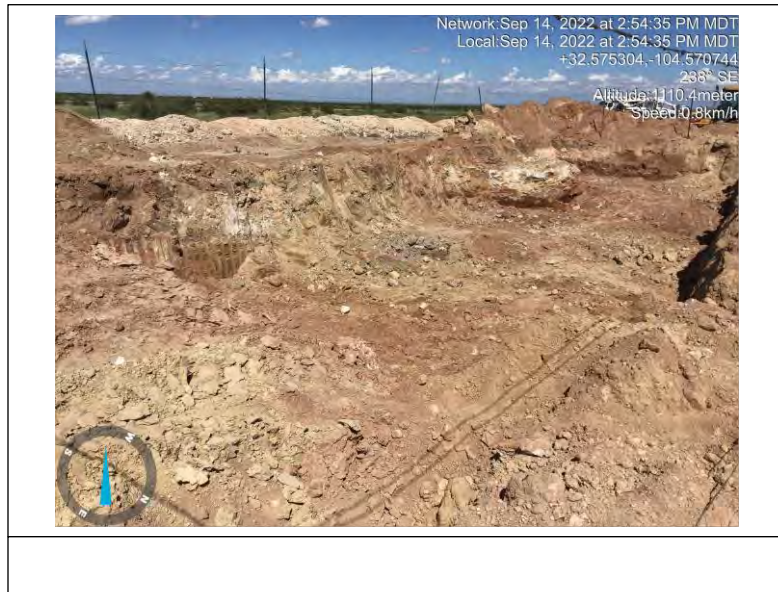
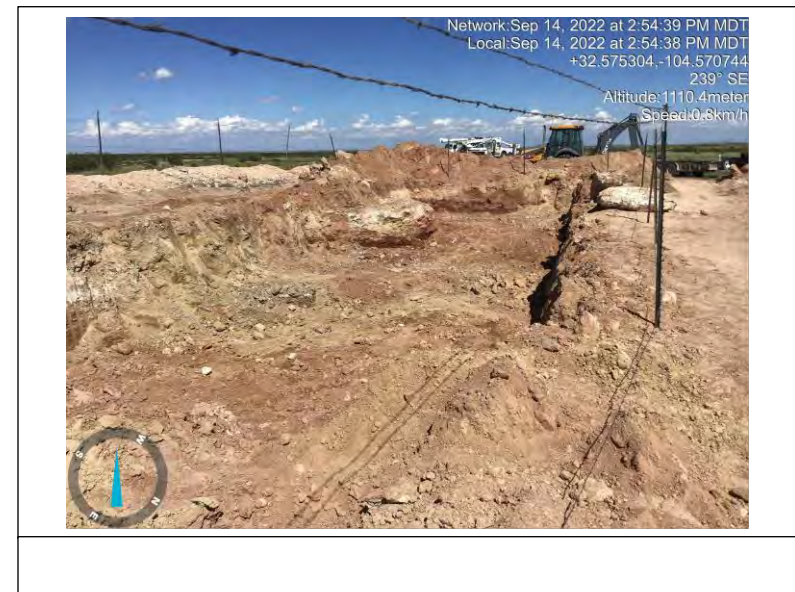
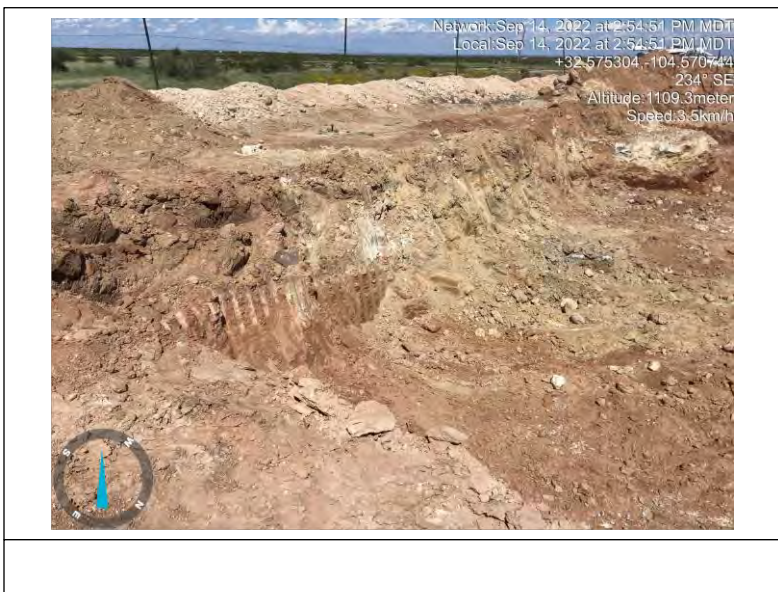
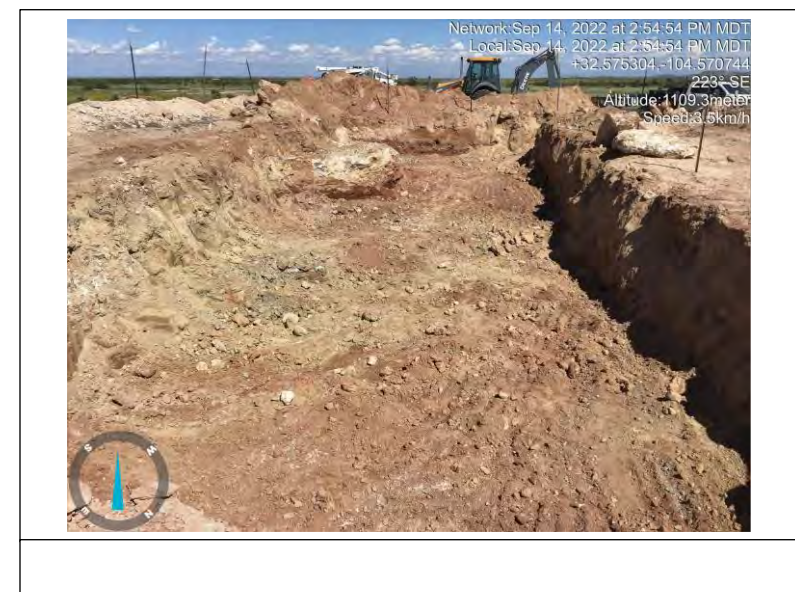
EOG Resources Inc. Sara AHA #2 Battery, Eddy County, NM Excavation Photos

During excavation of the release area, a PVC pipeline was discovered. During the removal of the pipeline, which was determined to be abandoned, a repair using concrete was discovered. The concrete was removed and the area below the repair was excavated to a depth of 5' bgs.

A total of 300 yards of contaminated soils were transported to an NMOCD approved facility for disposal. The excavated area was backfilled with topsoil.
