Cottonwood Draw 22 Fed 2H

CLOSURE REPORT

UL/I Sec 22, T25S, R26E, Eddy County NM

NMOCD Case #: 2RP-3136

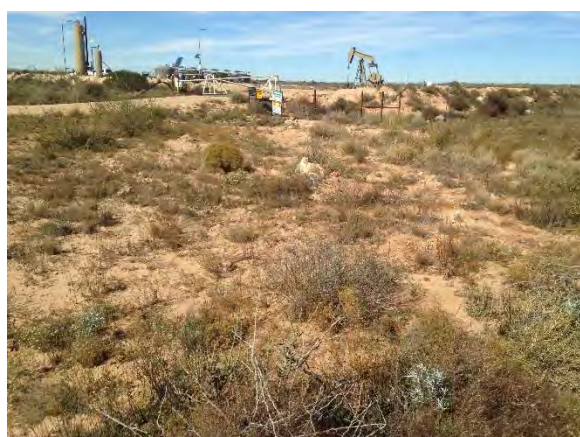
Site prior, facing southwest 11/24/2015

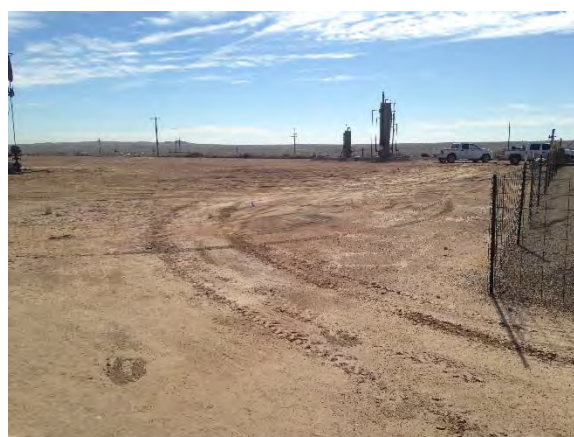
Site prior, facing northeast 11/24/2015

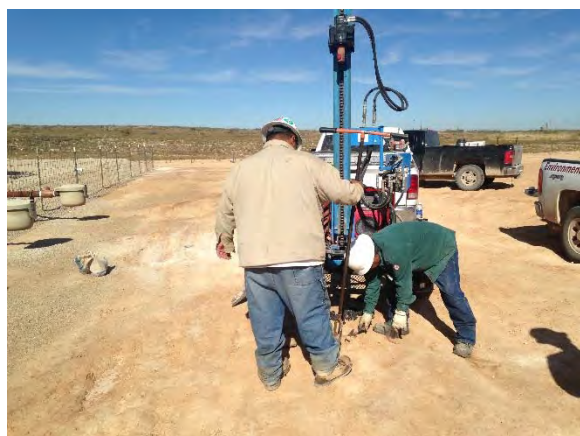
Collecting samples, facing west 11/24/2015

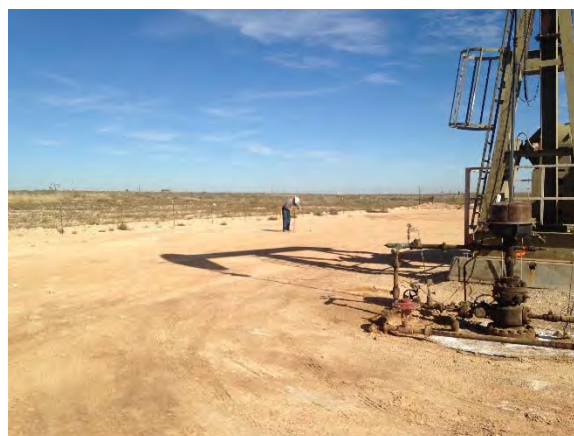
Collecting samples, facing northwest 11/24/2015

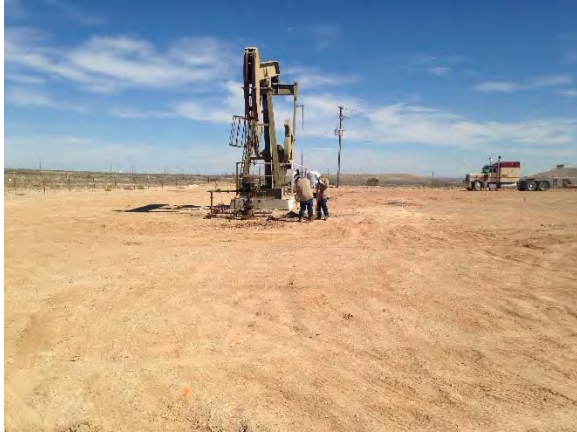
Excavating site, facing east 2/15/2016

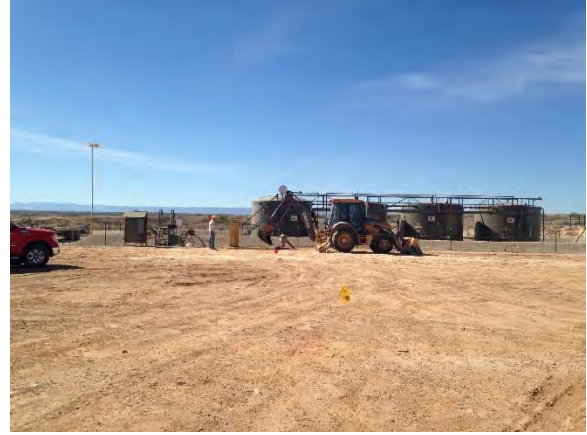
Excavating site, facing west 2/15/2016

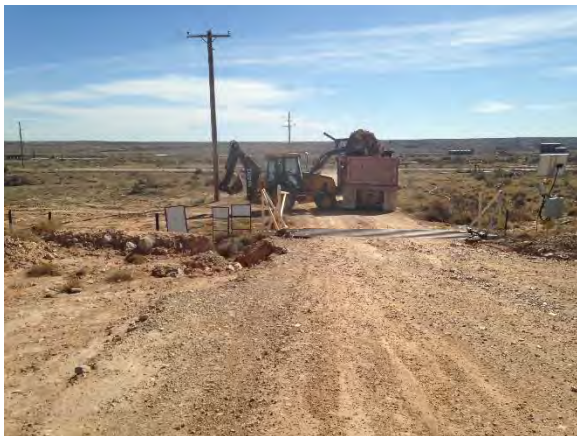
Exporting soil, facing south 2/15/2016

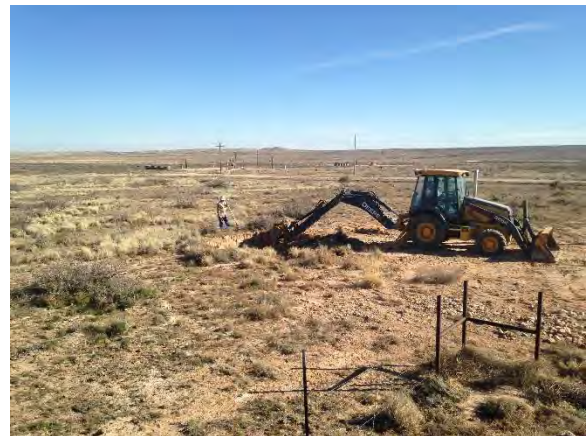
Excavating site, facing southeast 2/15/2016

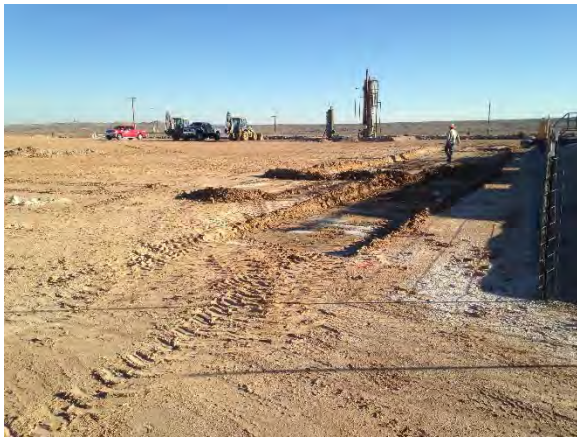
Completed 1' excavation, facing southeast 2/15/2016

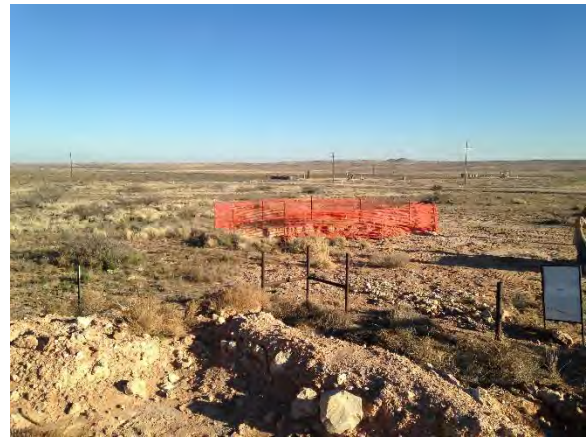
Completed 1' excavation, facing southeast 2/15/2016

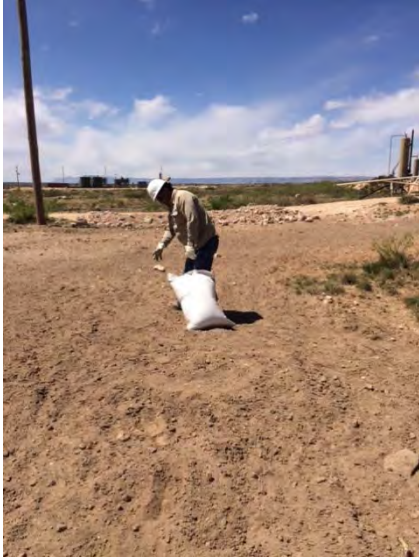
Seeding site 3/26/2016

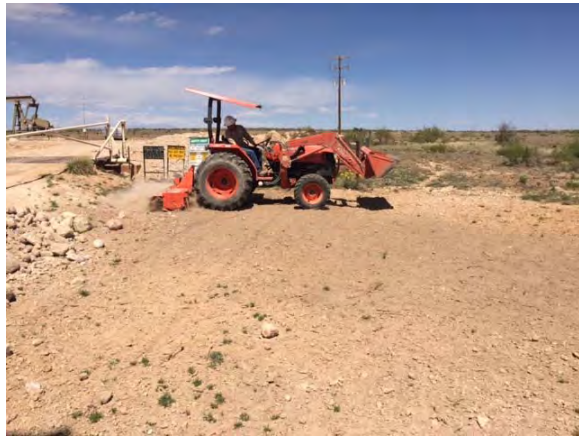
Seeding site 3/26/2016

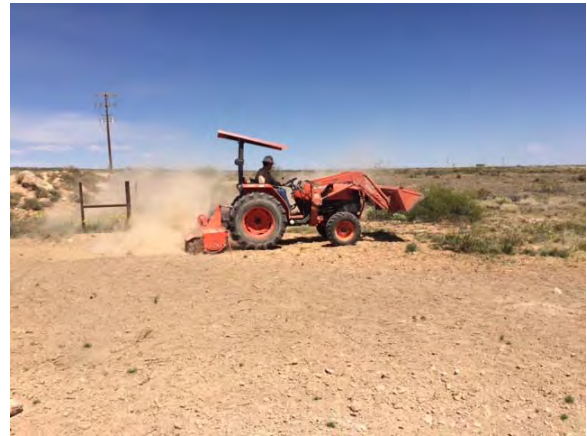
Seeding site 3/26/2016

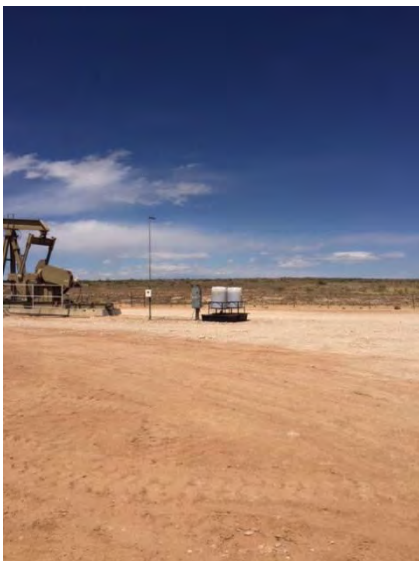
Site completed 3/26/2016

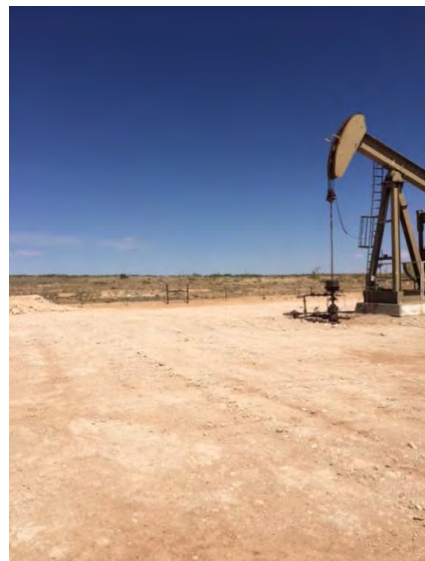
Site completed 3/26/2016
