Incident ID	NAB1602127288
District RP	2RP-3504
Facility ID	
Application ID

Hackberry 19 Fed #1  
API 30-015-30092  
Eddy County, NM  
Site Map

Devon Energy  
API #30-015-30092  
Eddy County, NM  
Confirmation Sample Map

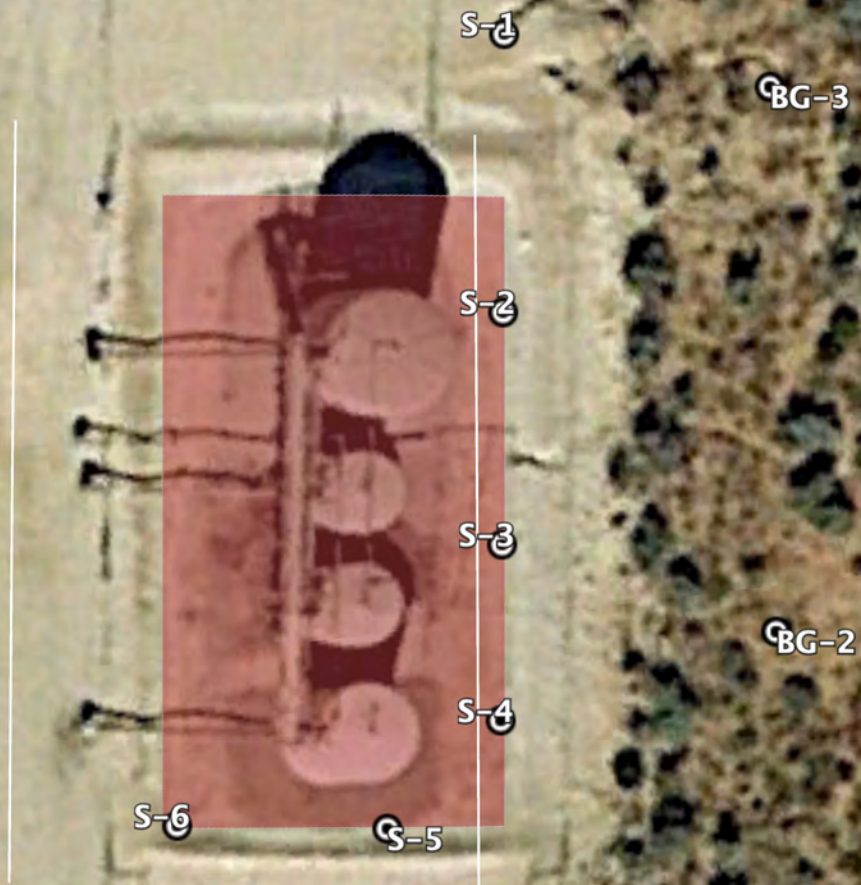
spill area

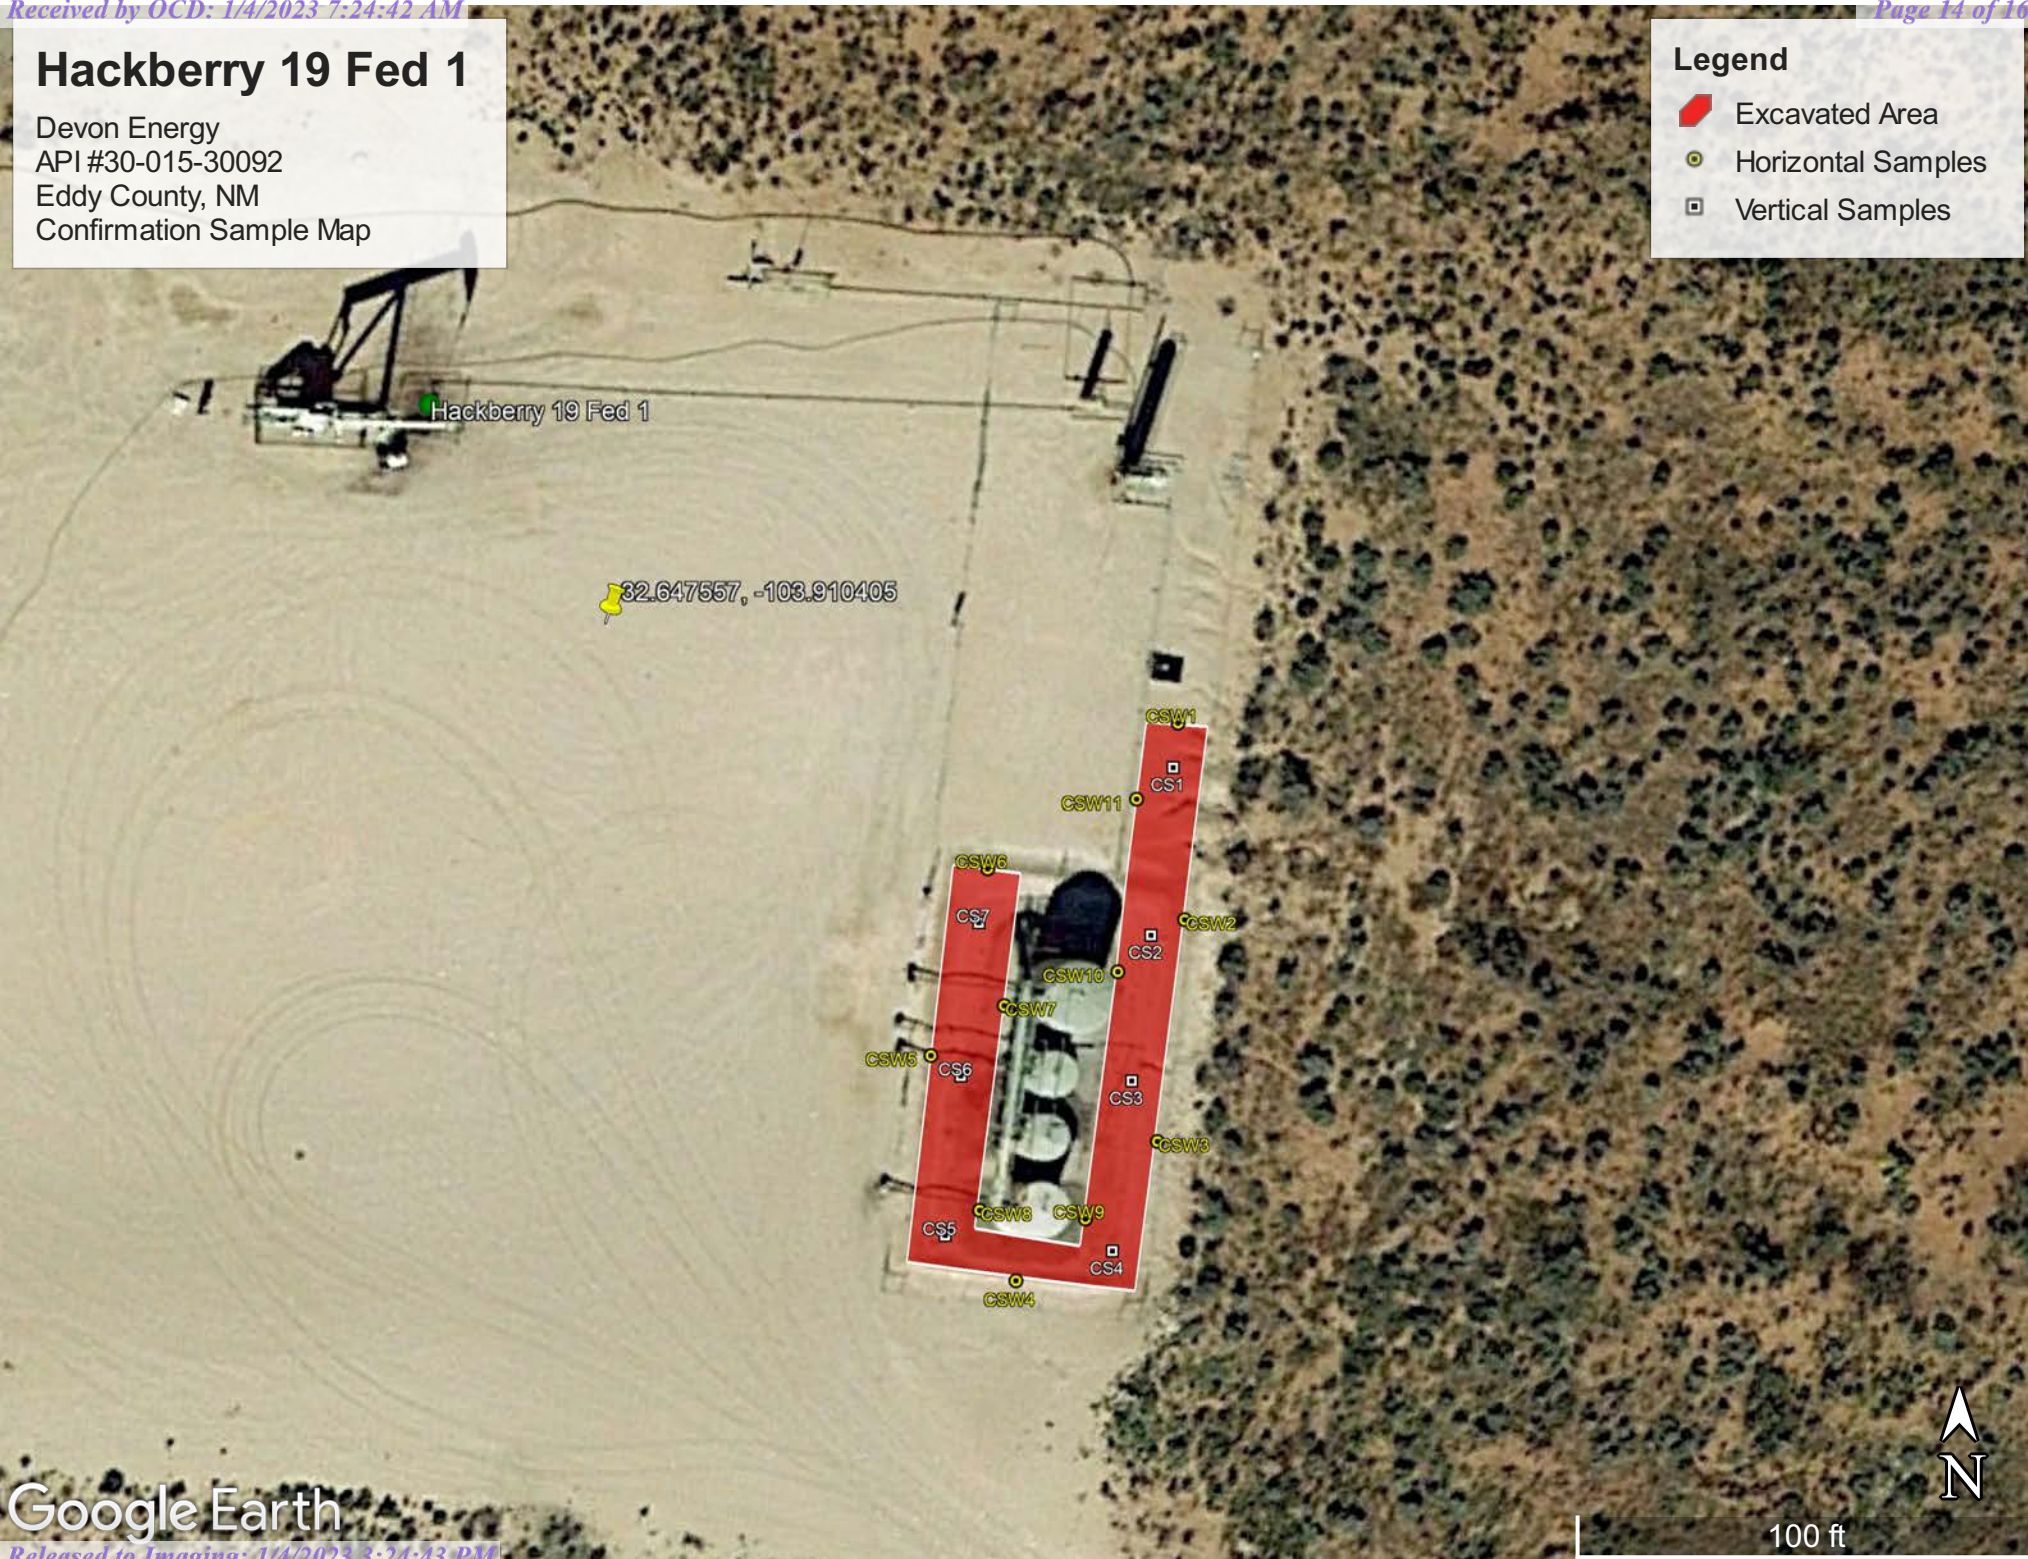
Vertical Samples

On December 15, 2022, after an NMOCD rejection of the previous closure report, Pima personnel returned to the site to definitively complete the delineation of the spill area and confirm that the previous remediation activities did in fact remove all contaminants from the spill areas. After sending a 48-hour notification via email, we collected vertical and horizontal samples from various depths. The laboratory results from this sampling event can be seen in the following data table. A Confirmation Sample Map can be found in Figure 5.

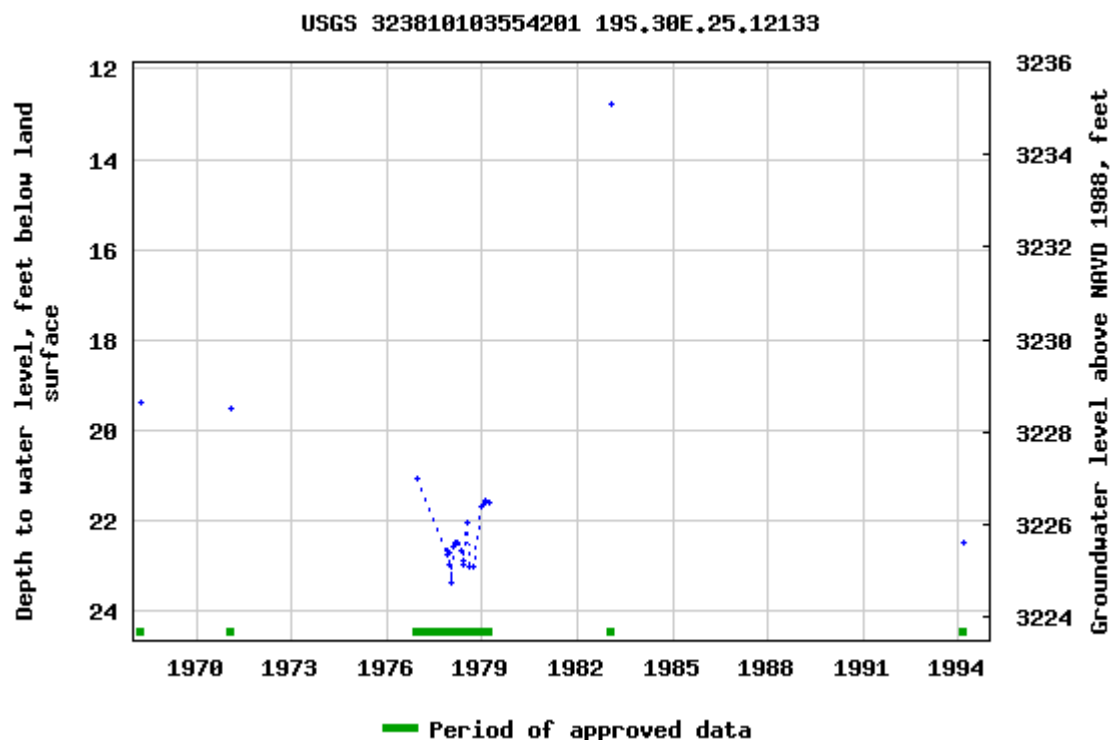
This well is completed in the Rustler Formation (312RSLR) local aquifer.

Breaks in the plot represent a gap of at least one year between field measurements.
