RE: Site Assessment and Closure Report
Rigel 20 Federal Com #003H
API No. 30-015-39725
GPS: Latitude 32.6435781 Longitude -103.8989164
ULSTR – “L”, 20, 19S, 31E
NMOCD Reference No. NAB1729752650

Devon Energy Production Company (Devon) has contracted Pima Environmental Services, LLC (Pima) to perform a site assessment, liner inspection, and prepare this closure report for a crude oil release that happened at the Rigel 20 Federal Com #003H (Rigel). An initial C-141 was submitted on October 11, 2017, and can be found in Appendix C. This incident was assigned Incident ID NAB1729752650, by the New Mexico Oil Conservation Division (NMOCD).

Devon Energy
API #30-015-39725
Eddy County, NM
Site Map-Flare

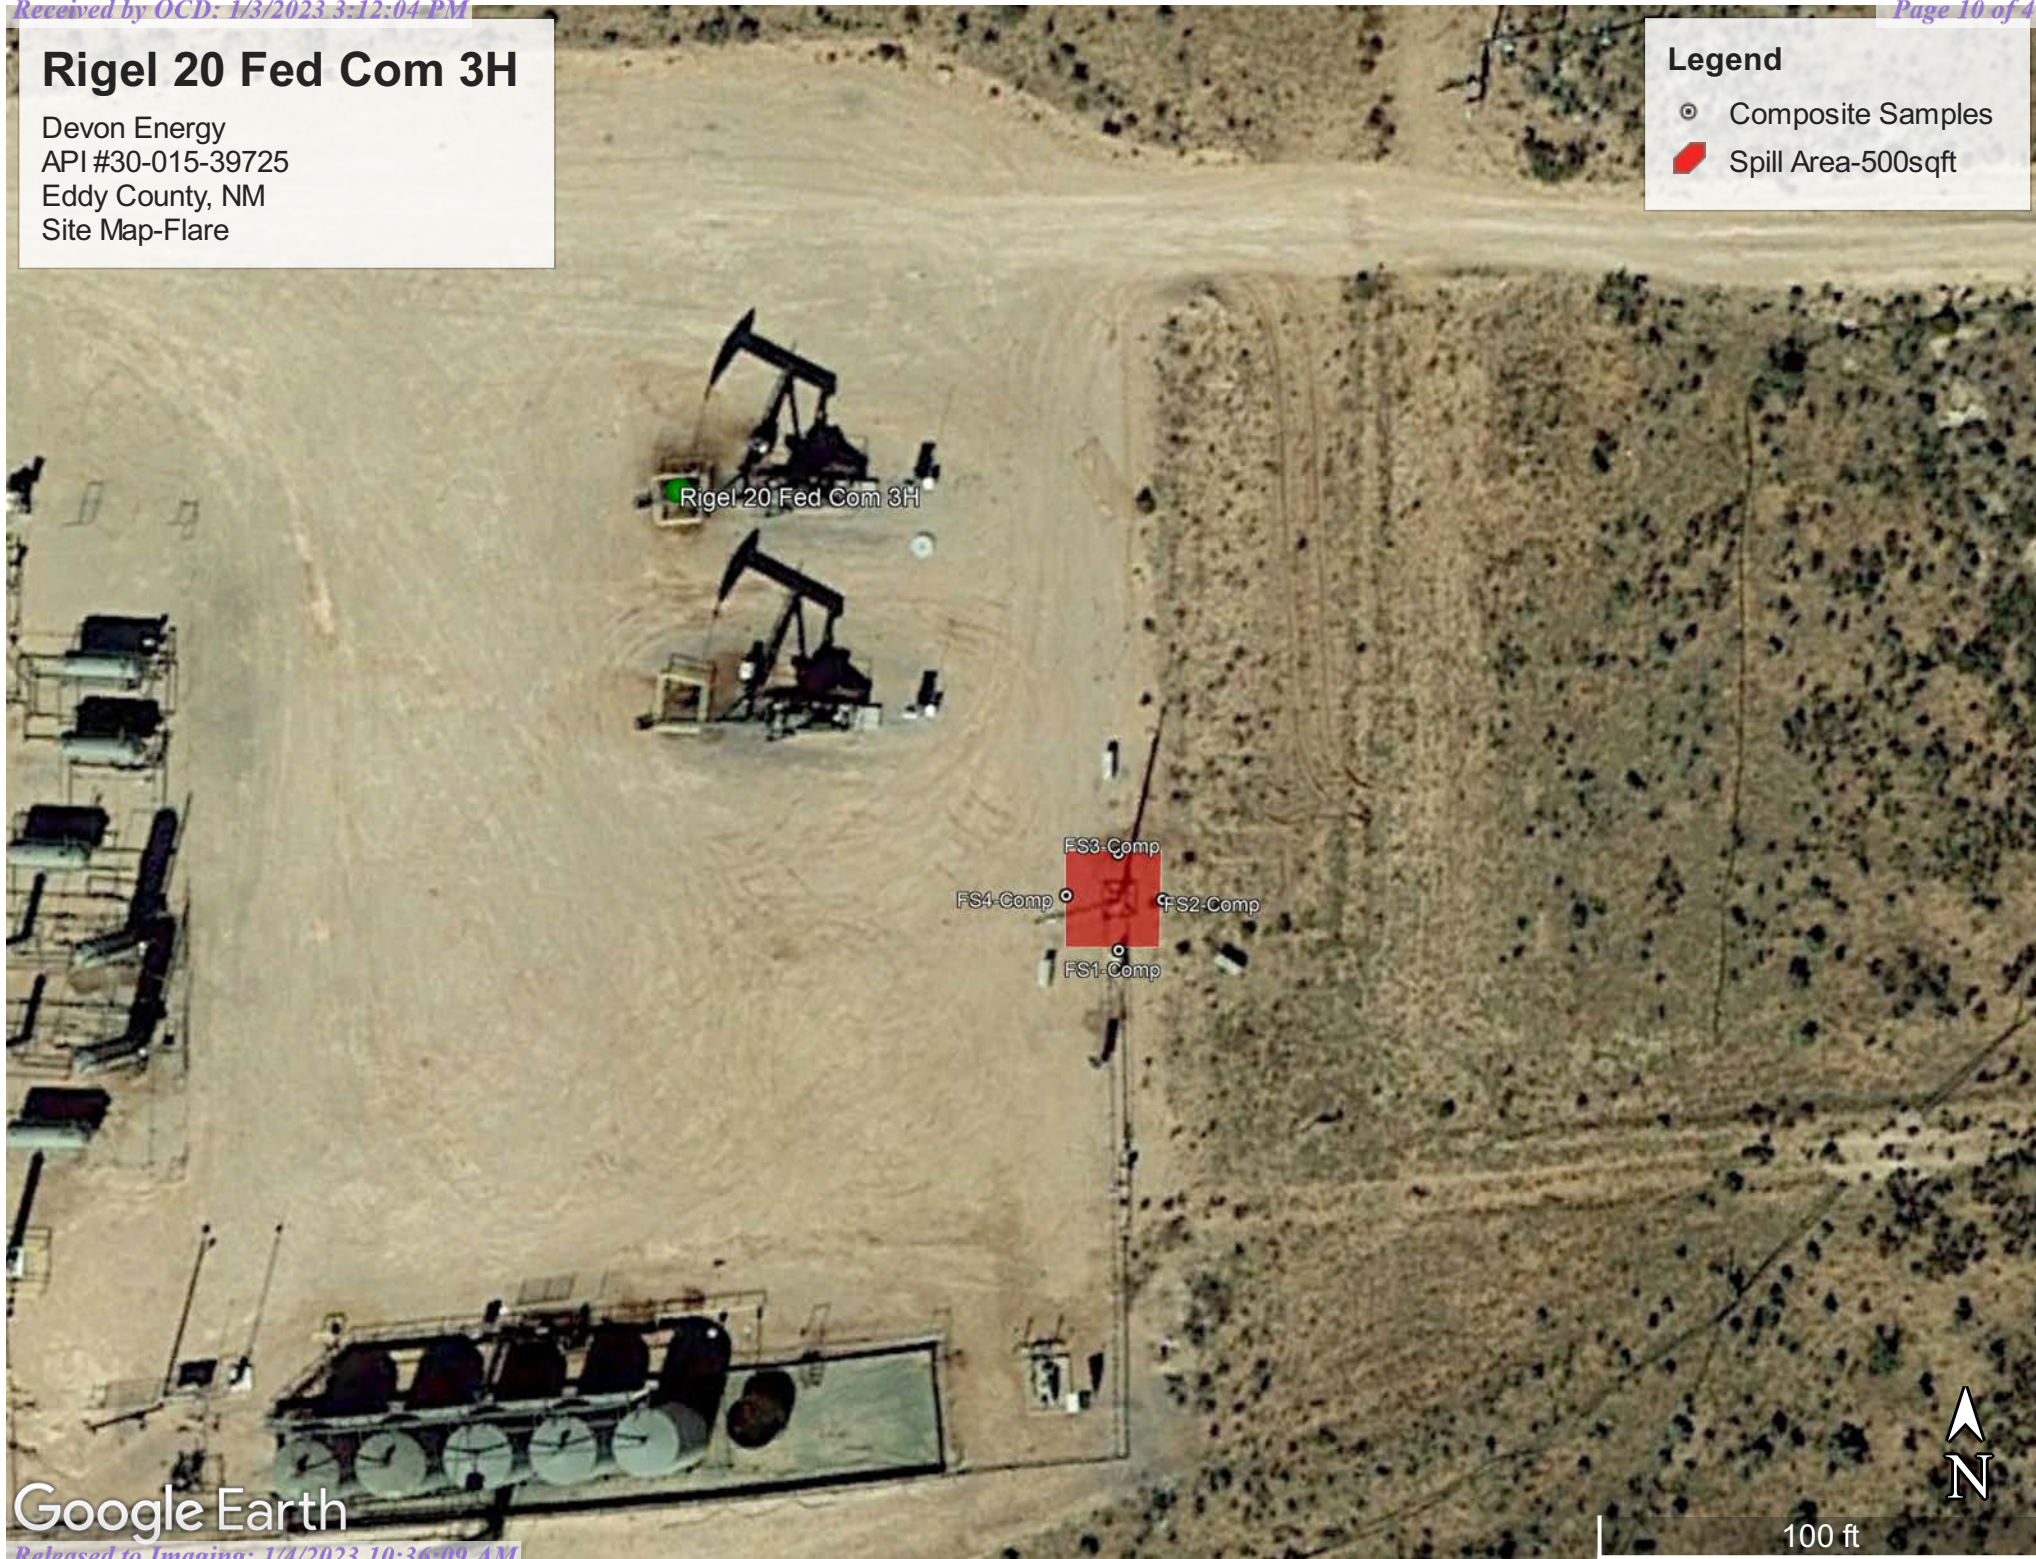
On December 12, 2022, Pima Environmental conducted a site assessment and obtained composite soil samples from the spill area around the flare. The laboratory results of this sampling event can be found in the following data table.

- Composite Samples
- Spill Area-500sqft

Based on the sample data collected, all results are under the regulatory requirements according to Table 1 of 19.15.29 NMAC.
