Closure Report

Kemnitz South AFL State #1
Lea County, New Mexico
API # 30-025-31636
Incident No. nAPP2224439131

Subject: **Closure Report**
Kemnitz South AFL State #1
Lea County, New Mexico
API # 30-025-31636
Incident No. nAPP2224439131

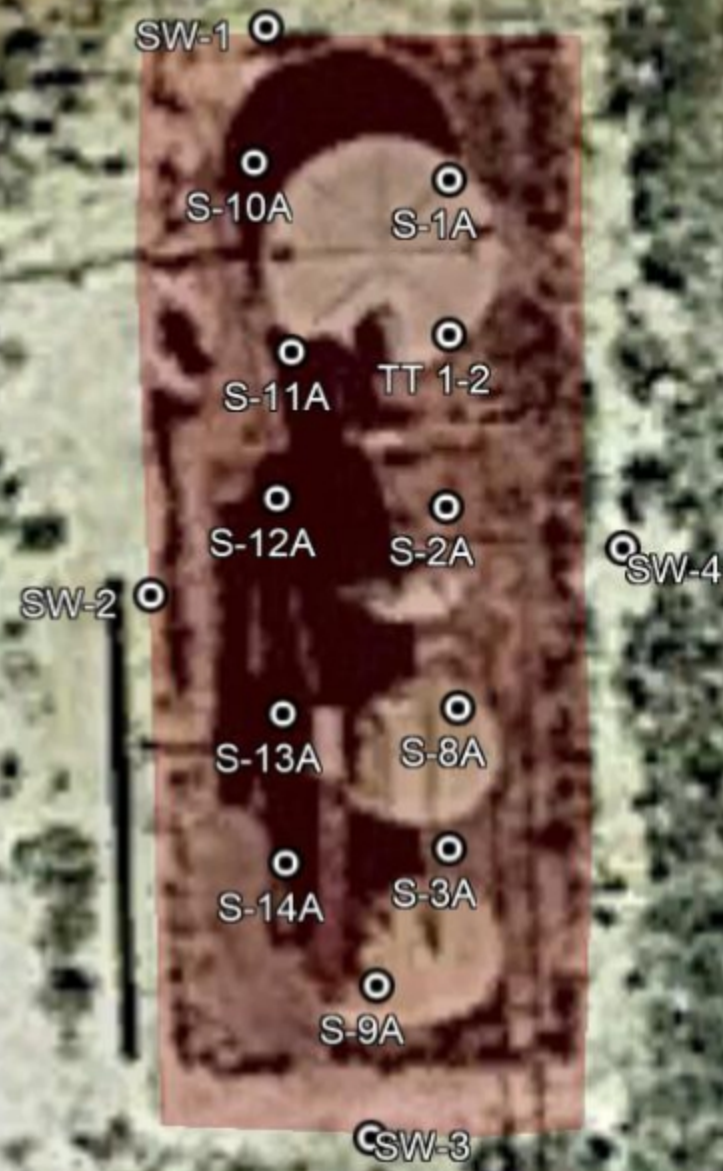
- Excavation
- Kemnitz South AFL State 1
- Sample Position

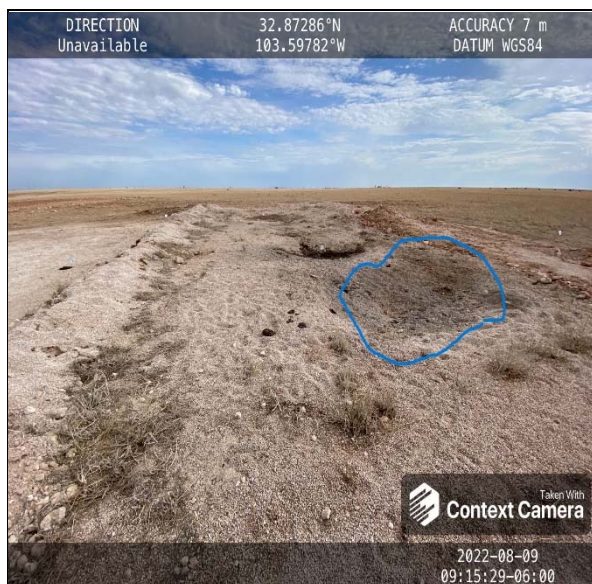
**Photograph No.2 Description:**

Impacted area in containment area.

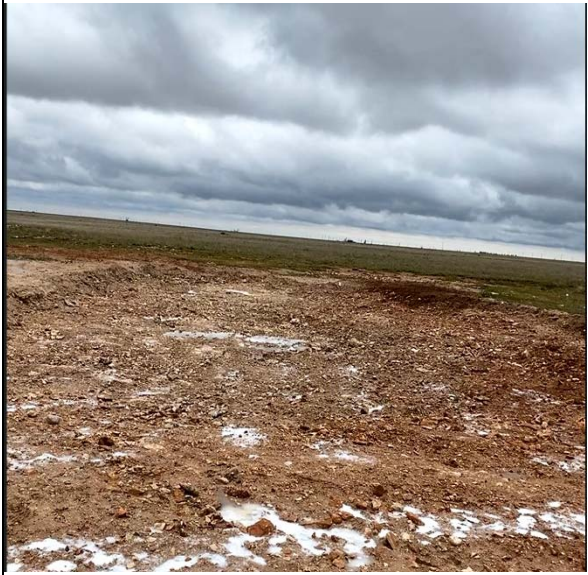
Photograph No.5 Description:

Micro-Blaze application North End

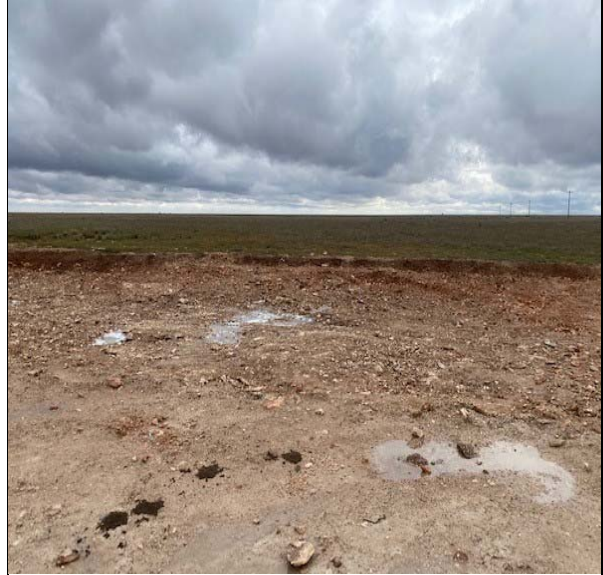
Photograph No.6 Description:

Micro-Blaze application South End
