RE: Liner Inspection and Closure Report
Grumpy Cat 15 CTB 2
API No. N/A
GPS: Latitude 32.309039 Longitude -103.664799
UL C, Section 15, Township 23S, Range 32E, Lea County, NM
NMOCD Reference No. NAPP2230965621

Devon Energy Production Company (Devon) has contracted Pima Environmental Services, LLC (Pima) to perform a liner inspection and prepare this closure report for a produced water release that happened at the Grumpy Cat 15 CTB 2 (Grumpy). An initial C-141 was submitted on November 17, 2022, and can be found in Appendix B. This incident was assigned Incident ID NAPP2230965621, by the New Mexico Oil Conservation Division (NMOCD).

**SITE PHOTOGRAPHS
DEVON ENERGY
GRUMPY CAT 15 CTB 2
LINER INSPECTION**

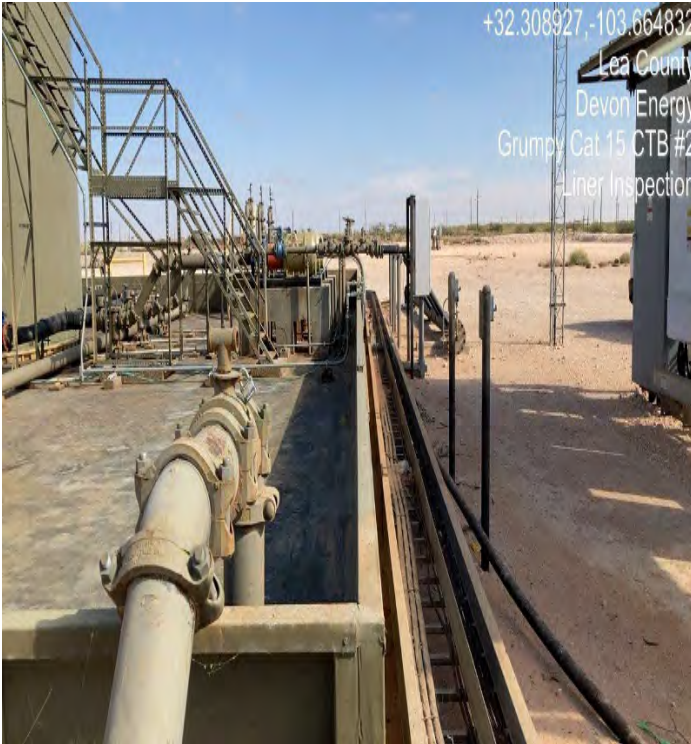
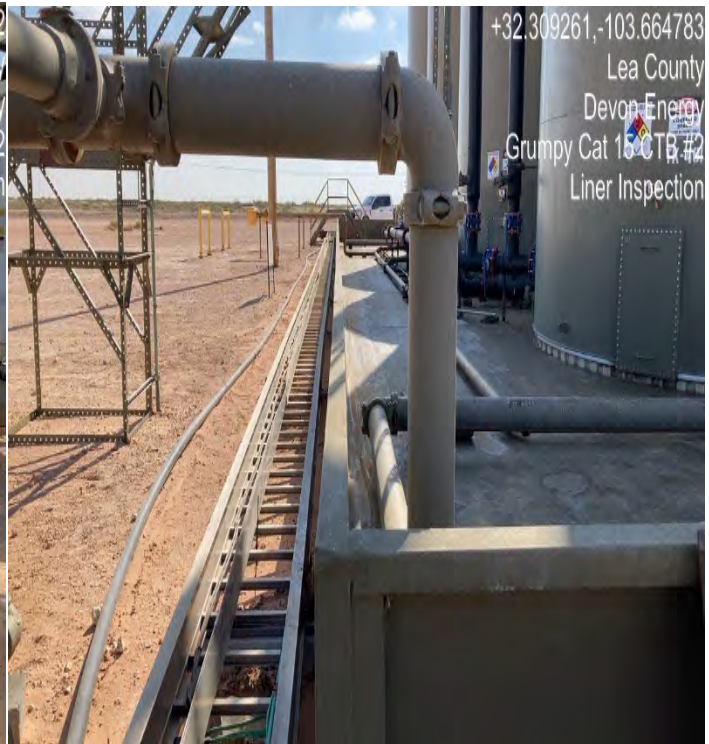
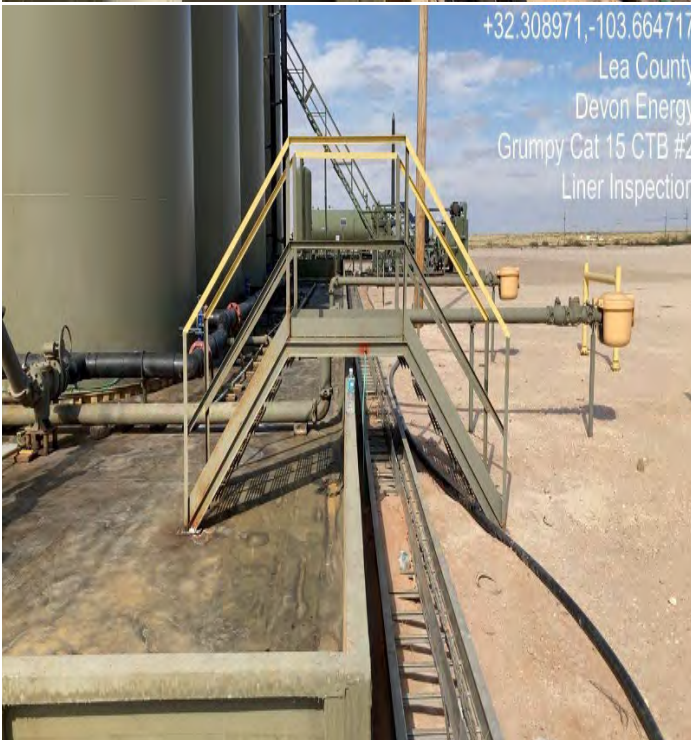
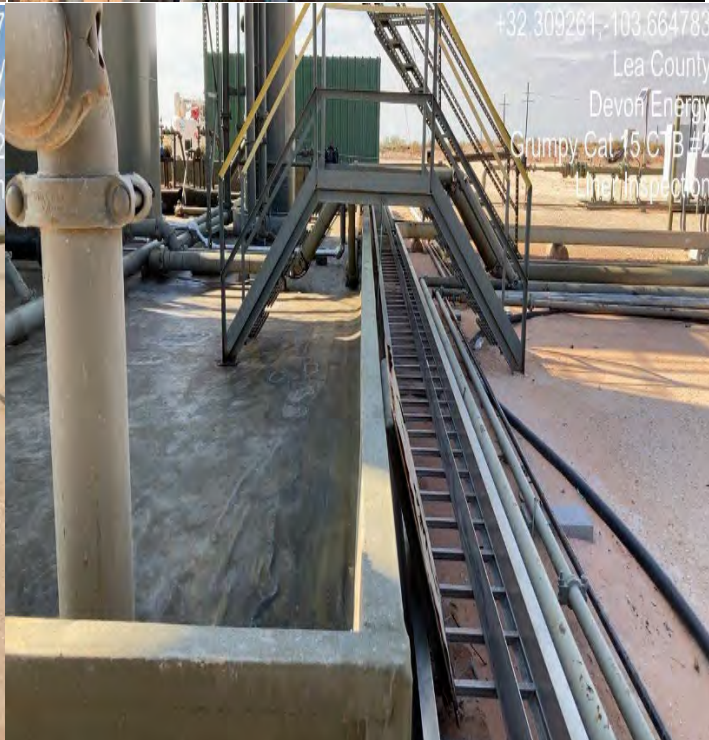
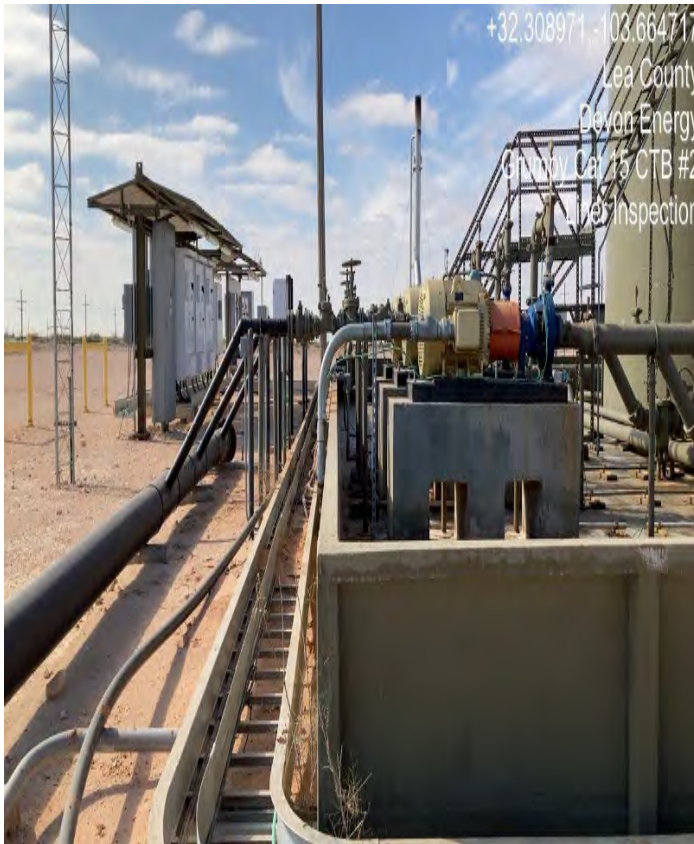
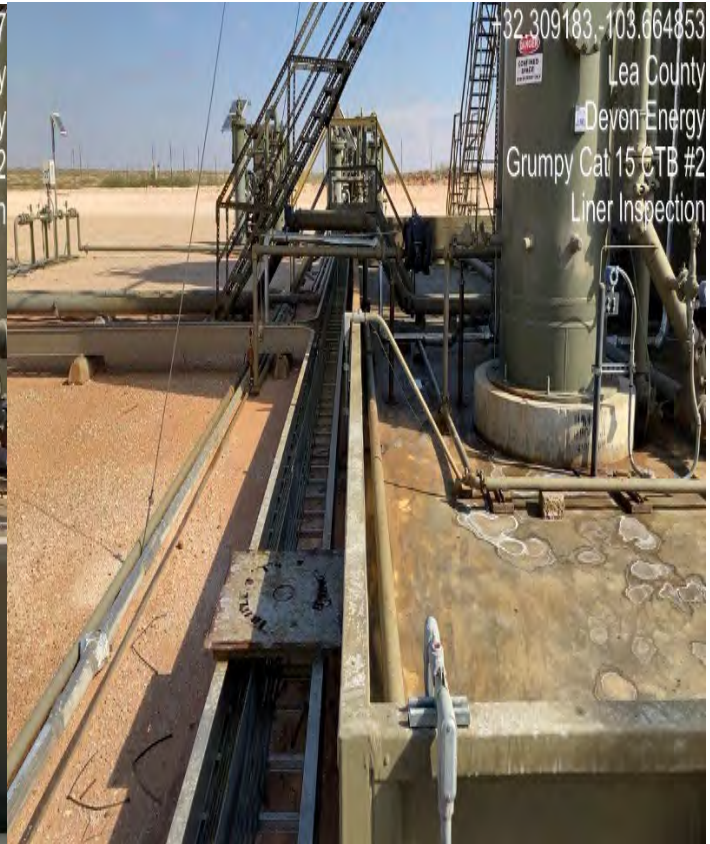
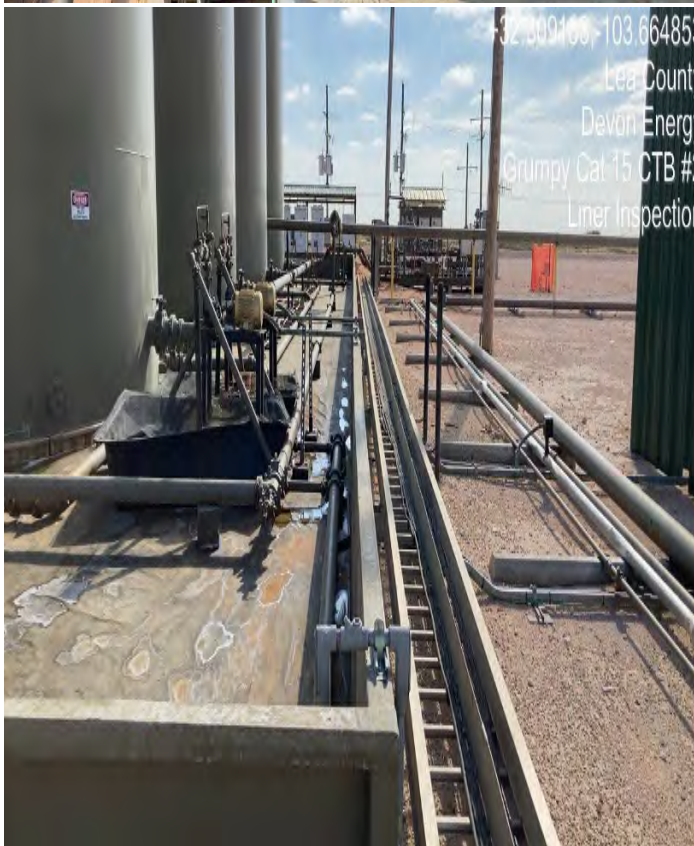
On November 19, 2022, after sending the 48-hour notification email, Pima Environmental conducted a liner inspection at this location. We concluded that this liner and containment maintained its integrity and was able to retain the fluids. The Liner Inspection Form and Photographic Documentation can be found in Appendix C.

| Visualization | Yes | No | Comments |
|--|---|---|---|
| Does the liner have integrity to contain a leak? | X | | |
