**Re: Closure Report
EOG Resources
Shinnery Federal #1
Unit Letter K, Section 13, Township 18 South, Range 32 East
Lea County, New Mexico.**

Tetra Tech, Inc. (Tetra Tech) was contacted by EOG Resources (EOG) to assess and remediate a release that occurred at Shinnery Federal #001 (Site) (API No. 30-025-30247). The release footprint is located in the Public Land Survey System (PLSS) Unit Letter K, Section 13, Township 18 South, Range 32 East, in Lea County, New Mexico (Site). The site coordinates are 32.7444°, -103.7217°, as shown Figures 1 and 2.

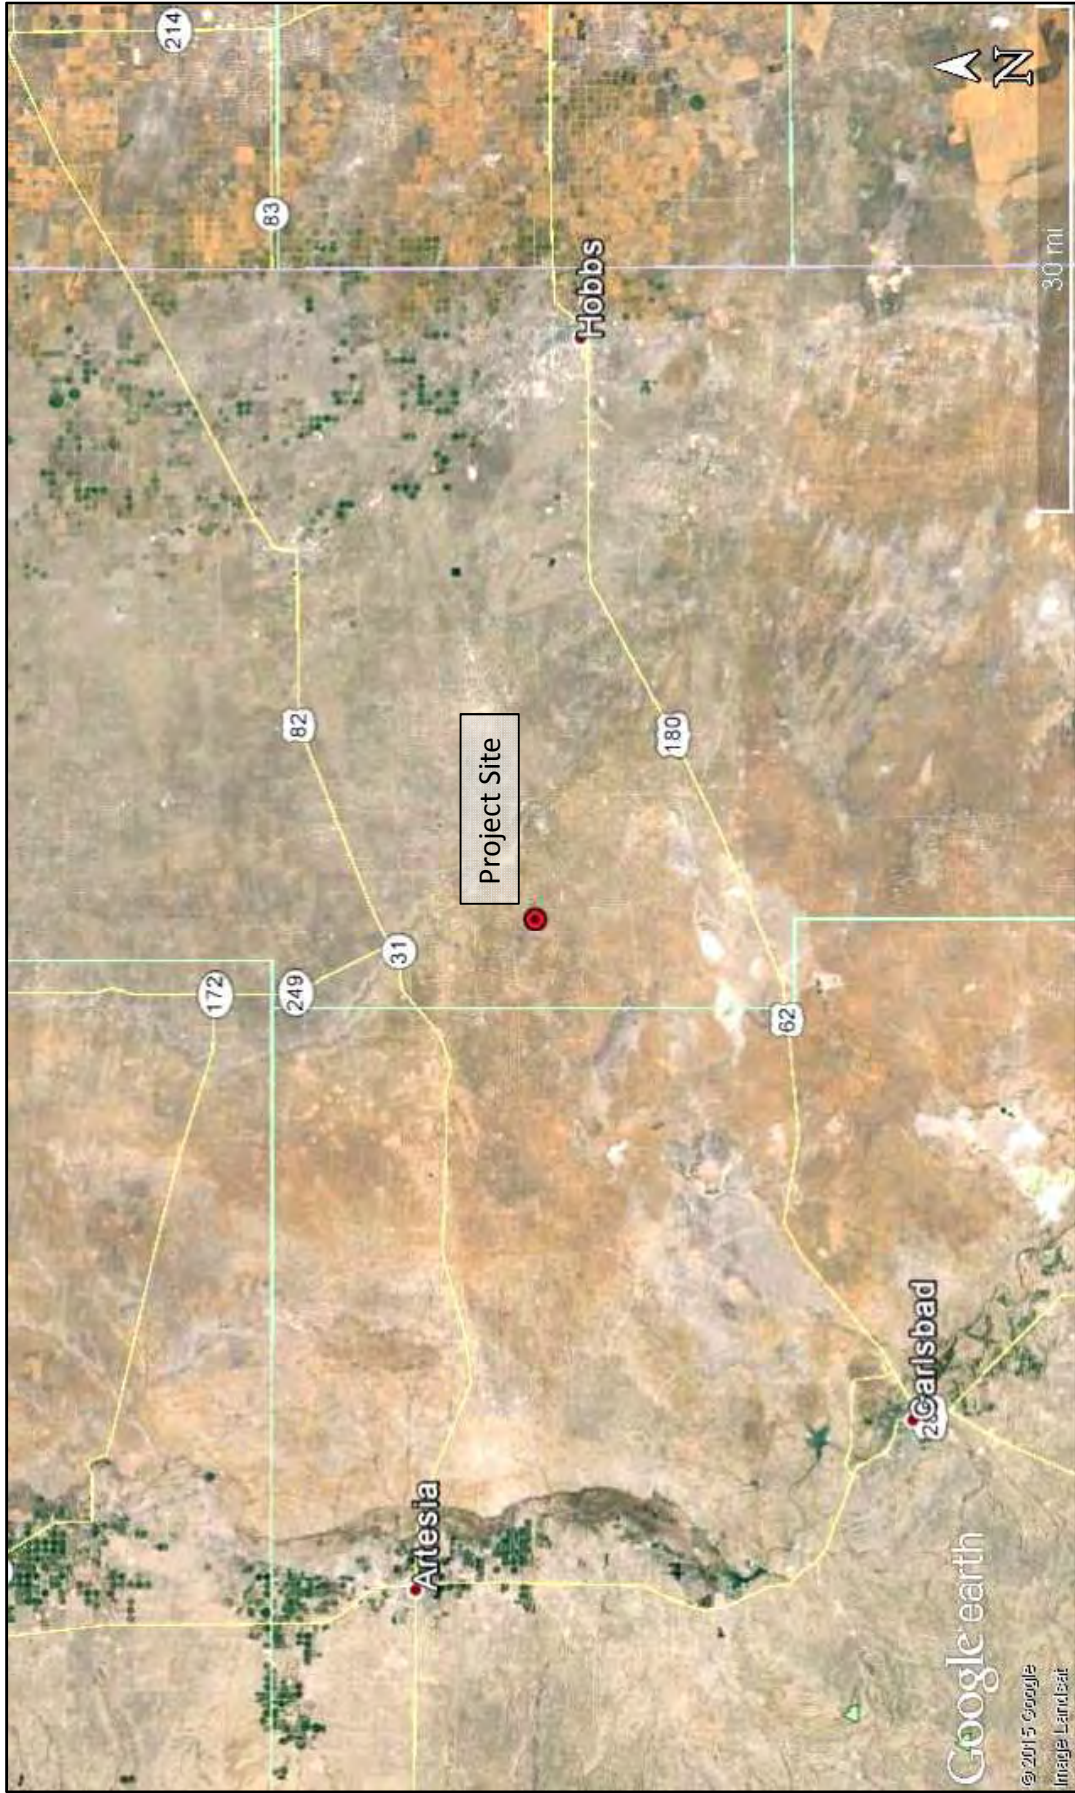
FIGURE 1
Site Location Map
EOG Resources - Shinnery Fed #1
Final Report (1RP3161)
Lea County, New Mexico

NOTE: This image has been modified from the original. The base map is from Google Earth Pro, but the superimposed information is from CH2M HILL.

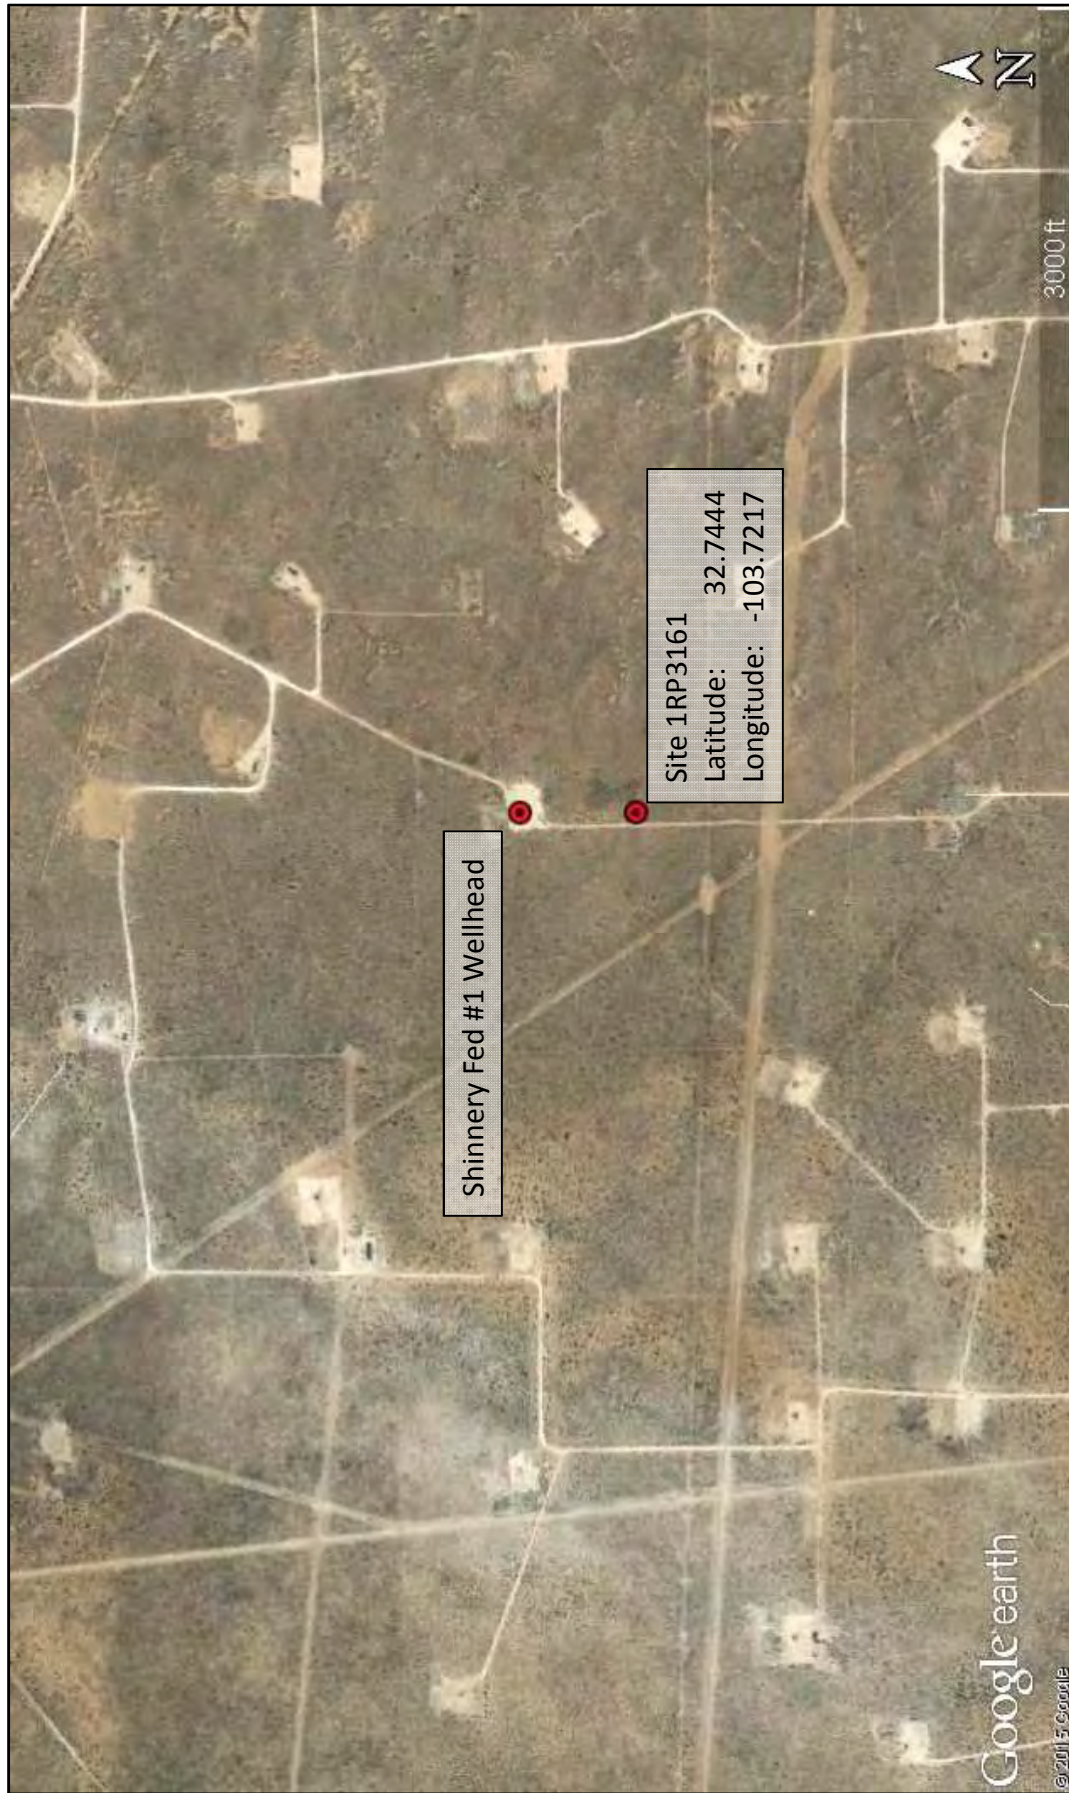
FIGURE 2
Area Map
EOG Resources - Shinnery Fed #1
Final Report (1RP3161)
Lea County, New Mexico

NOTE: This image has been modified from the original. The base map is from Google Earth Pro, but the superimposed information is from CH2M HILL.

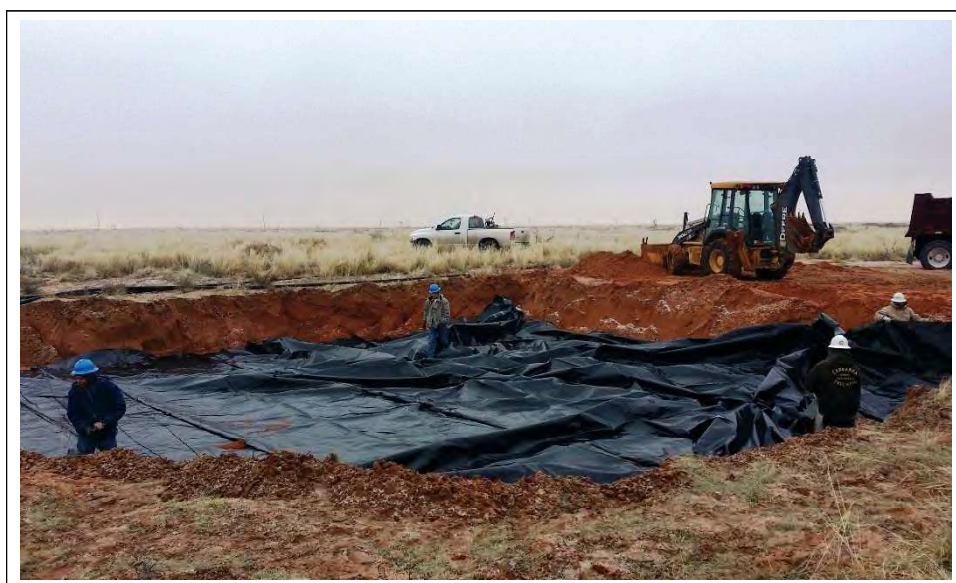
Liner Installation

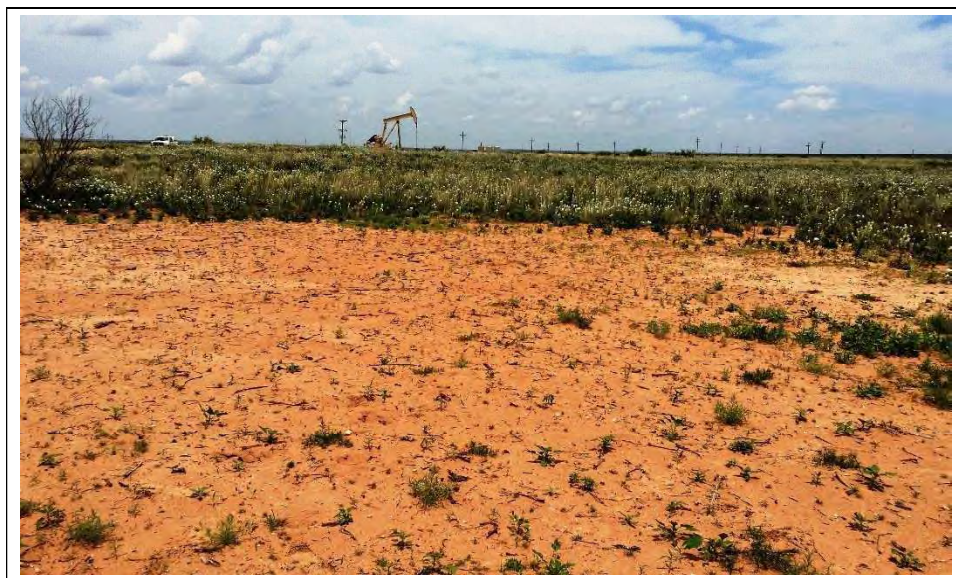
Post liner installation, looking north.

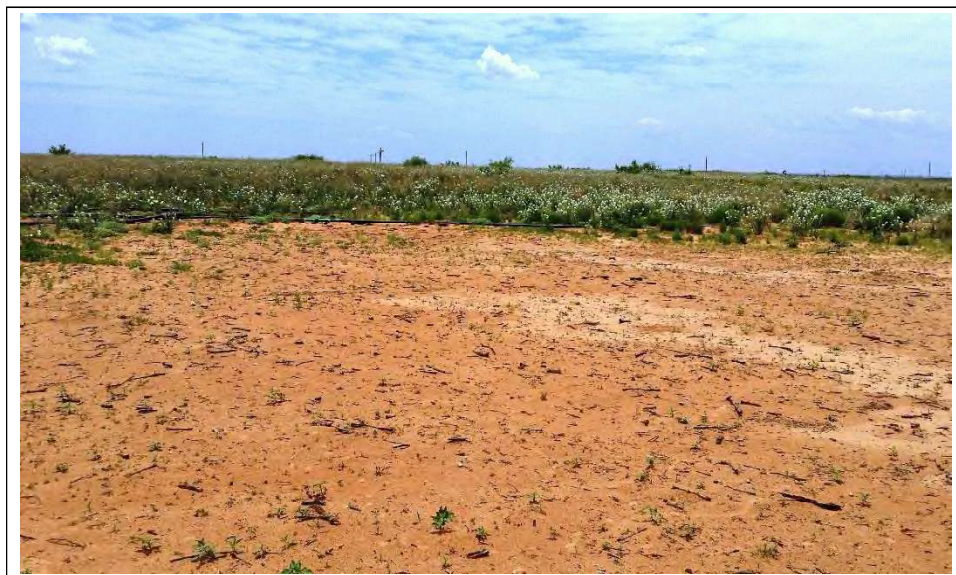
Post liner installation, looking south.

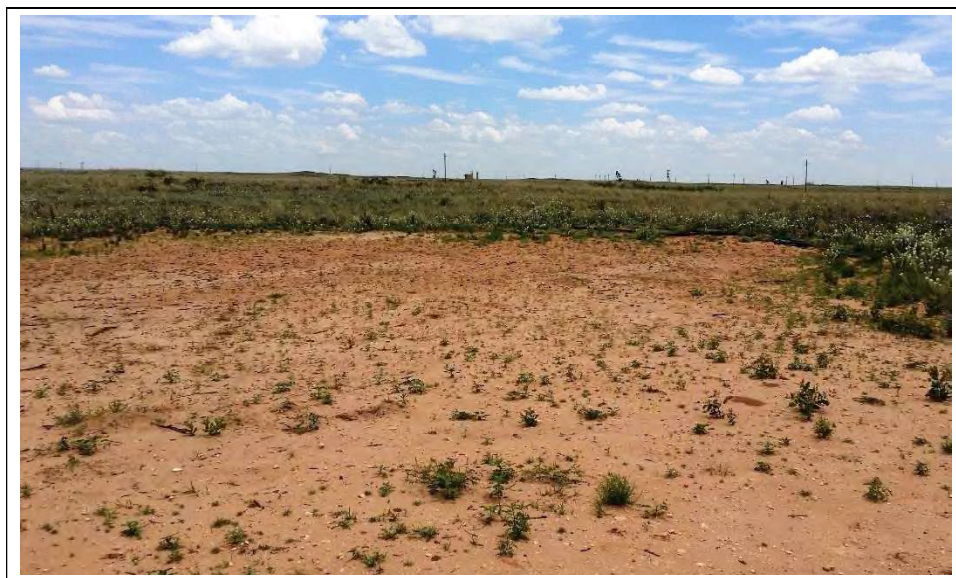
Post liner installation, looking east.

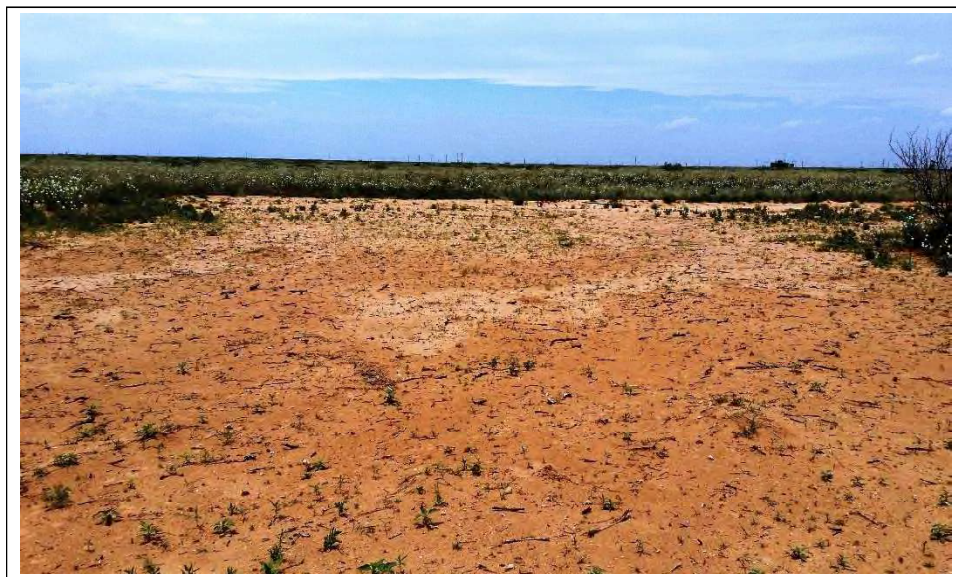
Post liner installation, looking west.

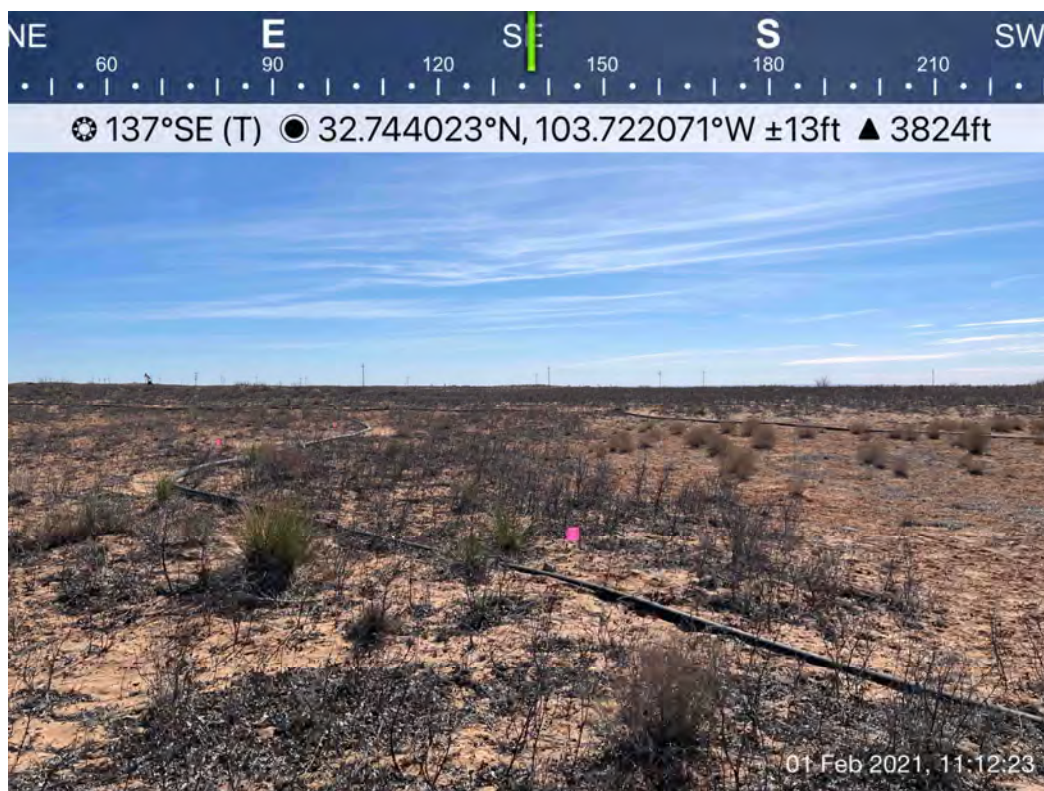
View of Remediated Area – View Southeast
