SUBJECT: Remediation Closure Report for the Thistle Unit 47H Release (1RP-3655), Lea County, New Mexico

Thistle Unit 47H Remediation Closure Report (1RP-3655)  
October 4, 2020

Location name: Thistle Unit 47H

OCD Spill Number: nKJ1515231550 (1RP-3655)

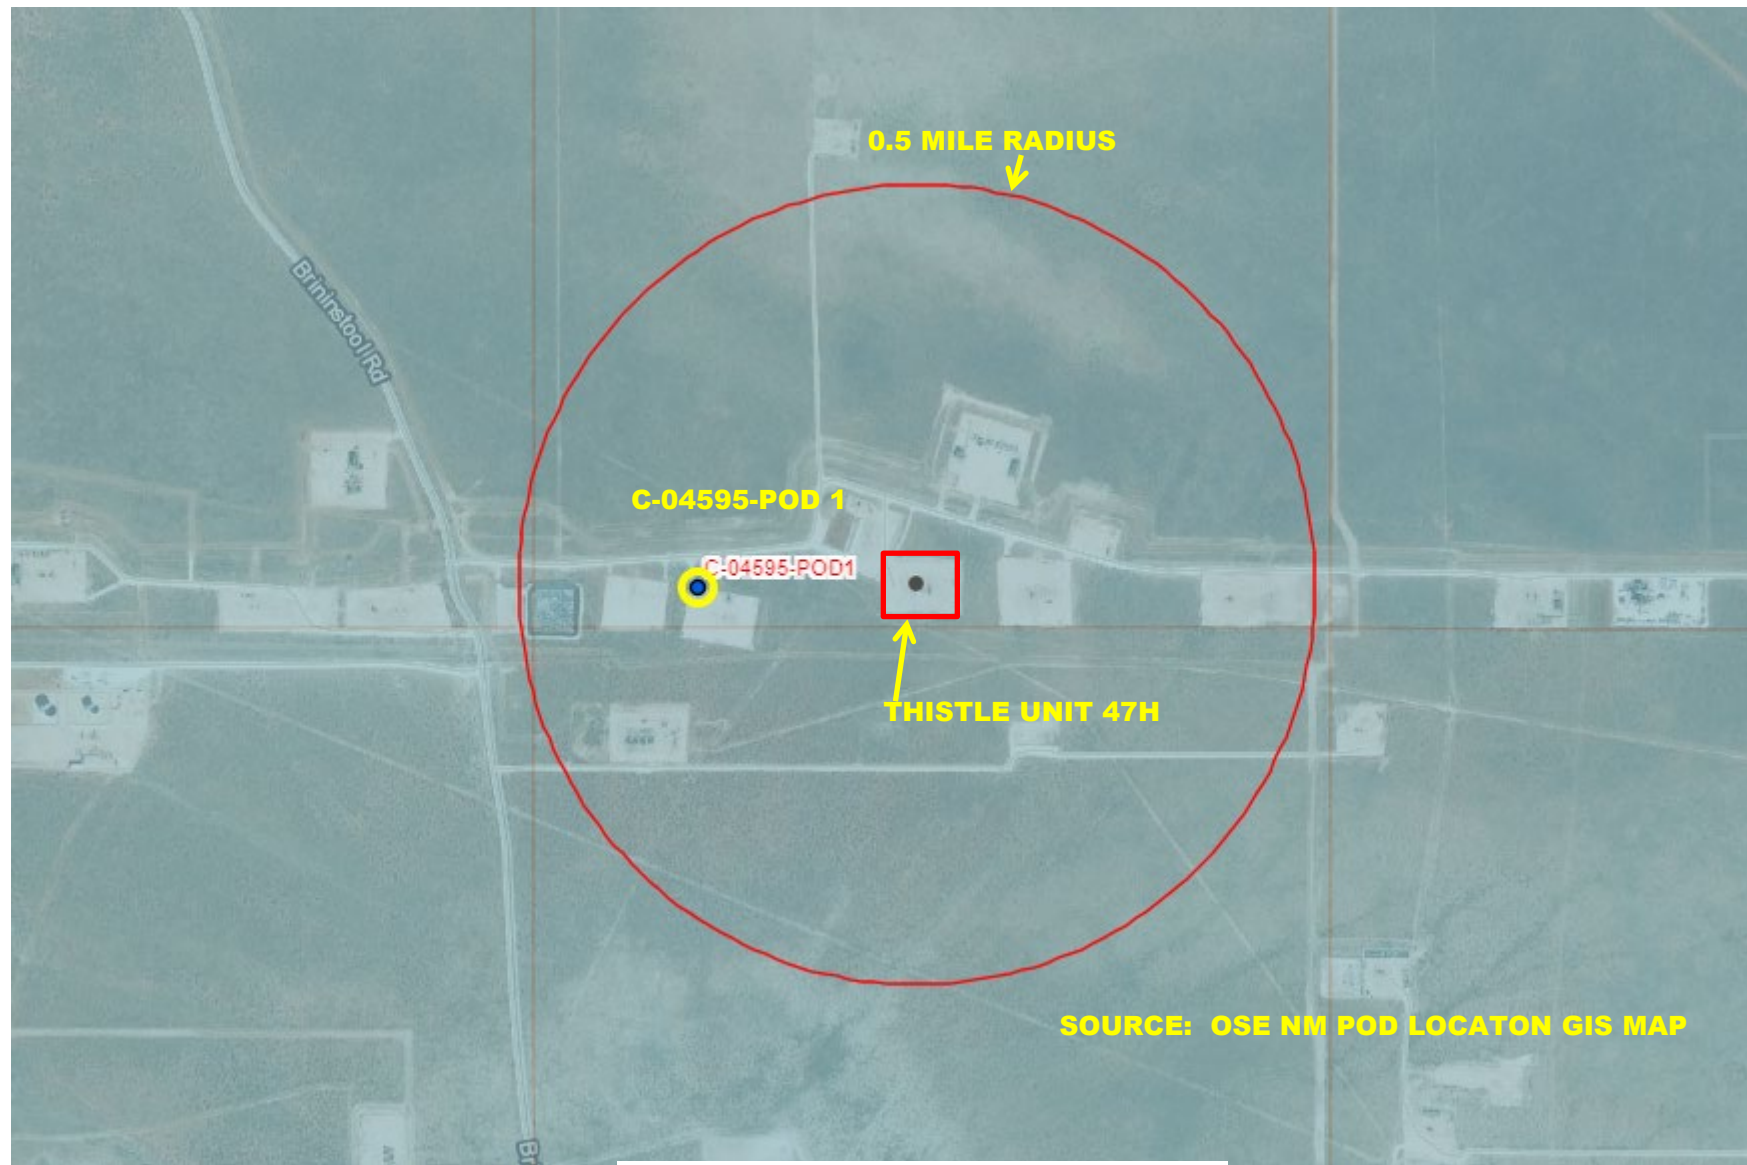
FIGURE 1: NM OSE POD LOCATIONS	
THISTLE UNIT 47H	
32.2546959,-103.5605698	
drawn by: RDW	Date: 01/2023

One pod location is within 0.5 miles of the location and less than 25 years old.

C-04637- POD1 (51 feet) = 0.23 miles from location

The spill was remediated to criteria for DTW of 51-100 feet bgs.
