**Re:** Remediation Work Plan  
**Pure Gold MDP1 29 17 Fed Com 171H**  
**Off Hwy 128**  
**32.2721838° N, 103.8021430° W**  
**Eddy County, New Mexico**  
**Incident ID: nAPP2222430401**  
 Ensolum Project No. 03B1417060

Ensolum, LLC. (Ensolum) has prepared this Remediation Work Plan to perform environmental consulting services in the vicinity of the Pure Gold MDP1 29 17 Fed Com 171H, referred to hereinafter as the "Site." The Site is located off Hwy 128 and an unnamed caliche road, approximately 17 miles east of Loving in Eddy County, New Mexico.

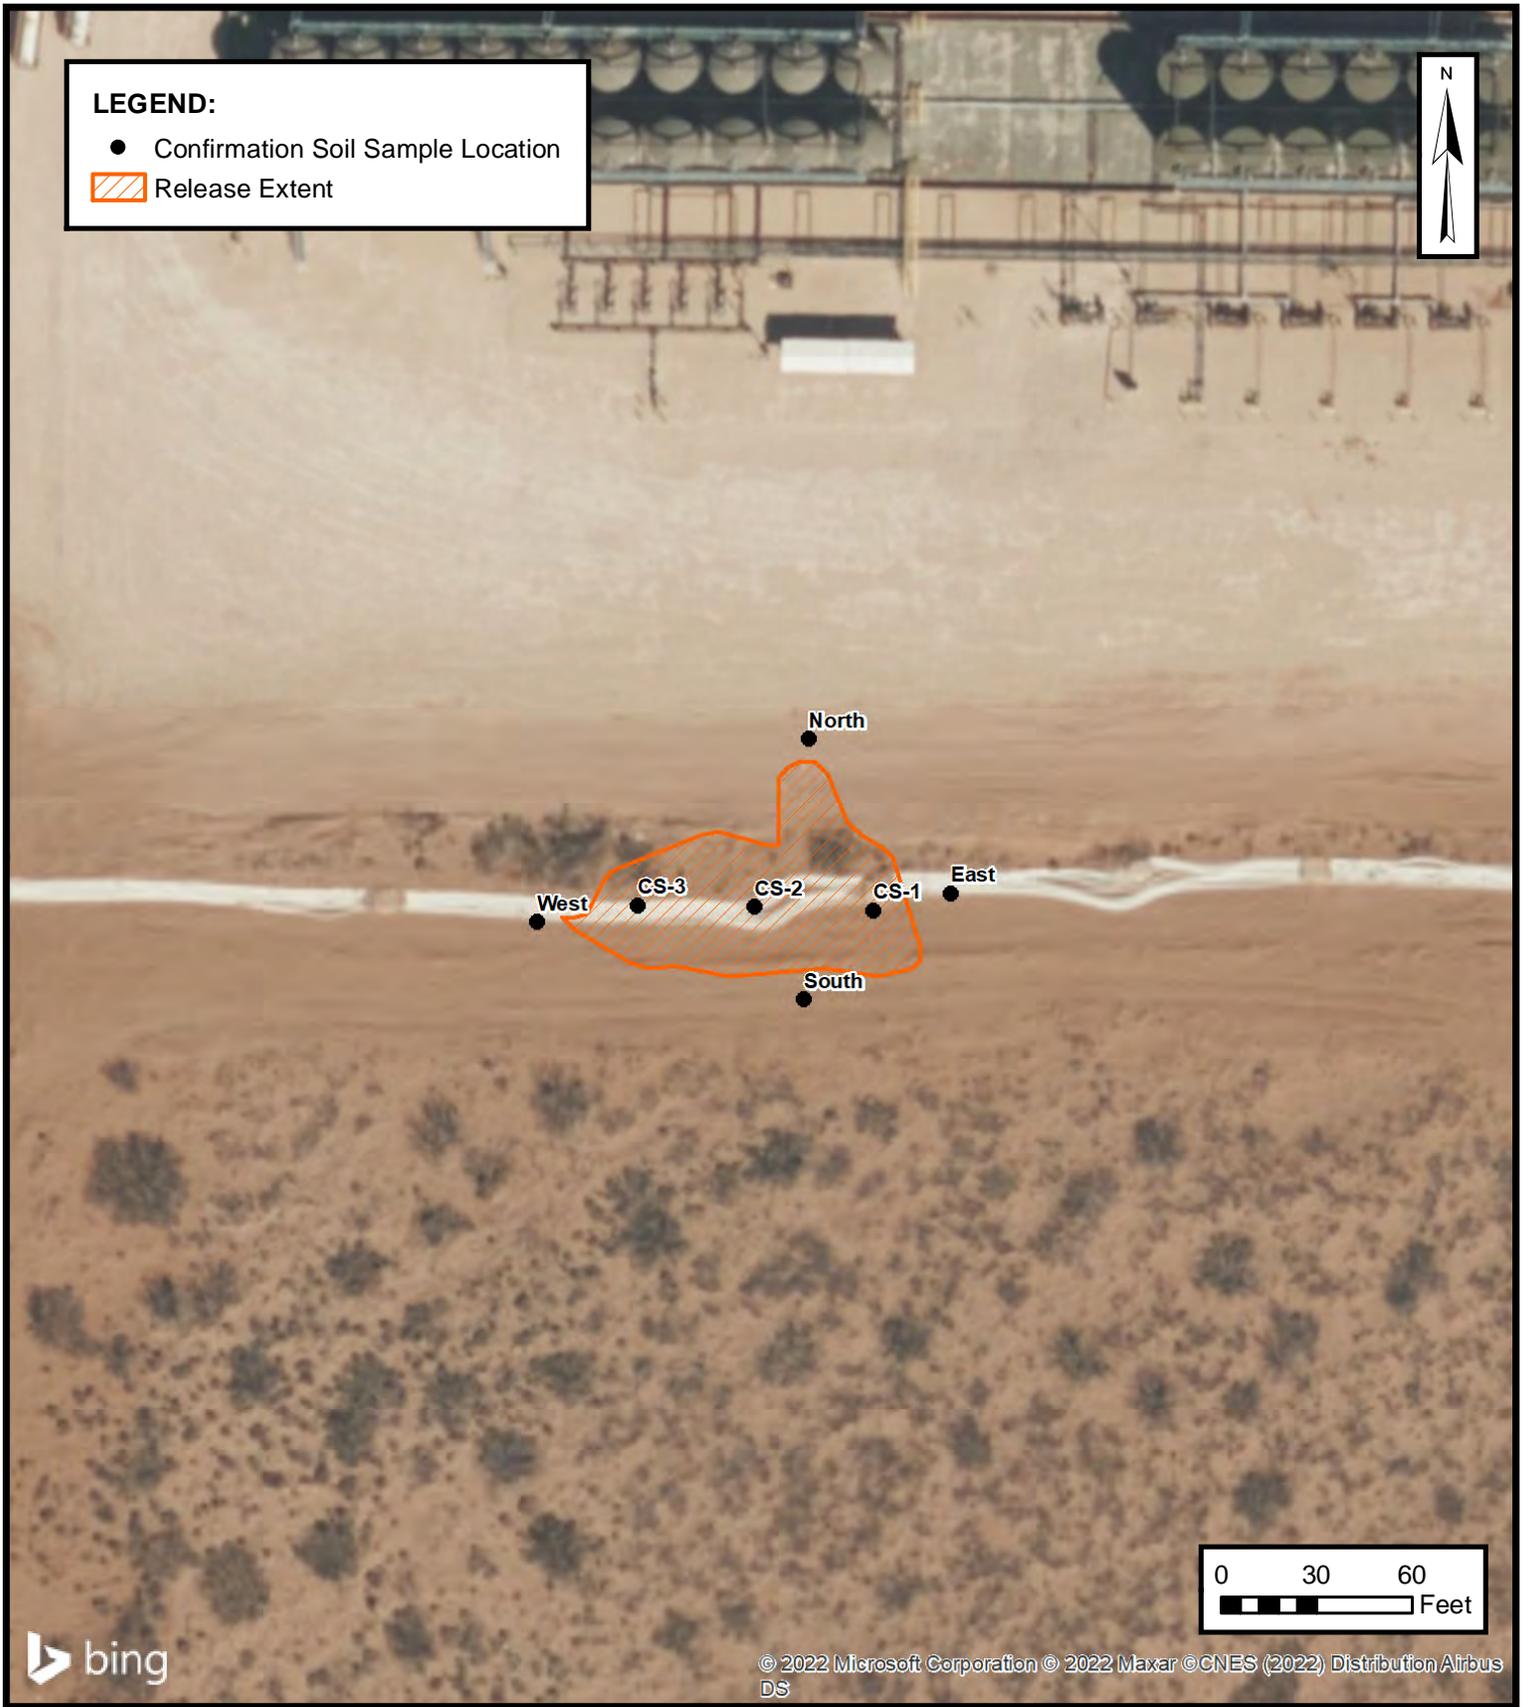
**SITE MAP**

The Site Map indicating the overall area of the release, the composite pothole soil sample's locations, and the delineation composite soil sample's locations are included as **Figure 3** in **Attachment A**.

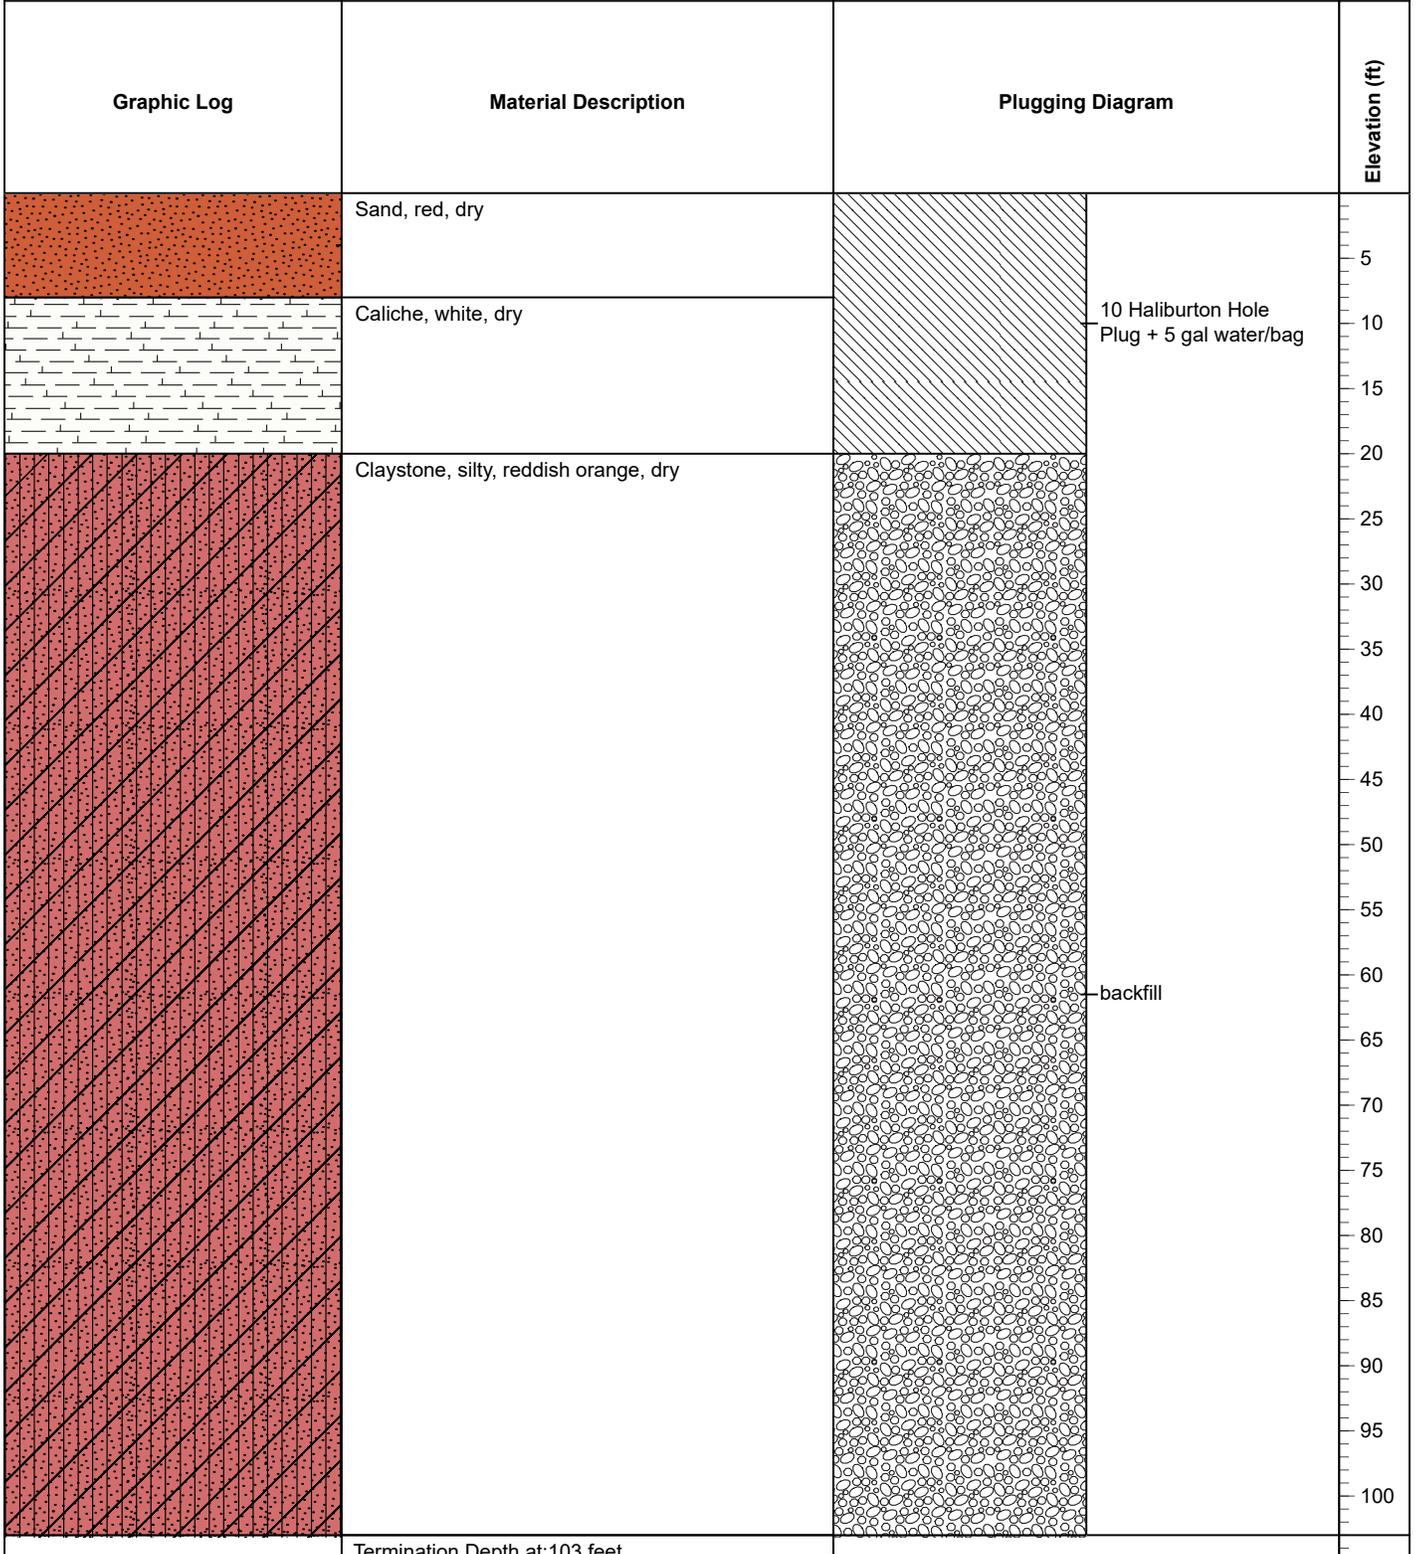
**COMMENTS** South of large mesquite bush - west side of pad

Termination Depth at: 103 feet

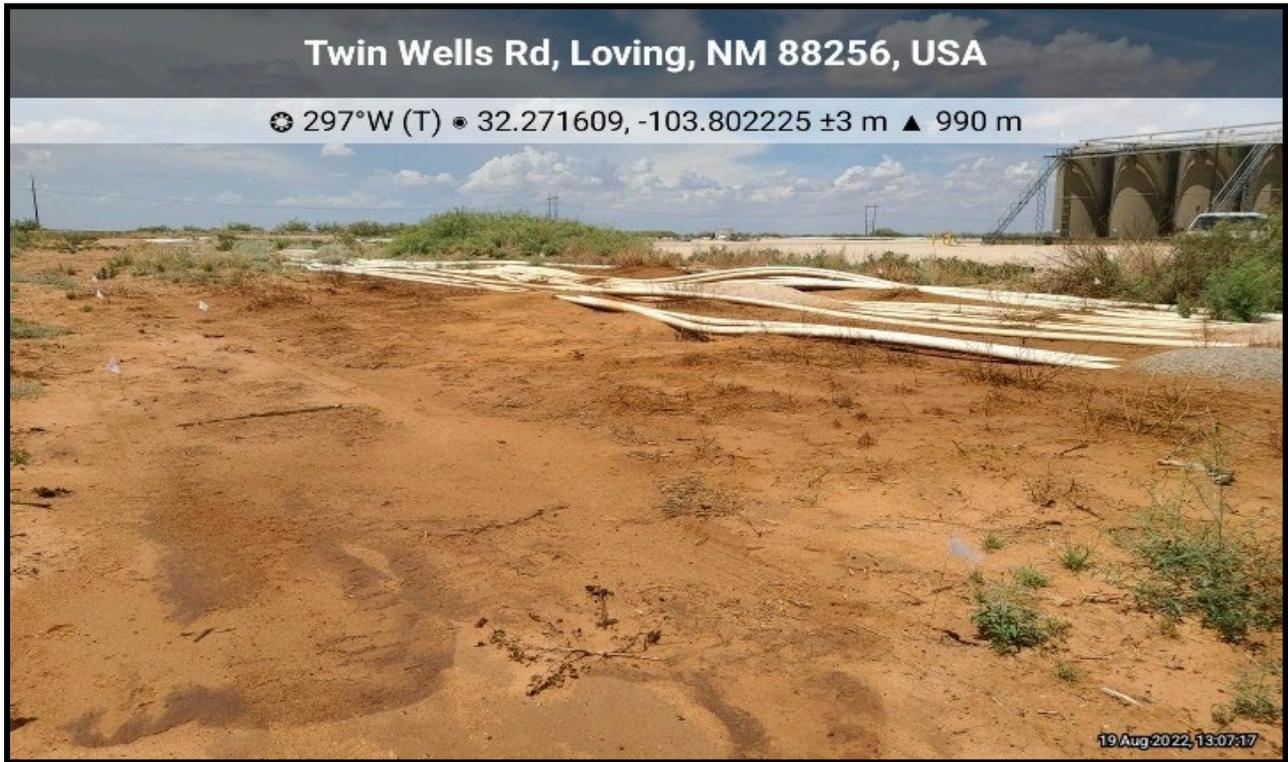
View of release area during initial soil sampling activities, facing northwest.

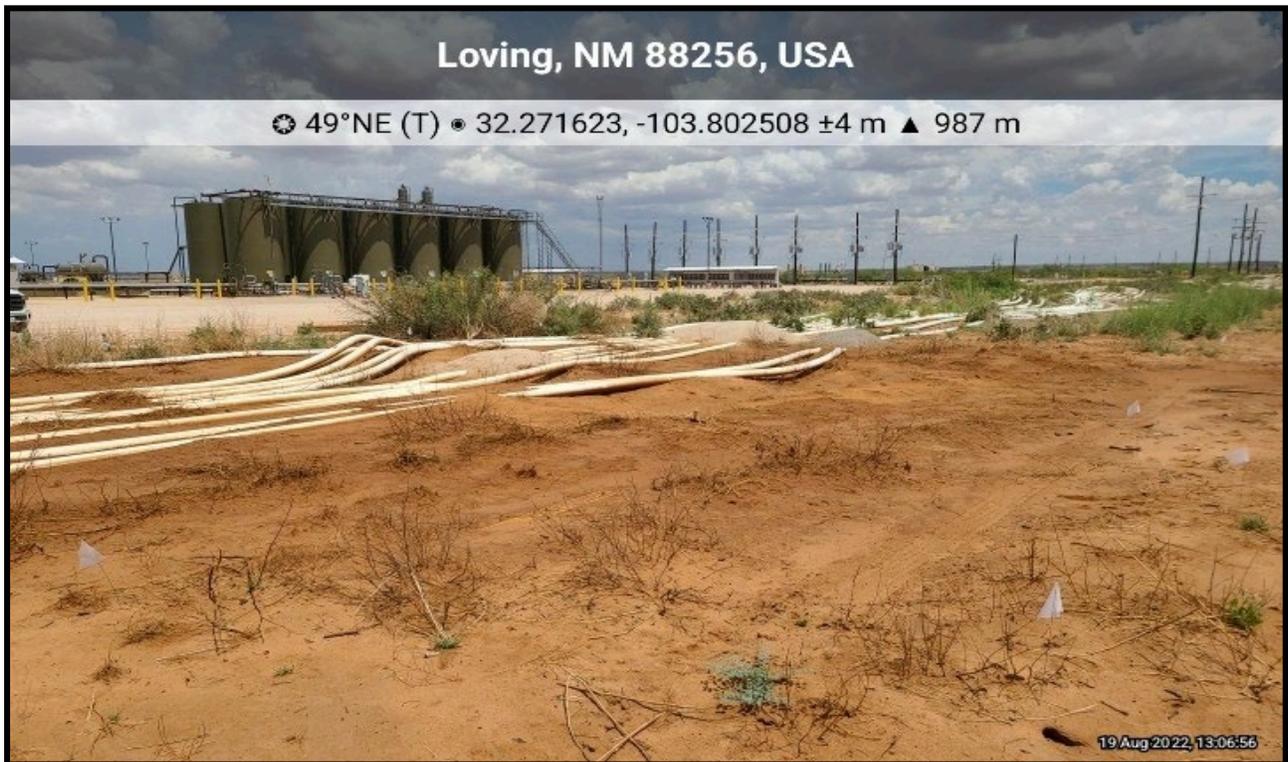
View of release area during initial soil sampling activities, facing northeast.
