Release Notification

Site Name: North East Blanco Unit 605 001 H	Site Type: Natural Gas Production Water System
Date Release Discovered: 07/06/2021	API# (if applicable) 30-045-35851

2022.04.11 Northeast Blanco Unit 605 H 1 pipeline leak remediation.

Initial Response Documentation

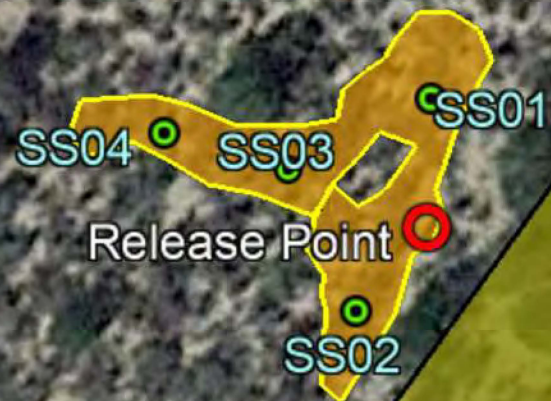
SIMCOE LLC**Northeast Blanco Unit 605 001-H Release**

- Soil Sample Location
- NEBU 605 Wellpad
- Release Extents
- Release Point

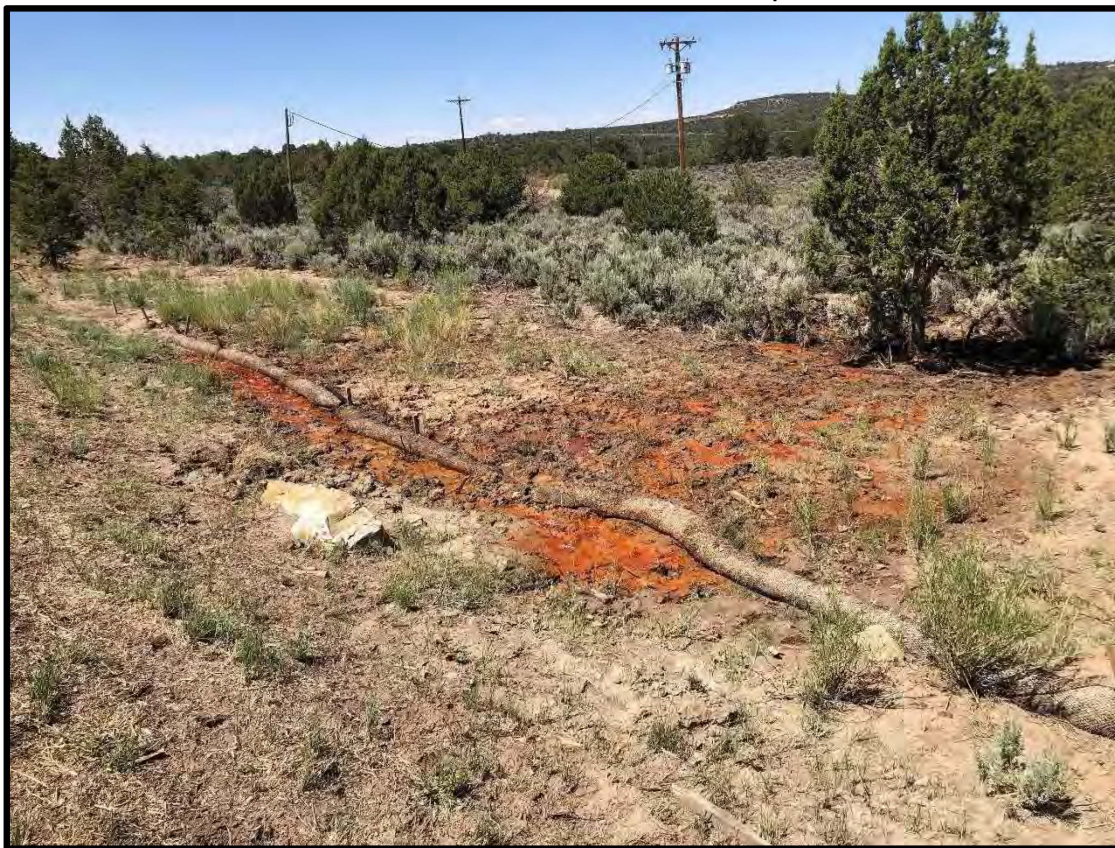
Photo 1 – Release area on 7/6/2021.

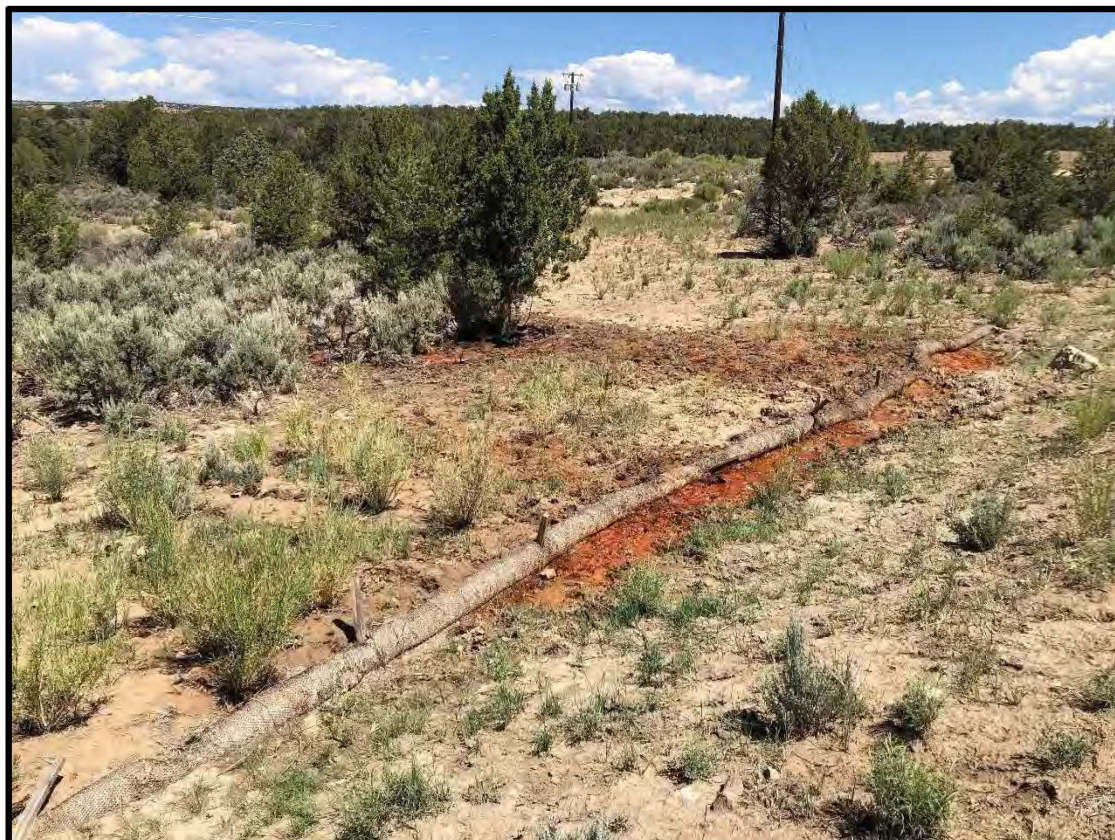
Photo 2 – Release area on 7/6/2021.

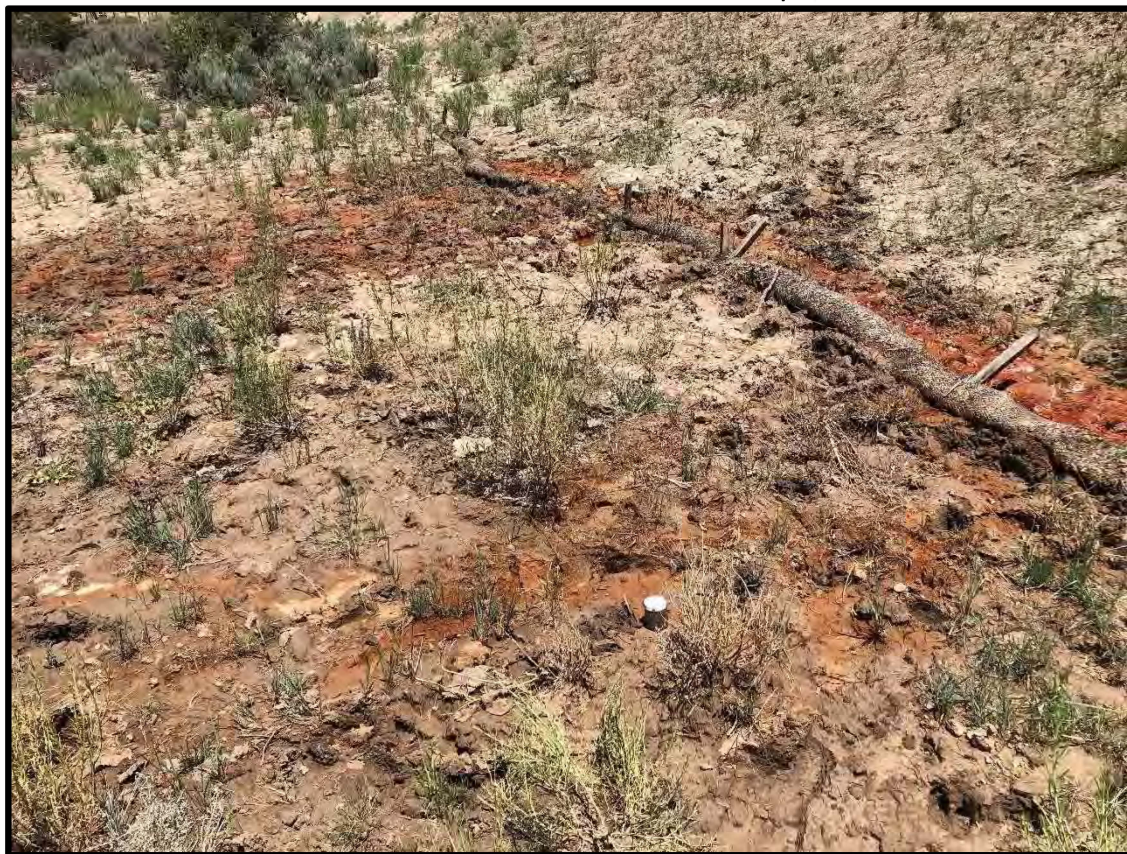
Photo 3 – SS01 grab sample location.

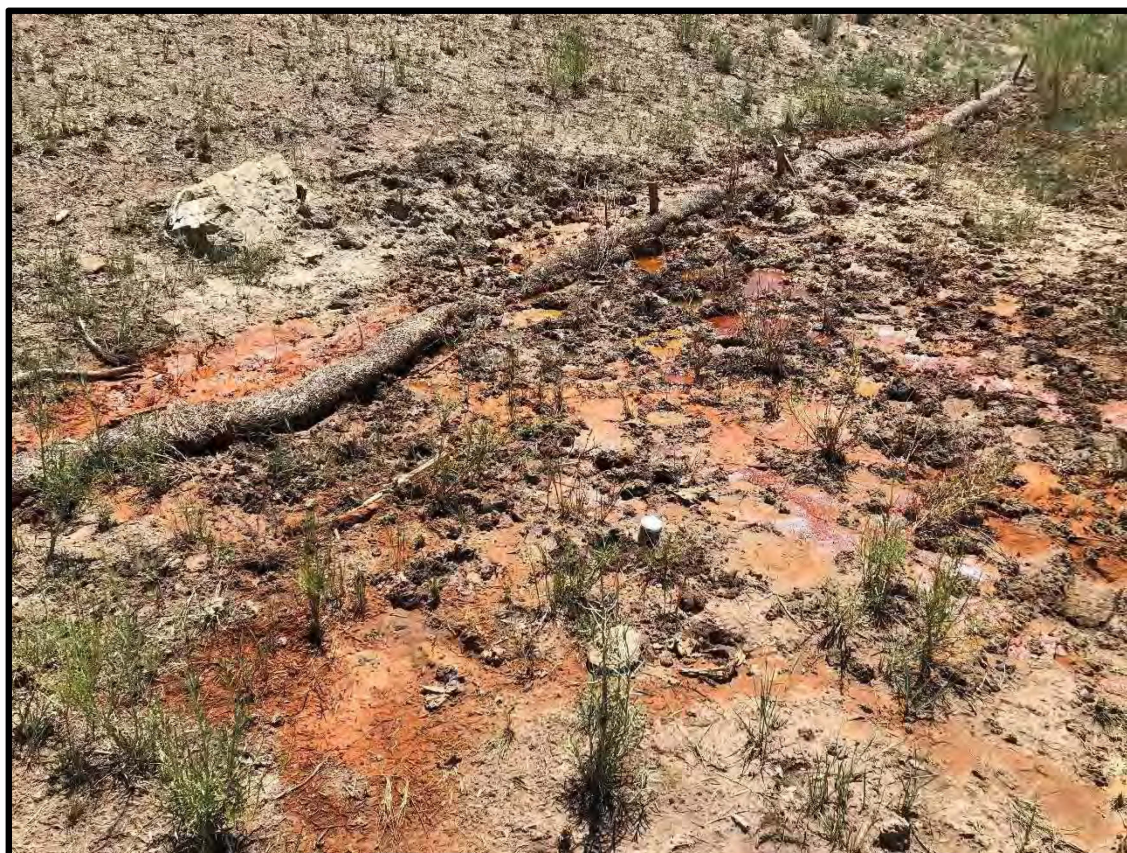
Photo 4 – SS02 grab sample location

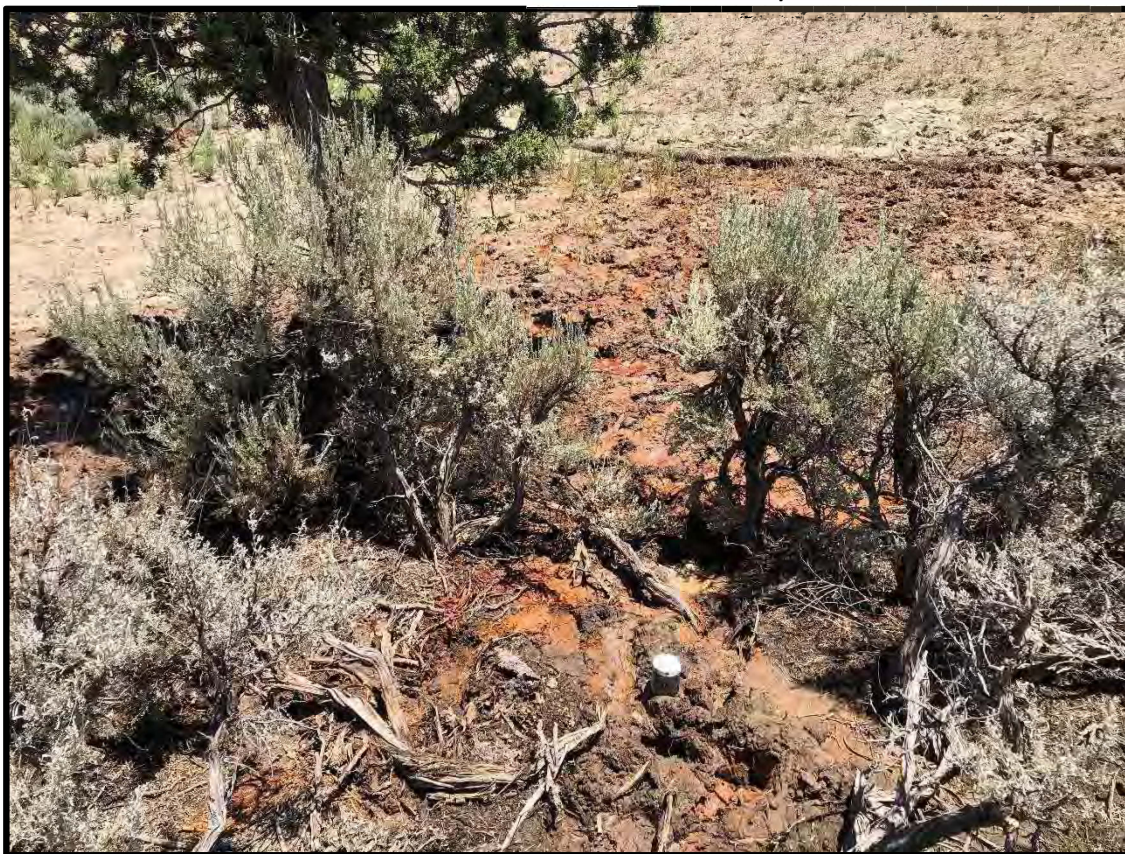
Photo 5 – SS03 grab sample location.

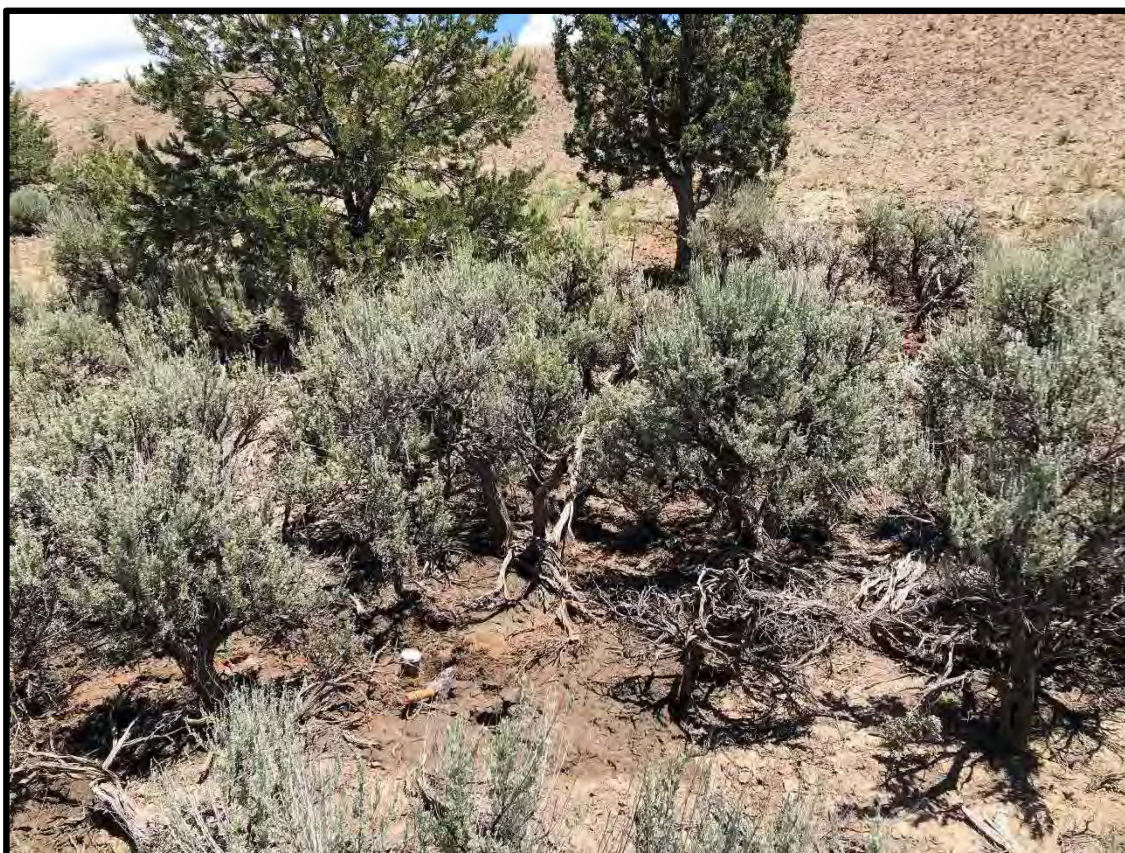
Photo 6 – SS04 grab sample location at the terminus of the release flow.

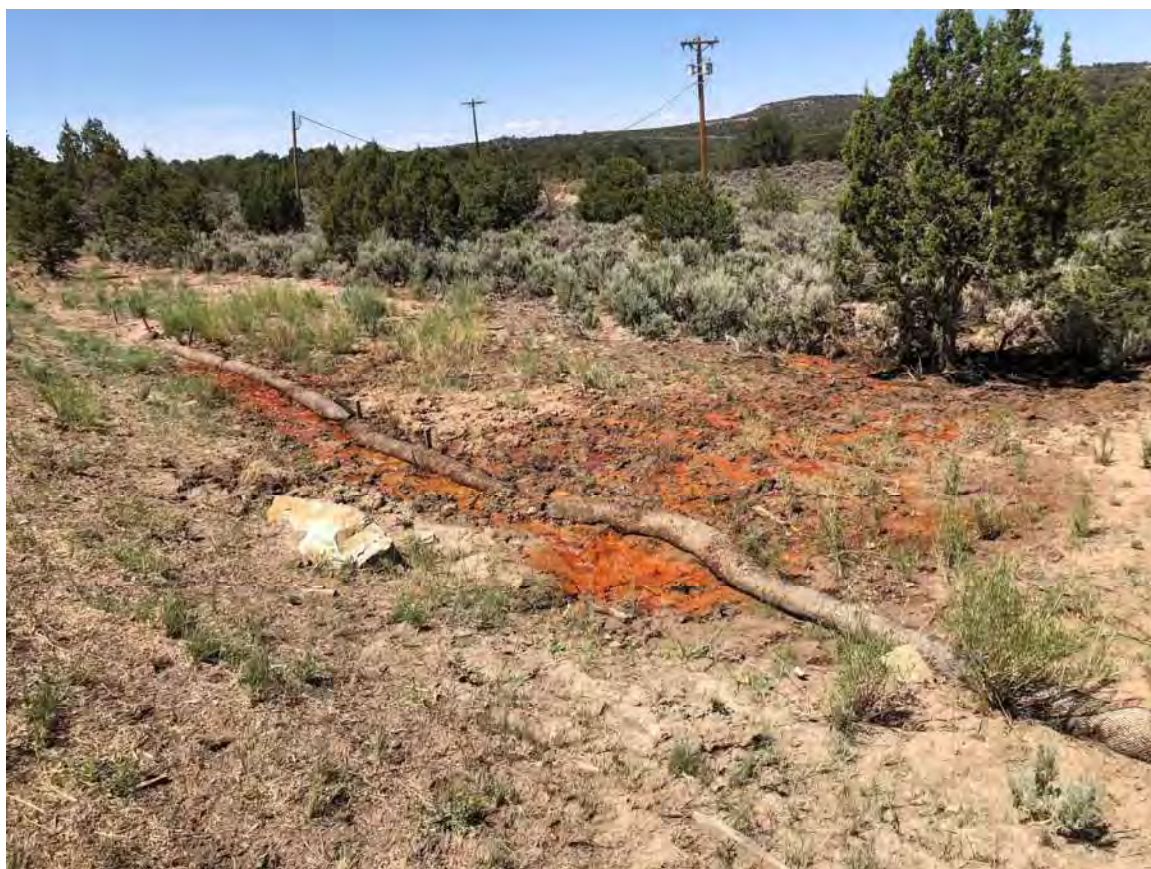
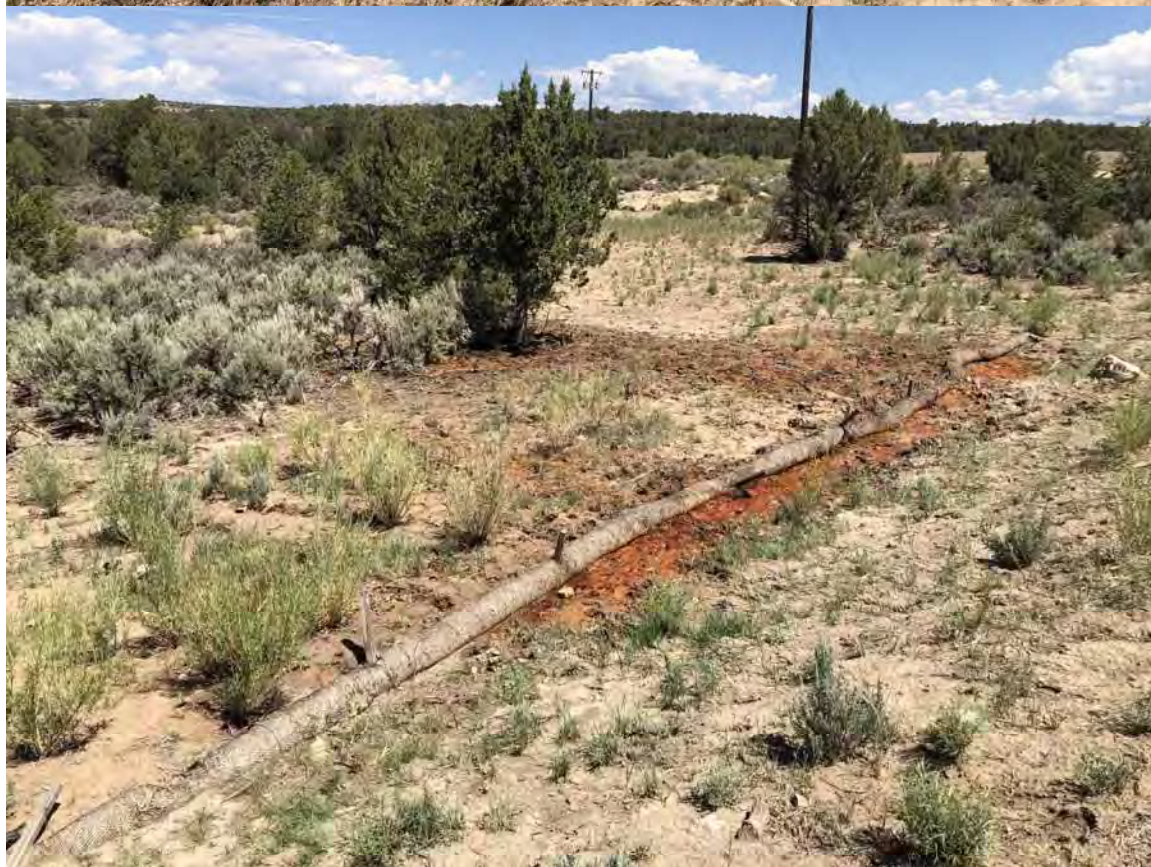
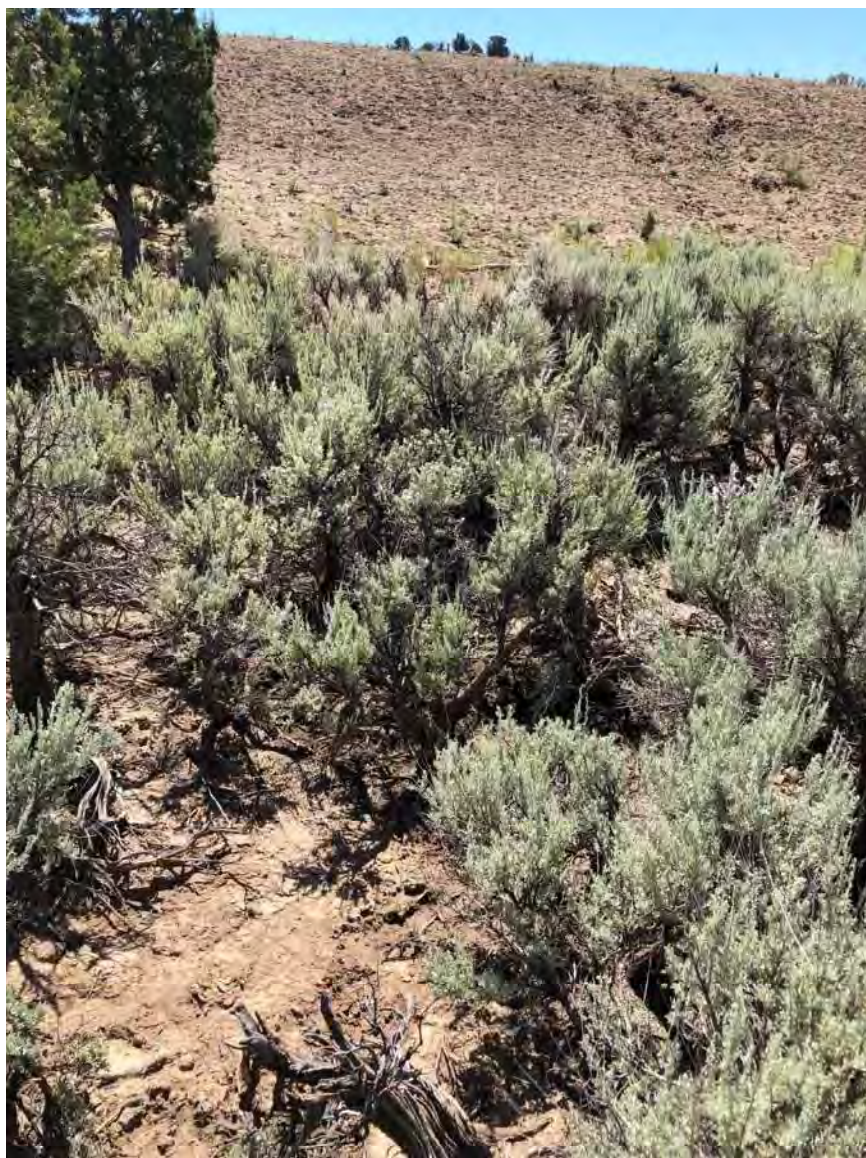
The release measures approximately 925 sq ft. I propose to collect 4 grab samples from the release area, bisecting (2 sample) the lateral NW/SE sections at the release point and 2 samples from the downgradient flow to the west. The attached map depicts the proposed sampling points in GREEN DOTS.

Due to the 605 well pad being a recent development location, the Google Earth imagery does not have a current depiction. I have added the approximate footprint of the well pad.

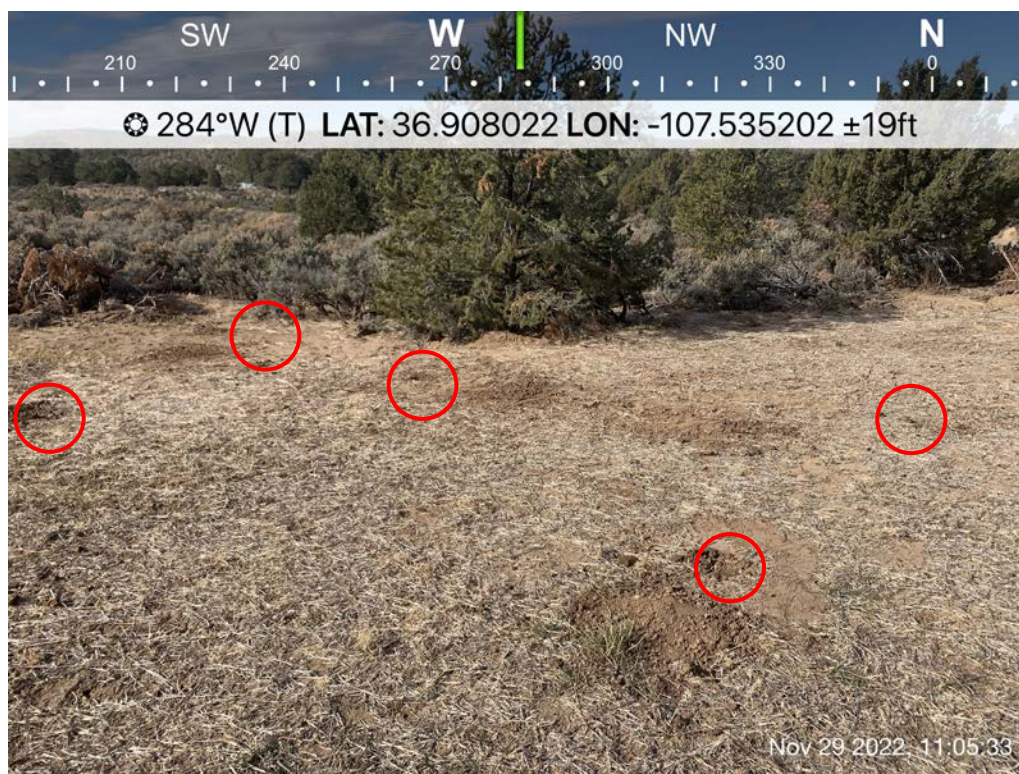
Photo 3: SS06 collected from the release area, 11/29/2022.
