Closure Report

August 20, 2020

Re: NEDU 339
Case # 1RP-2031

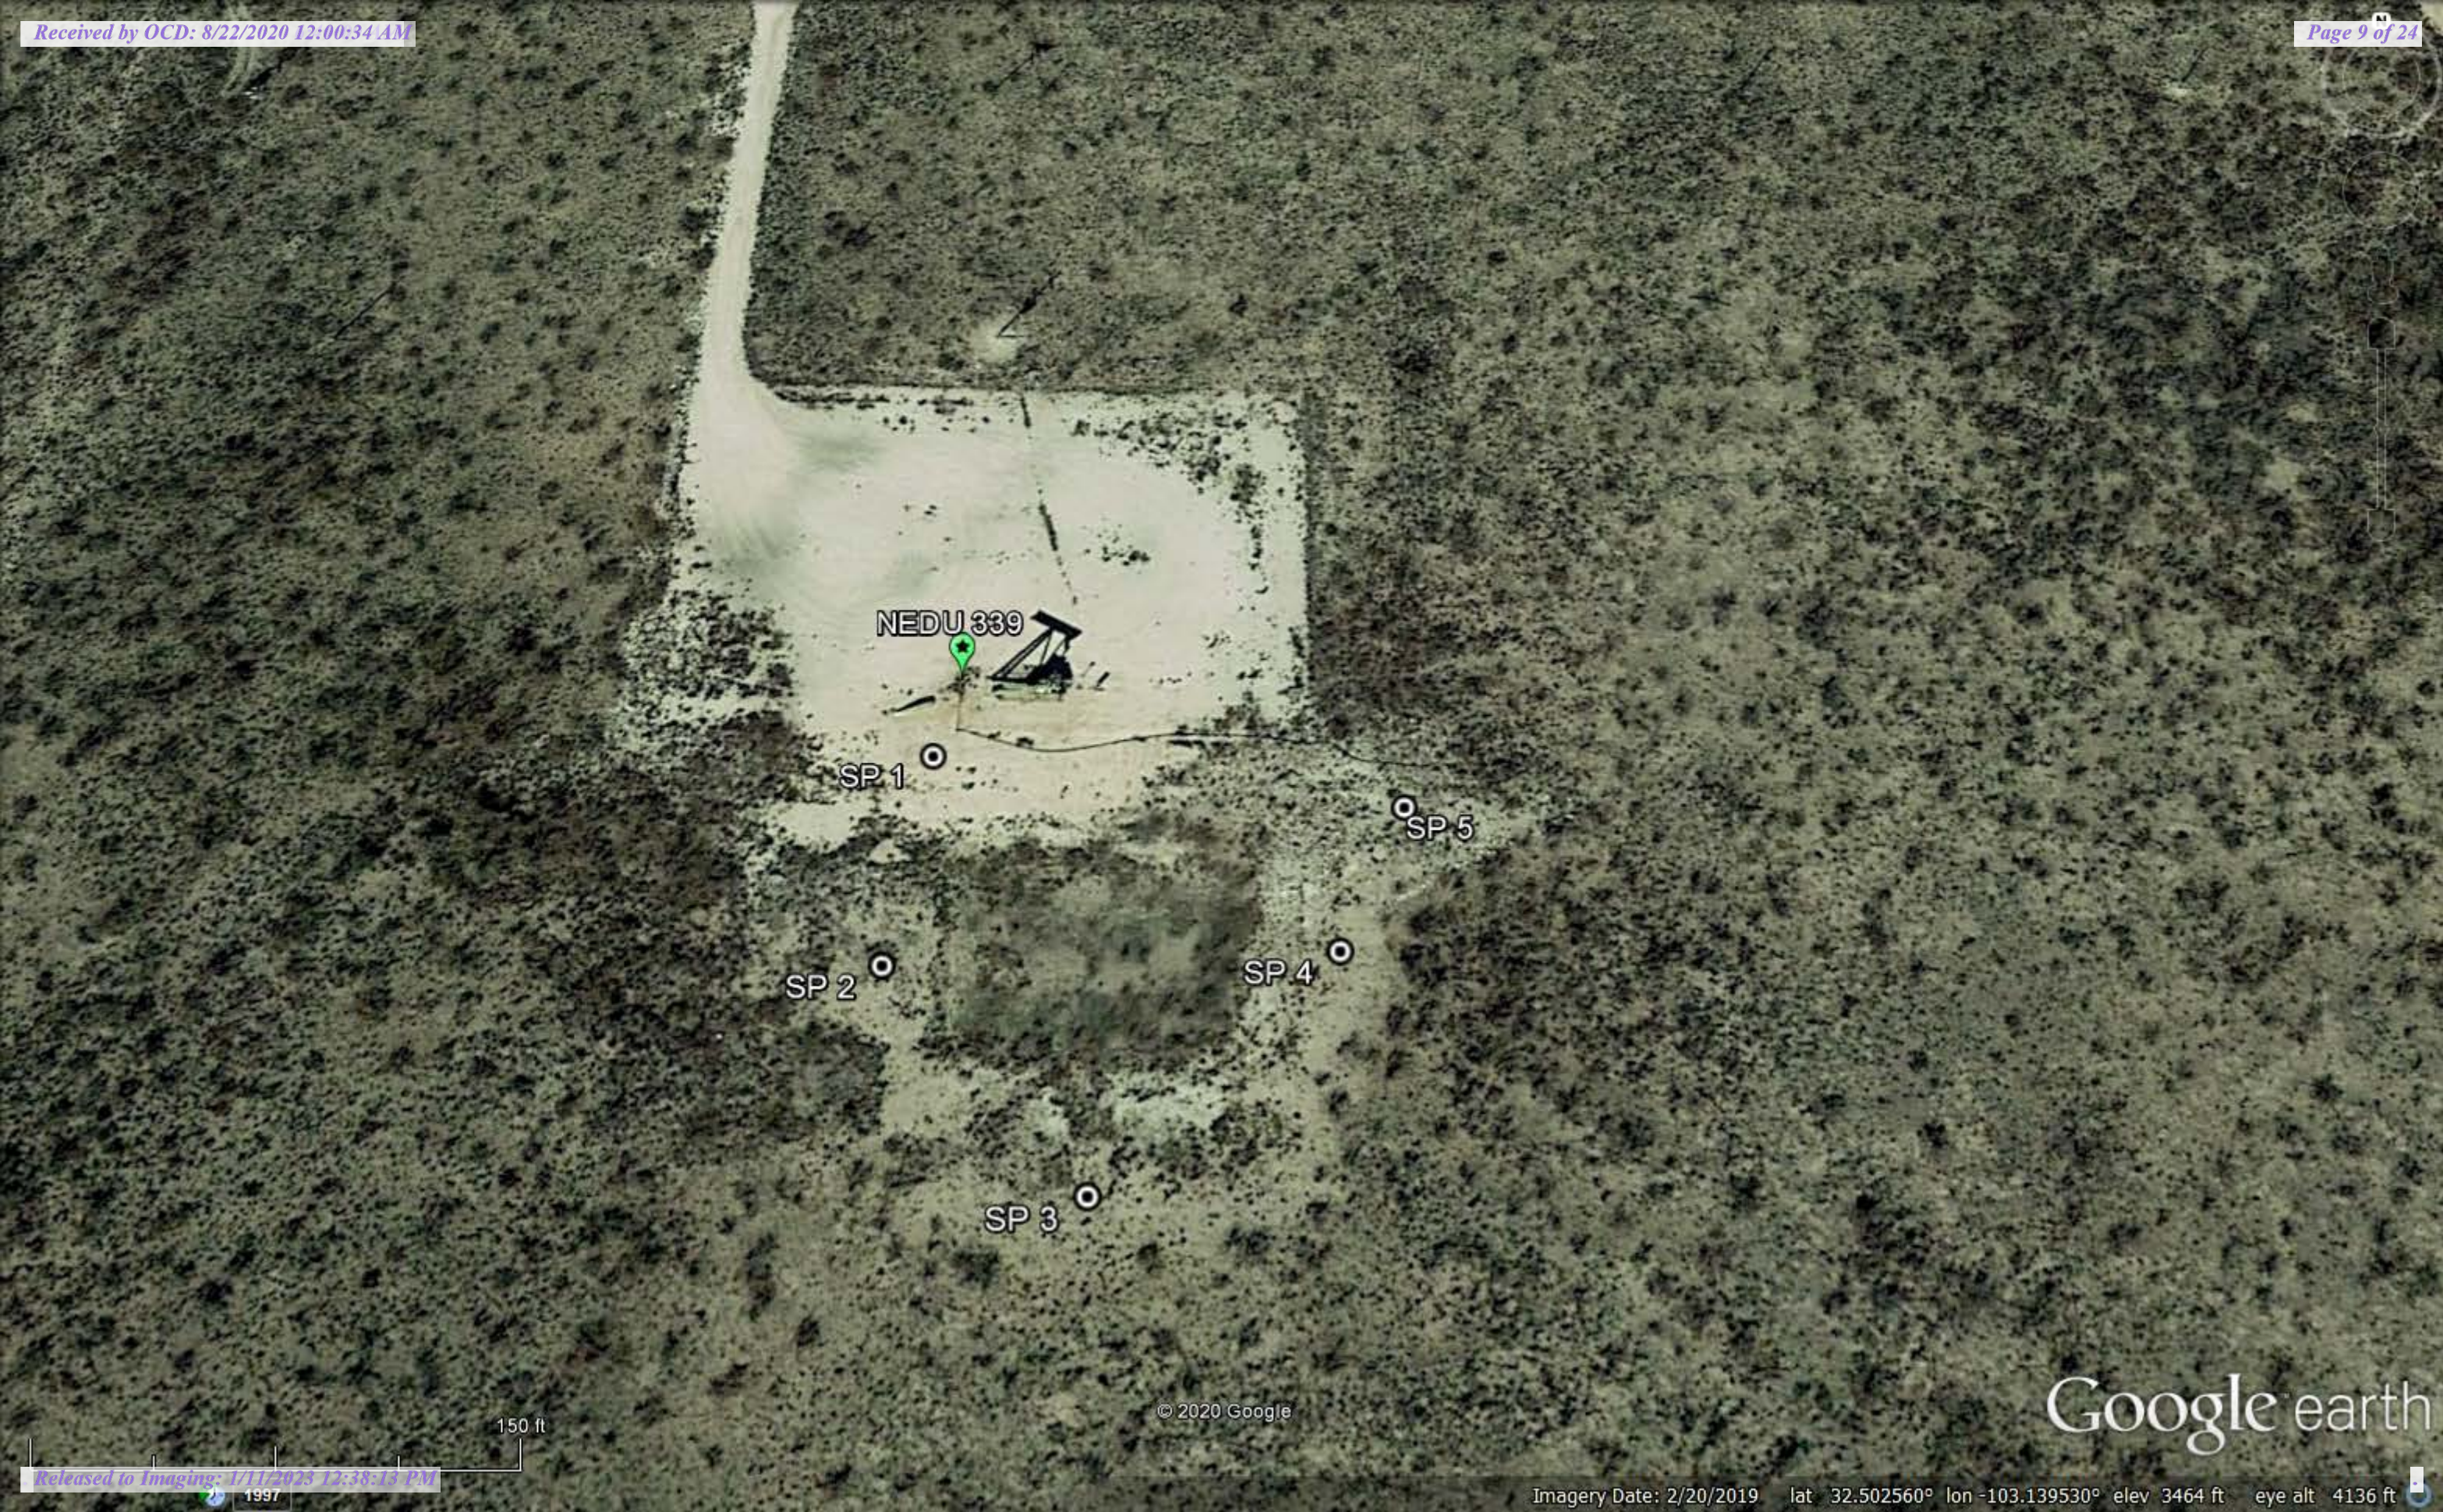
Map ID	Sample Date	Depth	Chloride	Benzene	Toulene	Ethybenzene	Total Xylenes	Total BTEX	GRO	DRO	EXT DRO	GPS Coordinates
SP1	8/23/2019	S	48	<0.050	<0.050	<0.050	<0.150	<0.300	<10.0	<10.0	<10.0	32.501534 -103.138148
	8/23/2019	1'	48	<0.050	<0.050	<0.050	<0.150	<0.300	<10.0	<10.0	<10.0	
		2'	416									
SP 2	8/23/2019	S	<16.0									32.501315 -103.138191
	8/23/2019	1'	<16.0									
SP3	8/23/2019	S	<16.0	<0.050	<0.050	<0.050	<0.150	<0.300	<10.0	<10.0	<10.0	32.501096 -103.137954
	8/23/2019	1'	<16.0	<0.050	<0.050	<0.050	<0.150	<0.300	<10.0	<10.0	<10.0	
SP 4	8/23/2019	S	<16.0									32.501327 - 103.137682
	8/23/2019	4"	<16.0									
SP 5	8/23/2019	S	<16.0	<0.050	<0.050	<0.050	<0.150	<0.300	<10.0	<10.0	<10.0	32.501477 -103.137606
	8/23/2019	1'	<16.0	<0.050	<0.050	<0.050	<0.150	<0.300	<10.0	<10.0	<10.0
