**Re: Remediation Report and Closure Request**

Grenier A 4  
San Juan County, New Mexico  
Hilcorp Energy Company  
NMOCD Incident No: nAPP2218030491

Ensolum, LLC (Ensolum), on behalf of Hilcorp Energy Company (Hilcorp), presents this *Remediation Report and Closure Request* for a release at the Grenier A 4 natural gas production well (Site). The Site is located on federal land managed by the Bureau of Land Management (BLM) in Unit M, Section 26, Township 30 North, Range 10 West, in San Juan County, New Mexico (Figure 1). The work described in this report was performed in order to remediate petroleum hydrocarbon impacted soil originating from a release of crude oil and produced water from an aboveground storage tank. Based on the remediation activities performed and laboratory analytical results, Hilcorp is requesting closure and no further action for Incident Number nAPP2218030491.

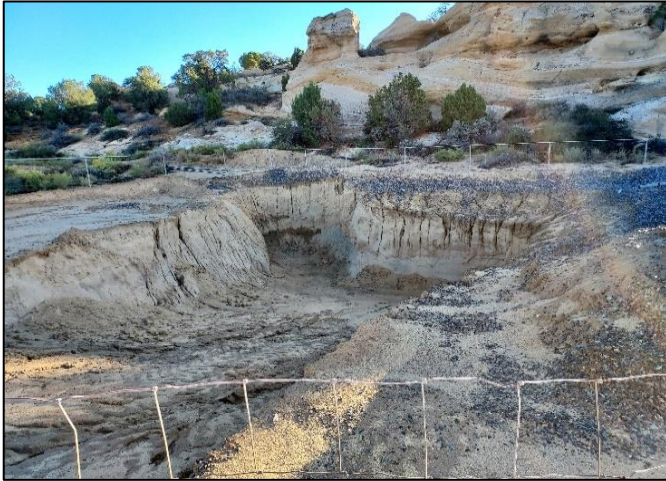
Photograph: 1  
Description: Initial Excavation  
View: Northeast

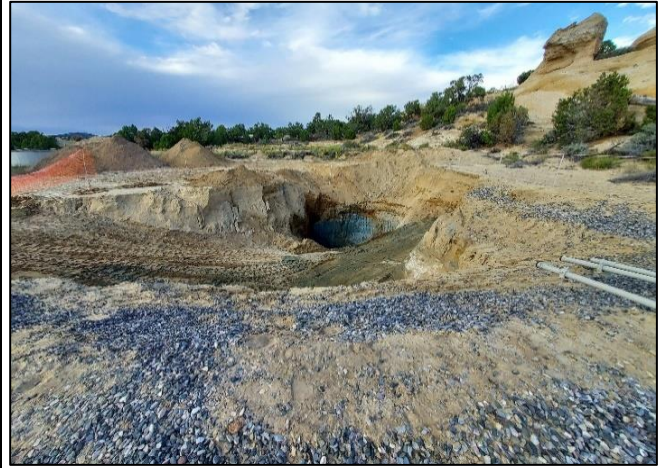
Photograph: 2  
Description: Soil staining in excavation  
View: North

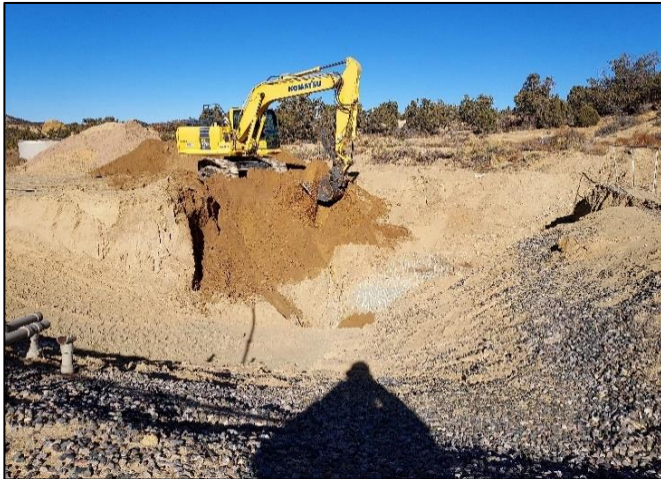
Photograph: 3  
Description: Excavation activities  
View: North

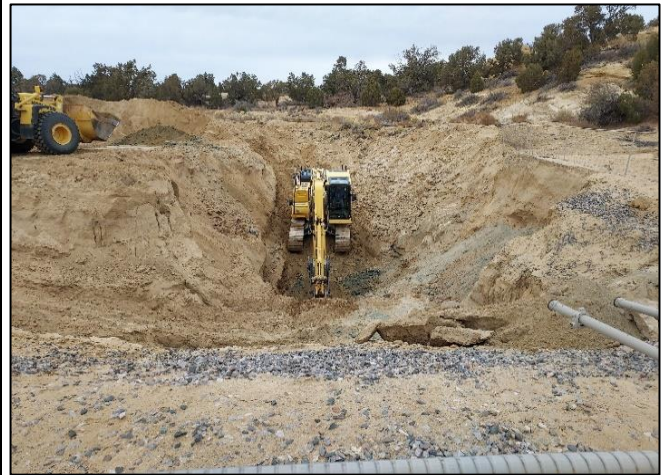
Photograph: 4  
Description: Final Excavation Extent  
View: North

The excavation was completed to depths ranging between 10 and 20 feet bgs to the lateral extent shown in Figure 2. Based on the area of the floor and sidewalls, four floor samples and eight sidewall samples were collected as presented on Figure 2. In total, approximately 832 cubic yards of soil were removed from the excavation and transported for disposal at the Envirotech Landfarm in San Juan County, New Mexico.
