## Remediation Summary and Closure Request

**Frontier Field Services, LLC**

**Santo Nino 6"**

**NMOCD Incident # nAPP2223724372**

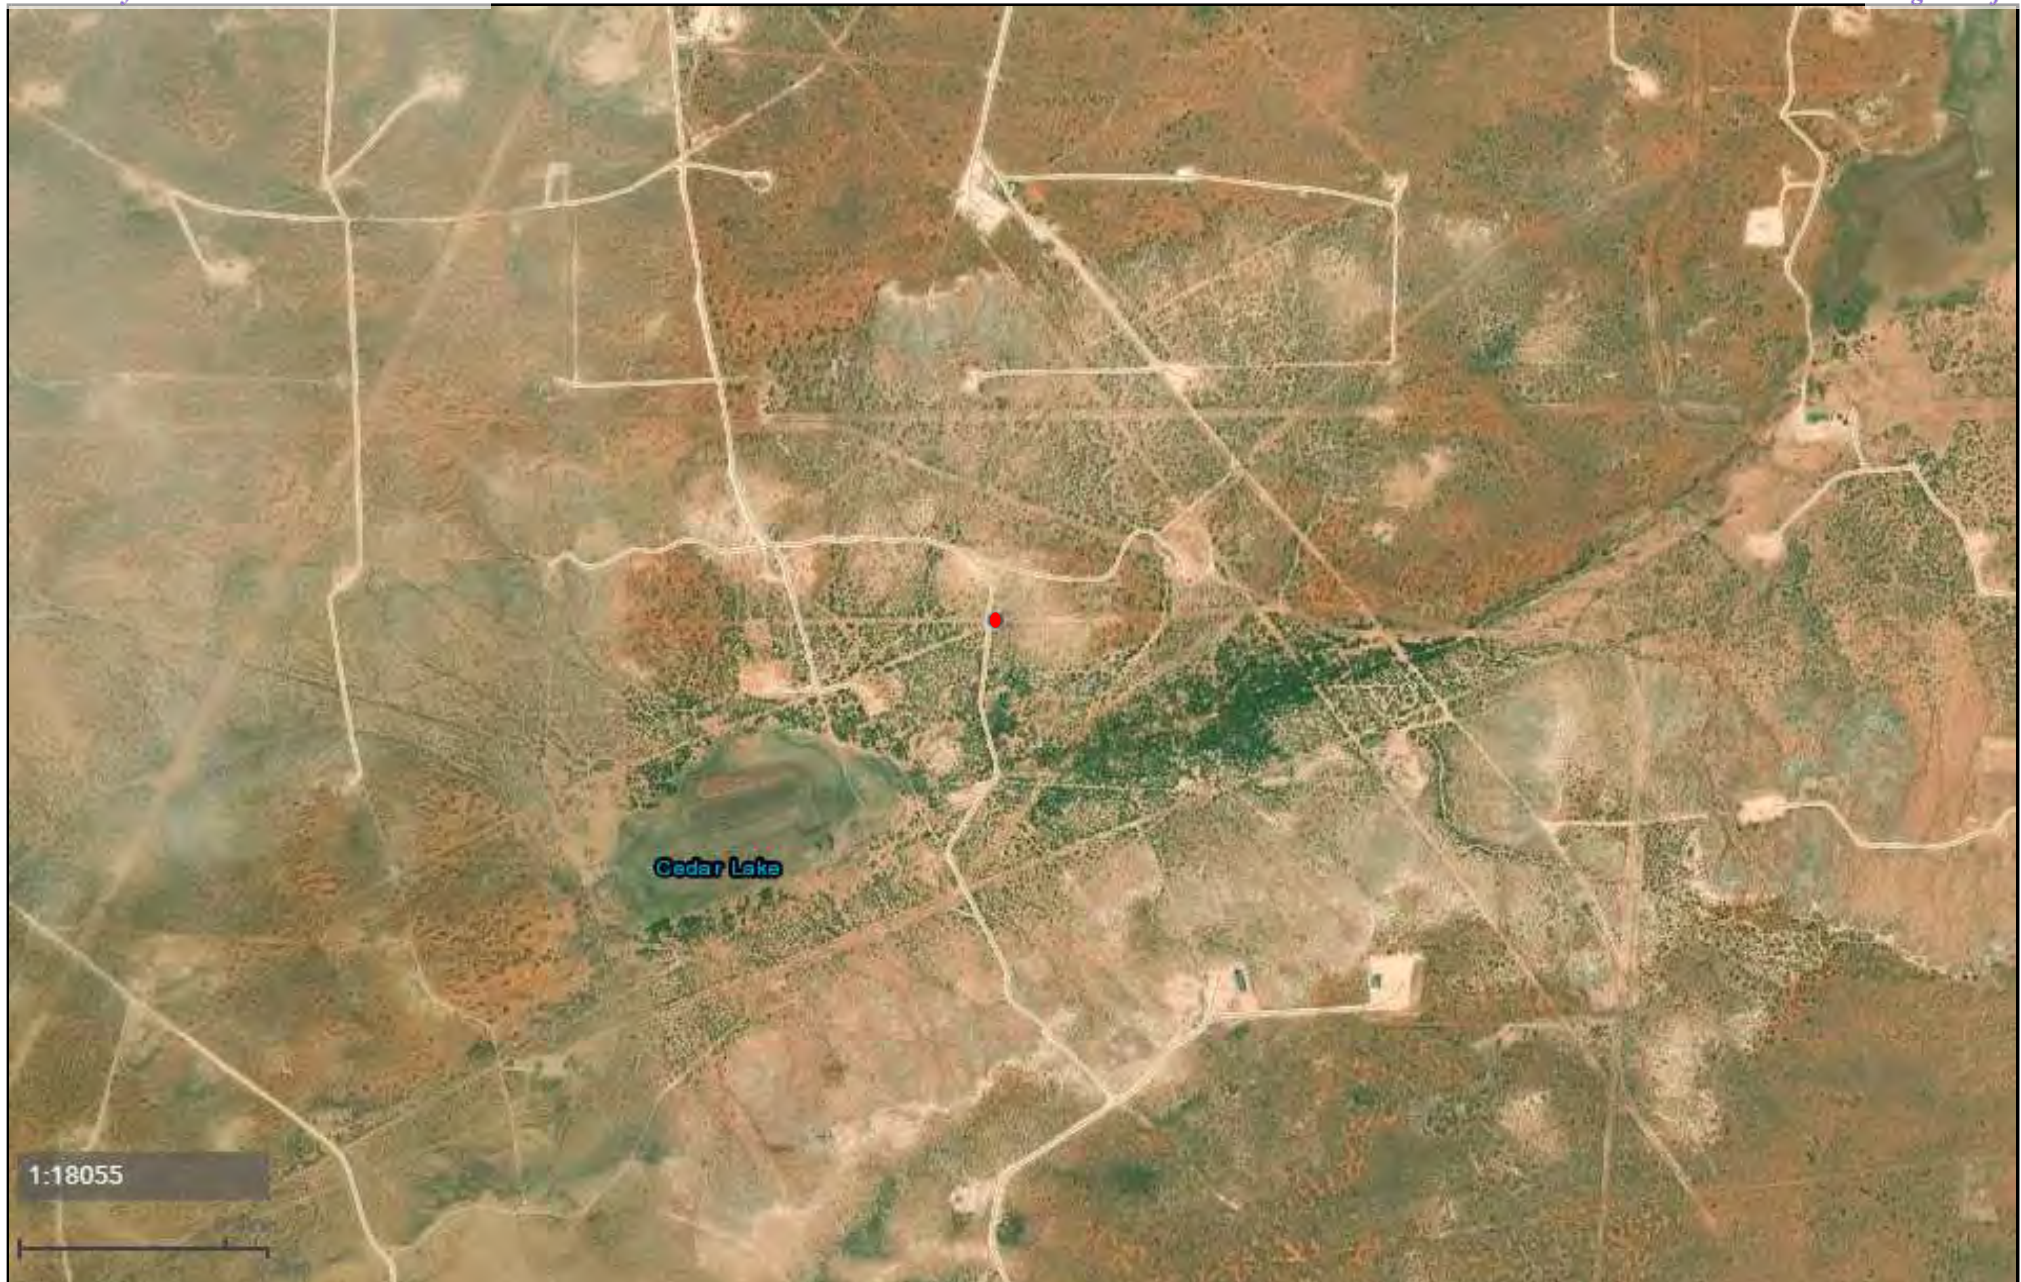
**Figure 2**

A search of the New Mexico Office of the State Engineer (NMOSE) and United States Geological Survey (USGS) groundwater databases was completed in an effort to determine the horizontal distance to known water sources within a half mile radius of the Release Site. Approximate depth to groundwater was determined using maintained and published water well data. Karst mapping indicates the site is not located in a Karst designated area. Karst and Wetland Maps are provided as Attachment I. Depth to groundwater information is provided as Attachment IV and the results are depicted on Figures 2 & 3.

OSE POD Locations Map  
Frontier Field Services, LLC  
6" Santo Nino  
GPS: 32.802947, -103.931421  
Eddy County

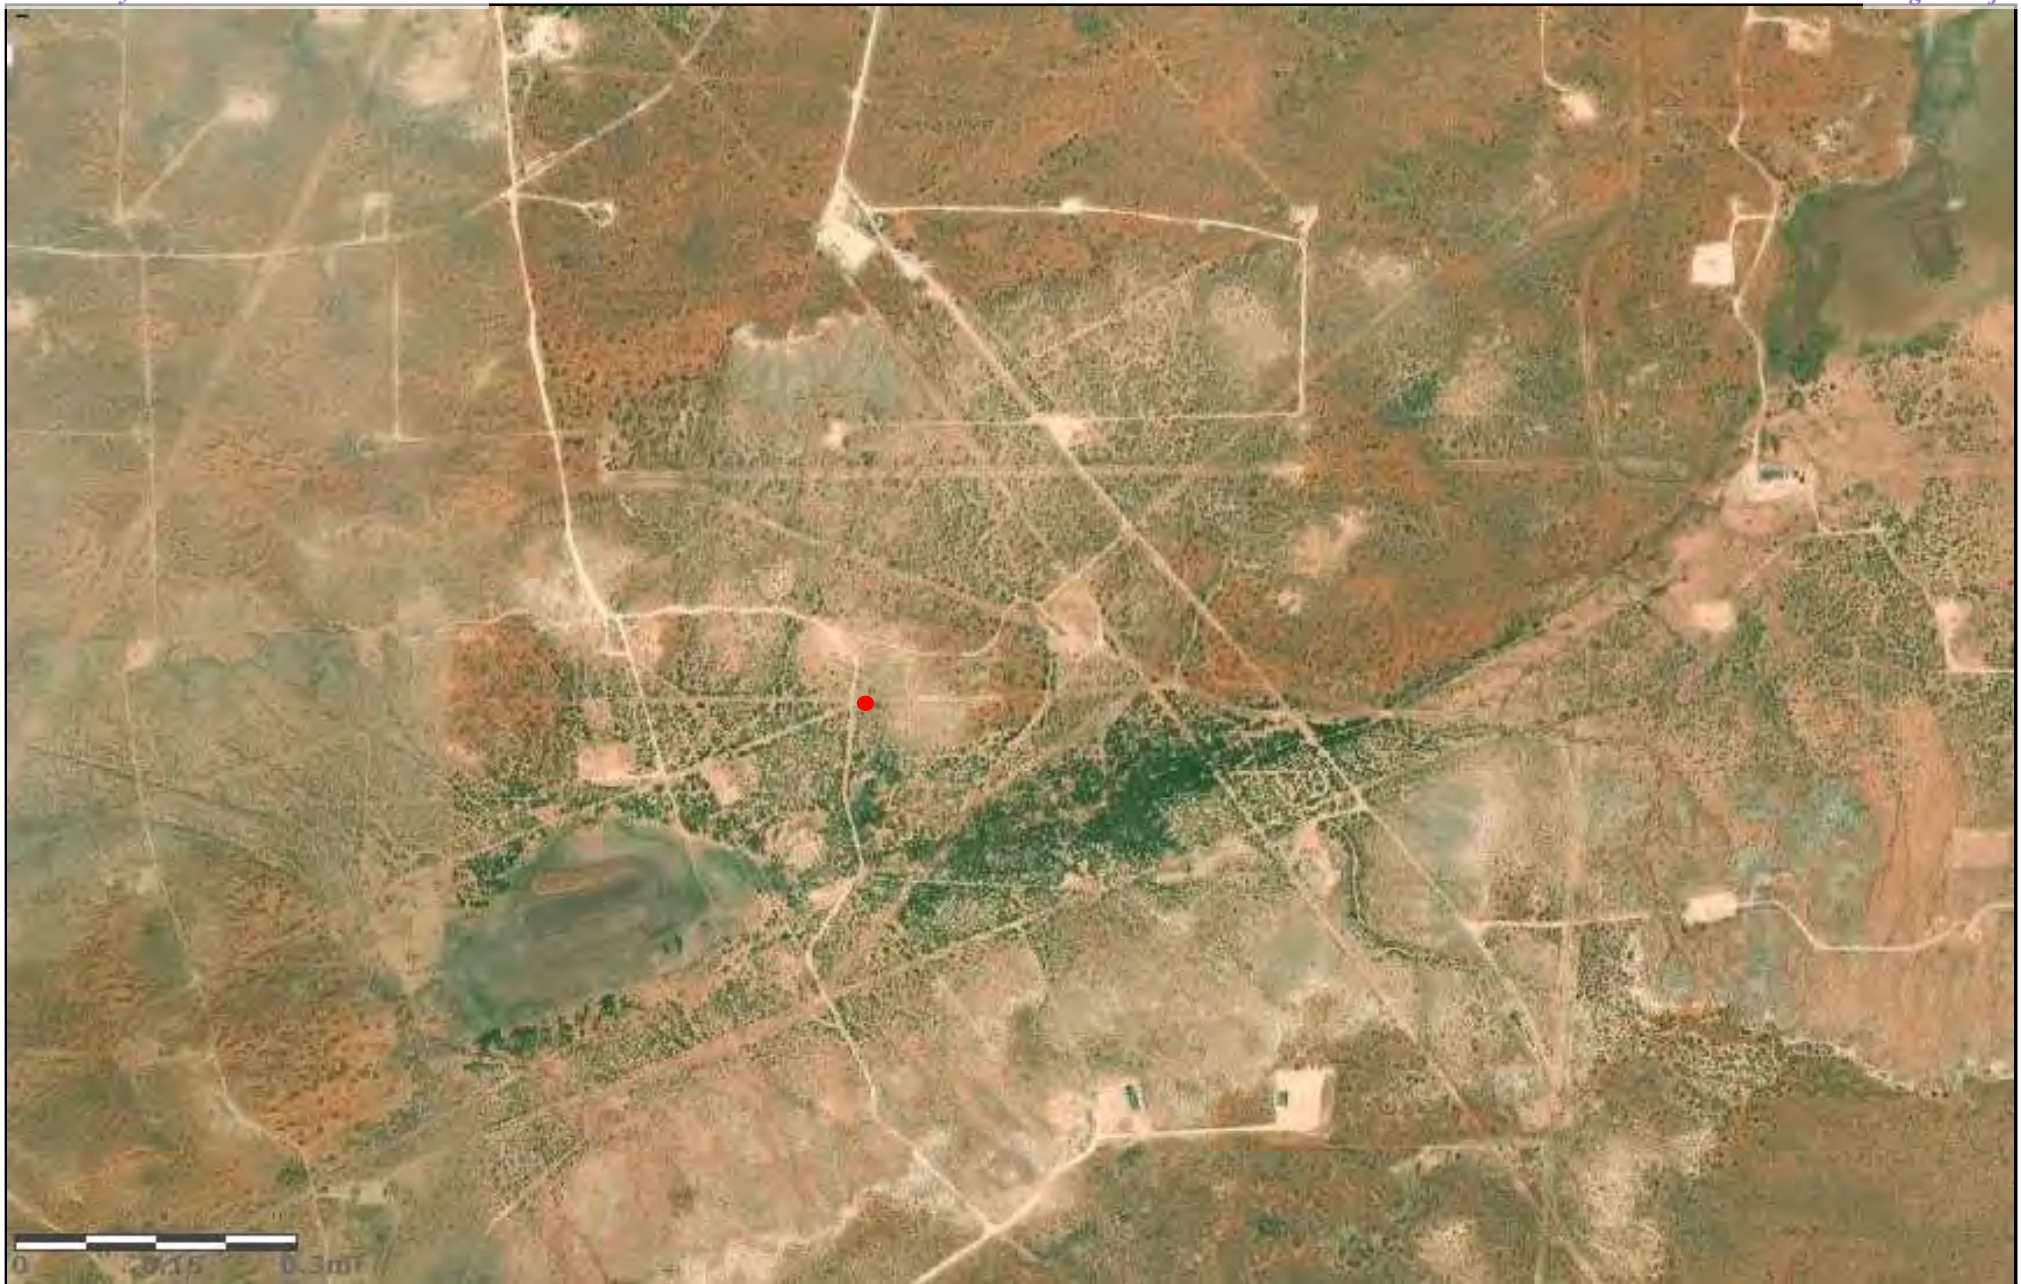
**Figure 3**

USGS Well Locations Map  
Frontier Field Services, LLC  
6" Santo Nino  
GPS: 32.802947, -103.931421  
Eddy County

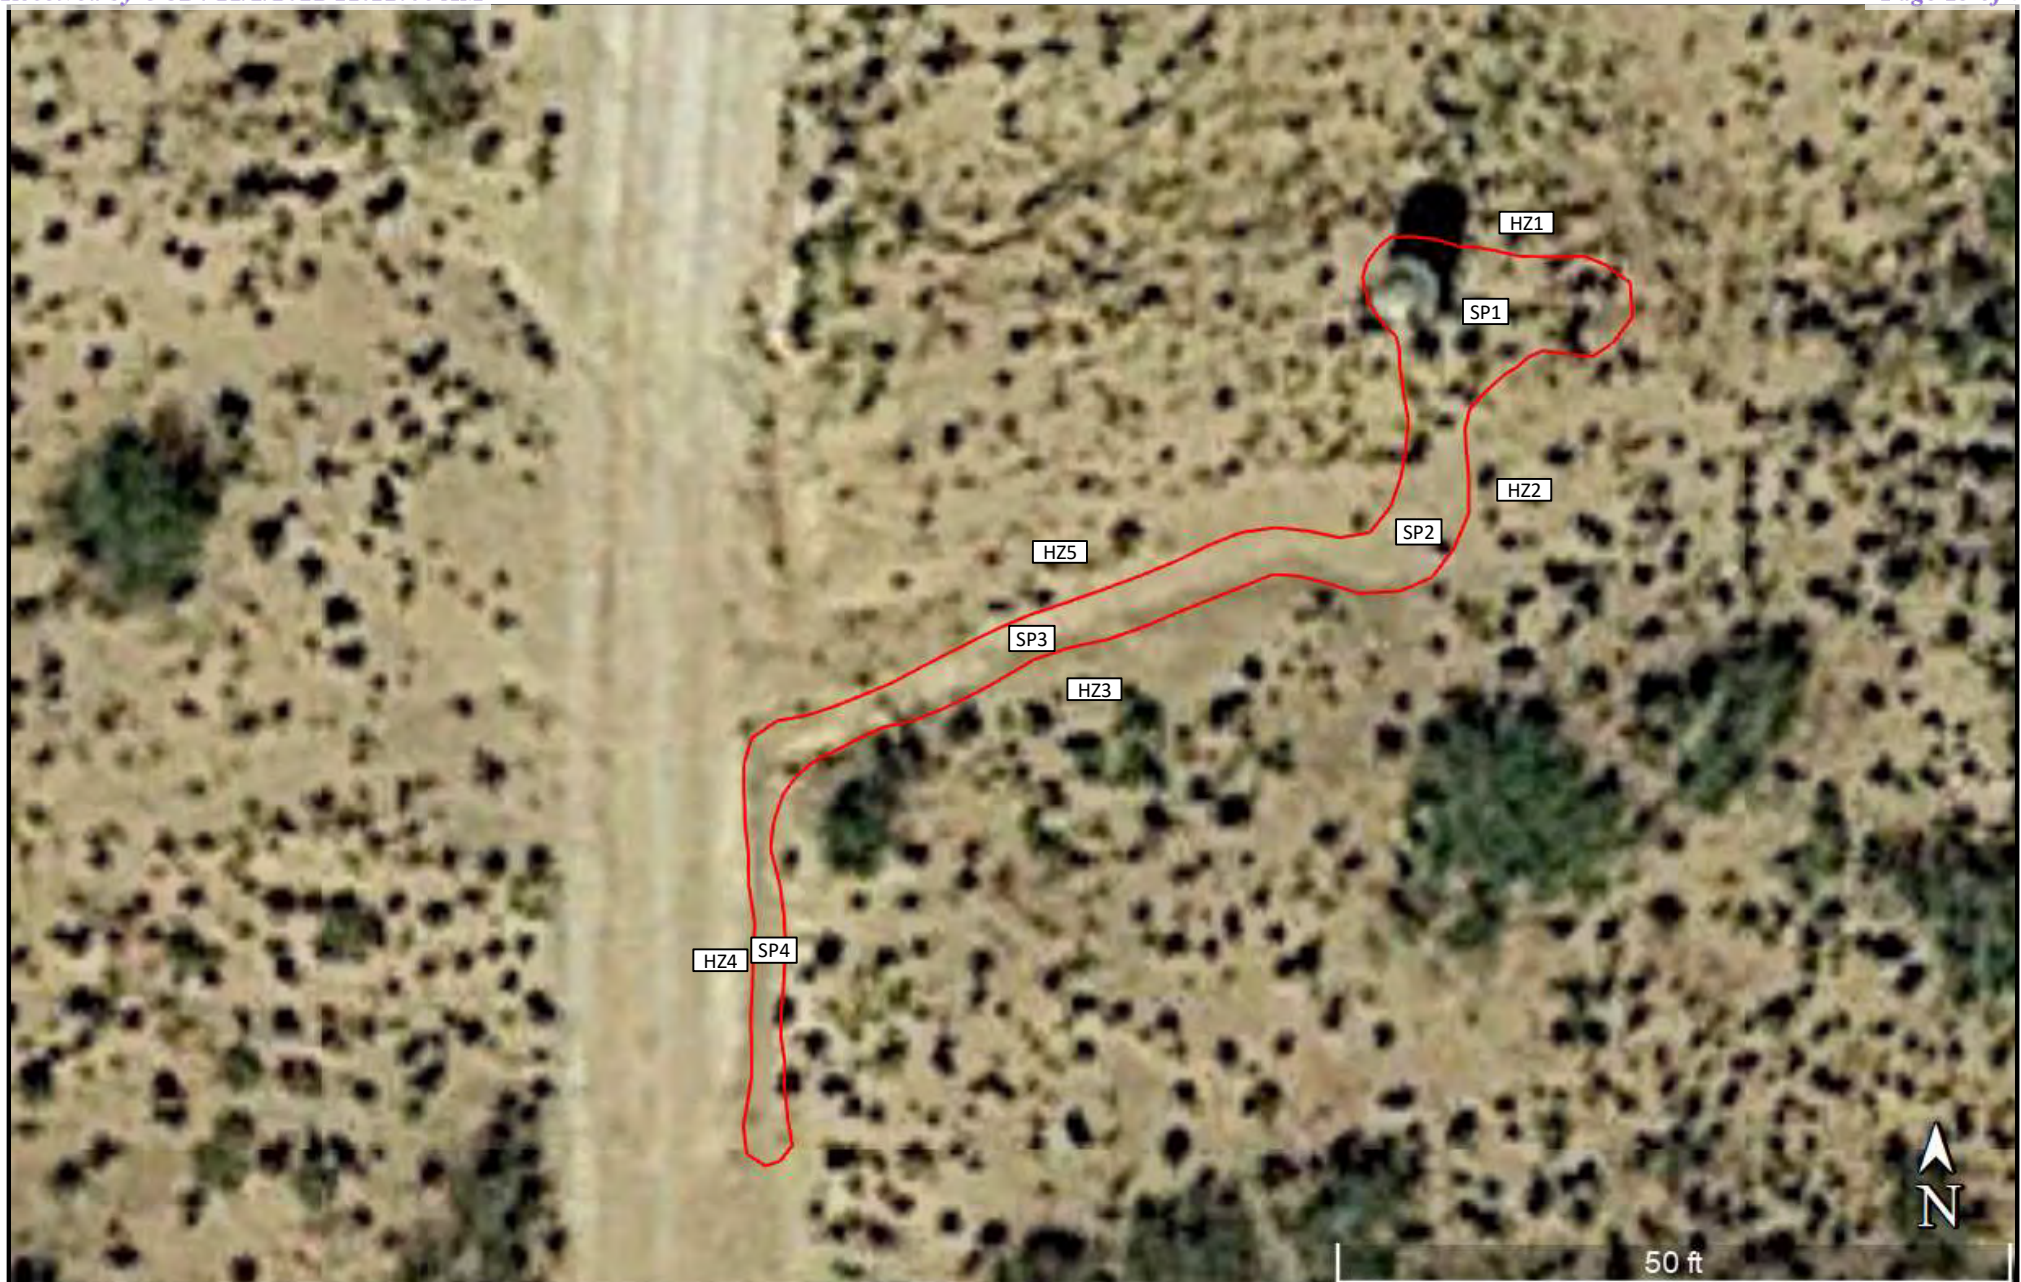
**Figure 4**

Based on field observations and field test data noted above and provided in Attachment V, eighteen representative soil samples, two from each sample location, were selected for laboratory analysis. Delineation soil samples SP1 through SP4, HZ1 through HZ5, were submitted to the laboratory for analysis of BTEX, TPH, and chloride. Laboratory analytical results indicated contaminant concentrations were below the NMOCD Closure Criteria in each of the submitted samples, with the exception of SP1 through SP4 at Surface, and SP3 at three feet bgs, which exhibited TPH and/or chloride concentrations in excess of the NMOCD Closure Criteria.

Delineation Sample Map  
Frontier Field Services, LLC  
6" Santo Nino  
GPS: 32.802947, -103.931421  
Eddy County

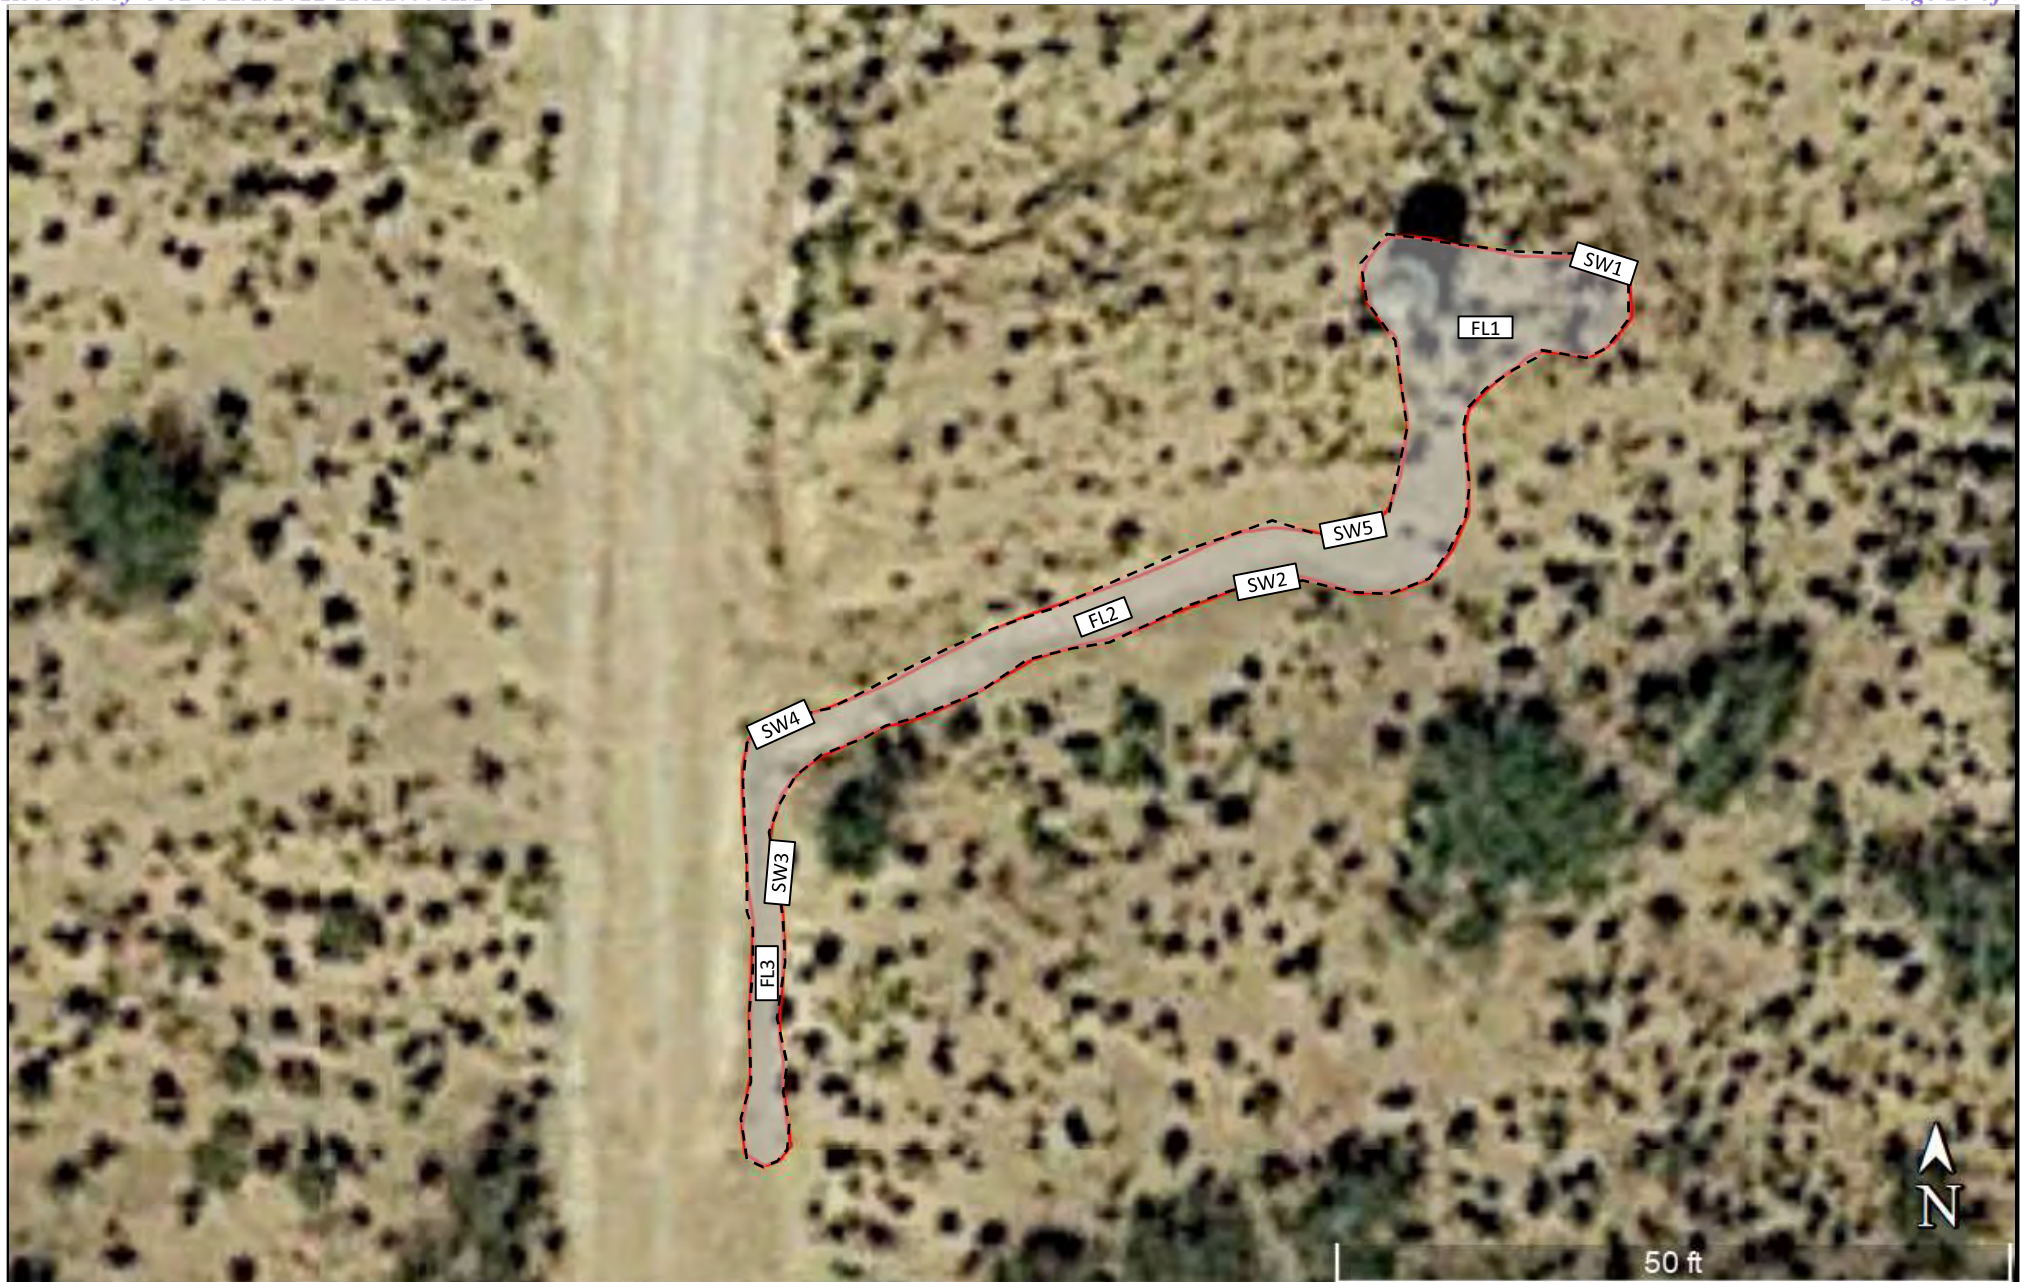
**Figure 5**

Excavation Sample Map  
Frontier Field Services, LLC  
6" Santo Nino  
GPS: 32.802947, -103.931421  
Eddy County
