**Re: Site Assessment and Closure Report  
W Shugart 19 Fed #2  
API No. 30-015-30780  
GPS: Latitude 32.722393 Longitude -103.829475  
UL "C", Sec. 19, T18S, R31E  
Eddy County, NM  
NMOCD Ref. No. NJMW1327756448 (2RP-1971)**

Pima Environmental Services, LLC (Pima) has been contracted by Devon Energy Production Company (Devon) to perform a spill assessment and has prepared this Closure Report for a produced water release that occurred at the W Shugart 19 Fed #2 (W Shugart). The initial C-141 was submitted on September 29<sup>th</sup>, 2013 (Appendix C). This incident was assigned 2RP-1971, Incident ID NJMW1327756448, by the New Mexico Oil Conservation Division (NMOCD).

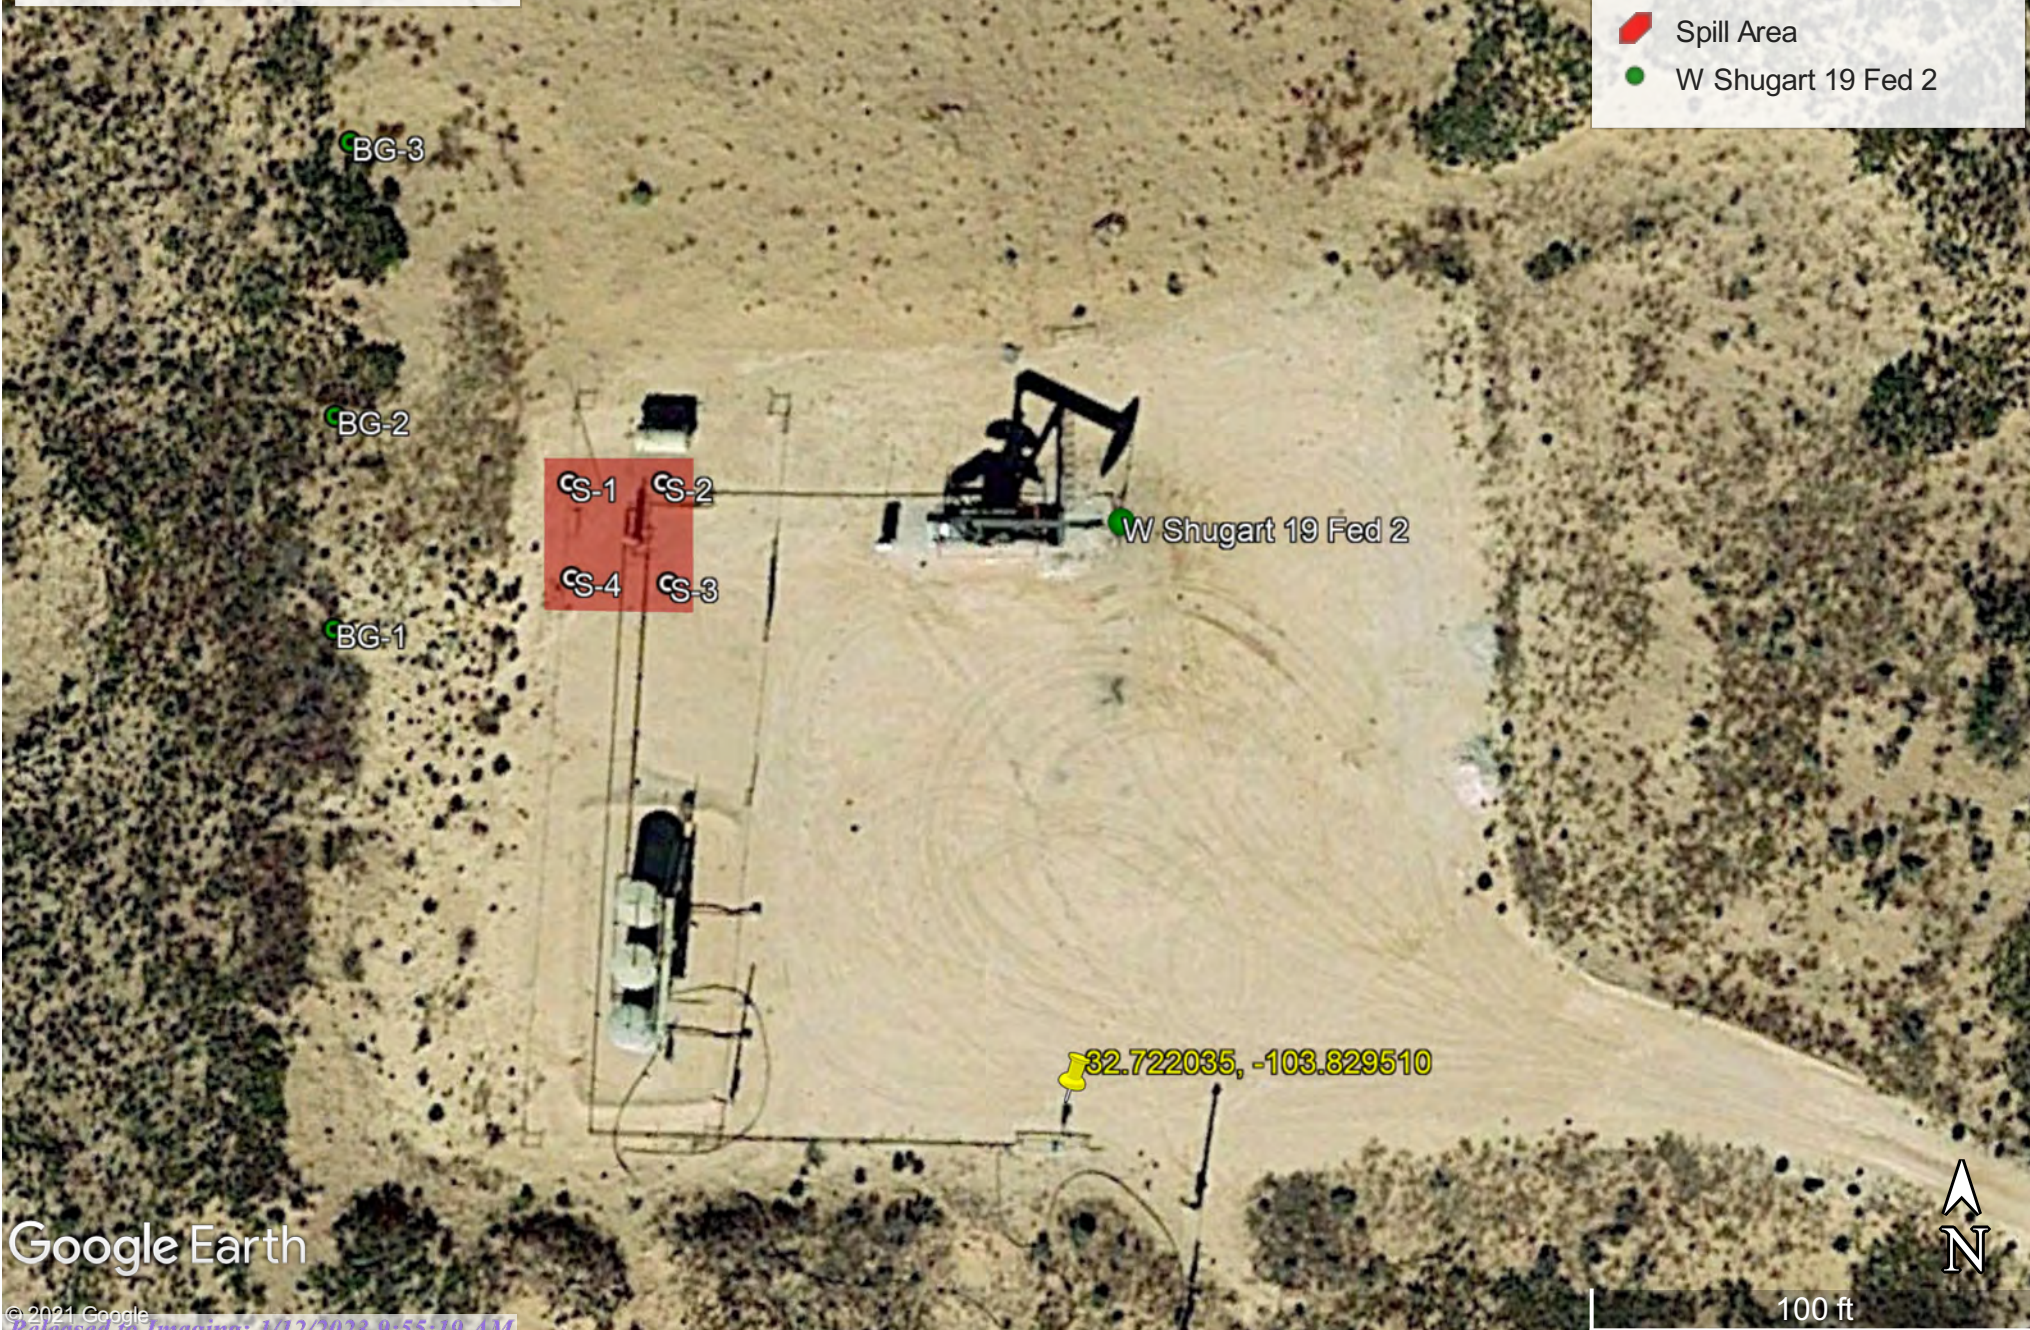
4-Site Map

On February 1<sup>st</sup>, 2021 Pima Environmental conducted a site assessment and obtained soil samples. The laboratory results of this sampling event can be found in the following data table.

API#30-015-30780  
Eddy County, NM  
Site Map

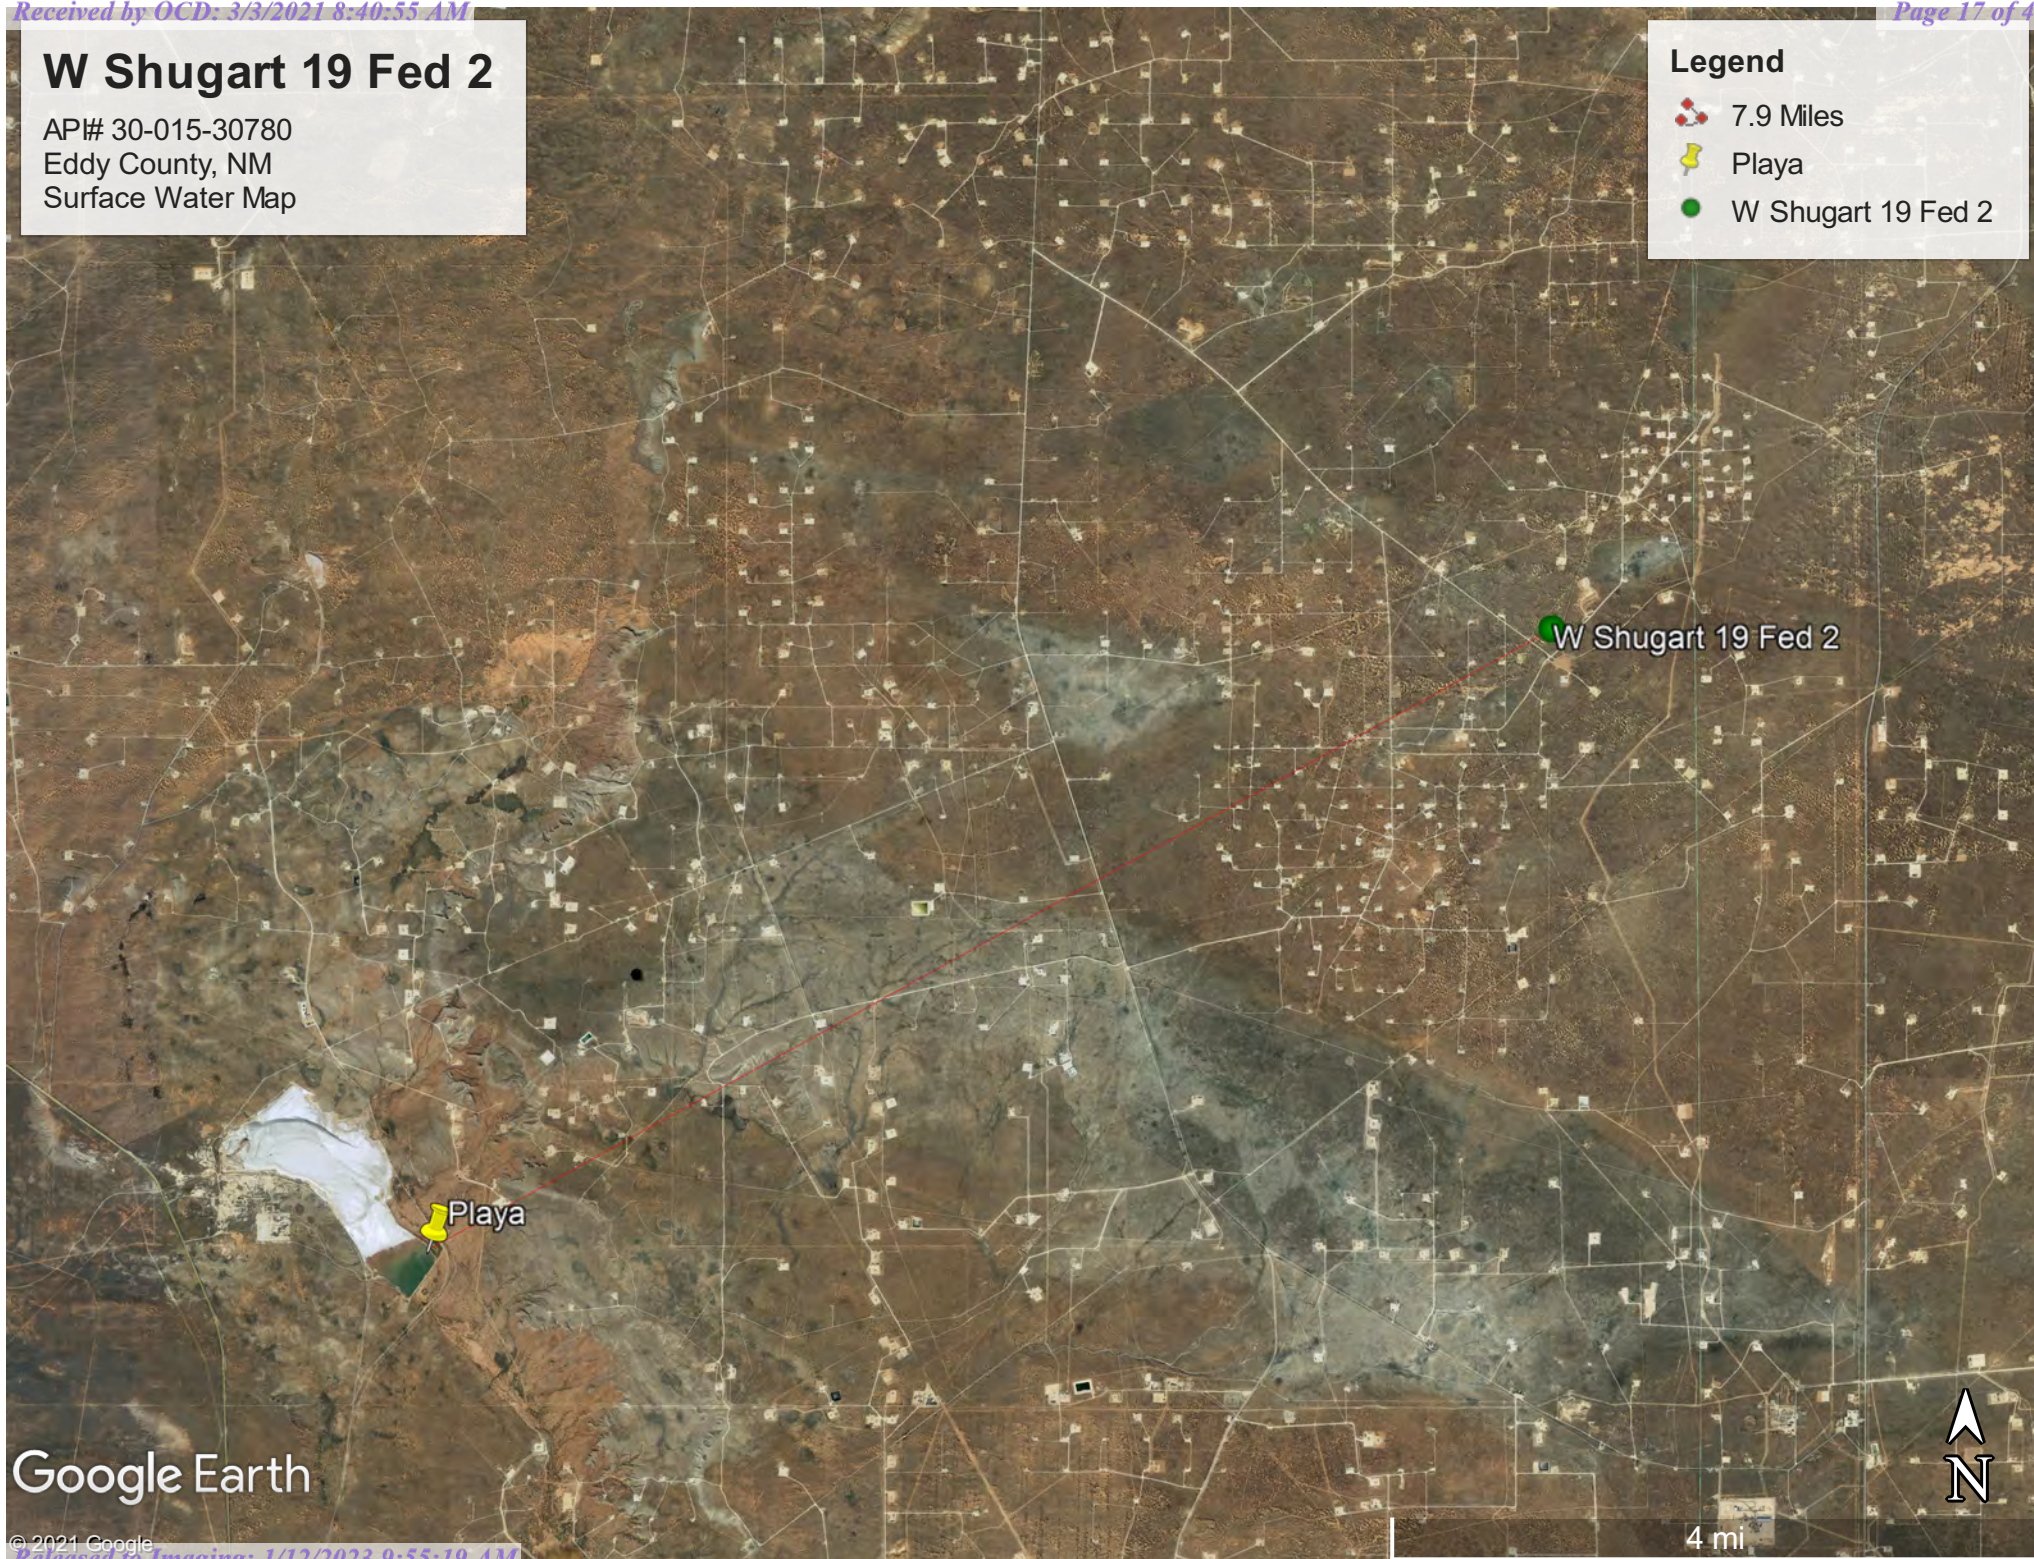
According to the New Mexico Office of the State Engineer, depth to the nearest groundwater in this area is 430 feet below grade surface (BGS). According to the United States Geological Survey (USGS), the nearest groundwater is greater than 250 feet BGS. The closest waterway is a playa located approximately 7.9 miles to the southwest of this location. See Appendix A for referenced Surface Water Map.

AP# 30-015-30780  
Eddy County, NM  
Surface Water Map
