Re: Site Remediation and Closure Report
Cowpens 28 Fed Com #1
API No. 30-015-36560
GPS: Latitude 32.628799 Longitude -103.871516
Unit J, Section 28, Township 19S, Range 31E
Eddy County, NM
NMOCD Ref. No. NKMW1105941469 (2RP-615)

Pima Environmental Services, LLC (Pima) has been contracted by Devon Energy Production Company (Devon) to perform a spill assessment and remediation activities for a produced water spill that occurred at the Cowpens 28 Fed Com #1 (Cowpens). The initial C-141 was submitted on February 11, 2011 (Appendix C). This incident was assigned 2RP-615, Incident ID NKMW1105941469 by the New Mexico Oil Conservation Division (NMOCD).

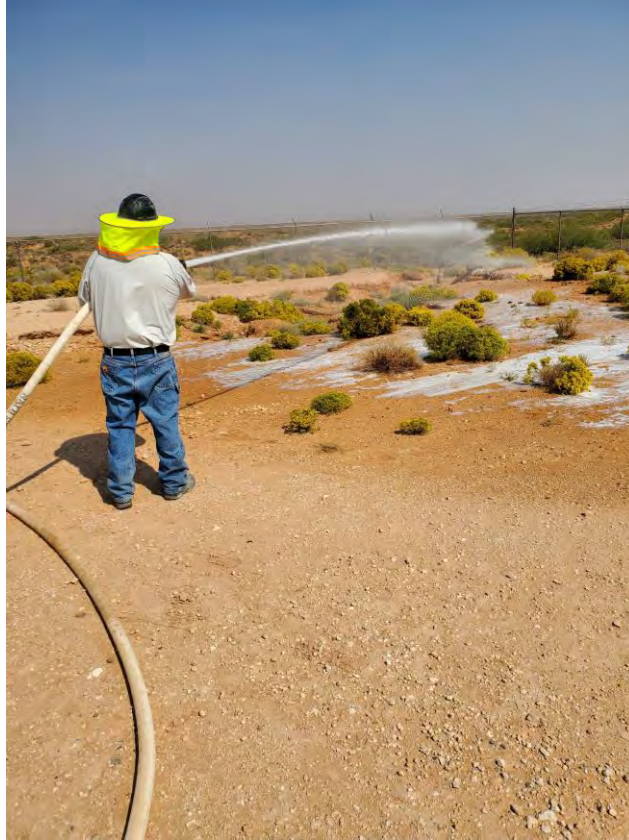
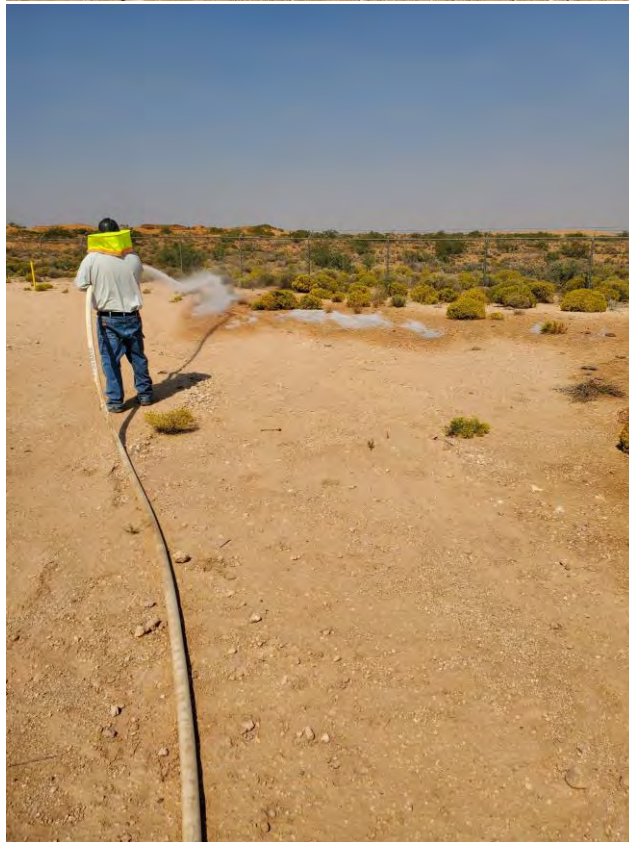
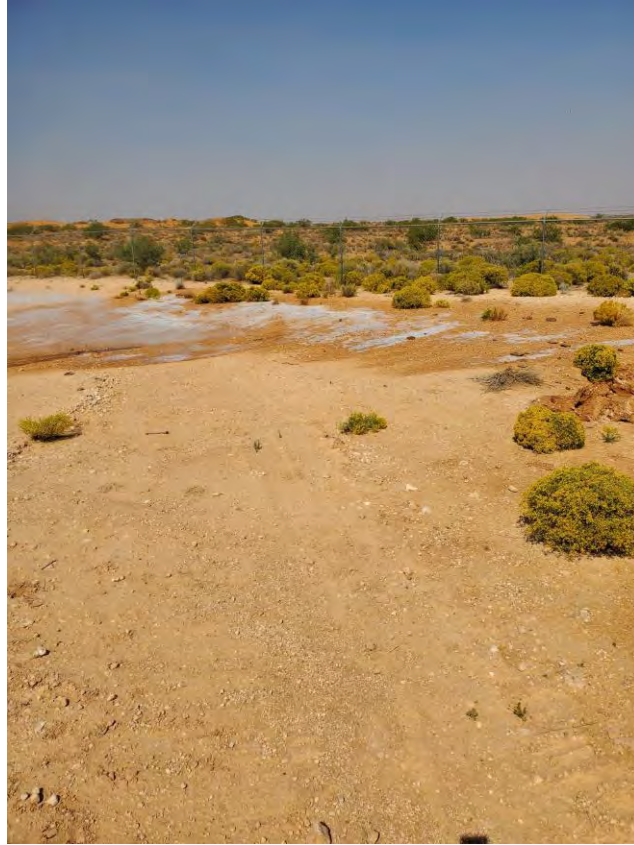
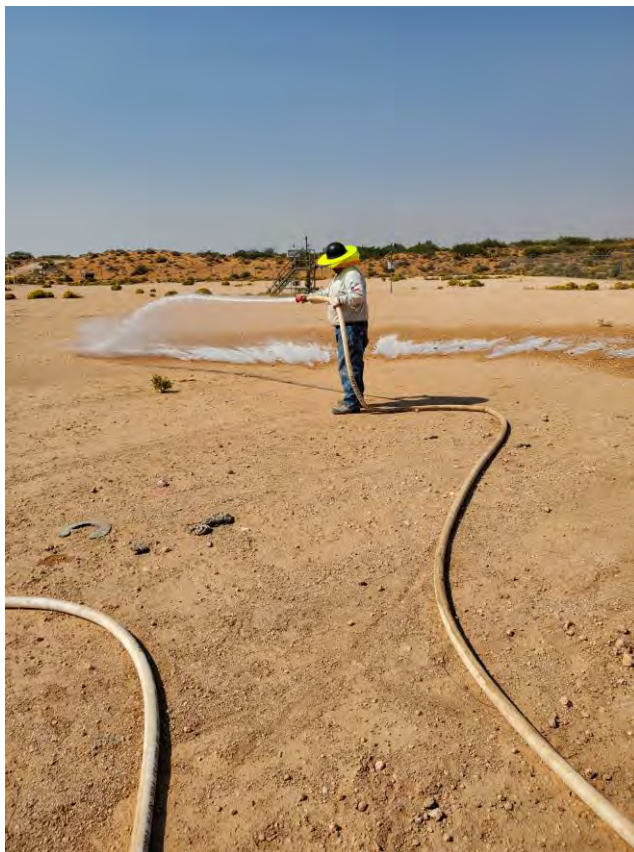
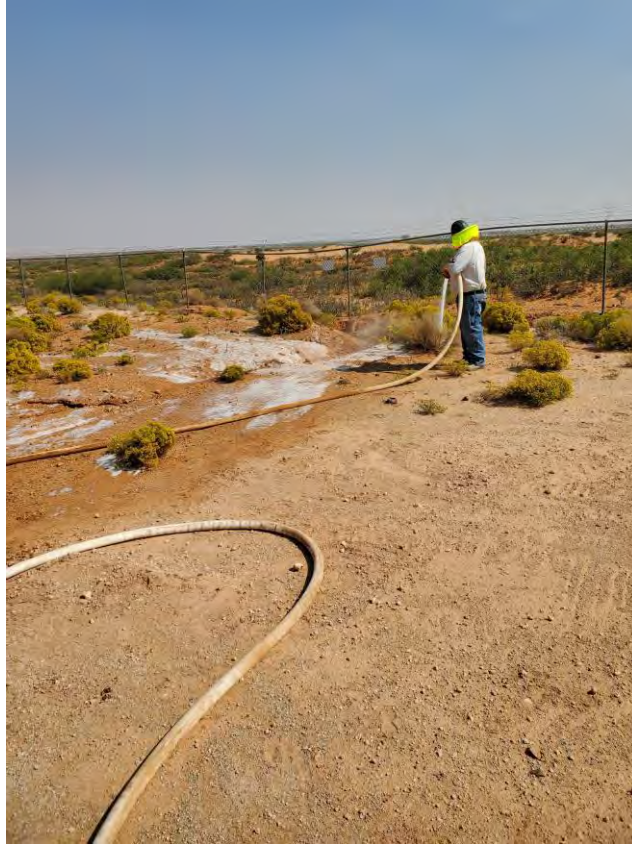
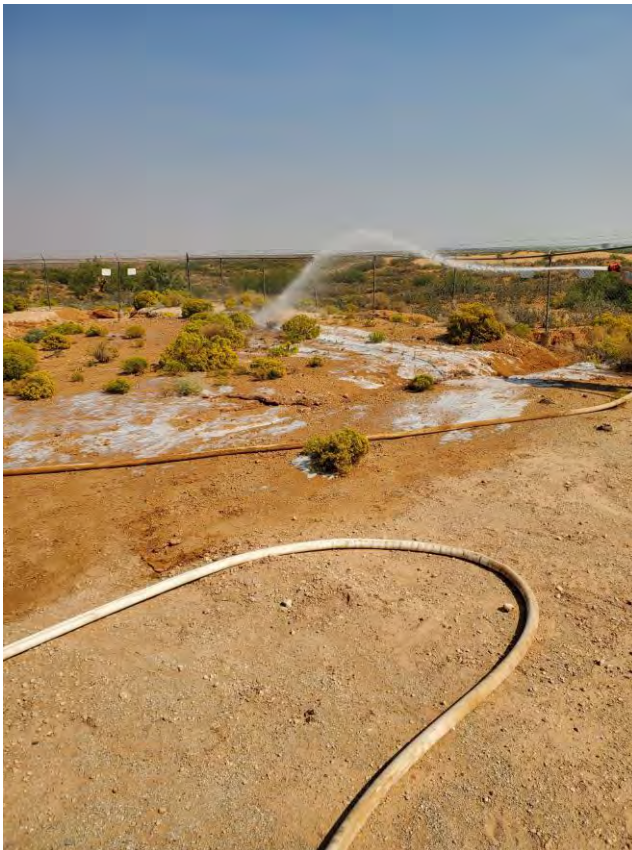
Photographic Documentation

See Appendix D for photographic documentation.

On October 7th, 2020, Pima mobilized personnel and equipment to conduct remedial activities. In the vicinity of BG-E2, we treated the area with a MicroBlaze solution. After 60 days, we returned to the site to assess and collect a confirmation sample of the treated area. The laboratory results of this sampling event can be found in the following data table.
