## **Delineation Summary and Closure Request**

**Frontier Field Services, LLC**

**Sherrell 4" Steel Pipeline**

**NMOCD Incident # nAPP2223829555**

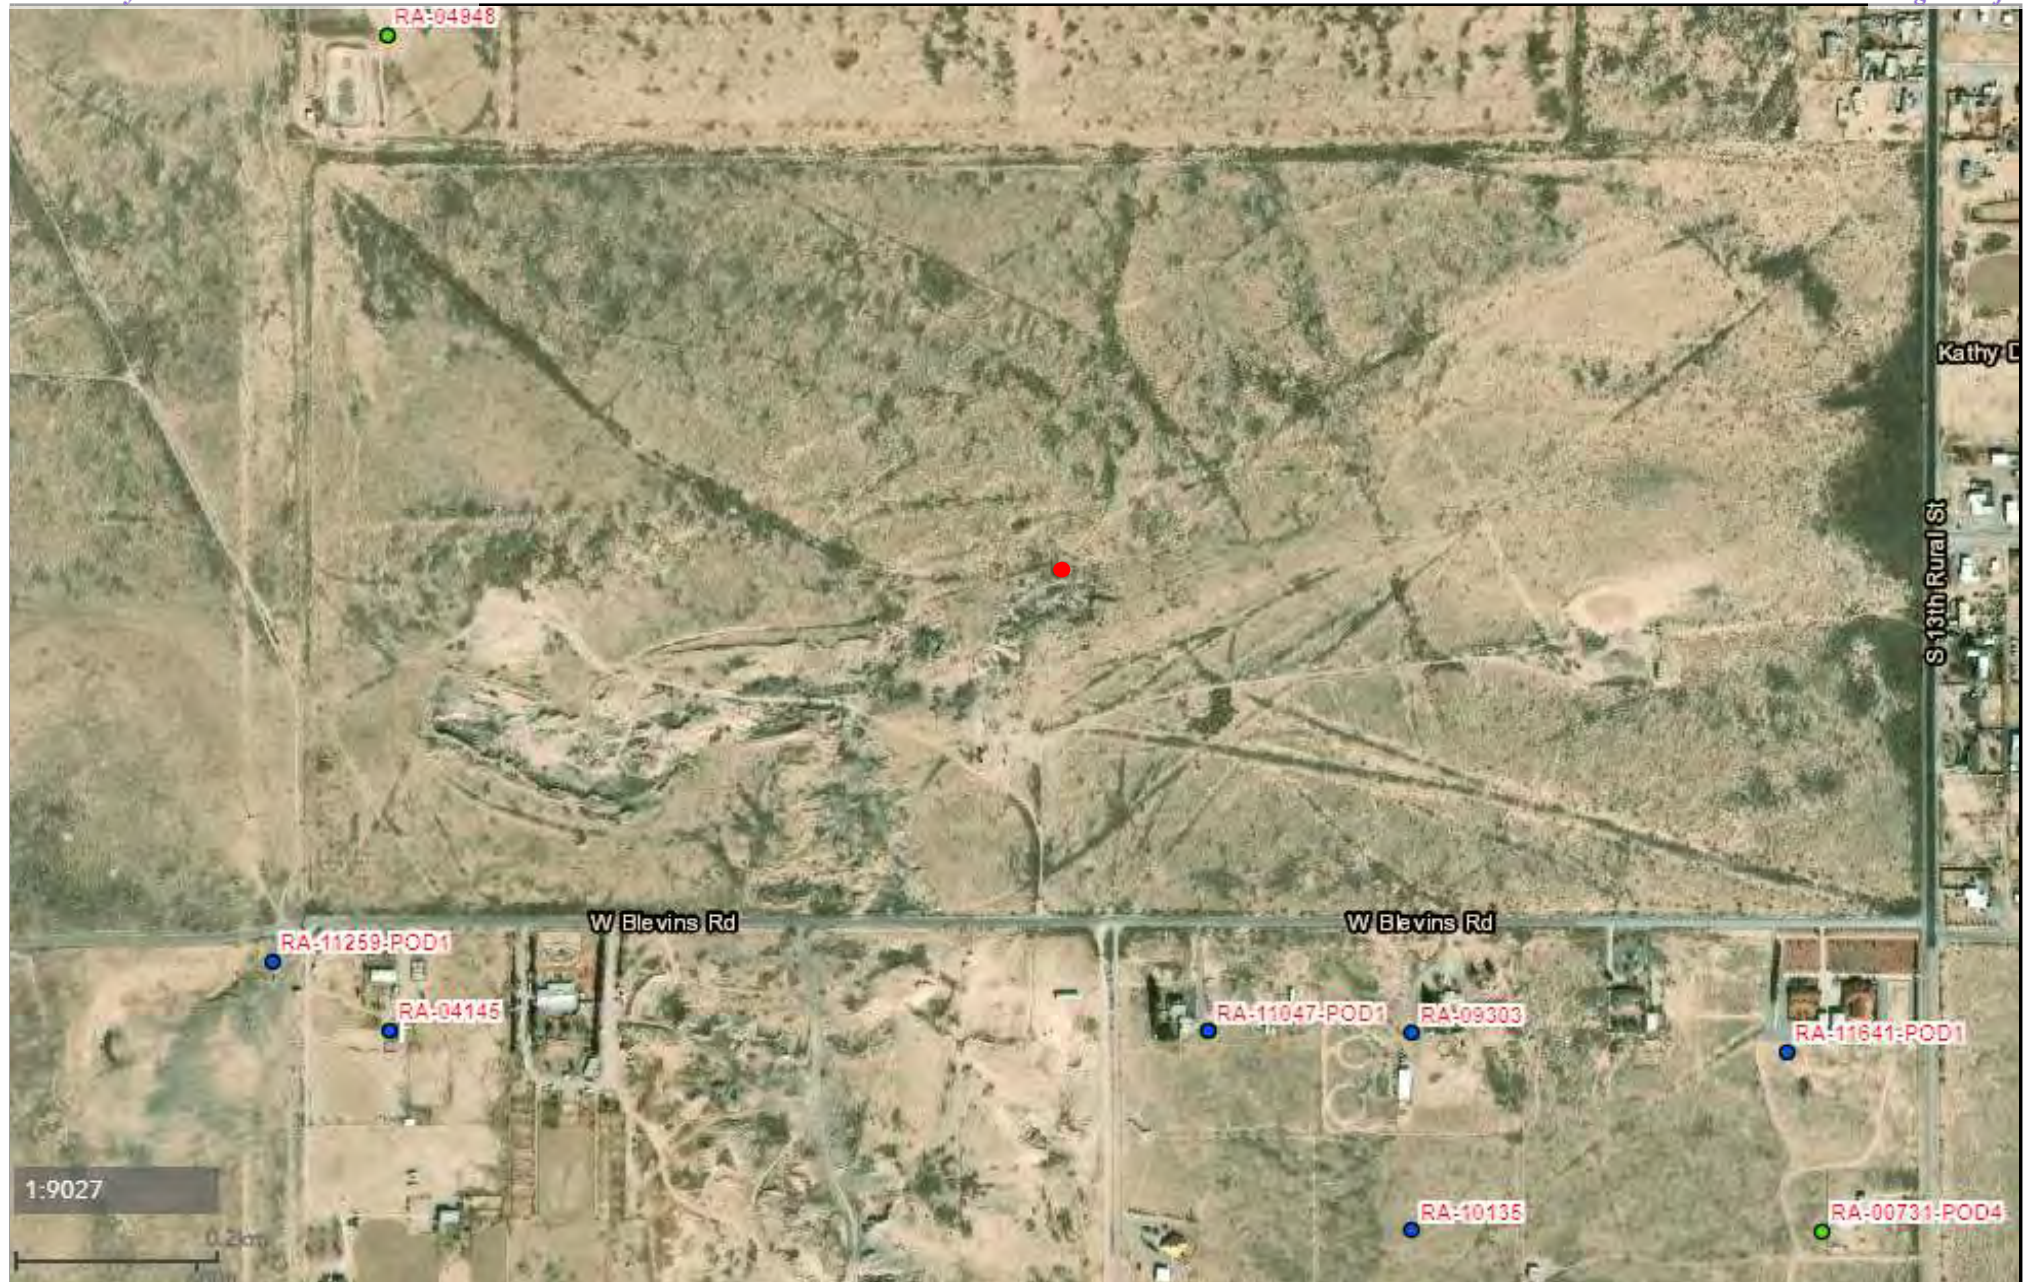
**Figure 2**

OSE POD Locations Map  
 Frontier Field Services, LLC  
 Sherrell 4"  
 GPS: 32.787732, -104.421794  
 Eddy County

A search of the New Mexico Office of the State Engineer (NMOSE) and United States Geological Survey (USGS) groundwater databases was completed in an effort to determine the horizontal distance to known water sources within a half mile radius of the Release Site. Approximate depth to groundwater was determined using maintained and published water well data. Karst mapping indicates the site is not located in a Karst designated area. Karst and Wetland Maps are provided as Attachment I. Depth to groundwater information is provided as Attachment IV and the results are depicted on Figures 2 & 3.

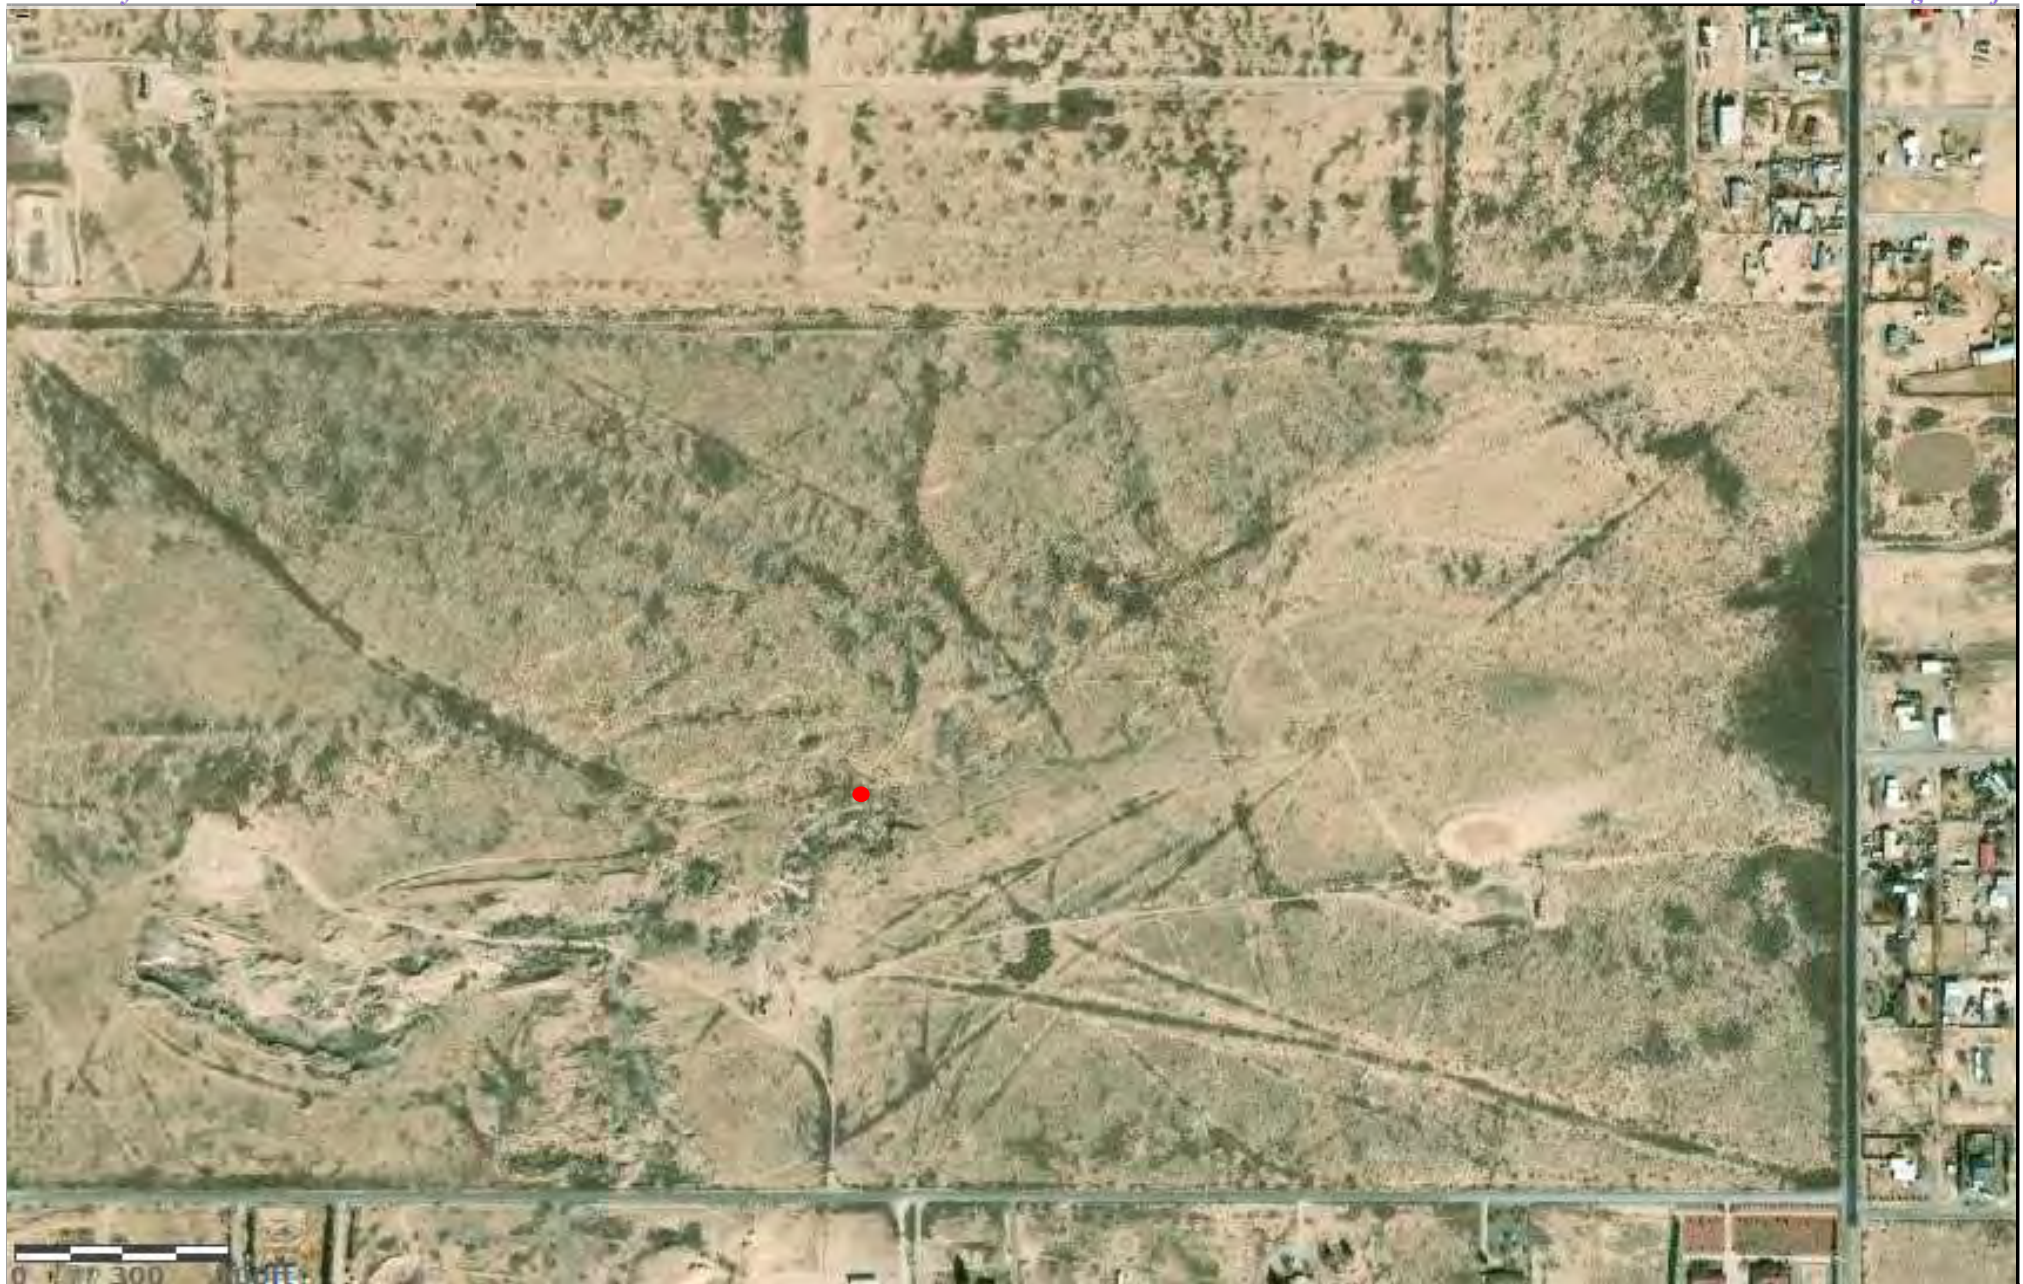
**Figure 3**

USGS Well Locations Map  
Frontier Field Services, LLC  
Sherrell 4"  
GPS: 32.787732, -104.421794  
Eddy County

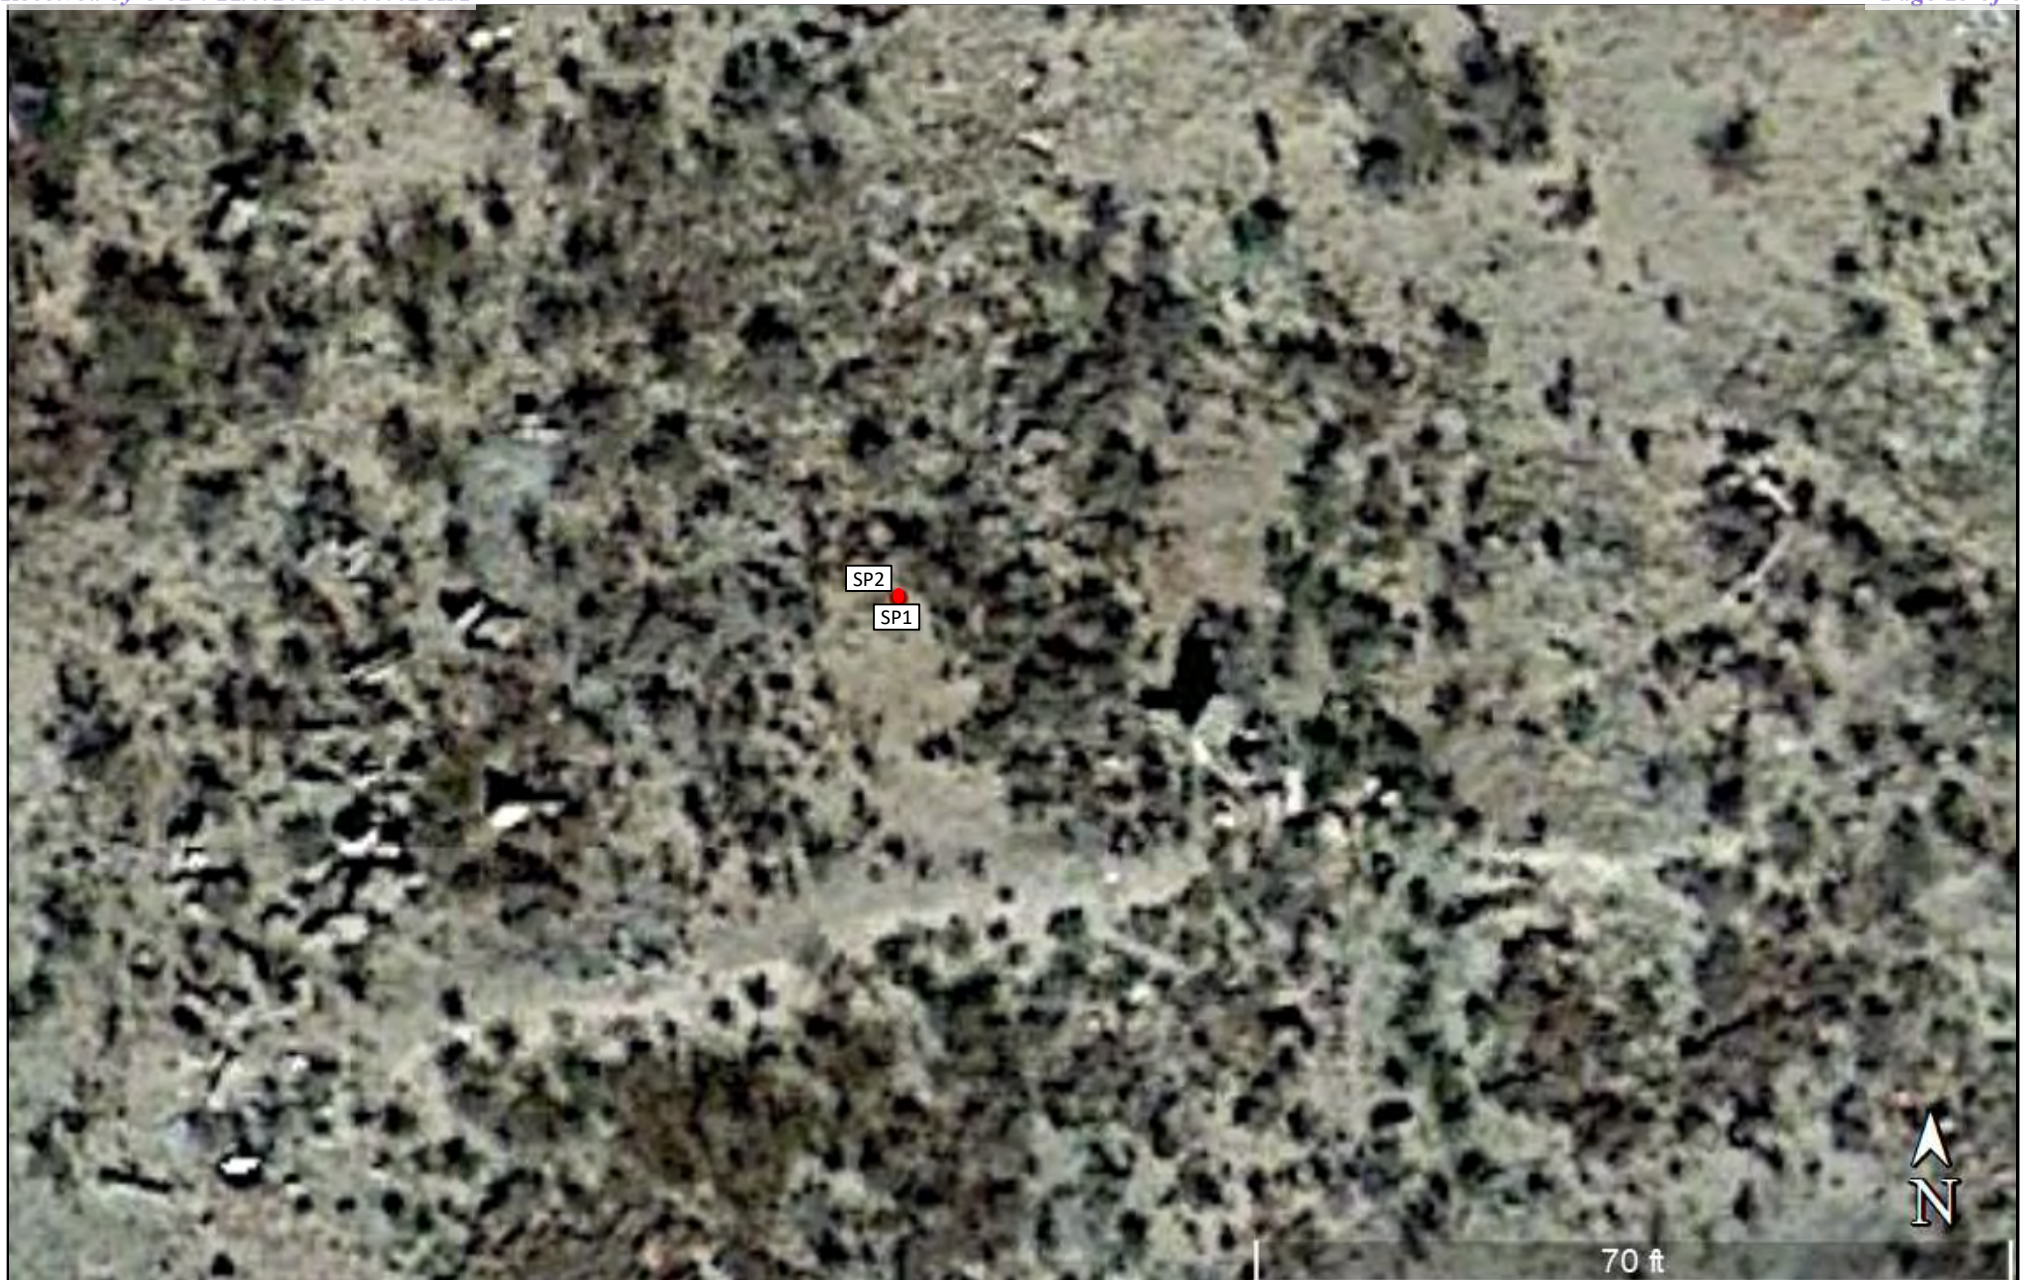
**Figure 4**

Delineation Sample Map  
Frontier Field Services, LLC  
Sherrell 4"  
GPS: 32.787732, -104.421794  
Eddy County

- Sherrell 4" Location
- SP1 Delineation Sample Location

Based on field observations and field test data noted above and provided in Attachment V, two representative soil samples were selected for laboratory analysis. Delineation soil sample SP1 Surface and SP1 3', were submitted to the laboratory for analysis of BTEX, TPH, and chloride. Laboratory analytical results indicated contaminant concentrations were below the NMOCD Closure Criteria in each of the submitted samples.

On October 6, 2022, Hungry Horse personnel returned to the release location to collect additional samples from the initial sample location. Soil samples SP1 1', SP1 2', and SP1 4', were collected and submitted to the laboratory for analysis of BTEX, TPH, and chloride. Laboratory analytical results indicated contaminant concentrations were below the NMOCD Closure Criteria in each of the submitted samples.

On October 25, 2022, in an effort to more fully delineate the release area, Hungry Horse personnel returned to the release location to collect samples from a second sample location. Soil samples SP2 Surf through SP2 4', were collected and submitted to the laboratory for analysis of BTEX, TPH, and chloride. Laboratory analytical results indicated contaminant concentrations were below the NMOCD Closure Criteria in each of the submitted samples.
