Incident ID	nAPP2218929337
District RP	
Facility ID	
Application ID

Site Assessment/Characterization

Based on laboratory analytical results and field activities conducted to date, Etech recommends Mewbourne Oil Company provide copies of this *Remediation Summary & Soil Closure Request* to the appropriate agencies and request closure be granted to the Zircon 12-7 GF SWD Line release site.

Site Characterization Map

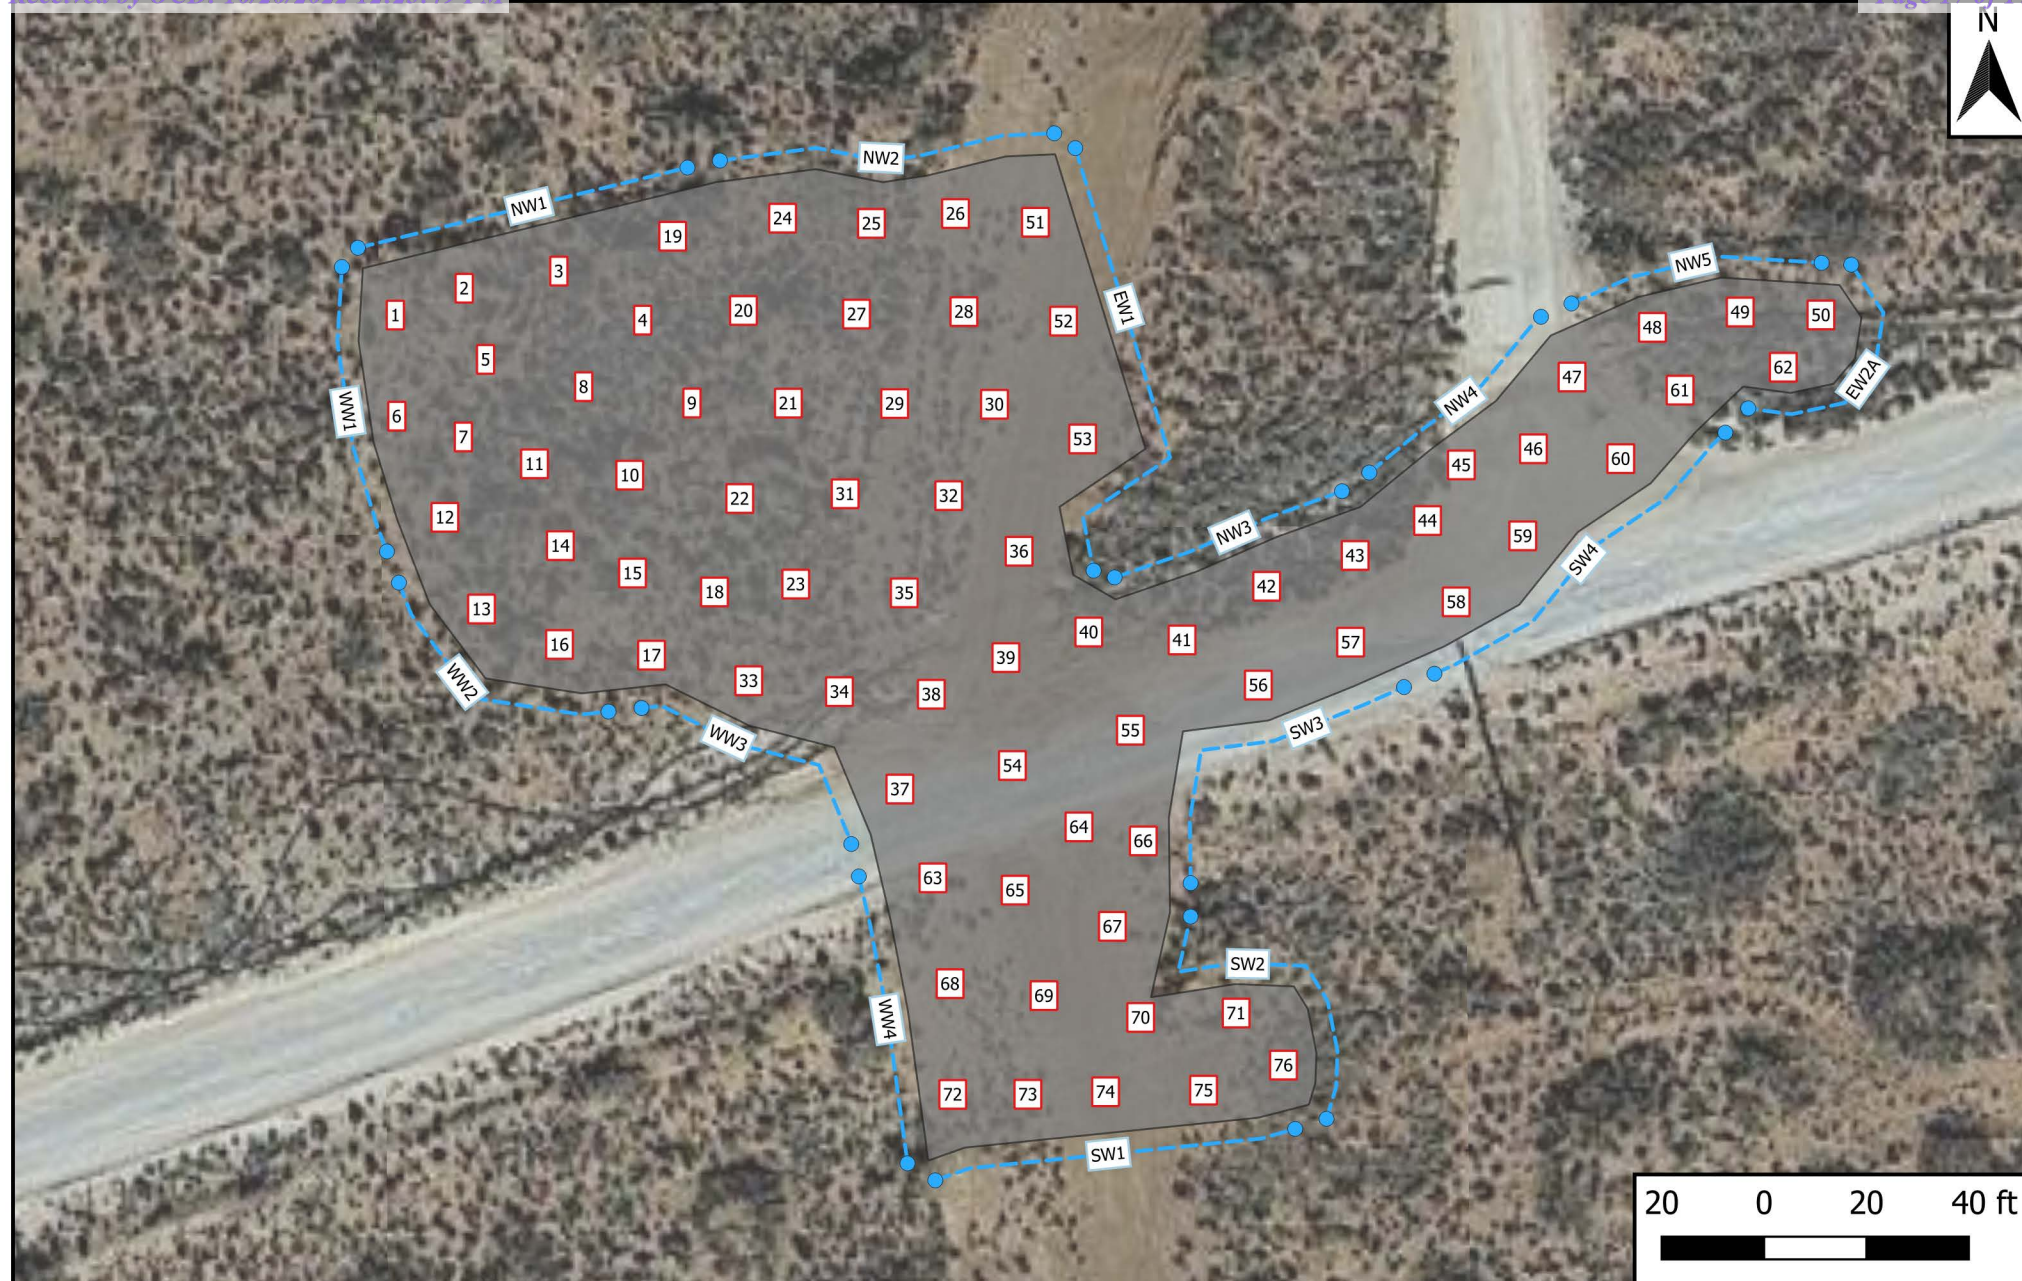
Figure 3

Site & Sample Location Map

- Excavation Extent
- Composite Floor Sample
- Composite Wall Sample

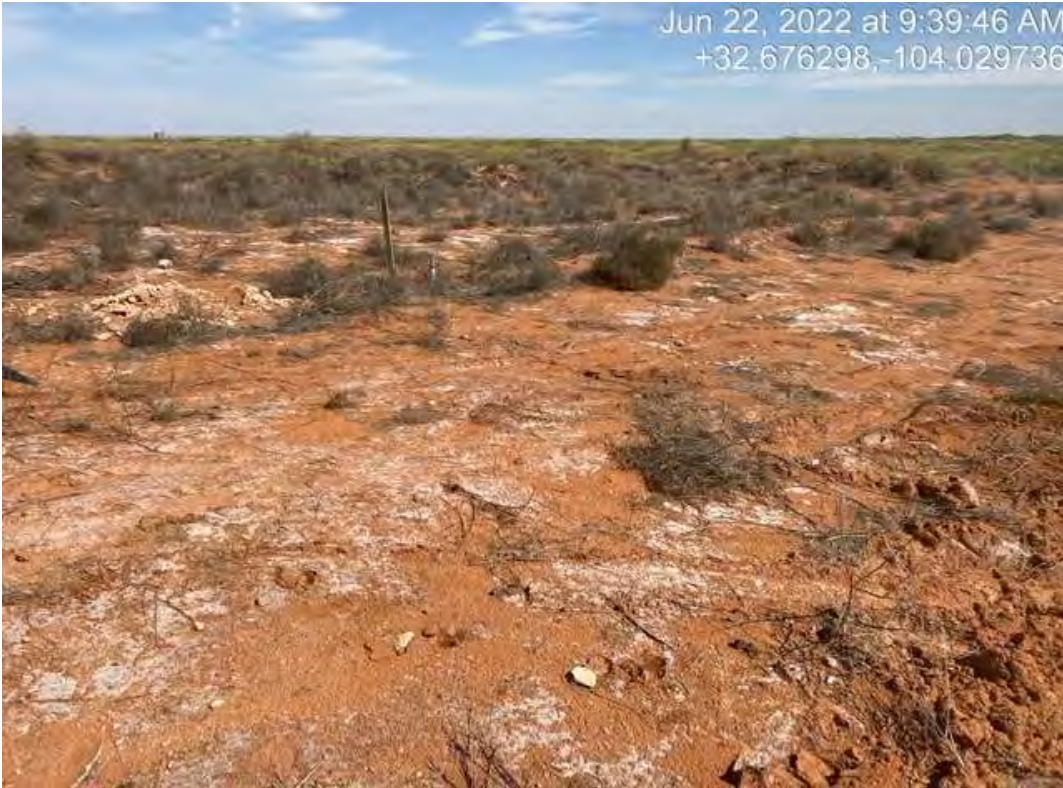
Photo Number: 1

Photo Direction: South-Southeast	
Photo Description: View of the affected area.

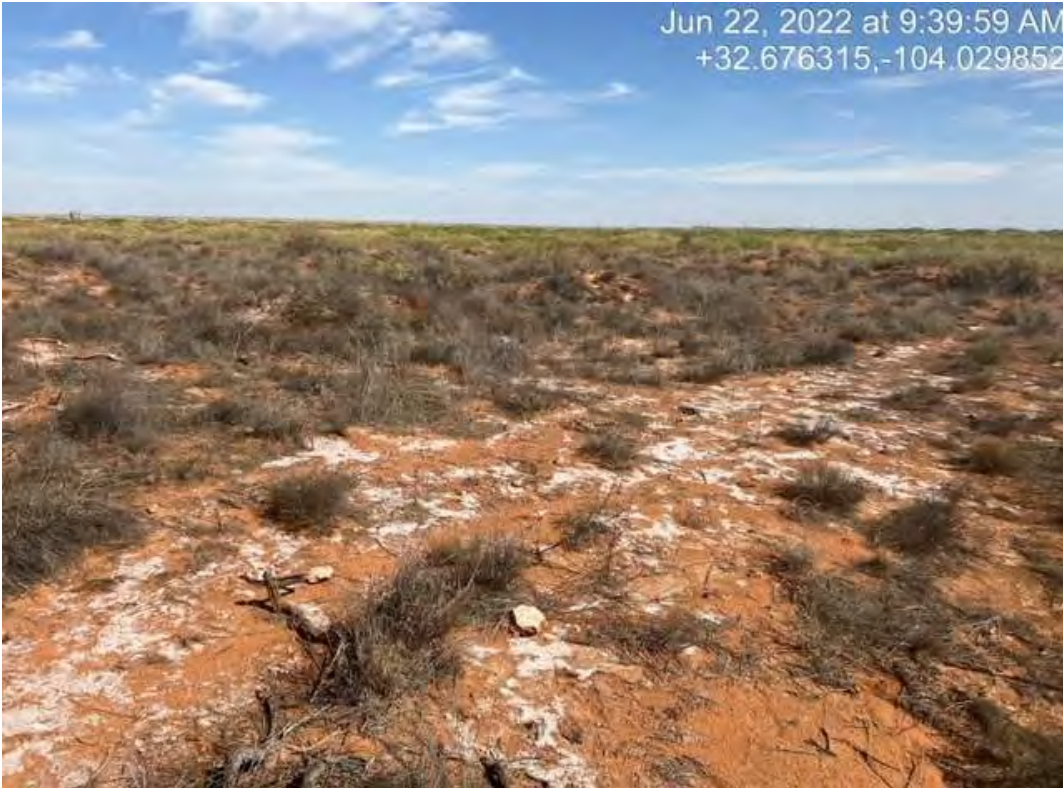
Photo Number: 2

Photo Direction: South	
Photo Description: View of the affected area.

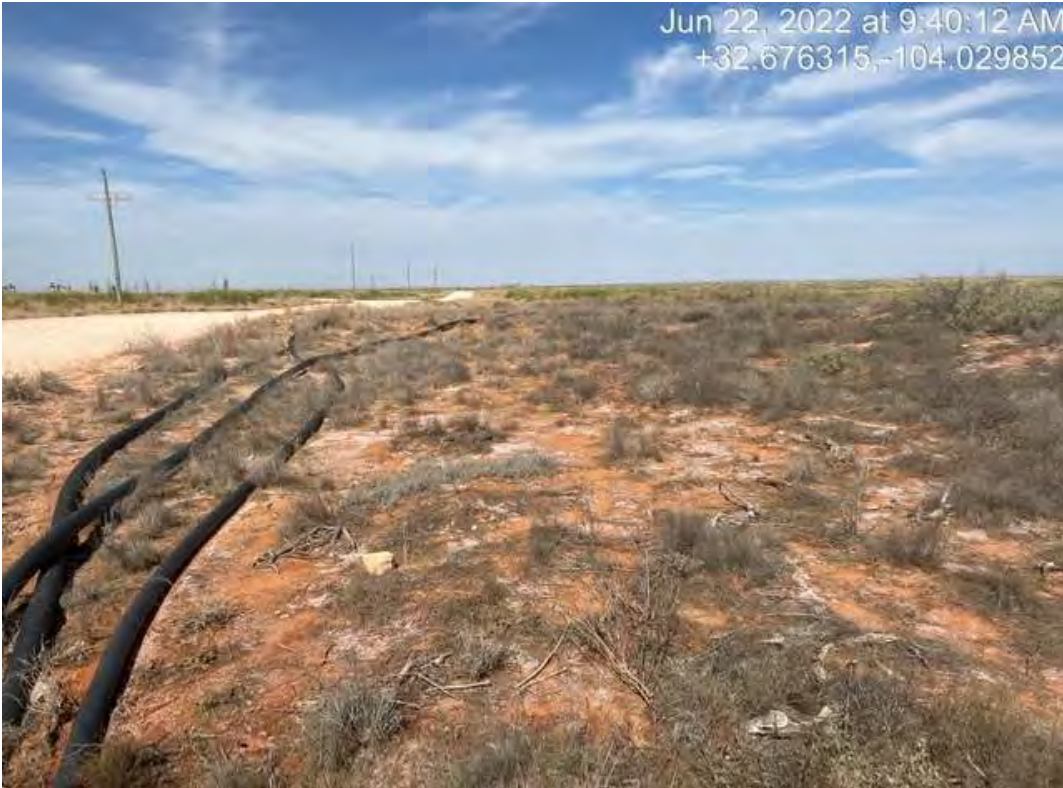
Photo Number: 3

Photo Direction: West	
Photo Description: View of the affected area.

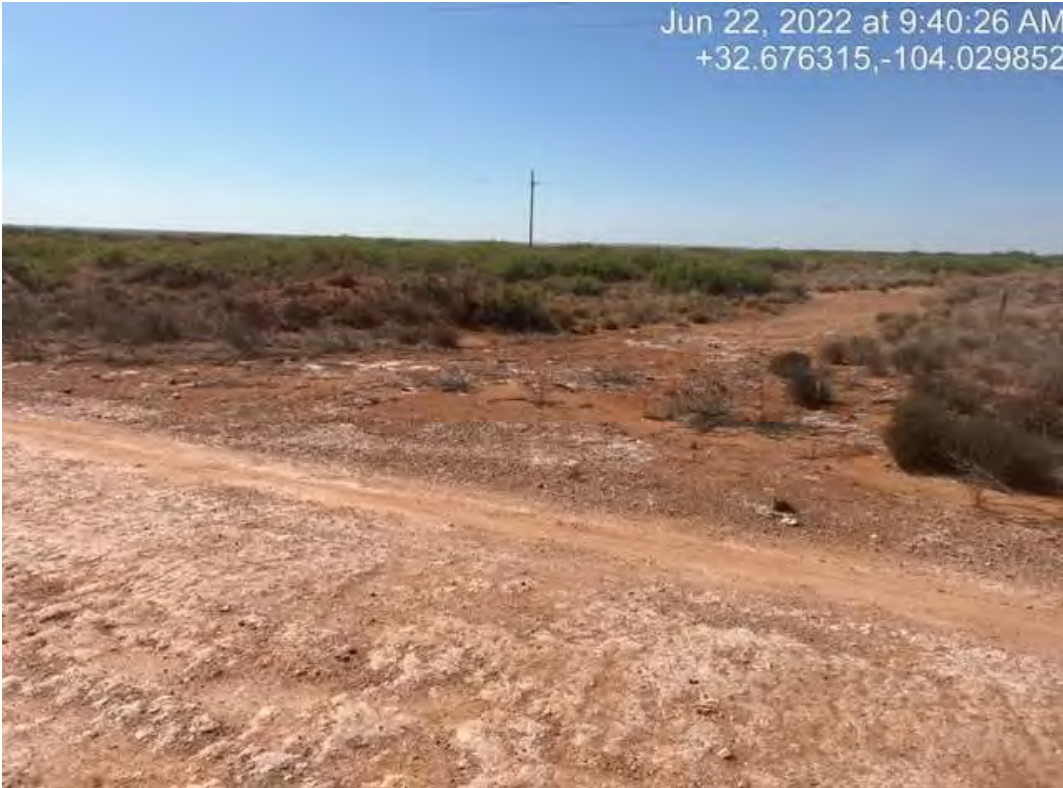
Photo Number: 4

Photo Direction: West-Southwest	
Photo Description: View of the affected area.

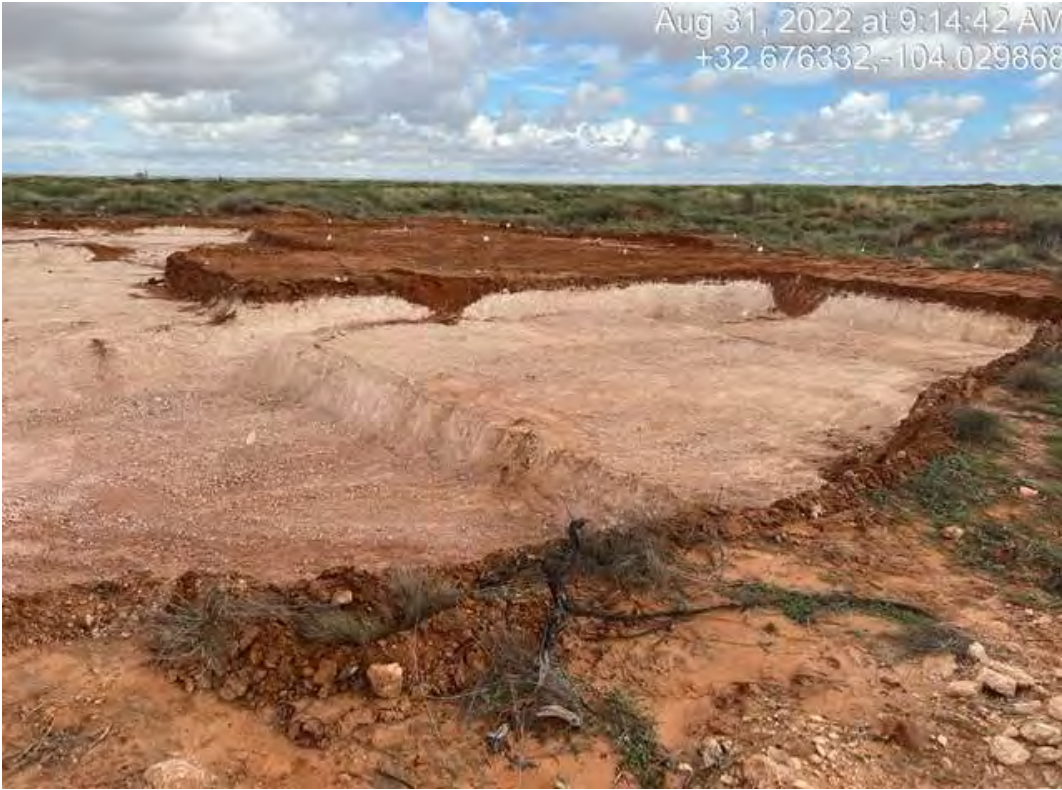
Photo Number: 5

Photo Direction: North-Northeast	
Photo Description: View of the excavated area.

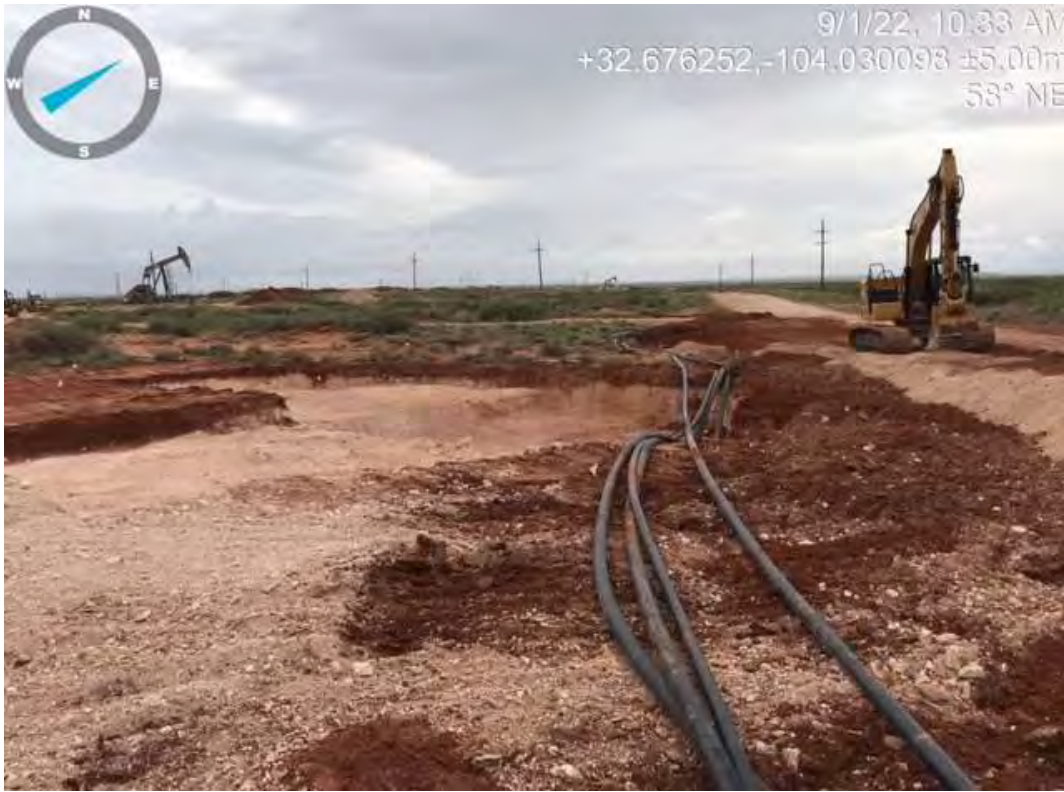
Photo Number: 7

Photo Direction: East-Northeast	
Photo Description: View of the excavated area.

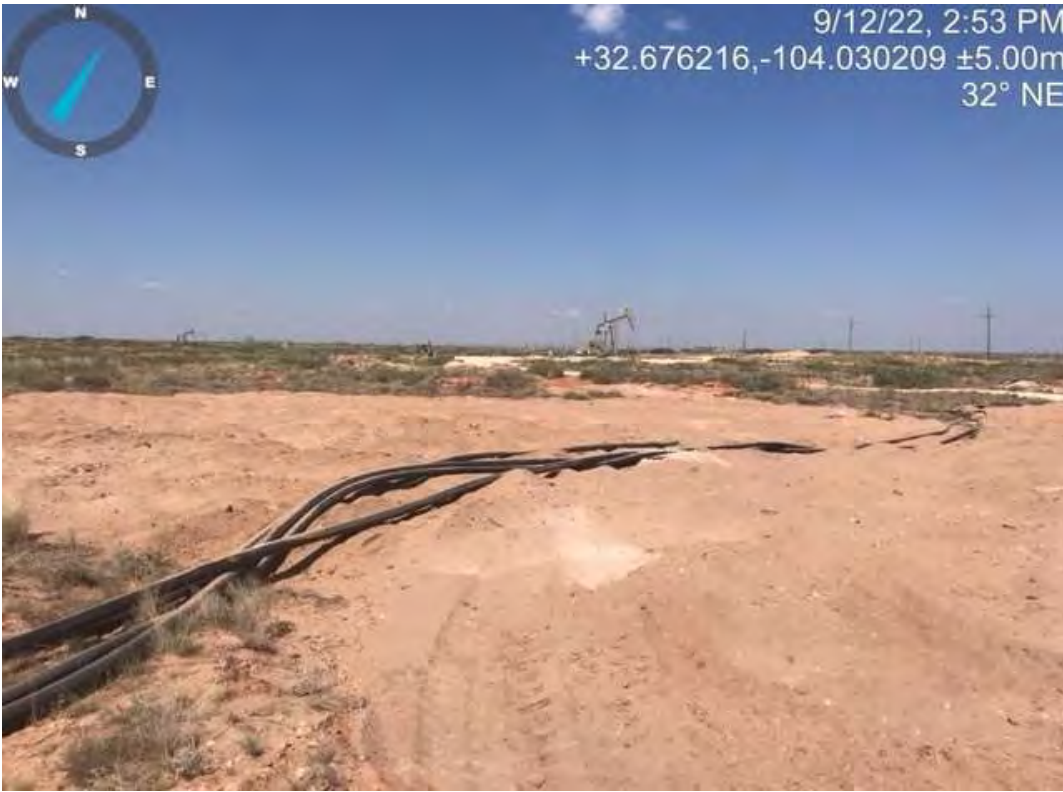
Photo Number: 9

Photo Direction: North-Northeast	
Photo Description: View of the remediated area after backfill and regrading.
