Site Assessment Report & Proposed Remediation Plan

Mewbourne Oil Company Silver Bullet Frac Booster

Eddy County, New Mexico
Unit Letter "D", Section 15, Township 26 South, Range 29 East
Latitude 32.049479 North, Longitude 103.978286 West
NMOCD Reference No. nAPP2222982853

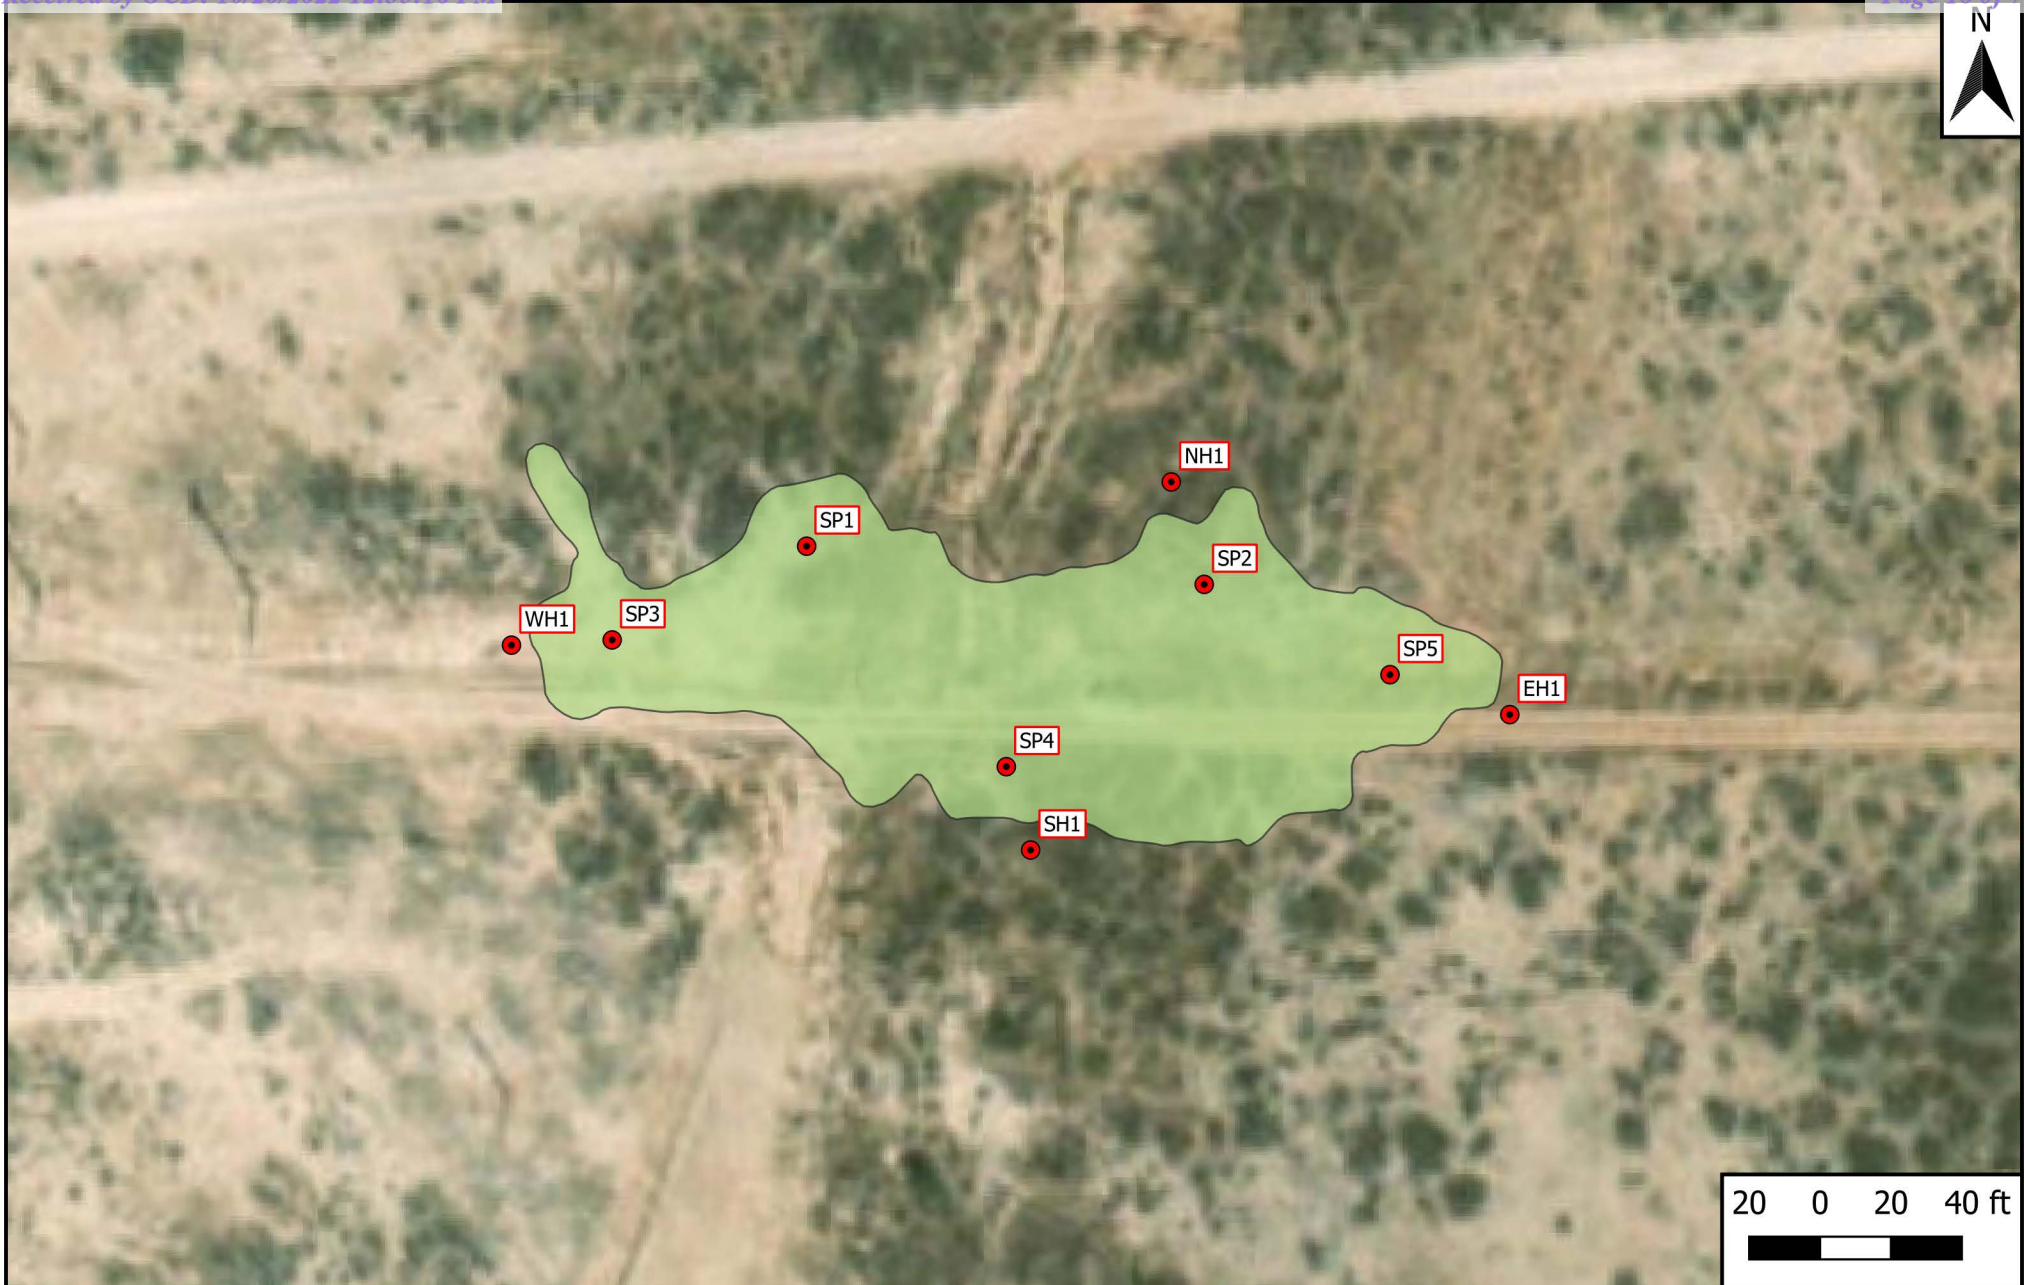
Figure 3

Site & Sample Location Map

- Affected Area ($\approx 17,130 \text{ ft}^2$)
- Delineation Sample Location

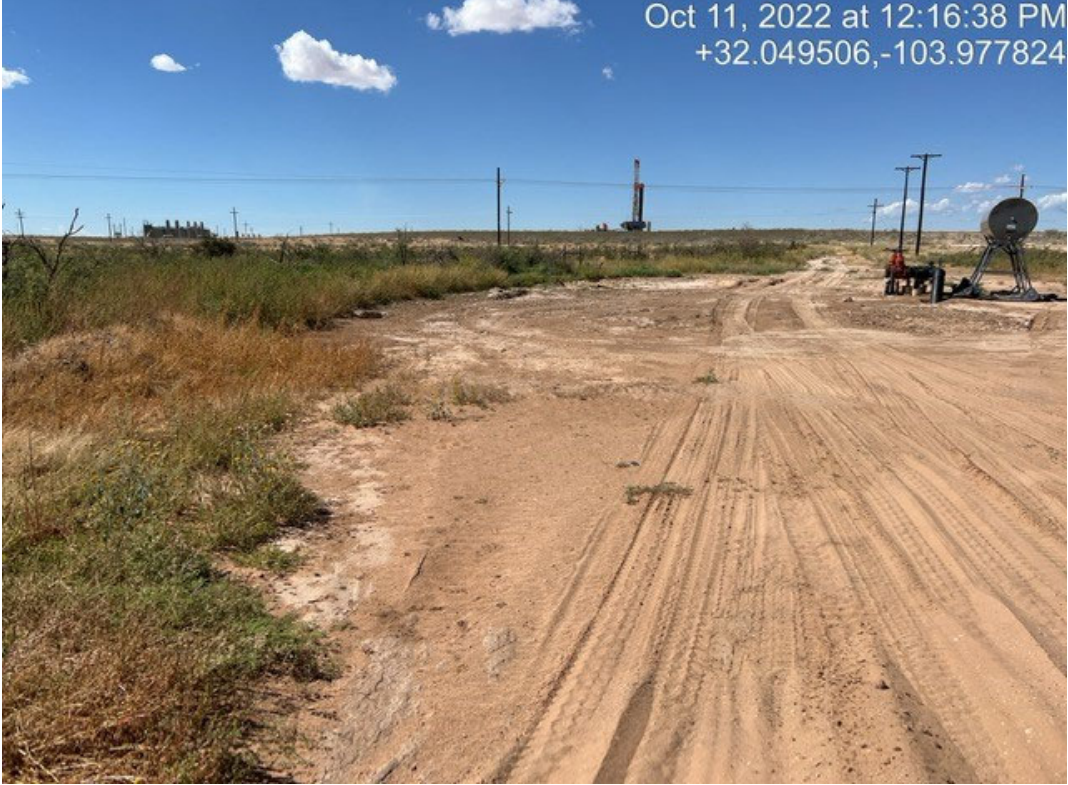
Photo Number: 1

<p>Oct 11, 2022 at 12:16:38 PM +32.049506,-103.977824</p>
Photo Direction: West	
Photo Description: View of the affected area.

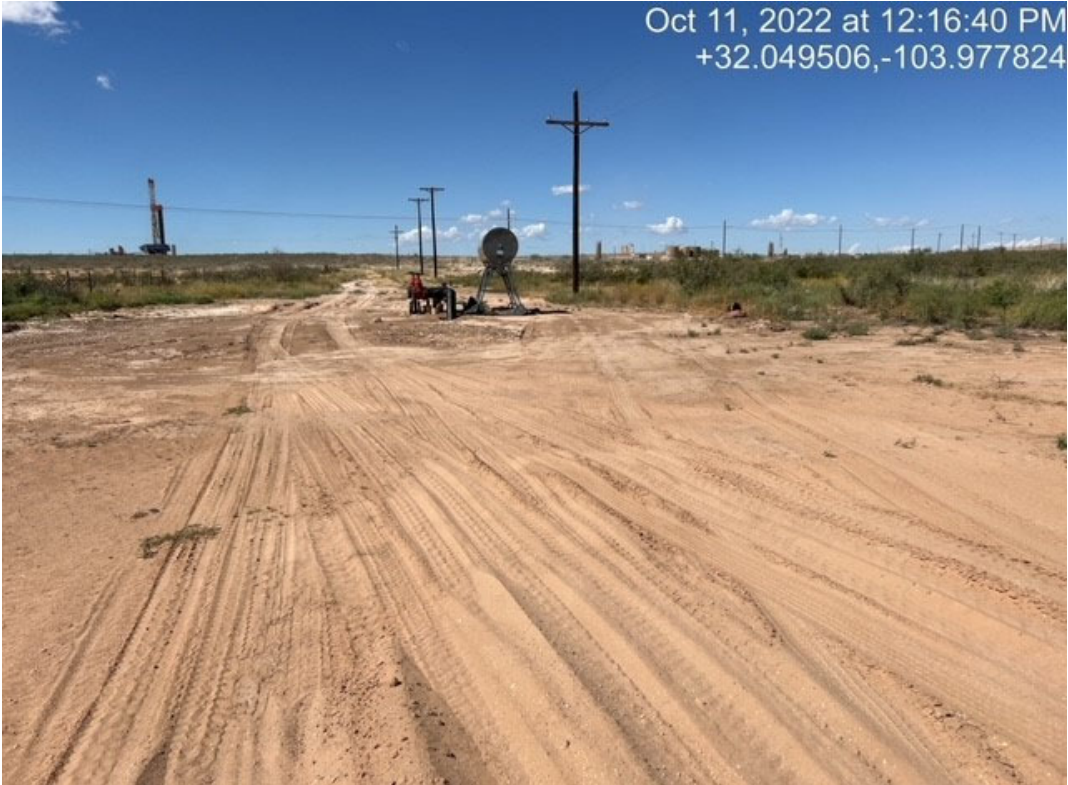
Photo Number: 2

<p>Oct 11, 2022 at 12:16:40 PM +32.049506,-103.977824</p>
Photo Direction: West	
Photo Description: View of the affected area.

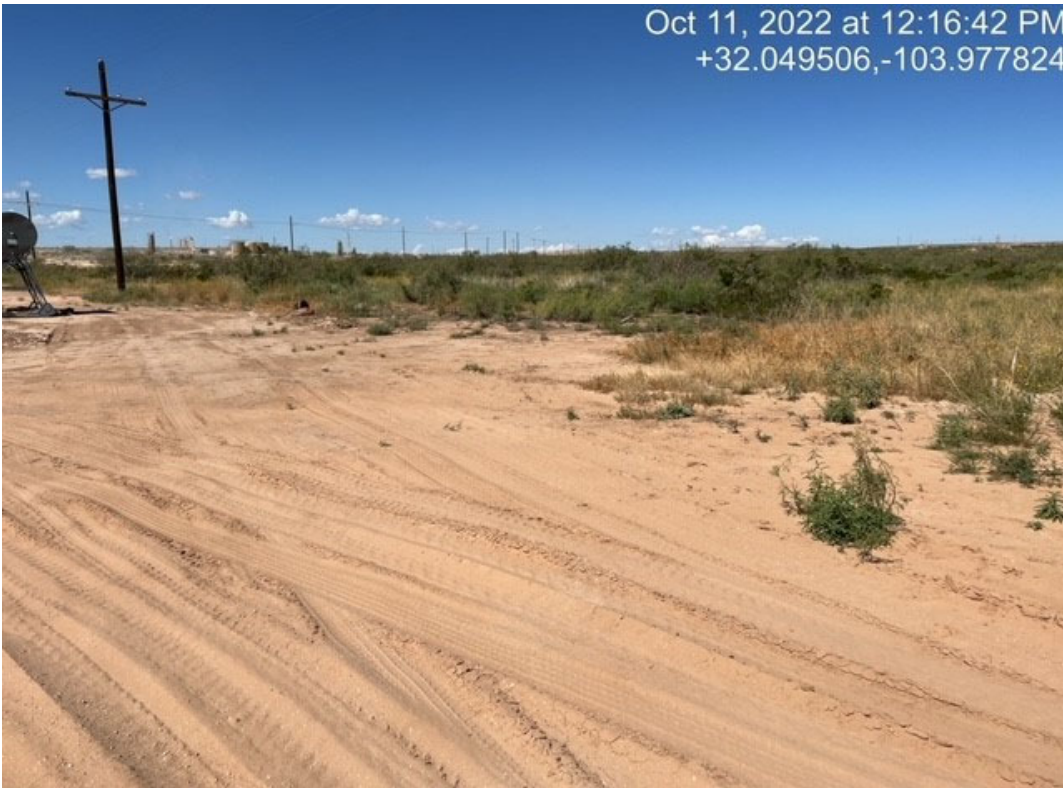
Photo Number: 3

Photo Direction: Northwest	
Photo Description: View of the affected area.
