**Re: State A-10
Site Assessment Report - Closure Request
NMOCD Case No 1RP-3637
Lea County, New Mexico**

Site Assessment Report - Closure Request

2018 HES Transfer Site – State A-10

NMOCD Case No. 1RP-3637

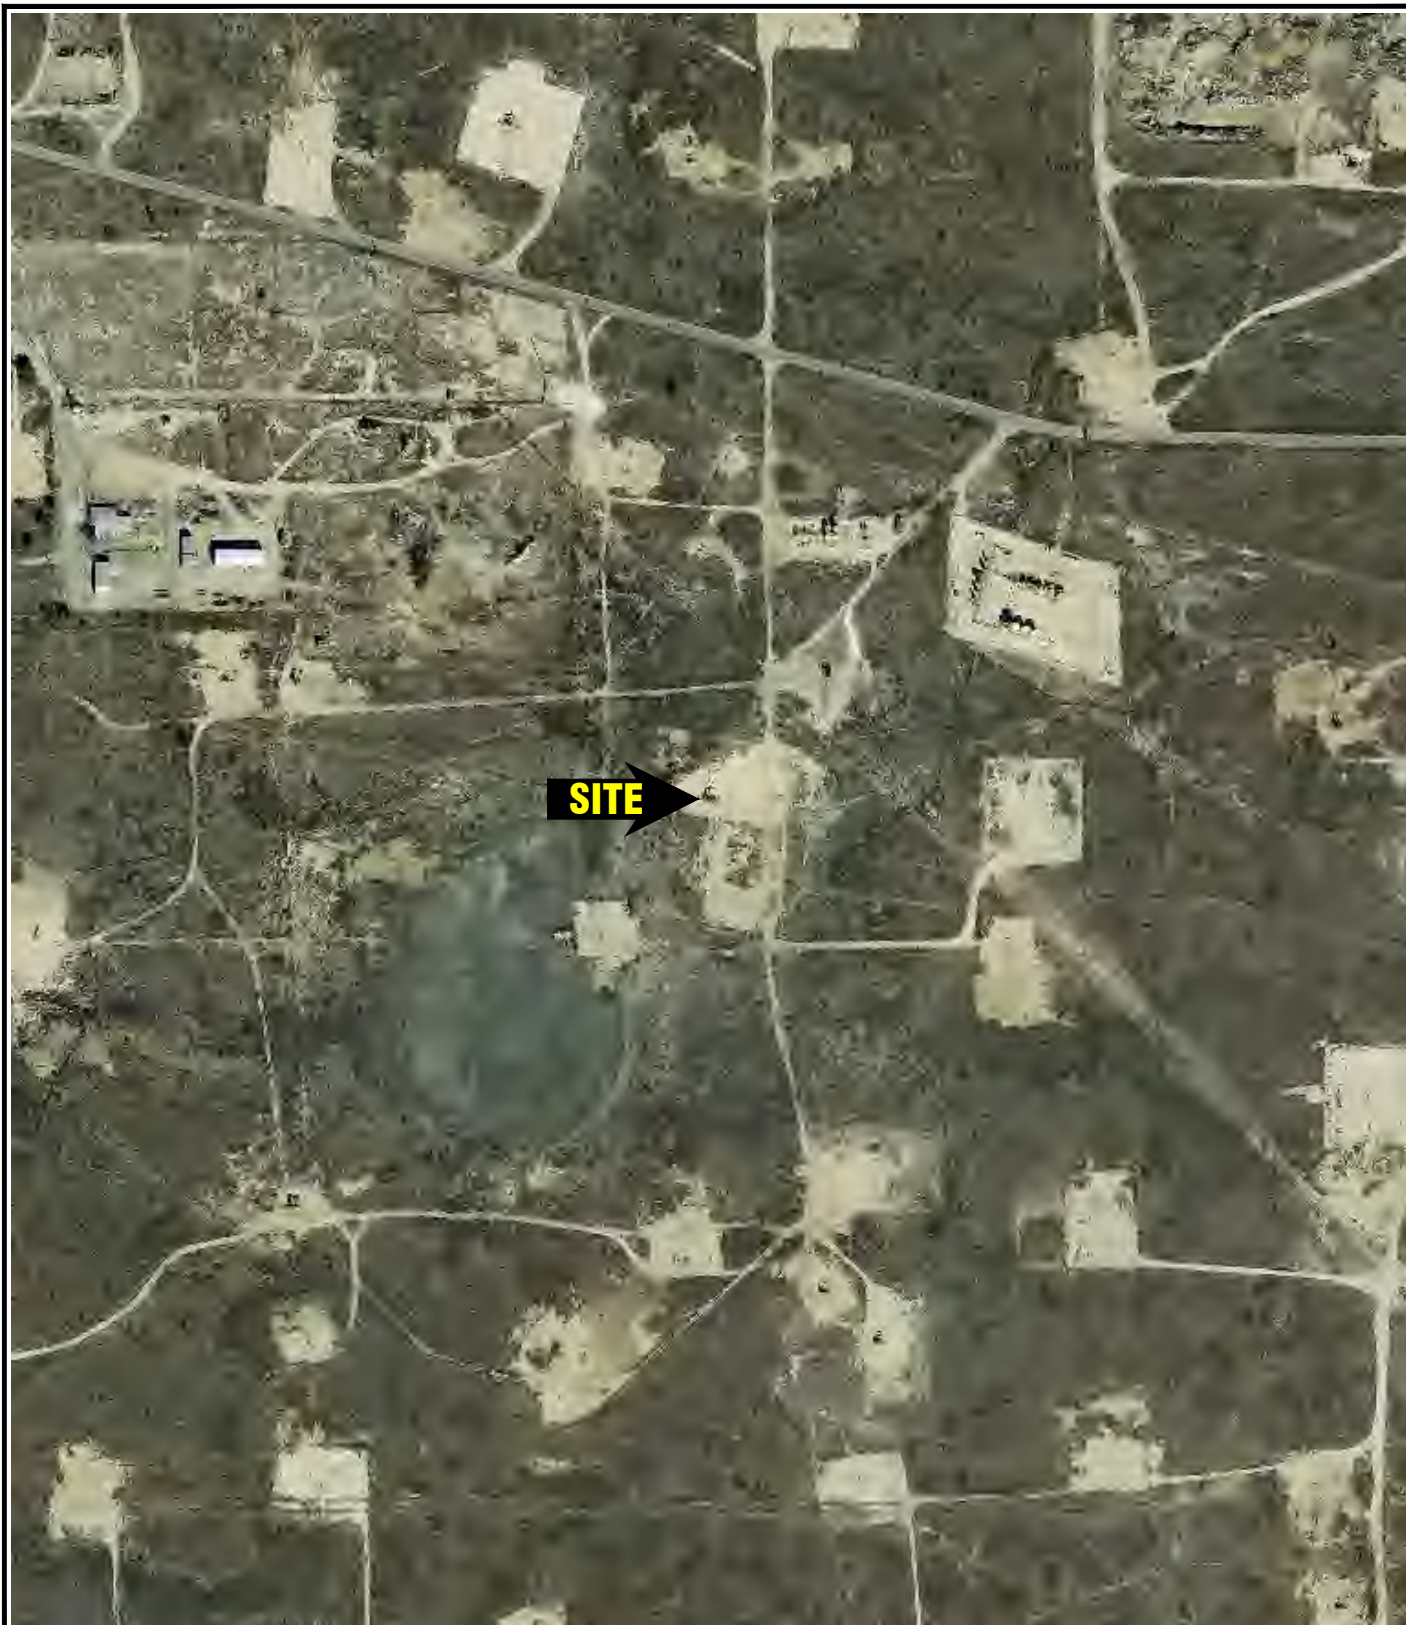
FIGURE
1

On behalf of Chevron Environmental Management Company (CEMC), Arcadis U.S., Inc. (Arcadis) prepared this Site Assessment Report (Report) for State A-10 located in Lea County, New Mexico (site; **Figure 1**). This Report summarizes the field activities completed and the results of samples collected during soil and groundwater investigation activities conducted on site in June 2016, September 2016 and August 2017. The purpose of the Report is to present final soil boring and monitoring well locations, monitoring well construction details, results of samples collected, and the data evaluation performed as part of the investigations after the May 3, 2015 release of oil and produced water.

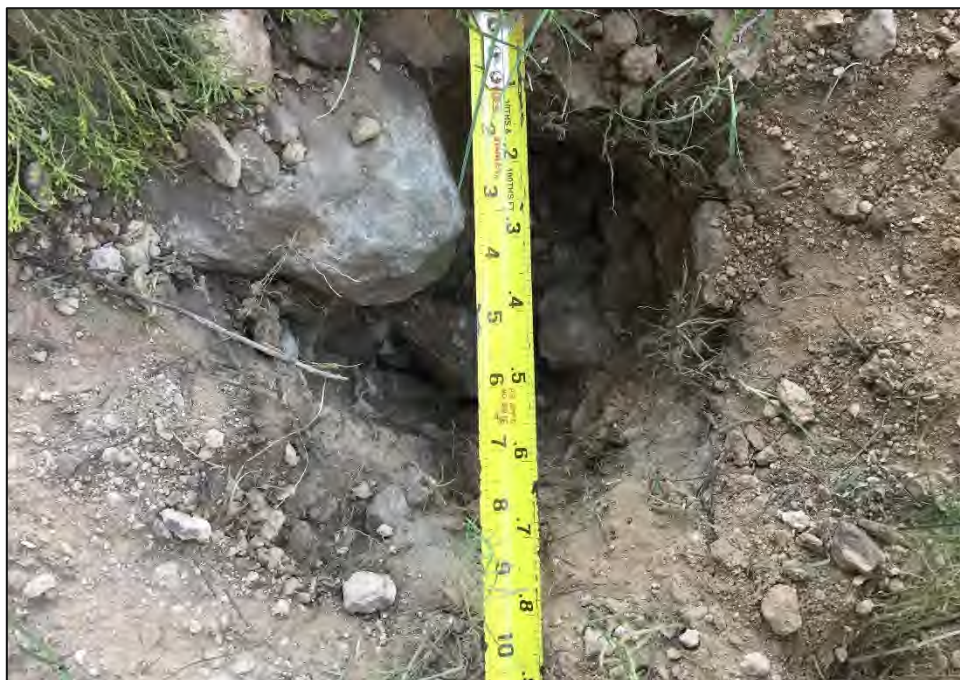
Description: StateA10-07
Air Knife Width
Measurement - 8 inches
North South

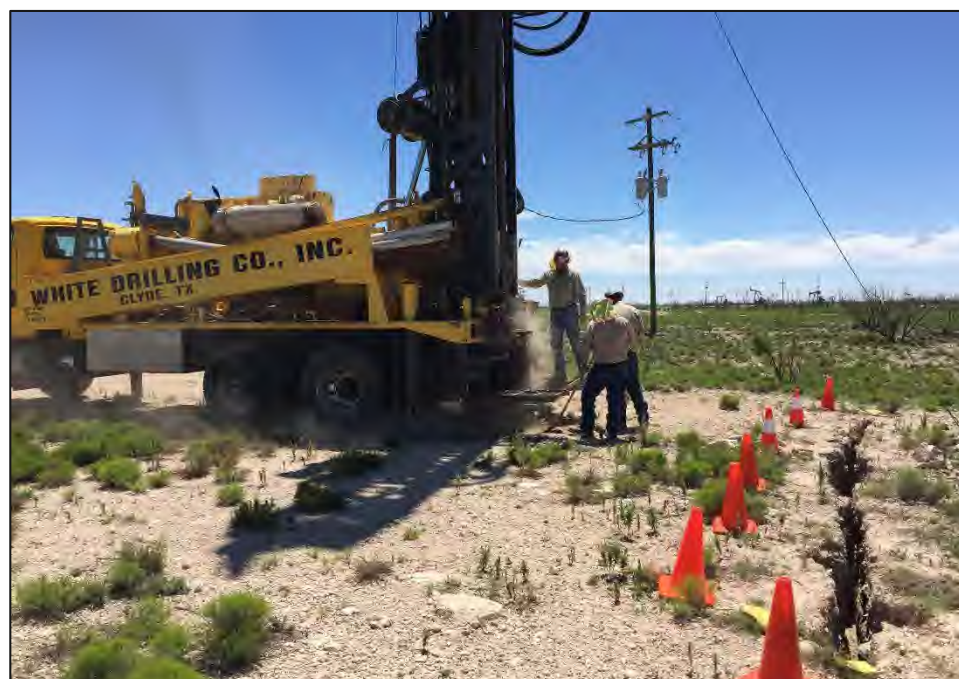
Description: White Drilling
Advancing StateA10-06
Soil Boring
