# Remediation Summary and Site Closure Request

## Willow A State #003

NMOCD Reference Number:  
NRM1935157445

**SITE ASSESSMENT SUMMARY  
AND  
PROPOSED VARIANCE AND REMEDIATION WORK PLAN**

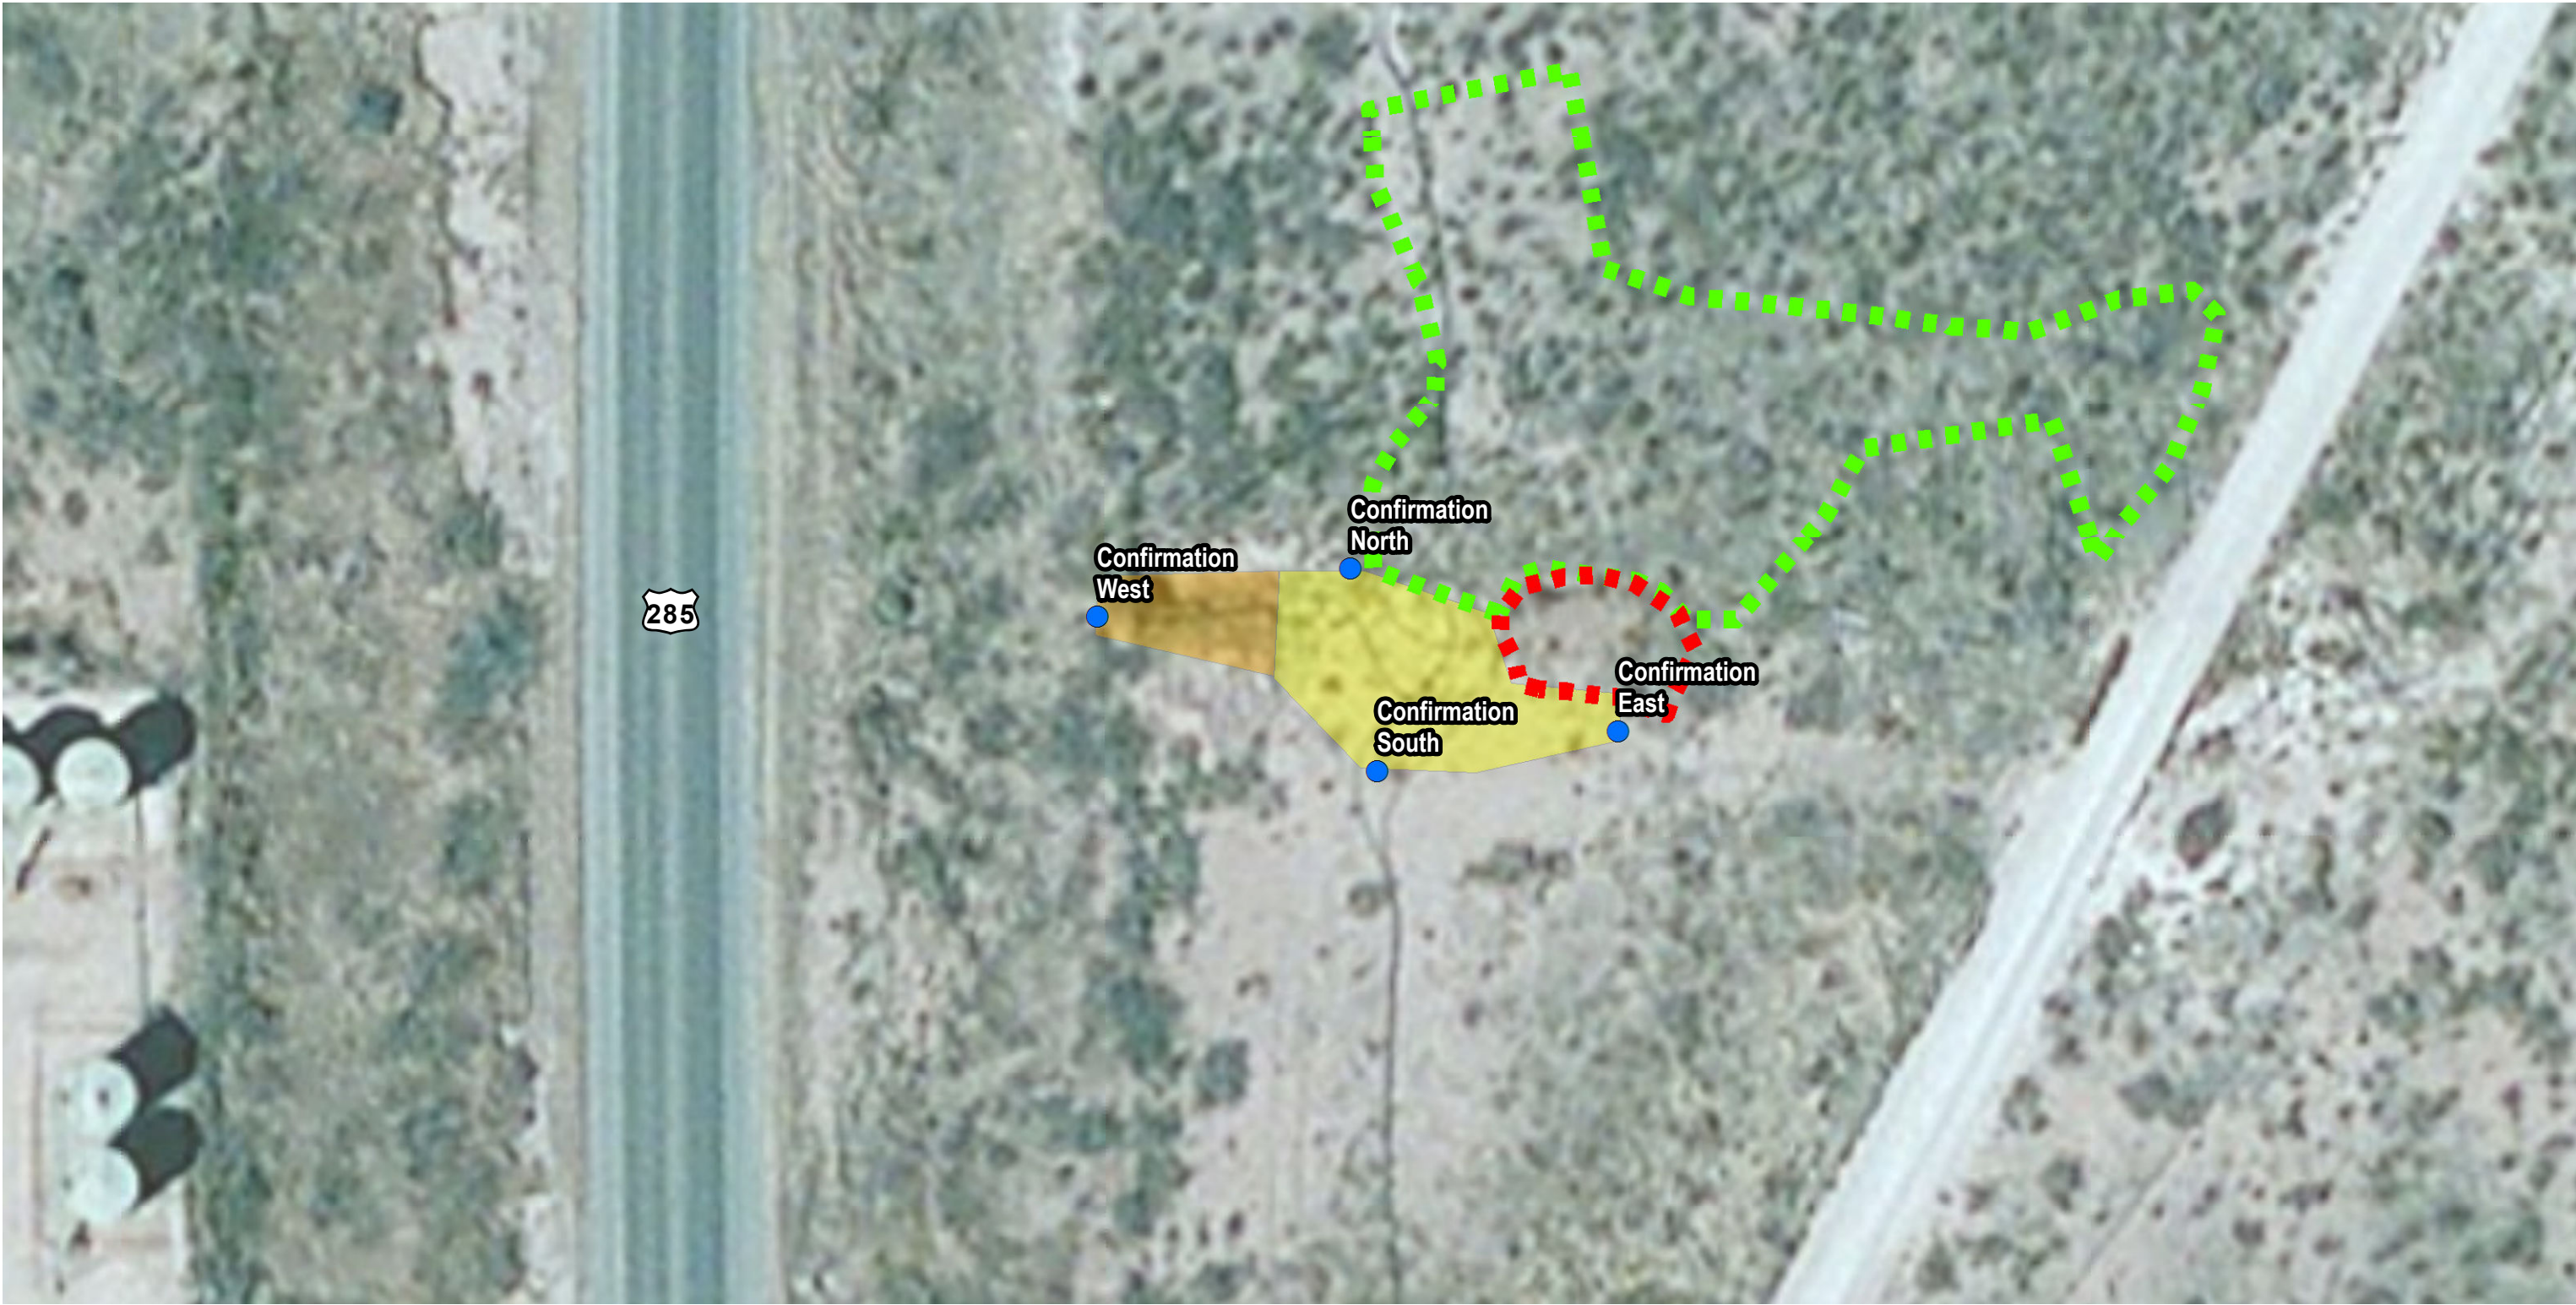
analysis by EPA 8021B, and chloride analysis by Method 300.0. **Figure 4** depicts the excavation footprint and the associated soil sample locations. Photographic documentation of the remediation activities is provided as **Appendix D** and the laboratory analytical package from the confirmation sampling event is provided as **Appendix F**.

- CONFIRMATION SAMPLE
- EXCAVATION (4 FEET) AND LINER 1
- EXCAVATION (9 FEET) AND LINER 2
- APPROXIMATE LINER LOCATION 2RP-1541
- APPROXIMATE LINER LOCATION 2RP-3105

Two (2) produced water releases, 2RP-1541 (2013) and 2RP-3105 (2015), previously closed with concurrence from the NMOCD, are located in the immediate vicinity of affected area. The northern and eastern boundaries of the Release area are immediately adjacent to and overlapping with the closed Release Sites. 2RP-1541 appears to overlap with the easternmost extent of the affected area. The southern extent of the remediation associated with 2RP-3105 appears to be immediately adjacent to the northern boundary of the affected area. Both produced water releases were remediated by removing the top approximately four (4) feet of contaminated soil and installation of a synthetic liner over deeper impacted soils, and soils below four (4) feet bgs in the underlying areas are expected to have elevated chloride concentrations. The approximate locations of the synthetic liners from the previous releases are depicted in **Figure 4**.

Confirmation soil samples Confirmation-North, Confirmation-South, Confirmation-East, and Confirmation-West were collected from the sidewalls of the excavation area. Each soil sample was submitted to Xenco Eurofins in Midland, TX for TPH analysis by Method 8015M, BTEX

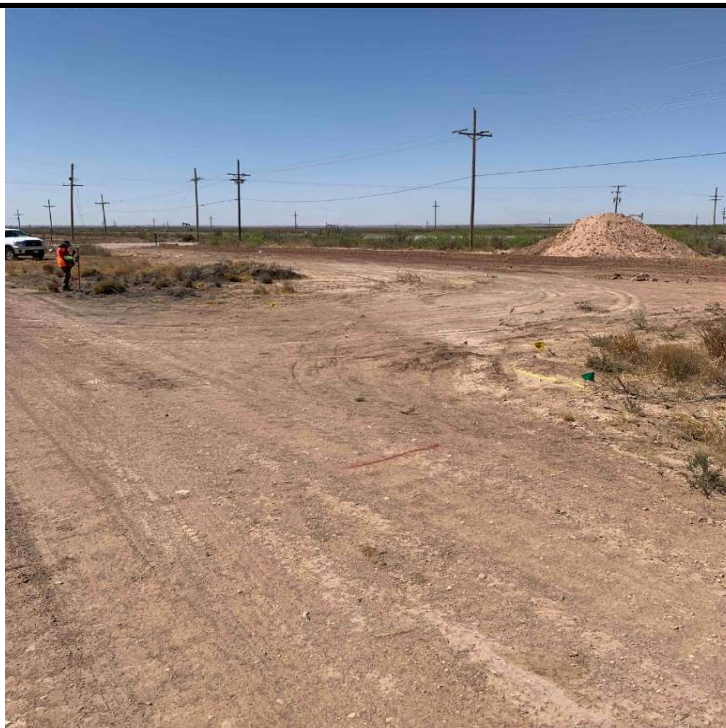
**Photographic Documentation****Photograph No. 1****Date:****4/13/2022****Direction:****Southwest****Description:****View of the site  
and excavated  
soil stockpile.**

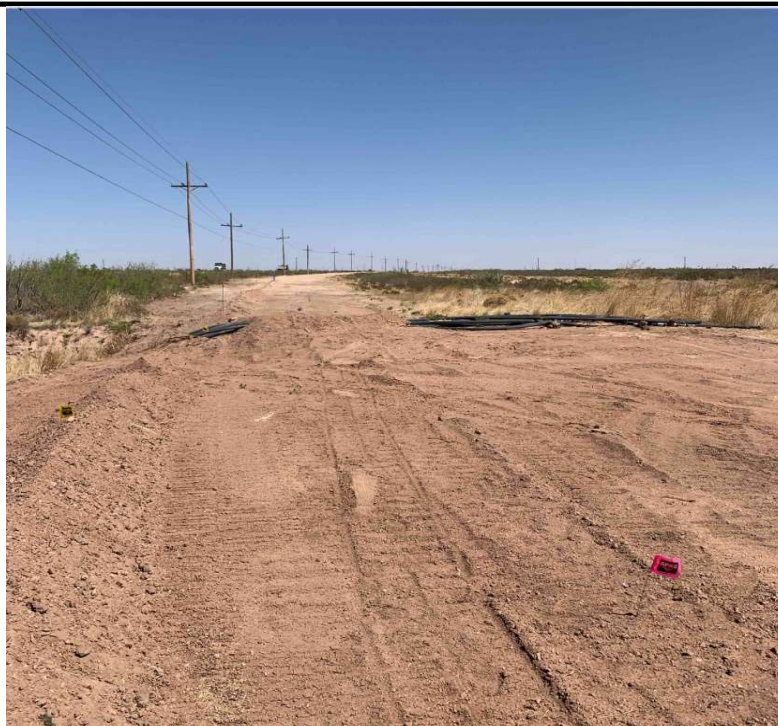
**Photograph No. 2****Date:****4/13/2022****Direction:****North****Description:****View of the site  
prior to  
excavation.**

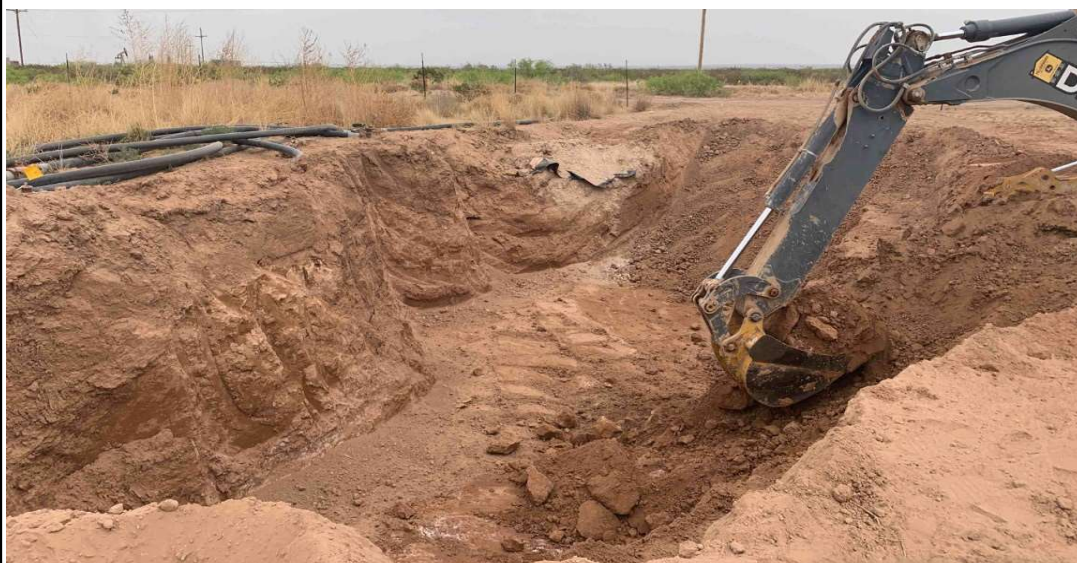
**Photographic Documentation****Photograph No. 3****Date:****4/19/2022****Direction:****East****Description:****View of the  
excavation.**

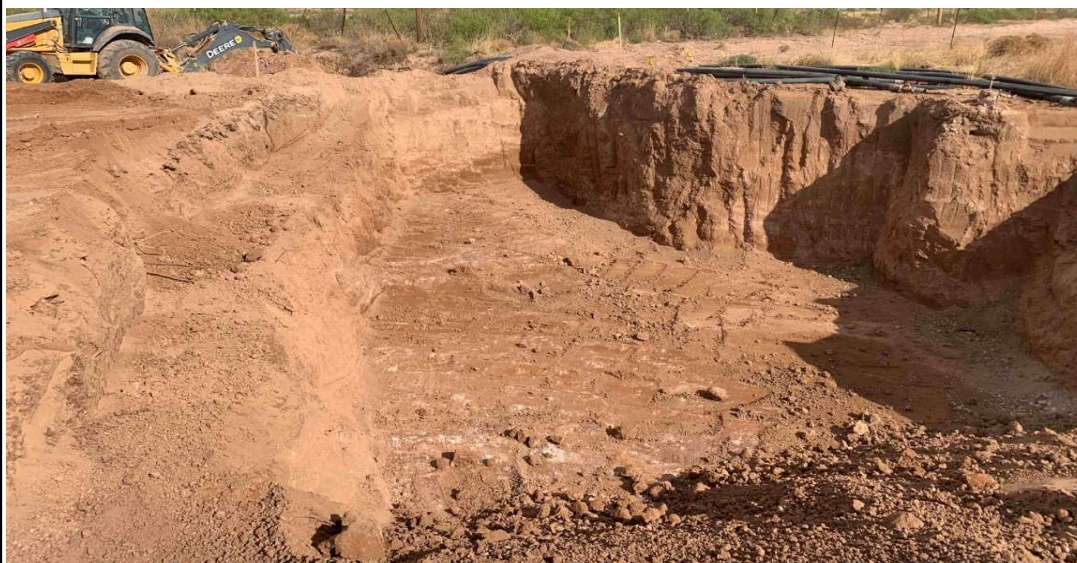
**Photograph No. 4****Date:****4/22/2022****Direction:****Northwest****Description:****View of the site  
after completion  
of excavating.**

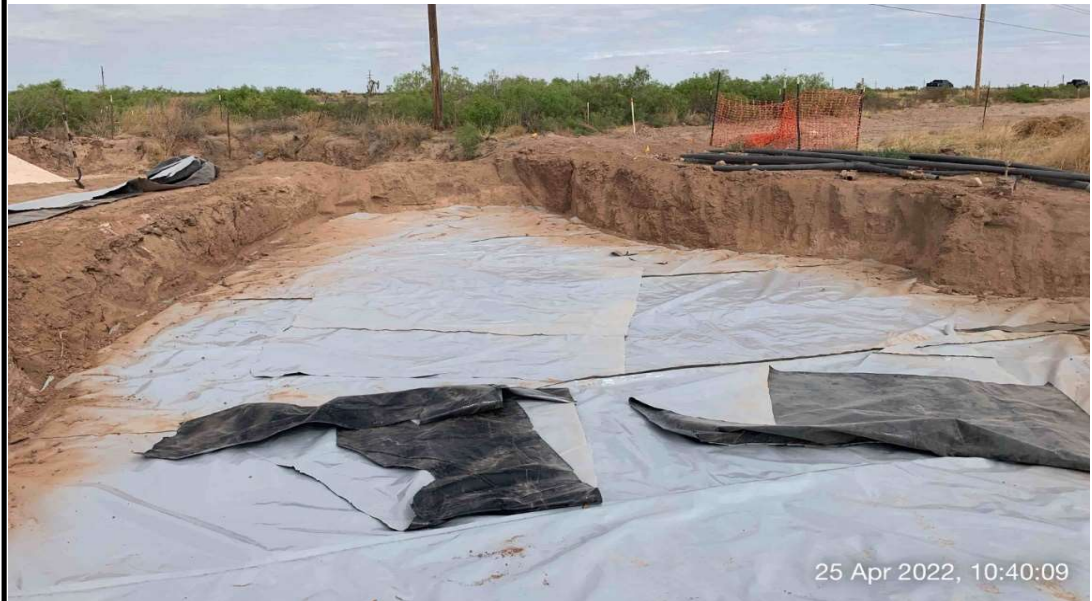
**Photographic Documentation****Photograph No. 5****Date:****4/24/2022****Direction:****Northwest****Description:****View of synthetic  
liner installation  
at floor of the  
excavation area.**

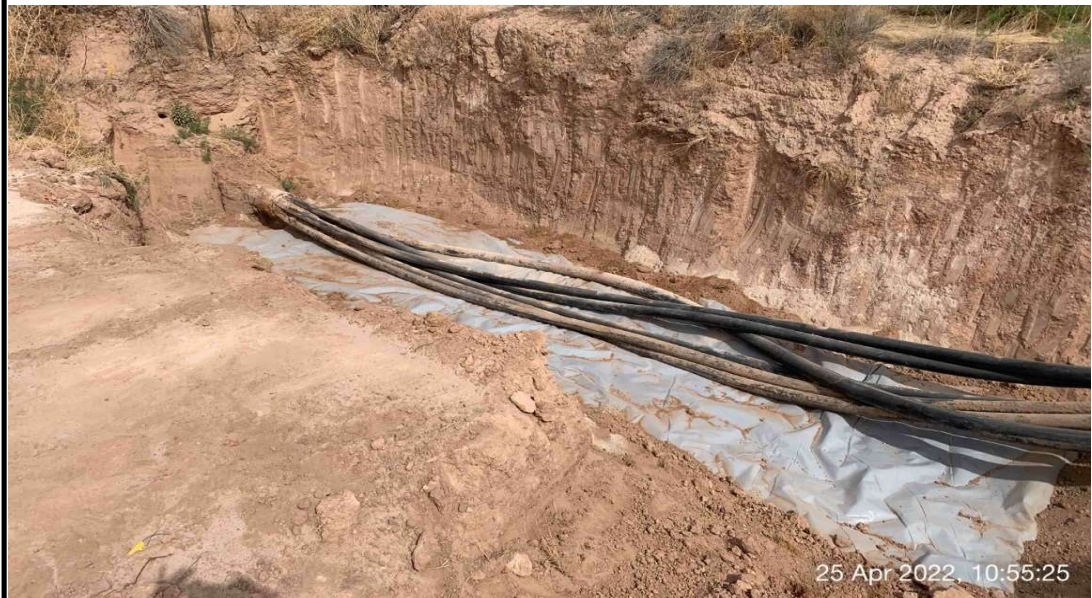
**Photograph No. 6****Date:****4/25/2022****Direction:****Northwest****Description:****View of pipes  
placed on top of  
the synthetic  
liner and  
backfilled  
sidewalls.**

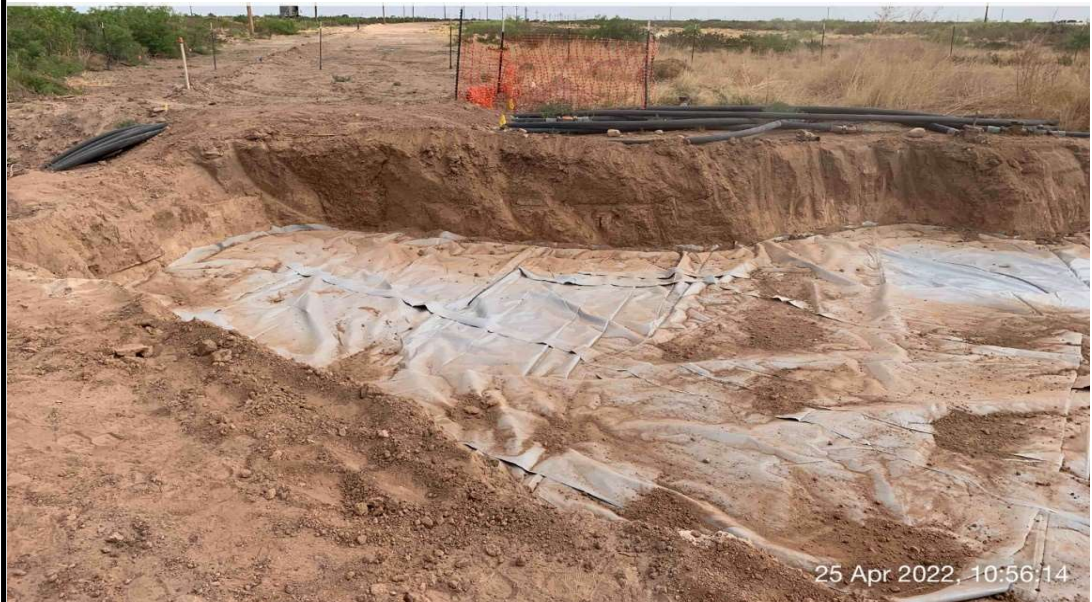
**Photographic Documentation****Photograph No. 7****Date:****4/25/2022****Direction:****North****Description:****View of the  
synthetic liner  
and backfilling  
the excavation.**

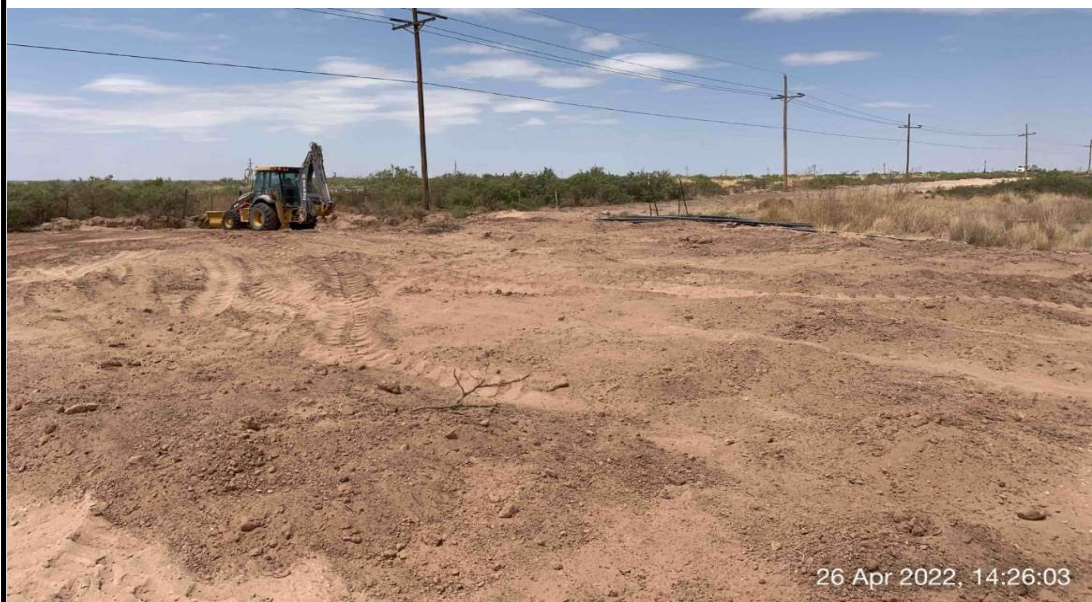
**Photograph No. 8****Date:****4/26/2022****Direction:****Northeast****Description:****View of the site  
after backfill.**

After review of all the analytical results, the excavation was backfilled to grade with commercially sourced backfill material. The site was contoured to near original grade. All excavated soils were transported offsite to the R360 Red Bluff facility.
