## Release Notification

Site Name: Sand 7 Federal 1	Site Type: Oil Production
Date Release Discovered: 12/03/2014	API# (if applicable) 30-015-25901

**Devon Energy Sand 7 Fed #1**

PHOTO DOCUMENTATION

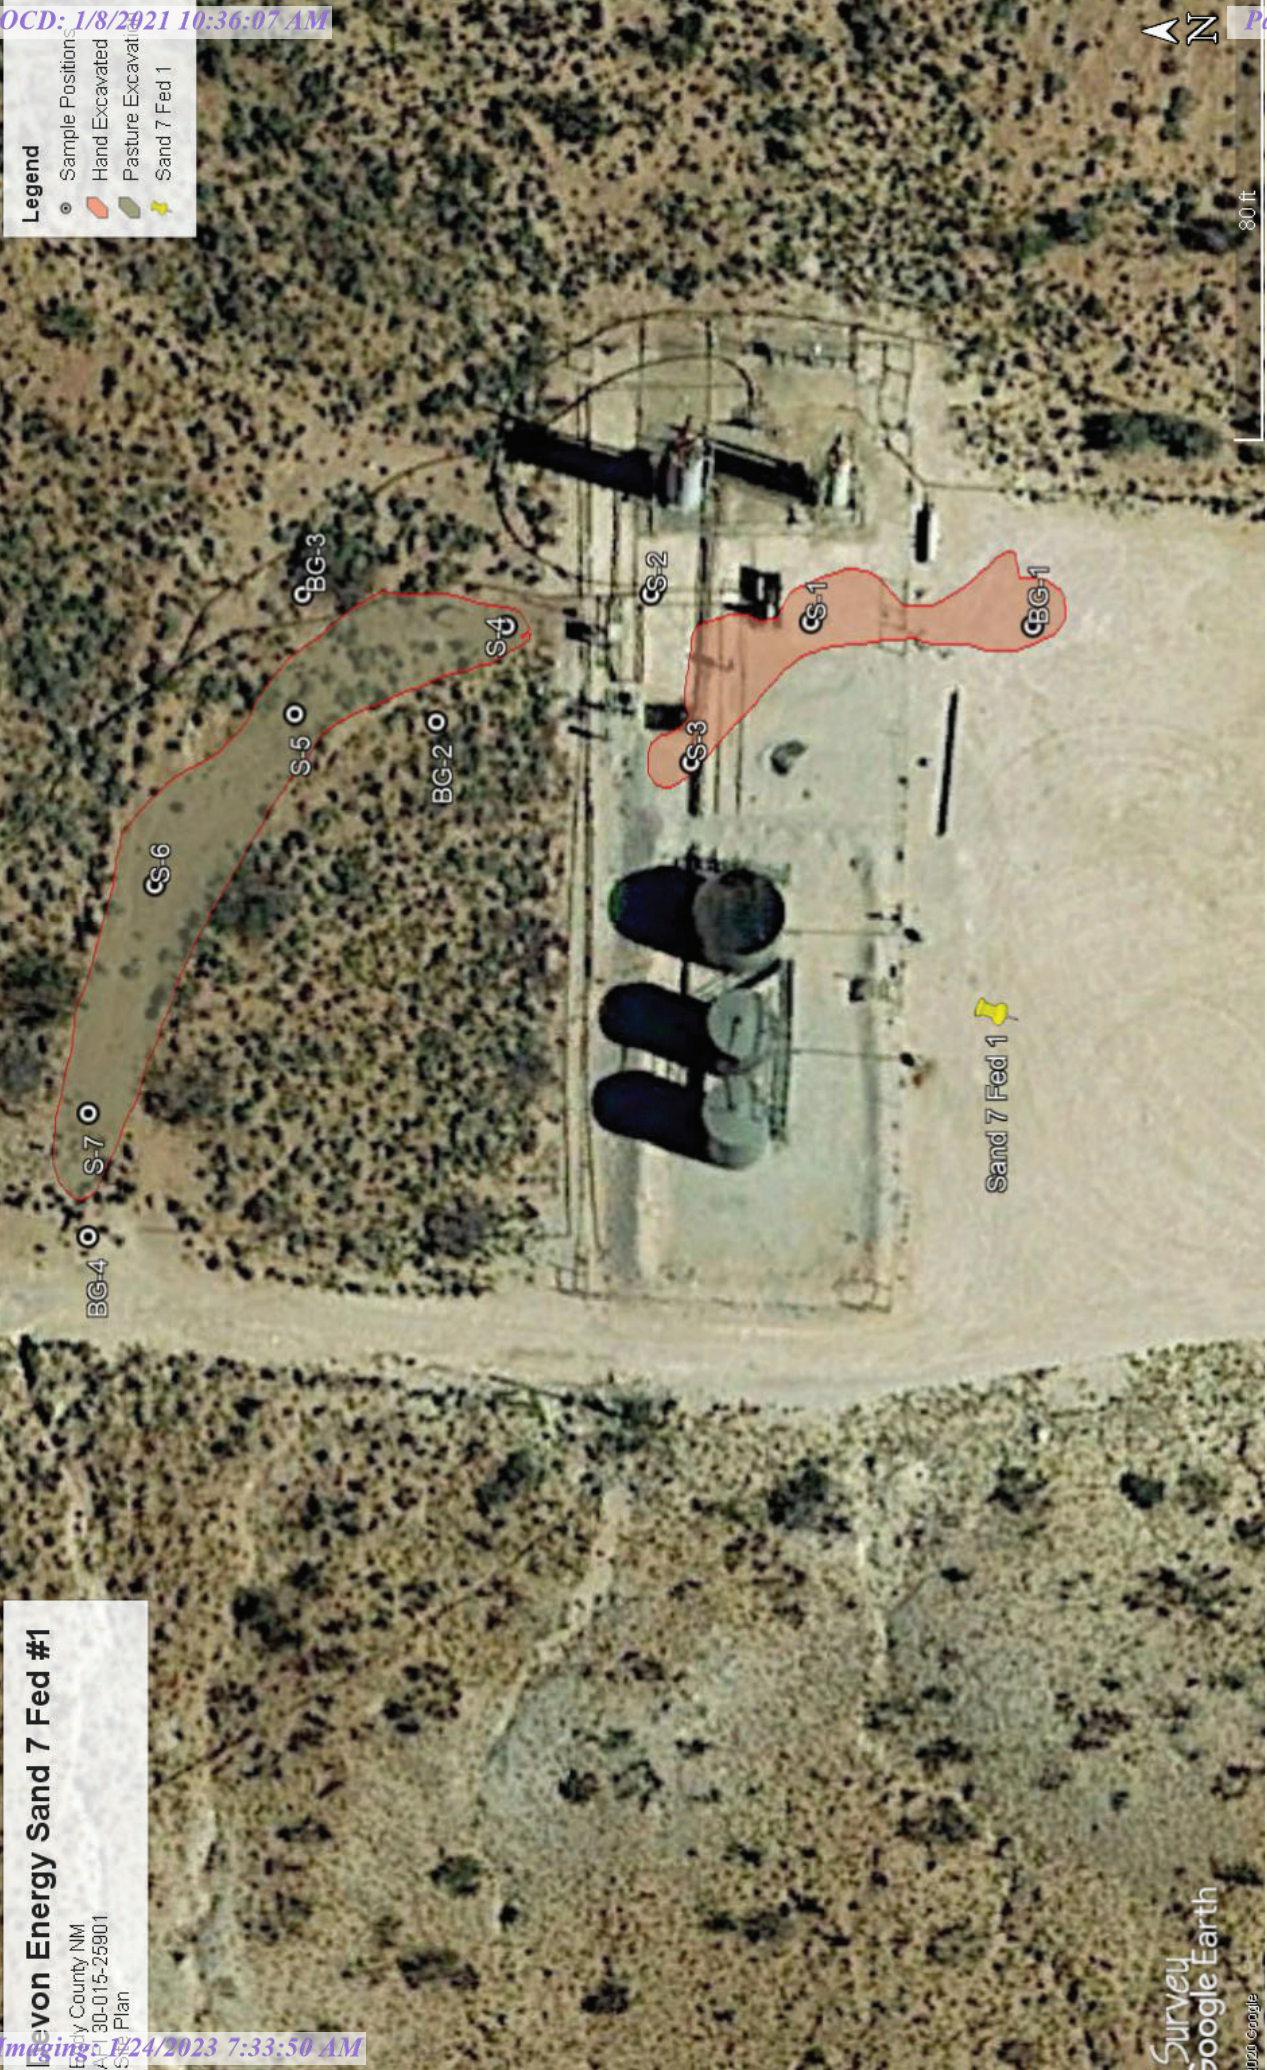
Bay County NM  
APN 30-015-25901  
Site Plan

On December 03, 2014 the hammer union on the recirculation pump malfunctioned, causing a release of approximately 7 bbls of mixed fluids. The well was immediately shut-in and the pump replaced. A vac truck was dispatched to the location and recovered 2 bbls of fluid. The affected area was on location surrounding the transfer pump with a flow path that traversed north along the lease road and west into the pasture area. The site map is presented in [Appendix I](#).

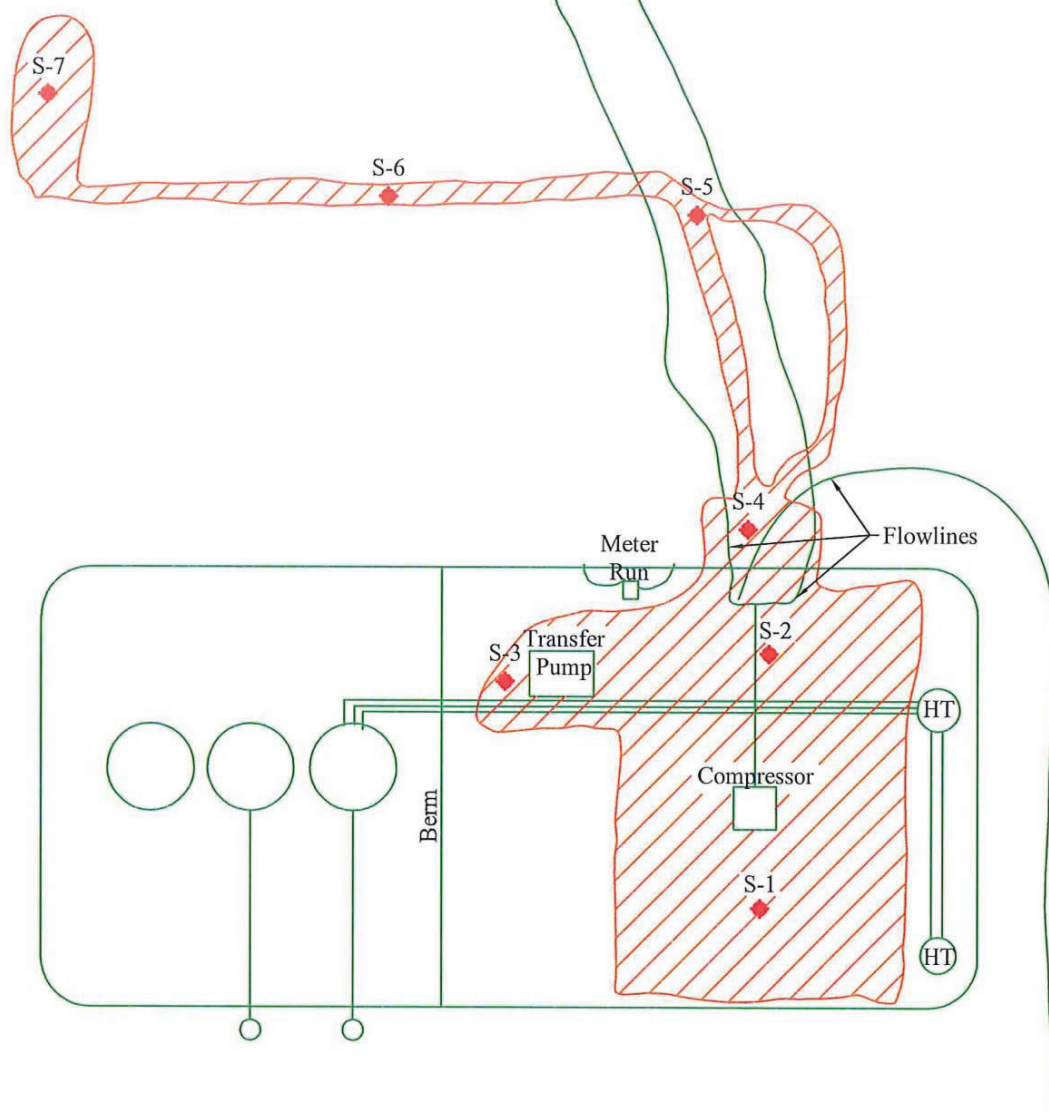
**SITE MAP**

On December 3, 2014 the hammer union on the recirculation pump malfunctioned causing a release of 7 barrels of mix fluids. The well was shut-in and the pump replaced. A vac truck was called to the location and recovered 2 barrels of fluid. The area affected was on location surrounding the transfer pump with a flow path that moved north along the lease road and west into the pasture. See site plan in [Appendix I](#).

- The impacted area in the vicinity of sample points S-1, S-3, S-5, S-6 and S-7 will be excavated to a depth of 0.5-feet deep. The impacted area in the vicinity of sample point S-2 will be excavated to depth of 1-foot deep. Field PID readings will be used to guide the excavation. Once field results indicate that the impacted soil is below NMOCD Recommended Remedial Action Level's (RRAL's), a confirmation soil sample will be taken to insure all of the impacted material was removed.
