November 8, 2022

**Re: Release Characterization and Closure Request  
ConocoPhillips  
Heritage Concho  
ETZ State Unit Battery Valve Release  
Unit Letter F, Section 16, Township 17 South, Range 30 East  
Eddy County, New Mexico  
Incident ID# NAB1821441378  
2RP-4887**

**ETZ STATE UNIT BATTERY VALVE RELEASE  
APPROXIMATE RELEASE EXTENT AND SITE ASSESSMENT (COG)**

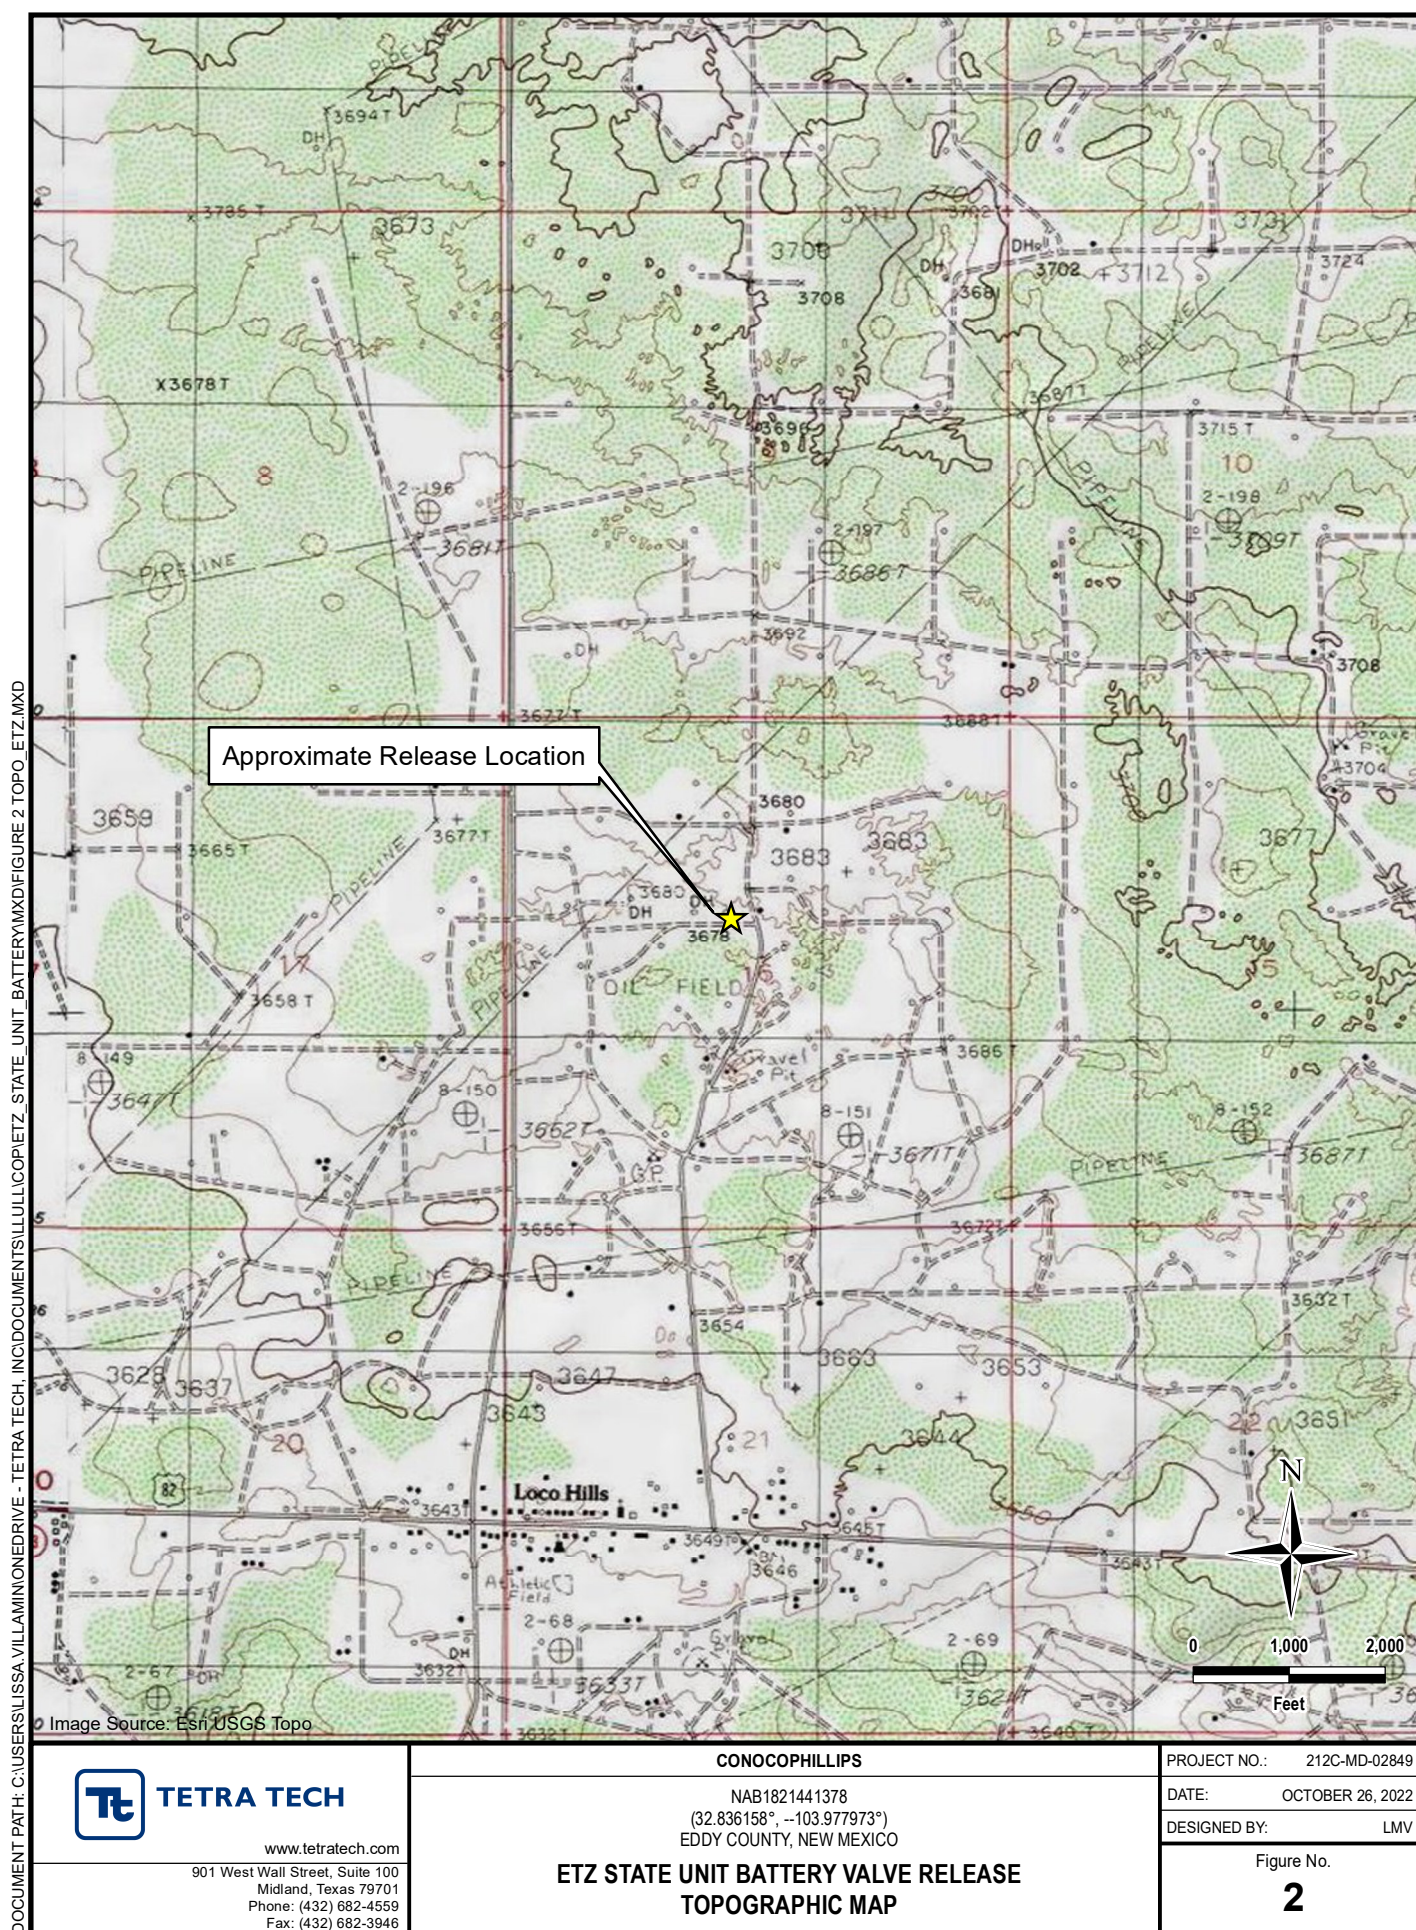
DOCUMENT PATH: C:\USERS\LISSA.VILLAMINONE\DRIVE - TETRA TECH\INCDOCUMENTS\ILLULLCOPIETZ STATE UNIT BATTERY\MXD\FIGURE 3 RELEASE AND ASSESSMENT ETZ.MXD

According to data provided in a Work Plan prepared by Concho on November 5, 2018, assessment sampling was conducted on September 5, 2018. Three (3) hand auger borings were installed to 5 feet bgs each in the release extent within the tank battery firewalls, and four (4) horizontal delineation samples were collected to the north, east, south, and west of the battery to 1 foot bgs, as shown on Figure 3. Following the receipt of sampling results, Concho proposed to excavate soils in the areas of AH-1 and AH-2 to a depth of 2 feet bgs and in the area of AH-3 (mistakenly identified in the Work Plan as AH-1) to a depth of 1 foot bgs. These areas correspond to soil intervals with Total TPH and BTEX concentrations above the Site RRALs. The proposed excavation consists of approximately 60 cubic yards of impacted soils. A copy of the Work Plan is included as Appendix C.

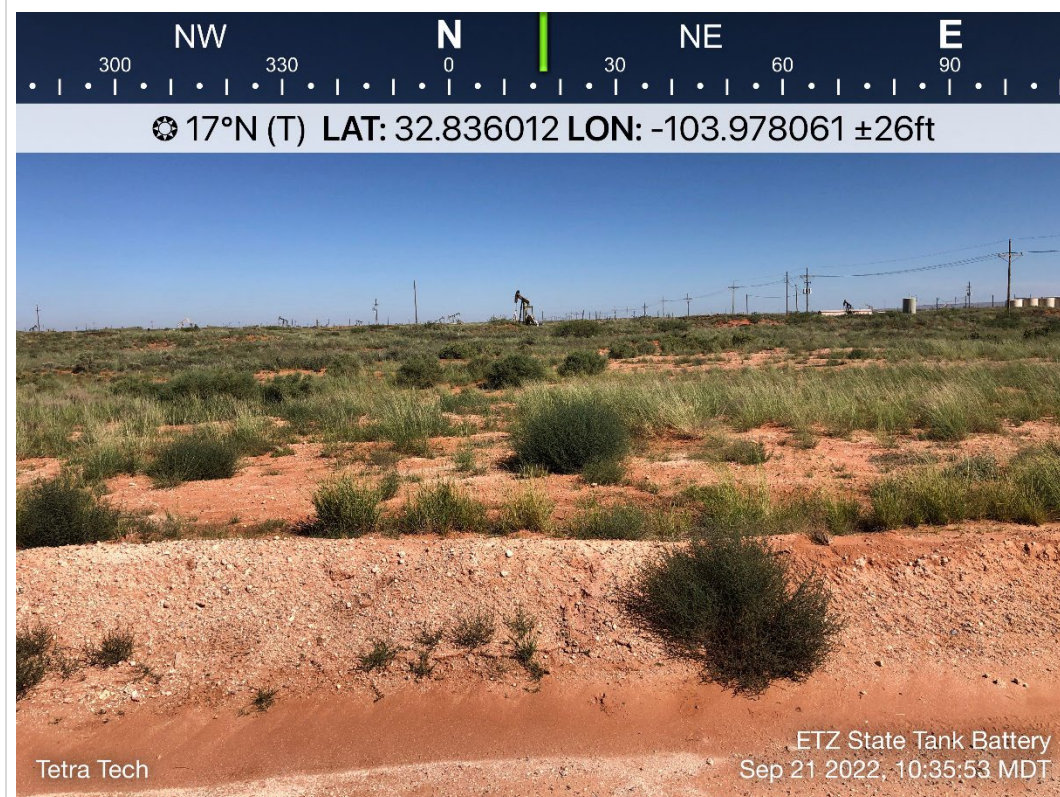
TETRA TECH, INC. PROJECT NO. 212C-MD-02849	DESCRIPTION	View north from lease road of area where the battery has been reclaimed.	2
	SITE NAME	ConocoPhillips hCXO ETZ State Unit Battery Release	9/21/2022

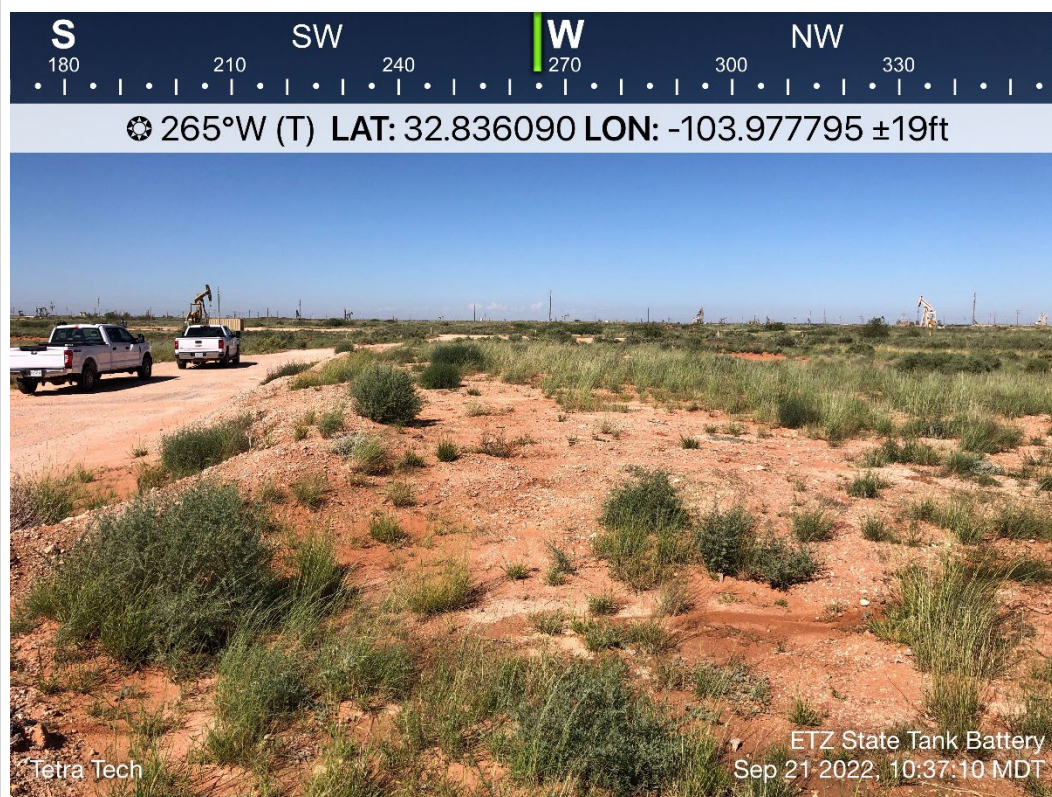
TETRA TECH, INC. PROJECT NO. 212C-MD-02849	DESCRIPTION	View west from atop the area that was previously the battery.	4
	SITE NAME	ConocoPhillips hCXO ETZ State Unit Battery Release	9/21/2022

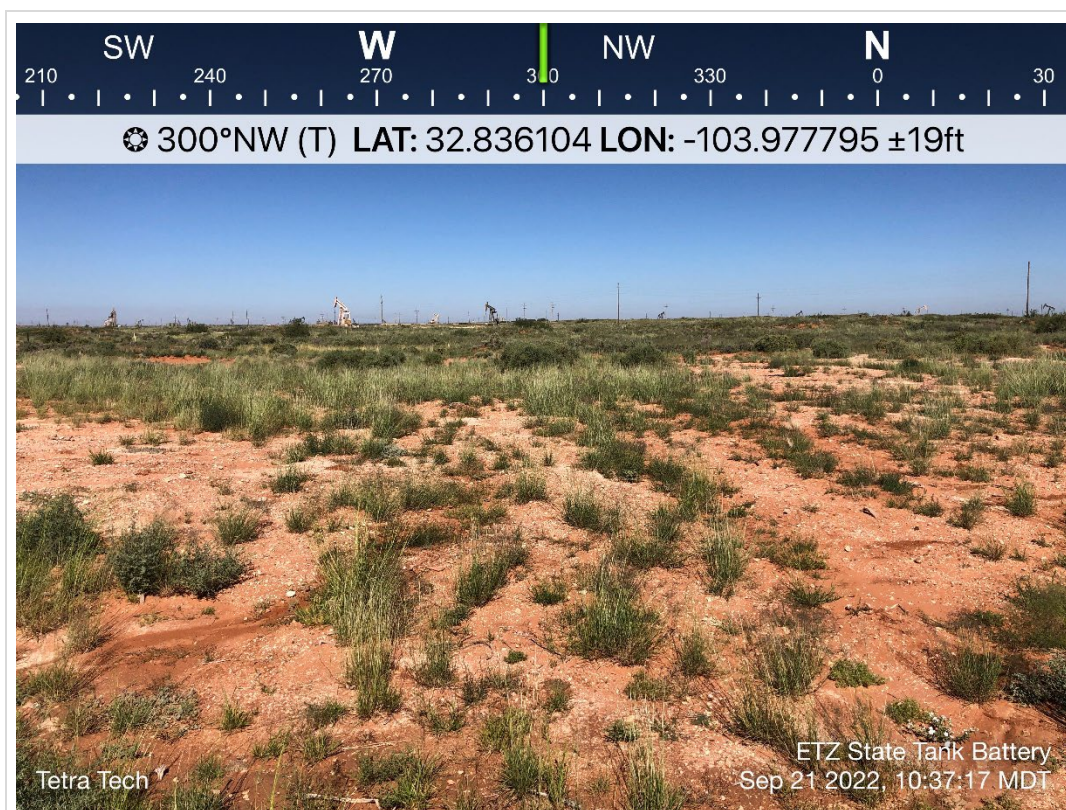
TETRA TECH, INC. PROJECT NO. 212C-MD-02849	DESCRIPTION	View northwest of the reclaimed battery and surrounding pad.	5
	SITE NAME	ConocoPhillips hCXO ETZ State Unit Battery Release	9/21/2022

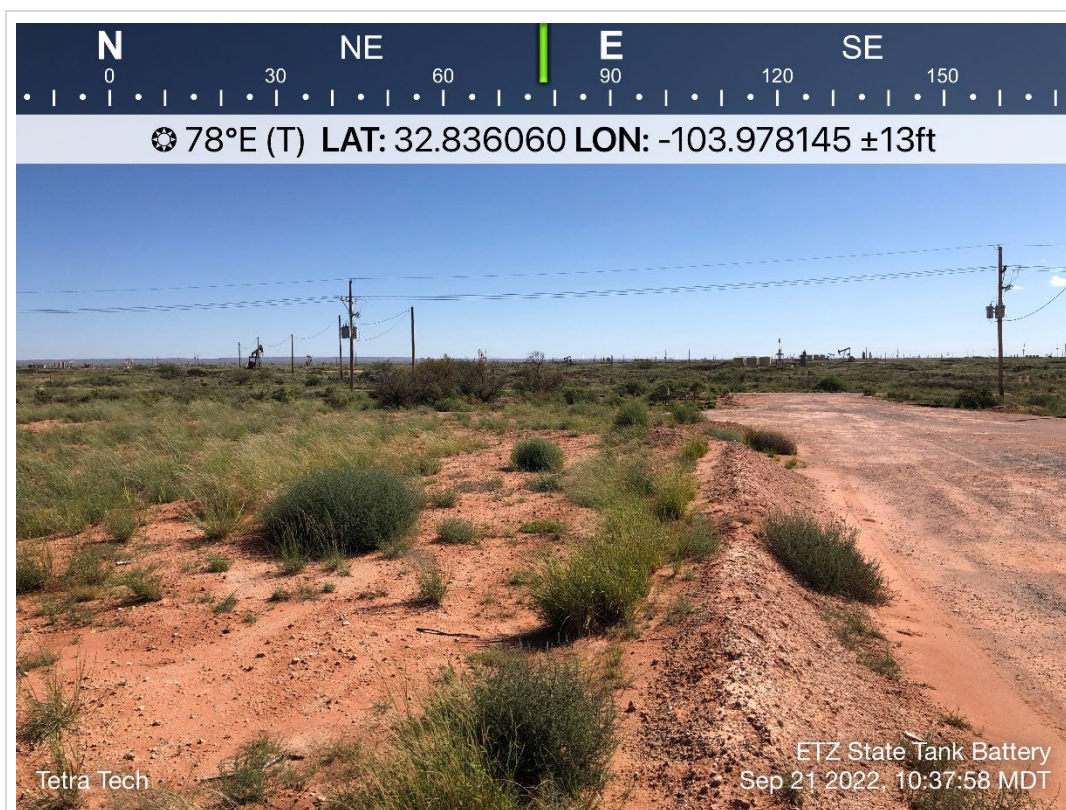
TETRA TECH, INC. PROJECT NO. 212C-MD-02849	DESCRIPTION	View east from the lease road of the reclaimed battery and surrounding pad.	7
	SITE NAME	ConocoPhillips hCXO ETZ State Unit Battery Release	9/21/2022

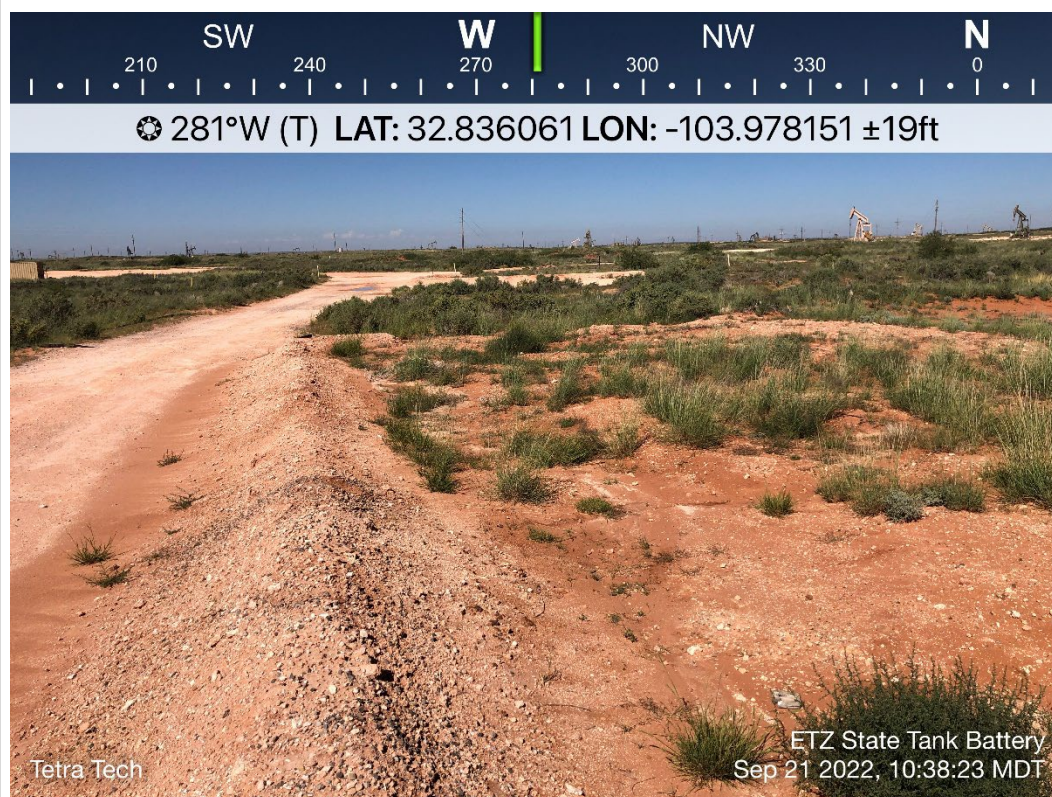
TETRA TECH, INC. PROJECT NO. 212C-MD-02849	DESCRIPTION	View west from the lease road of the reclaimed battery and surrounding pad.	8
	SITE NAME	ConocoPhillips hCXO ETZ State Unit Battery Release	9/21/2022
