Re: Site Assessment, Remediation, and Closure Report
Pearsall Federal SWD 1
API No. 30-025-40712
GPS: Latitude 32.8065033 Longitude -103.7759476
UL "E", Sec. 28, T17S, R32E
Eddy County, NM
NMOCD Ref. No. NAPP2218026857

Paragon Environmental, LLC (Paragon) has been contracted by Spur Energy Partners (Spur) to perform a spill assessment and remediation activities for the Release Site known as the Pearsall Federal SWD 1 (Pearsall). Details of the release are summarized below:

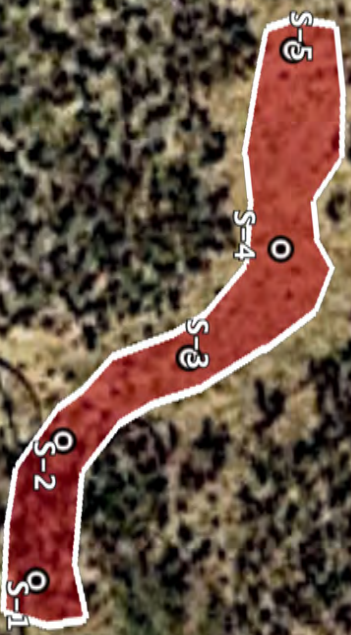
Pearsall Federal SWD #1
API# 30-025-40712
Lea County, NM
Site Map

On July 11, 2022, Paragon conducted an initial site assessment. During the initial site assessment, we obtained samples in the open pasture area along the spill path. The spill path measured approximately 85 feet long by 10 feet wide. Five (5) soil samples were collected in these areas in an effort to determine the vertical extent of soil impact. These samples were collected in accordance with NMAC 19.15.29 and submitted to an approved laboratory for analysis. A table summarizing laboratory analytical results from soil samples collected during the above-stated activities is provided below:

All Laboratory analytical reports are provided in Appendix E. A Site Map is provided in Figure #1.

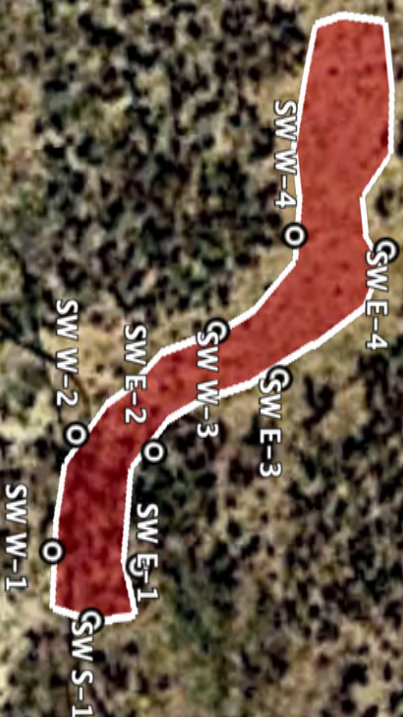
Pearsall Federal SWD #1
API# 30-025-40712
Lea County, NM
Sidewall Sample Map

All excavated soils were temporarily stockpiled on-site atop a poly liner during the project. Once these areas were excavated, we obtained confirmation bottom and sidewall samples. We utilized composite sampling, where each sample was representative of no more than 200 sq/ft. The results of this event are in the following data table:

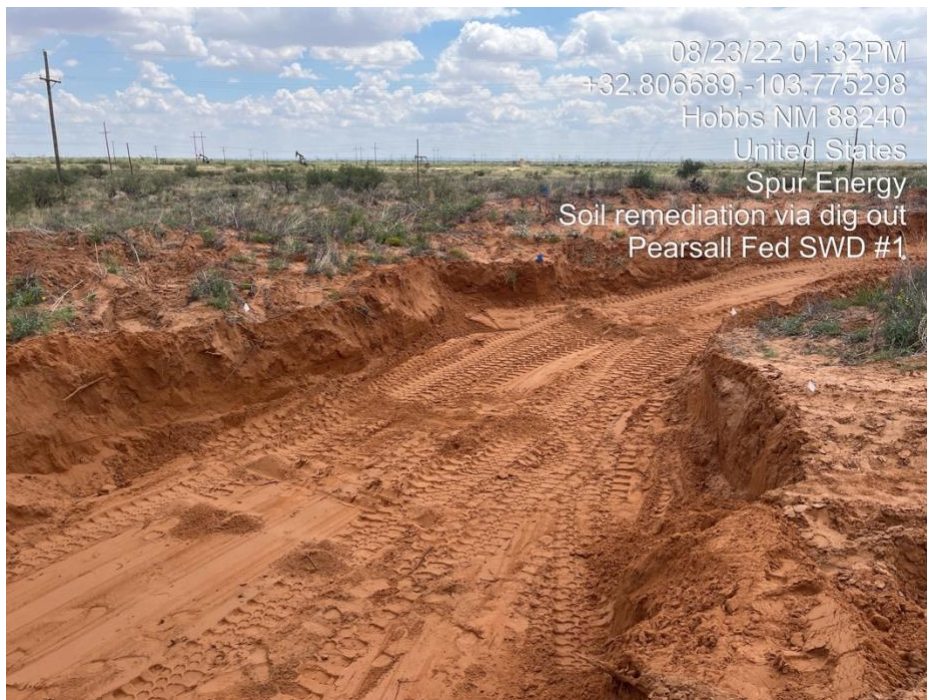
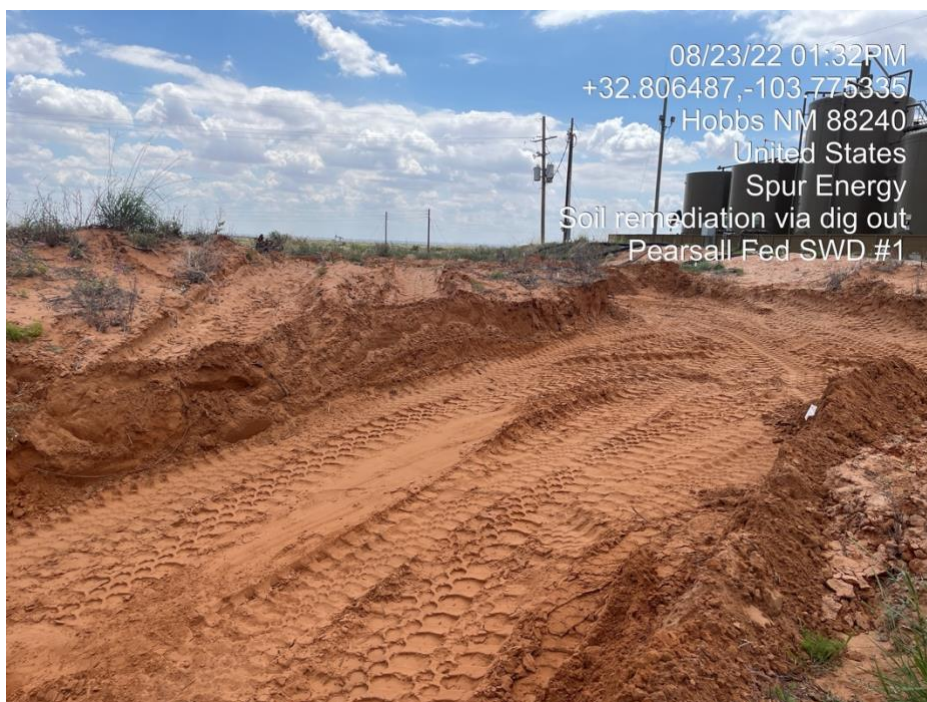
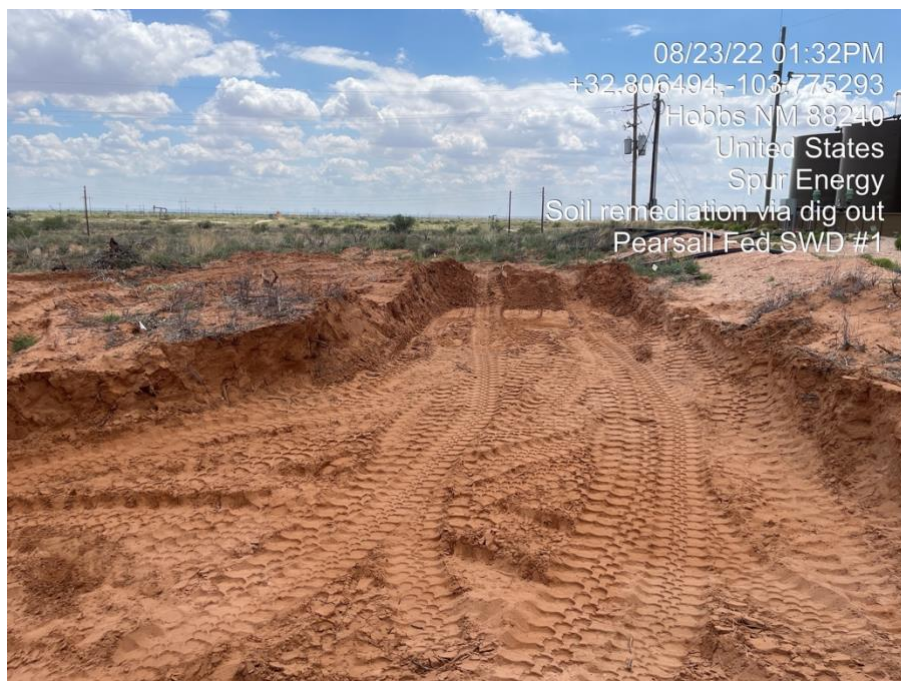
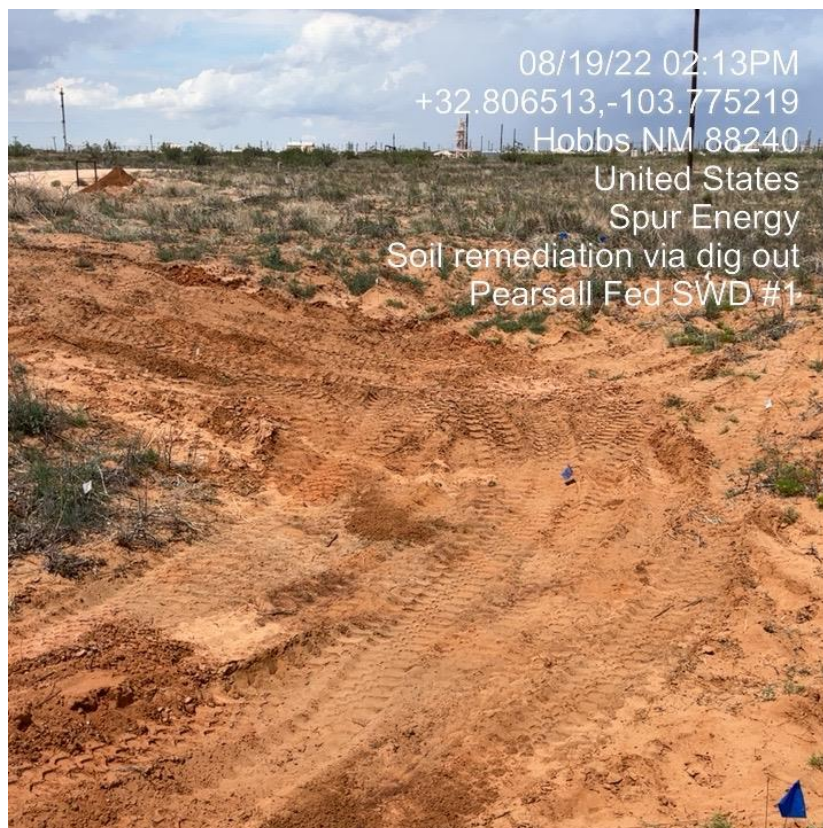
During

- S-1 was excavated to a depth of 1-foot BGS.
- S-2 through S-4 was excavated to a depth of 5-feet BGS.
- In the area of S-5, we excavated 6 inches to remove the staining. The initial sampling for this area proved to be below the closure criteria.

On August 4, 2022, Paragon mobilized personnel and heavy equipment to conduct remedial activities. Based on the analytical results, site characteristics, and field observations made during the site assessment, the following remedial activities were undertaken to advance the Release Site toward an NMOCD-approved closure.

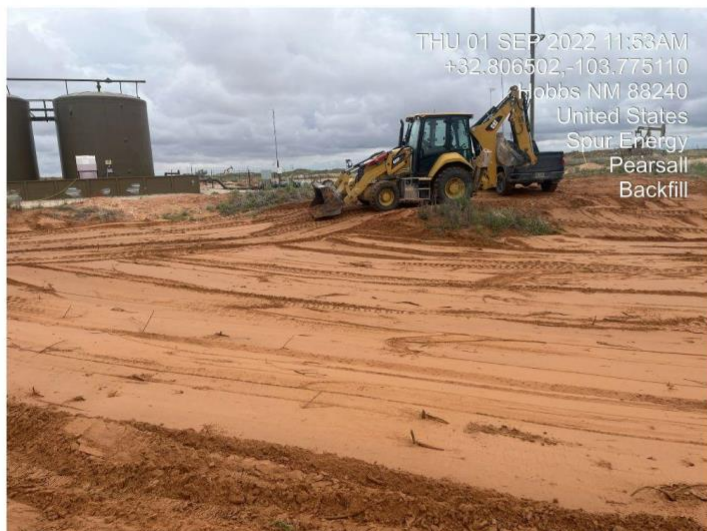
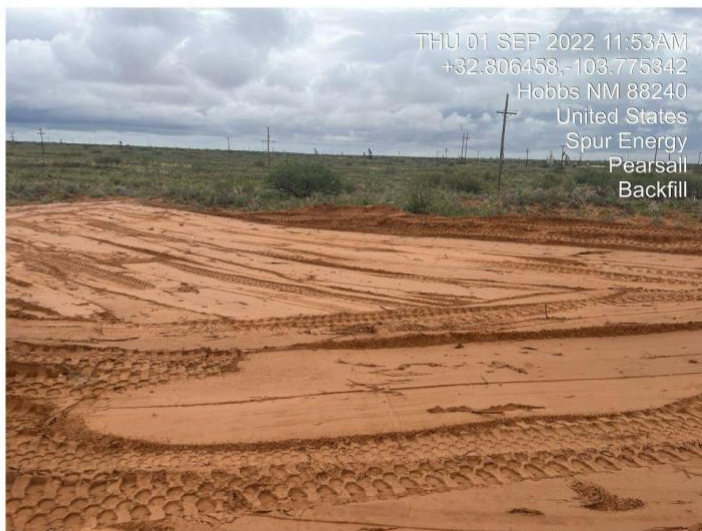
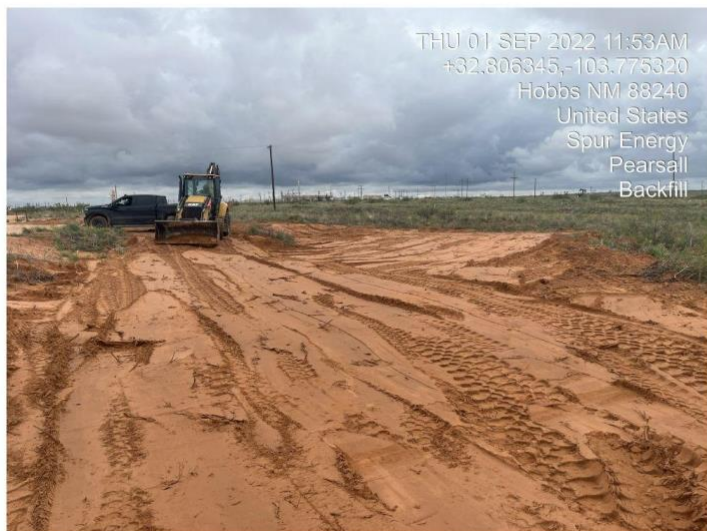
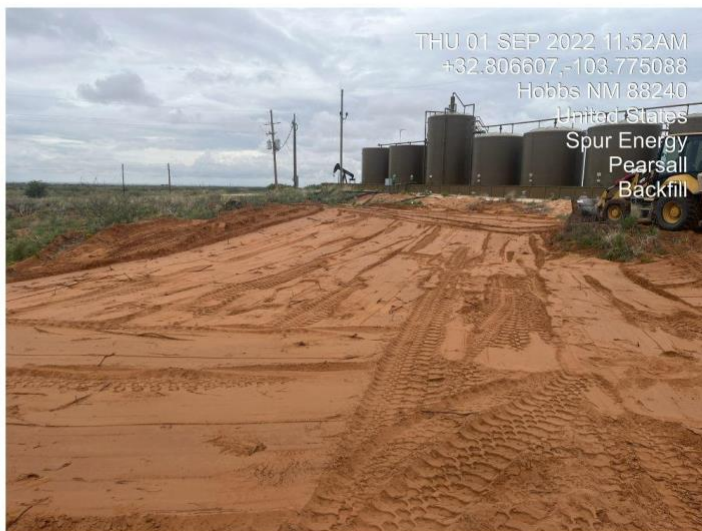
Completed

The laboratory analytical results confirmed that the soil sample concentrations were below NMOCD Closure Criteria. We then began to transport the contaminated material to Lea Land, an NMOCD-approved waste disposal facility. The excavated areas were backfilled utilizing the surrounding sand dunes to keep the area's native soils intact. The affected area was then contoured and machine compacted to match the surrounding grade.
