**Re: Site Assessment and Closure Report
State BH #001
API No. 30-025-00350
GPS: Latitude 32.9688911 Longitude -103.7324295
UL "P", Sec. 32, T15S, R32E
Lea County, NM
NMOCD Ref. No. NPAC0730333078**

Pima Environmental Services, LLC (Pima) has been contracted by Devon Energy Production Company (Devon) to perform a spill assessment and has prepared this Closure Report for a produced water release that occurred at the State BH #001 (State BH). An initial C-141 could not be found, please see the details of this incident in Appendix C. This incident was assigned Incident ID NPAC0730333078, by the New Mexico Oil Conservation Division (NMOCD).

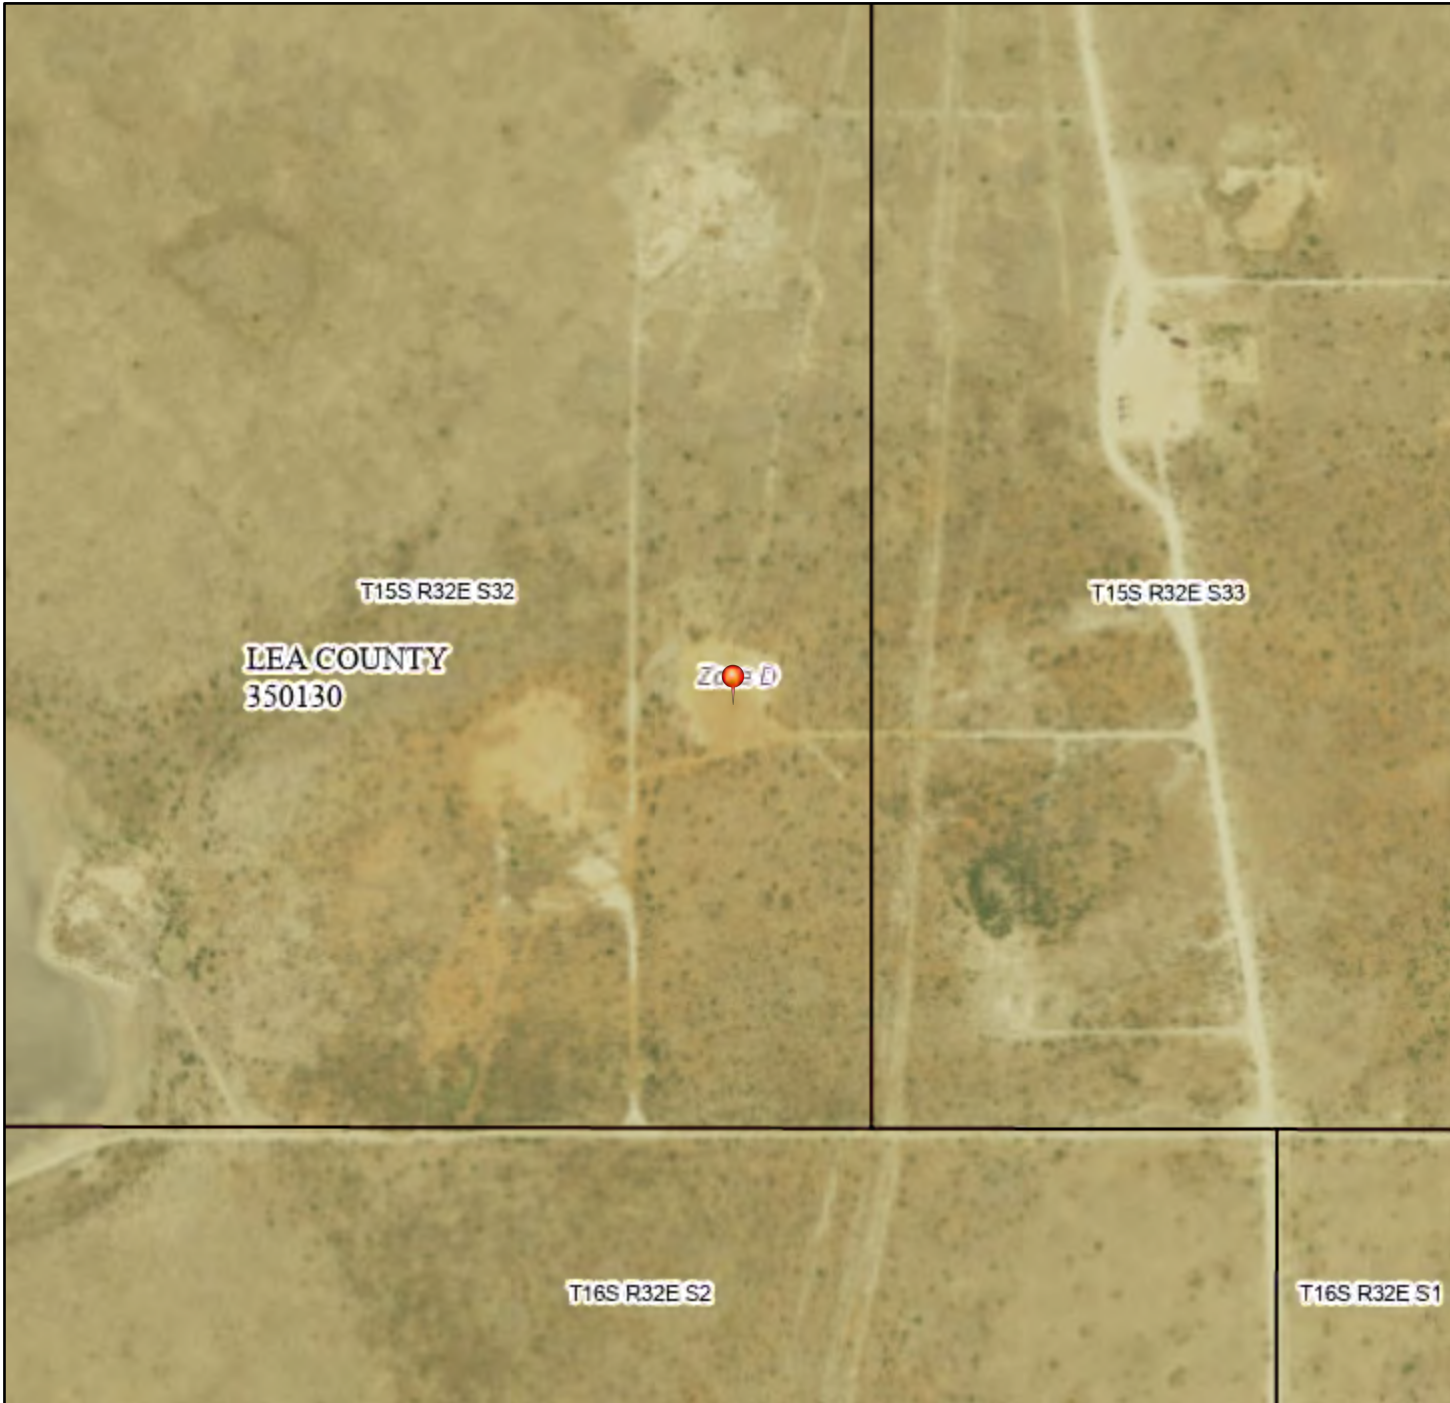
National Flood Hazard Layer FIRMette

The flood hazard information is derived directly from the authoritative NFHL web services provided by FEMA. This map was exported on 4/12/2021 at 3:08 PM and does not reflect changes or amendments subsequent to this date and time. The NFHL and effective information may change or become superseded by new data over time.
