Closure Report

Site Name:	Purdy 8 Federal #001 Battery
Company:	COG Operating LLC
Legal Description:	U/L A, Section 8, T23S, R26E
County:	Eddy County, NM
GPS Coordinates:	N 32.32340 W-104.31073

Date of Release:	4/17/18
Type of Release:	Oil
Source of Release:	Valve failure
Volume of Release:	0.5 bbl
Volume Recovered:	0 bbl

COG, Purdy 8 Federal #001 Battery

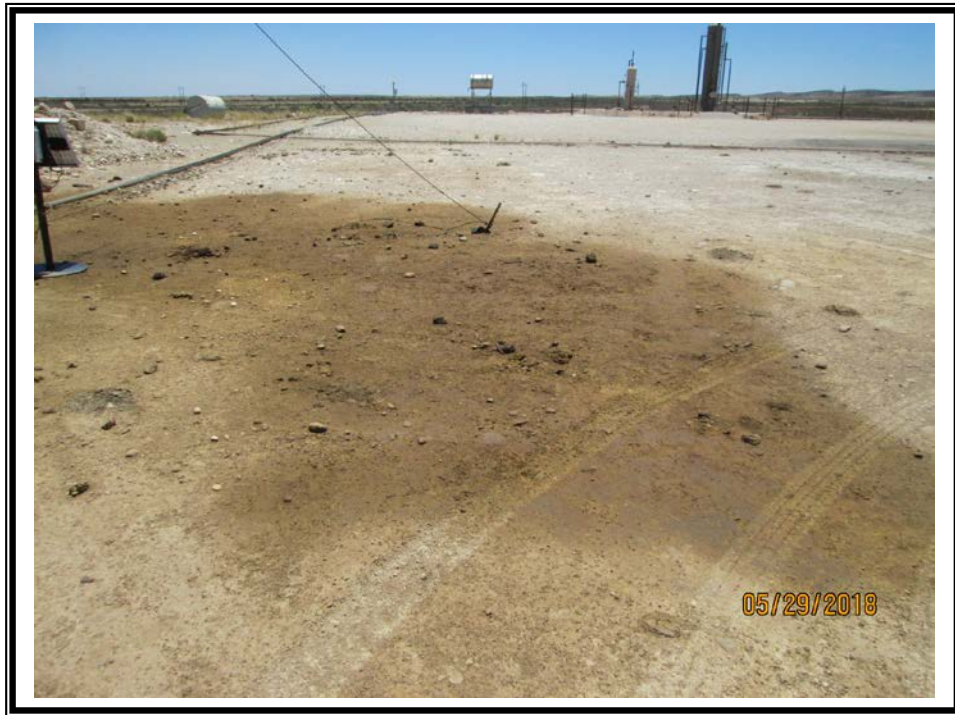
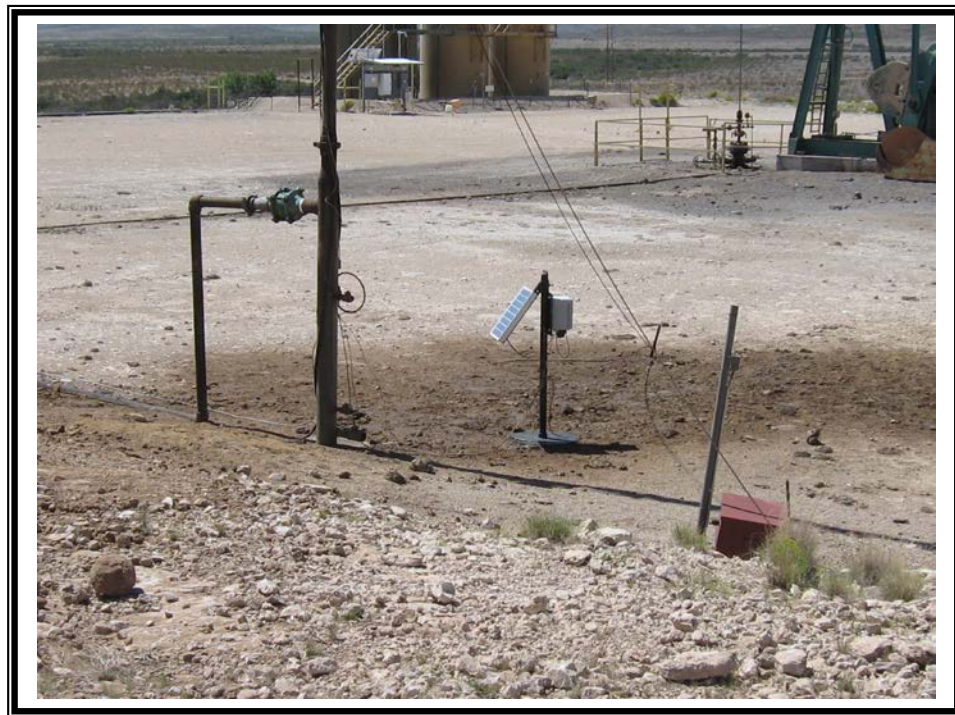
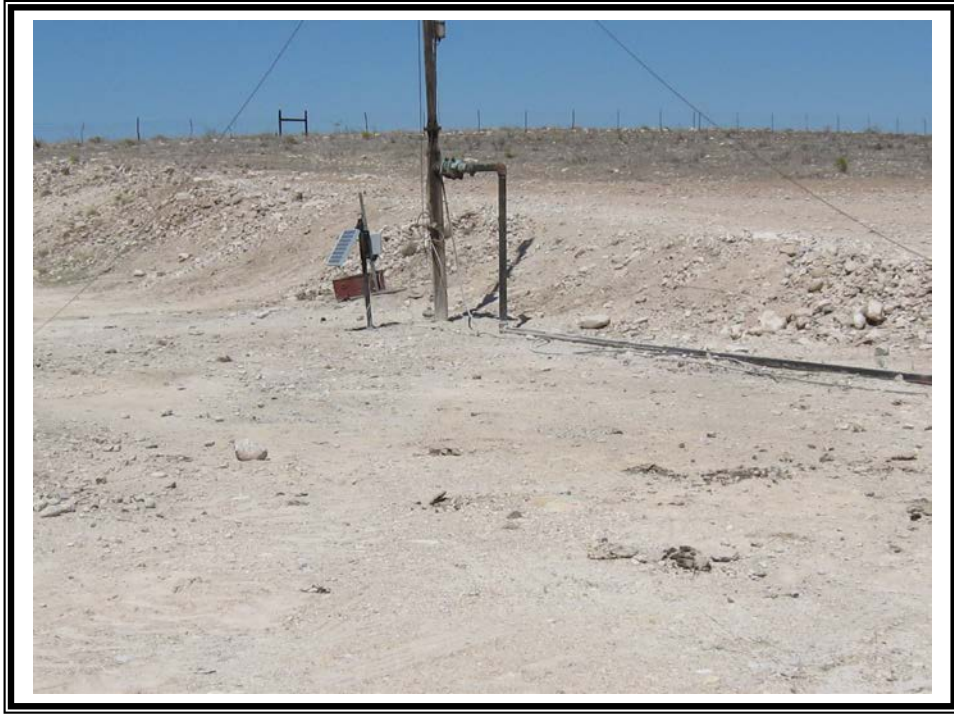
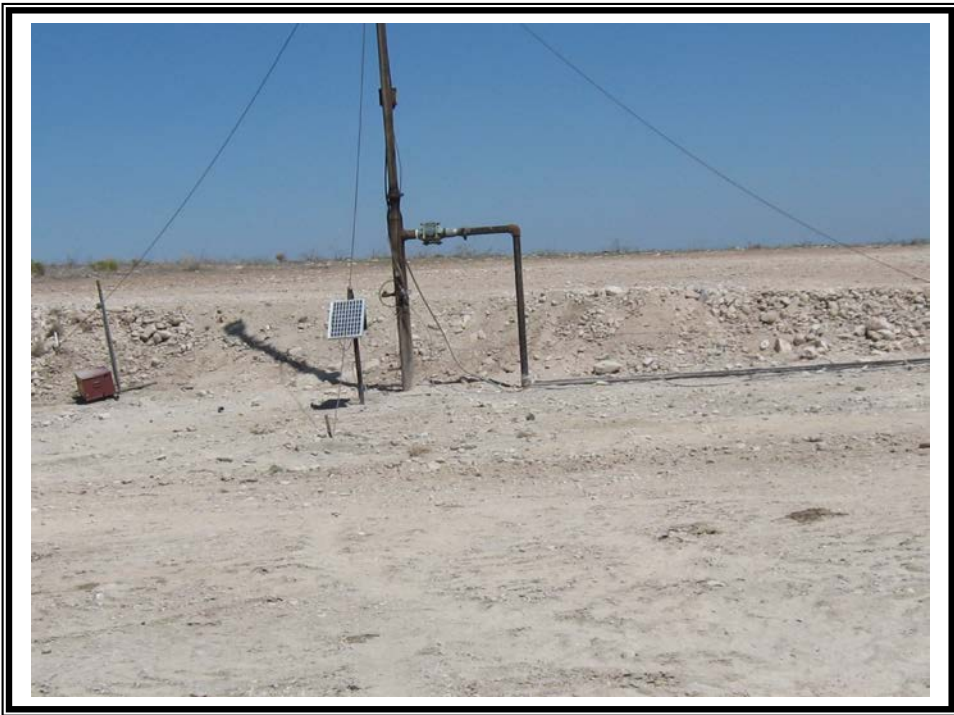
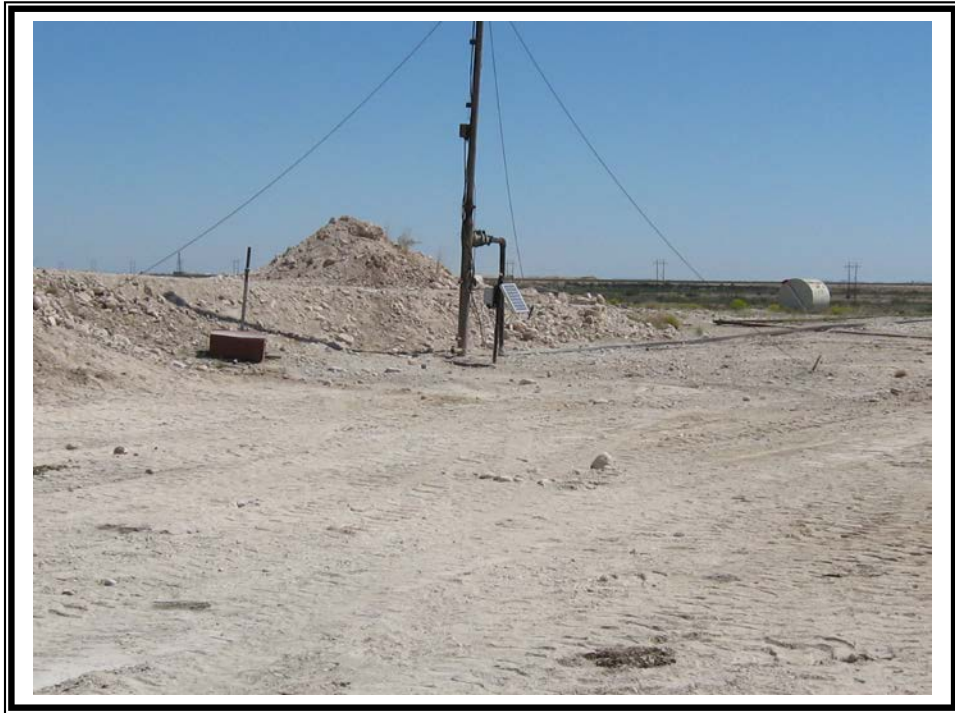
Initial C-141	Signed 04/19/2018
Final C-141	Signed 10/23/2018
Site Diagram	May 2018
Pictures	Initial visit-May 2018; Remediation-October 2018

Remediation Parameters:	Remediated the leak area by scraping the surface. Obtained a confirmation sample and backfilled the site with clean soil.	
Remediation Activities:	October 2018	
Plan Sent to OCD:	n/a	Unrecordable leak reported due to fire
OCD Approval of Plan:	n/a	n/a
Plan Sent to BLM:	n/a	n/a
BLM Approval of Plan:	n/a	n/a
