M&M Excavating, Inc. (MMX) has prepared this Remediation Closure Report for Devon Energy Production Company that describes the remediation of a release of liquids at the Thistle Unit #118H site. The site is in Unit N, Section 34, Township 23S, Range 33E, Latitude 32.2556006, Longitude -103.5616293, Lea County, New Mexico, on State land. Figure 1 provides the vicinity and site location on an USGS 7.5-minute quadrangle map.

Regional Vicinity & Wellhead Protection Map
 Thistle Unit #118H - Devon Energy
 Sec 34 T23S R33E Lea County, New Mexico

Site & Sample Locations
 Thistle Unit #118H - Devon Energy
 Sec. 34 T23S T33E, Lea County, NM

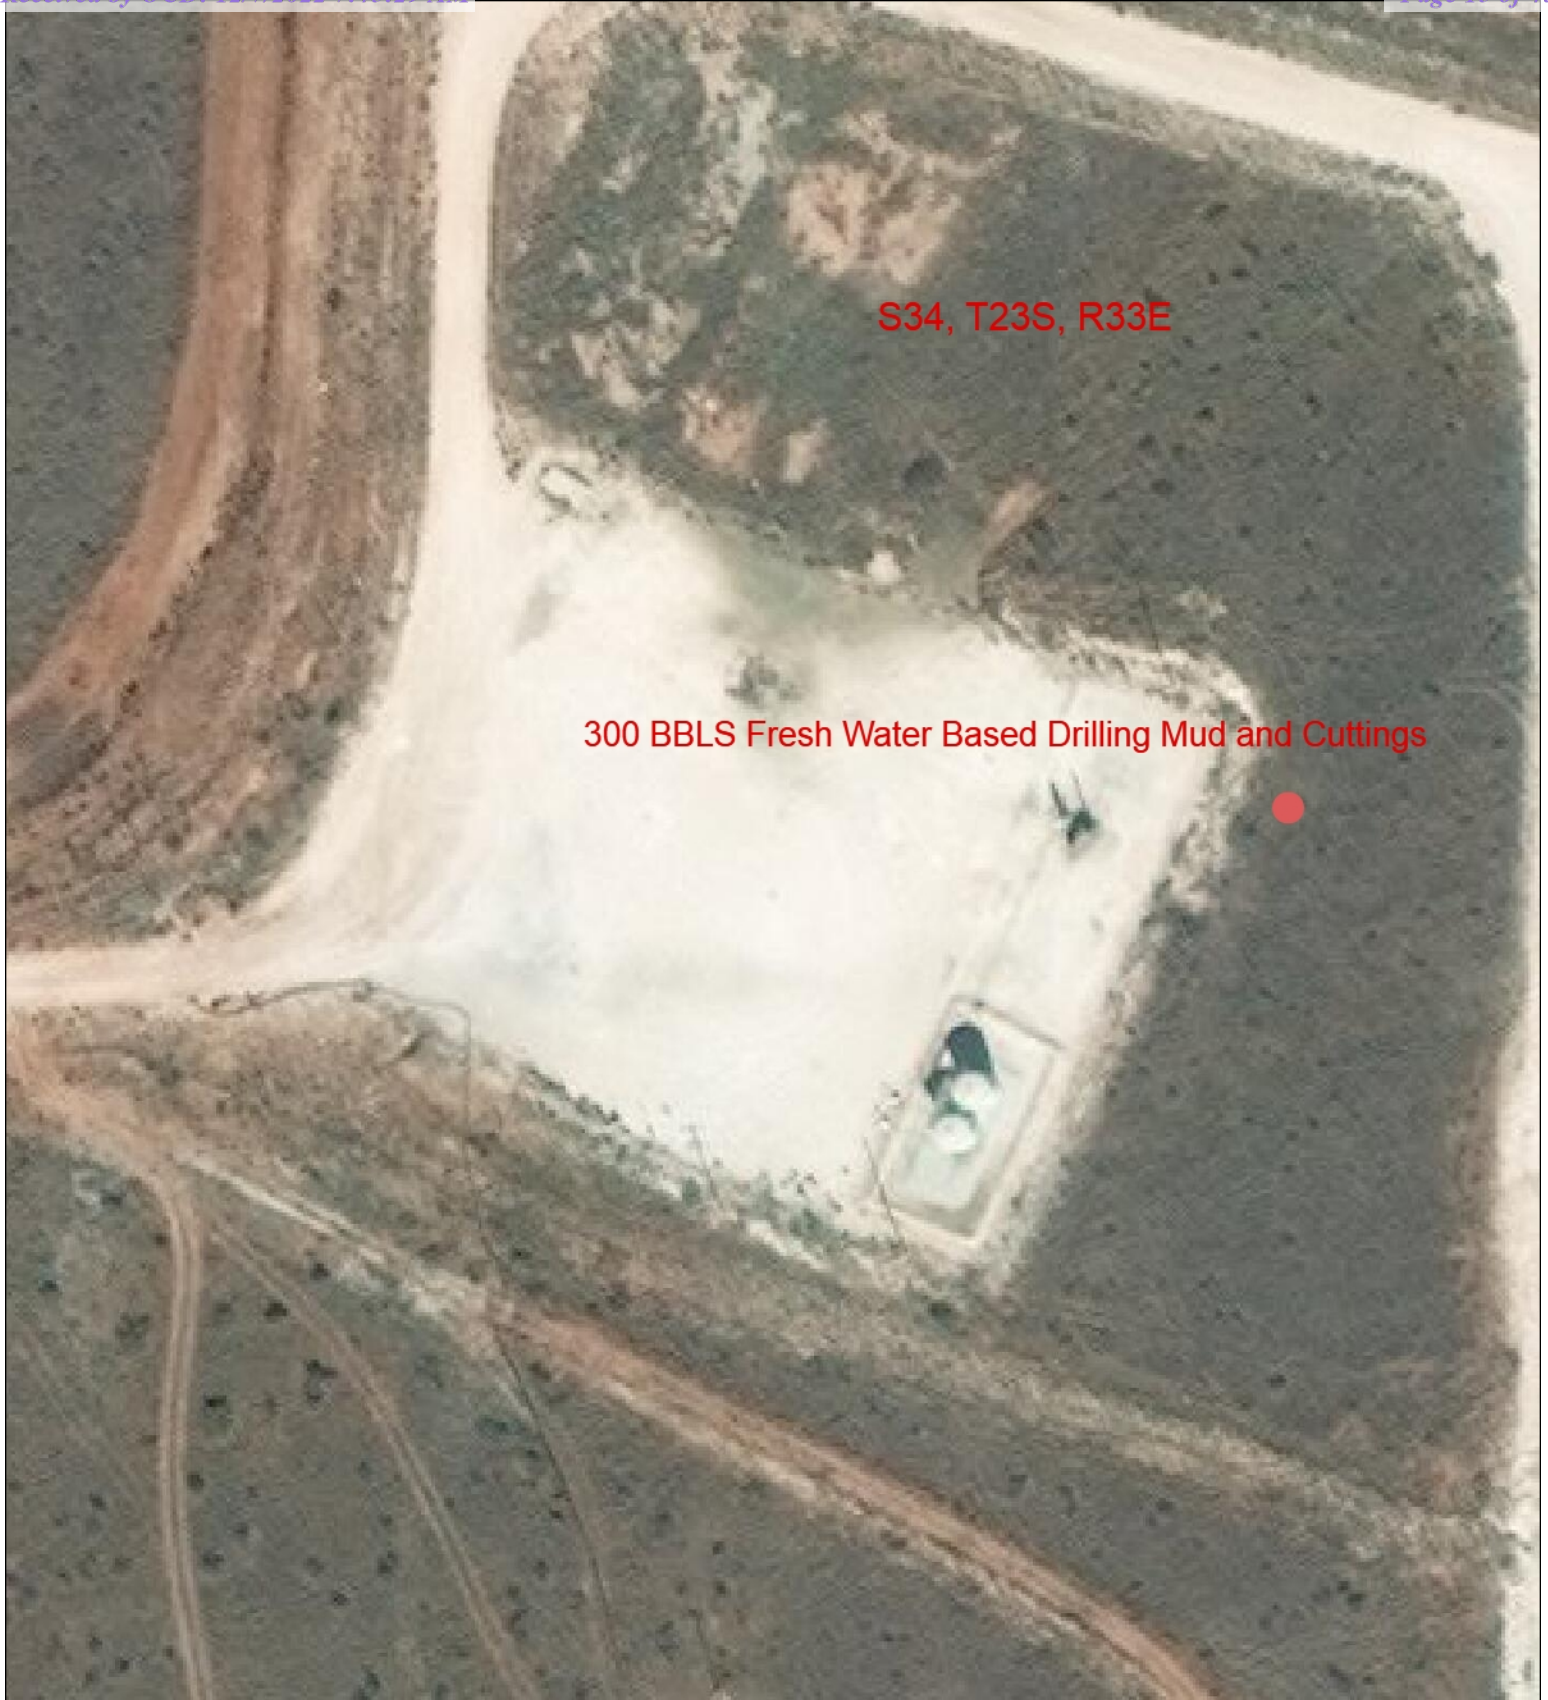
300BBL Fresh WBM and Cutti

On April 4, 2017, an air pocket was encountered during the drilling of the Thistle Unit #118H causing the release of 300 bbls of produced water onto the location. Initial response activities were conducted by the operator and included source elimination and site containment, recovering 140 bbls of the produced water. Figures 1 and 2 illustrate the vicinity and site location. Figure 3 illustrates the release location. The C-141 form is included in Appendix A.

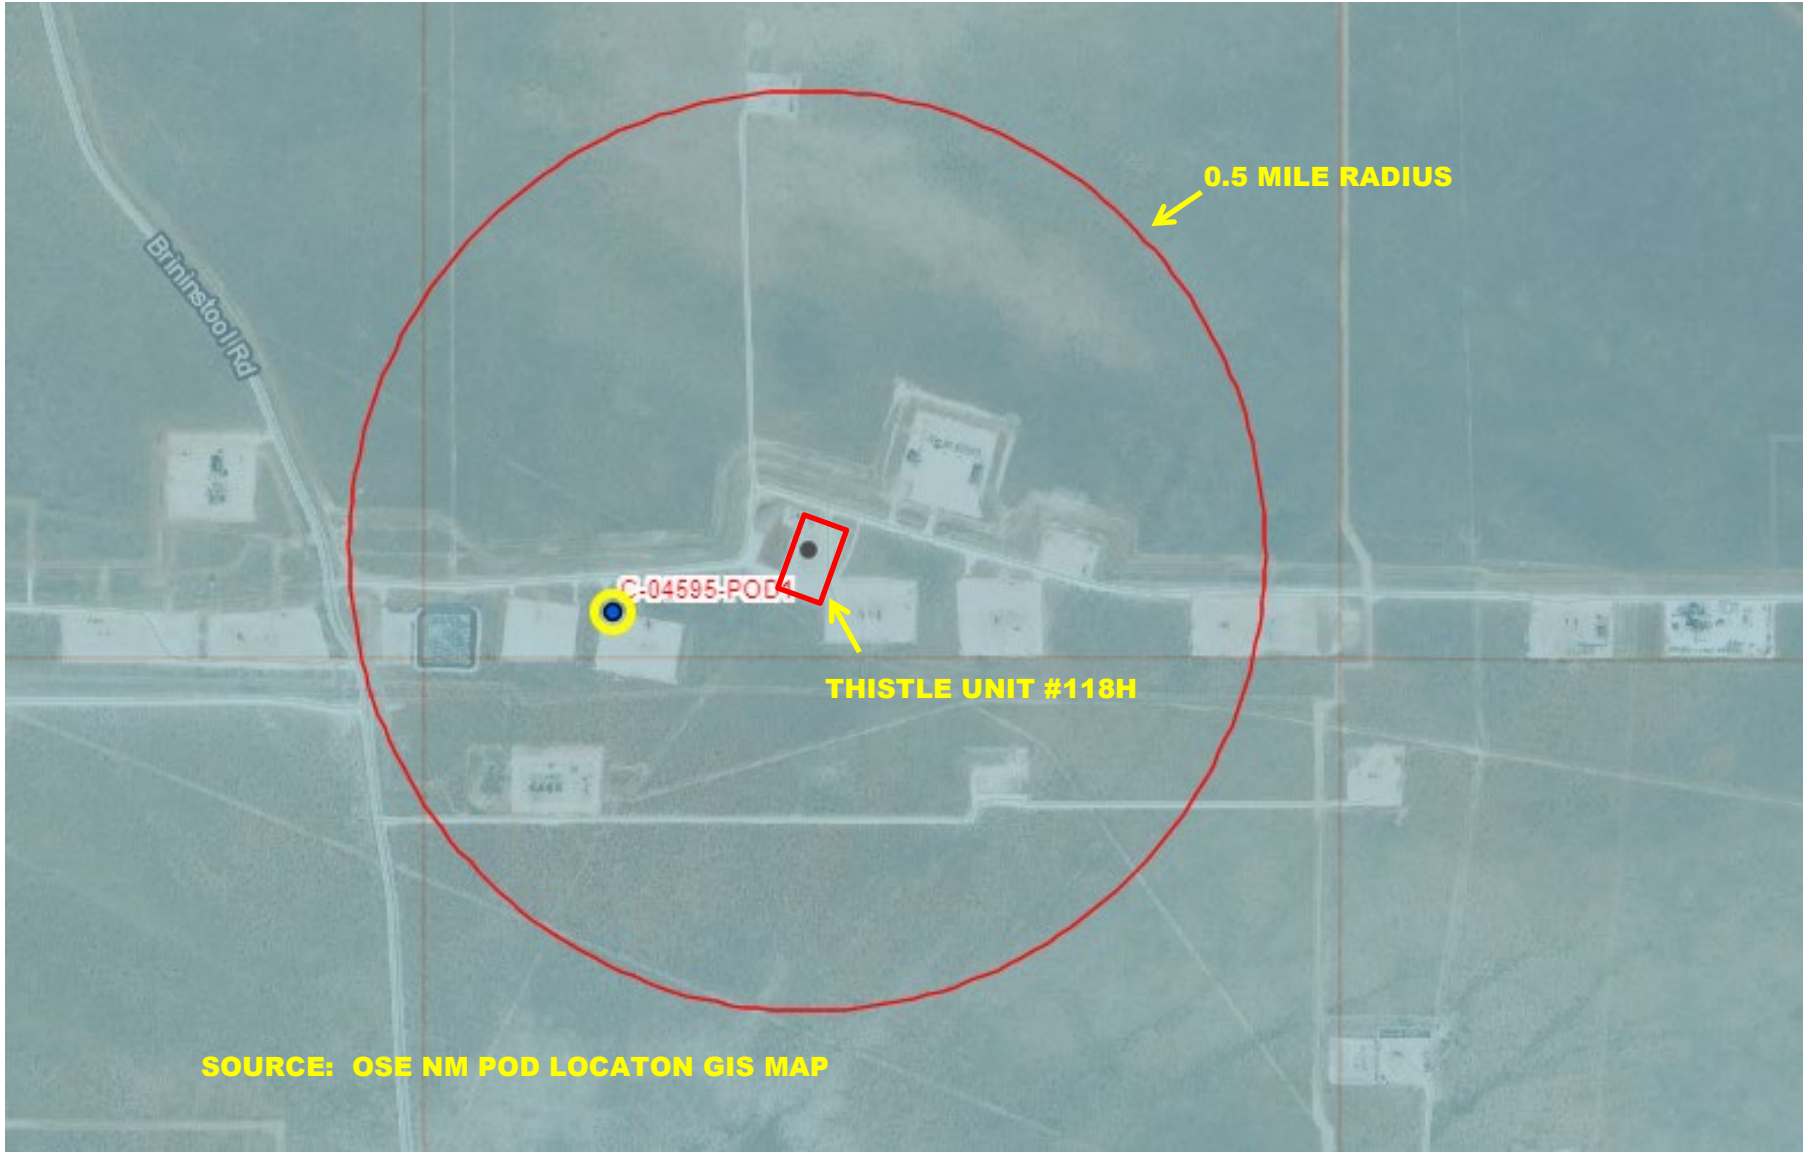
FIGURE 1: NM OSE POD LOCATIONS	
THISTLE UNIT 118H	
32.2556006,-103.5616293	
OCD INCIDENT nOY1711147510	
drawn by: RDW	Date: 12/2022

Based upon well water data. (Appendix B), depth to groundwater in the area is estimated to be more than 51 feet below grade surface (bgs). Pod 04595 is within ½ mile of the location, according to the New Mexico Office of the State Engineer (NMOSE) and USGS. The nearest significant watercourse is an unnamed pond located approximately 5975 feet to the southwest.
