Release Notification

**Re: Addendum to the "Updated Site Characterization Report and Variance Request"
Sandrock Water Gathering Pipeline
San Juan County, New Mexico
Hilcorp Energy Company
NMOCD Incident No: nAPP2104155952**

**Re: Updated Site Characterization Report and Variance Request
Sandrock Water Gathering Pipeline
San Juan County, New Mexico
Hilcorp Energy Company
NMOCD Incident No: nAPP2104155952**

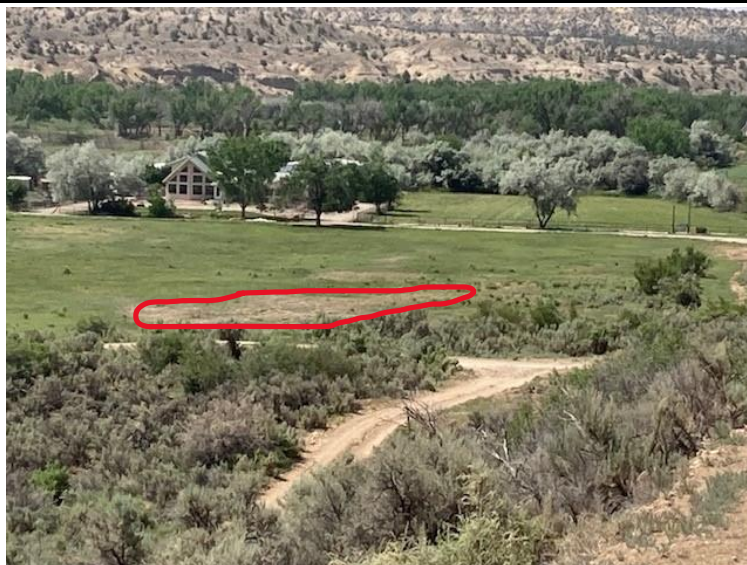
Photograph 1

Additionally, although the release has impacted some vegetation at the Site, the entire 15,315 square foot extent has not been impacted equally. The attached photographs (Appendix A) show the current impact to vegetation. While some of the vegetation is dead, there is visual evidence of live vegetation. An excavation would also impact healthy areas outside of the release footprint. Disturbance at the extent of excavation proposed may be more damaging to the property and outweigh the benefit of soil removal.

View of pasture looking south, impacted area outlined in red, taken June 28, 2022.

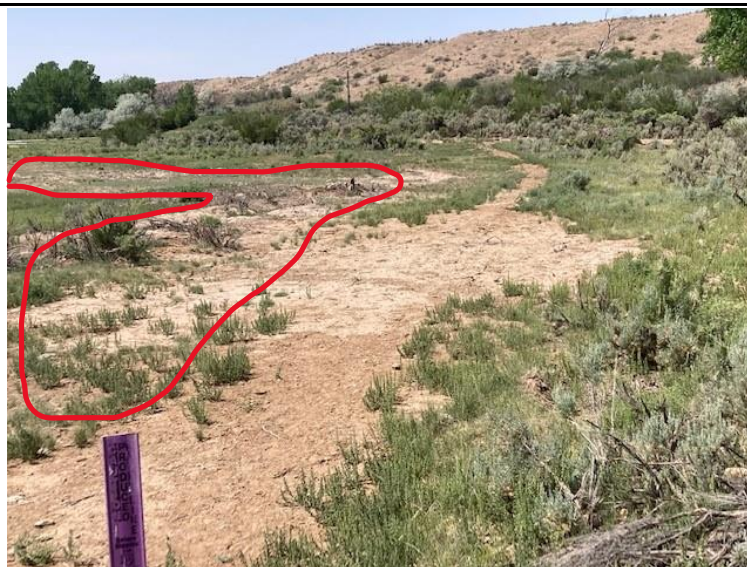
**Photograph 2**

View of pasture looking southwest, impacted area outlined in red. Other bare areas in photograph are cattle paths. Photograph taken June 28, 2022.

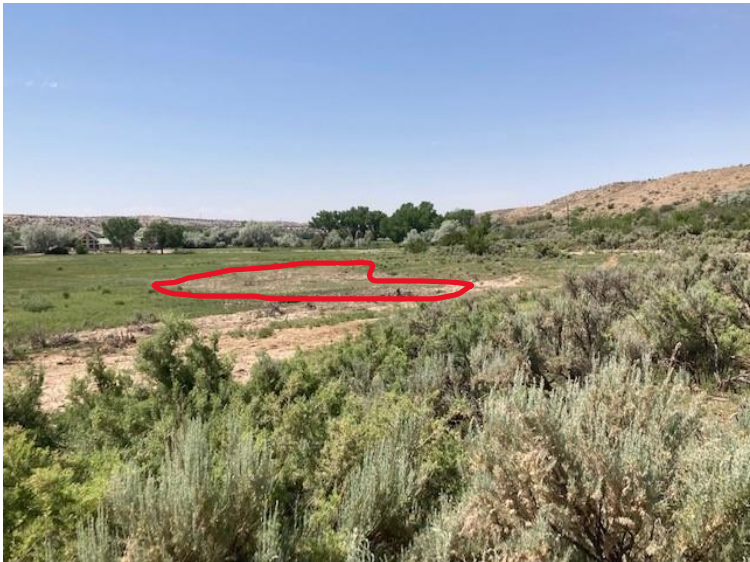
<p>Photograph 3</p> <p>View of pasture looking south-southwest, impacted area outlined in red. Photograph taken June 28, 2022.</p>

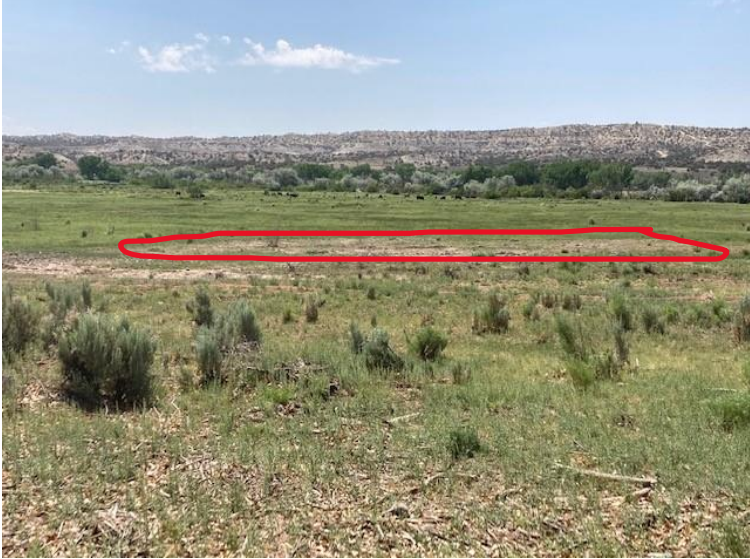
<p>Photograph 4</p> <p>View of pasture looking southeast, impacted area outlined in red. Photograph taken June 28, 2022.</p>

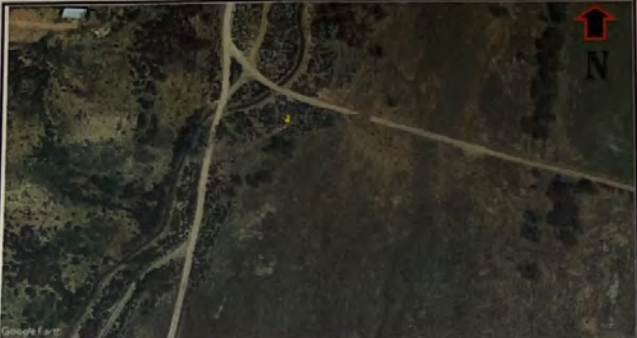
WSP USA INC								
		848 East 2nd Avenue								
		Durango, CO 81301								
		BORING LOG/MONITORING WELL COMPLETION DIAGRAM								
Boring/Well Number: BH01		Project: Sandrock Water Gathering								
Date: 4/7/2021		Project Number:								
Logged By: Eric Carroll		Drilled By: Hilcorp								
Elevation: 6,000	Detector: PID	Drilling Method: Hollow Stem	Sampling Method: Continuous							
Gravel Pack: 10-20 Silica Sand		Seal: Bentonite	Grout: Bentonite							
Casing Type: Schedule 40 PVC	Diameter: 2"	Length: NA	Hole Diameter: 6"							
Screen Type: Schedule 40 PVC	Slot: 0.010"	Diameter: 2"	Length: NA							
		Total Depth: 9'	Depth to Liquid: NA							
			Depth to Water: 6-5							
Penetration Resistance	Moisture Content	Vapor (ppm)	HC Staining?	Sample #	Depth (ft. bgs.)	Sample Run	Recovery	Soil/Rock Type	Lithology/Remarks	Well Completion
	m	5.6	✓	BH01 0-2'	0			SM	moist, loose, red brown, silty sand no stain/odor

1	1			CI ⁻ = 4.2 636	
					2					
	m	4.1	✓		3	2		SM	SAA	
					4				CI ⁻ = 3.2 392	
					5					
	m	3.2		BH01 4-5'	6	3		SM	SAA	
					7				CI ⁻ = 1.8 152	
					8					
	w	2.2			9	4		SC	wet, cohesive, sand, some clay	
					10				Dark brown GW @ 6.5'	
					11				CI ⁻ 1.2 <124	
					12					
					13					
					14					
					15					
									to SAA	
									CI ⁻ 0.4 <125

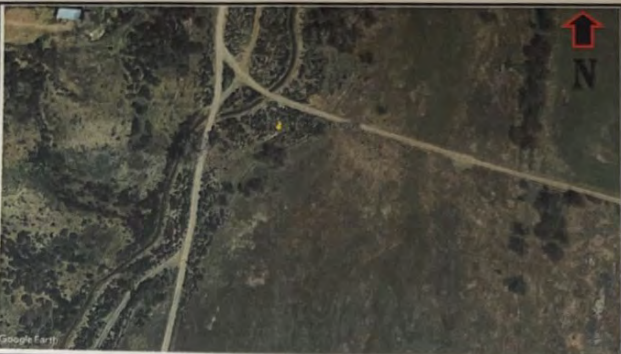
WSP USA INC								
		848 East 2nd Avenue Durango, CO 81301								
		BORING LOG/MONITORING WELL COMPLETION DIAGRAM								
		Boring/Well Number: BH03	Project: Sandrock Water Gathering							
Date: 4/7/2021		Project Number:								
Logged By: Eric Carroll		Drilled By: Hilcorp								
Elevation: 6,000	Detector: PID	Drilling Method: Hollow Stem	Sampling Method: Continuous							
Gravel Pack: 10-20 Silica Sand		Seal: Bentonite	Grout: Bentonite							
Casing Type: Schedule 40 PVC		Diameter: 2"	Length: 6'							
Screen Type: Schedule 40 PVC		Slot: 0.010"	Diameter: 2"							
		Length:	Total Depth: 5'							
			Depth to Liquid: NA							
			Depth to Water:							
Penetration Resistance	Moisture Content	Vapor (ppm)	HC Staining?	Sample #	Depth (ft. bgs.)	Sample Run	Recovery	Soil/Rock Type	Lithology/Remarks	Well Completion
	m	24.7	N		0			SM	moist dark brown silty sand Cl ⁻ = 0.8 < 124	
					1	1				
					2

3	2		SM	moist, red brown silty sand Cl ⁻ = 0.8 < 124	
					4					
					5	3		SC	moist, brown, silty sand, few clay Cl ⁻ 0.6 < 124	
					6					
					7					
					8					
					9					
					10					
					11					
					12					
					13					
					14					
					15

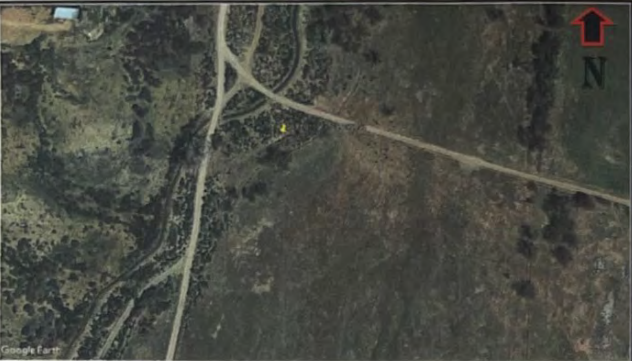
WSP USA INC						
				848 East 2nd Avenue						
				Durango, CO 81301						
				BORING LOG/MONITORING WELL COMPLETION DIAGRAM						
Boring/Well Number: BH04				Project: Sandrock Water Gathering						
Date: 4/7/2021				Project Number:						
Logged By: Eric Carroll				Drilled By: Hilcorp						
Drilling Method: Hollow Stem				Sampling Method: Continuous						
Elevation: 6,000				Detector: PID						
Gravel Pack: 10-20 Silica Sand				Seal: Bentonite						
Casing Type: Schedule 40 PVC				Diameter: 2"		Length: NA				
Screen Type: Schedule 40 PVC				Slot: 0.010"		Diameter: 2"				
						Hole Diameter: 6"				
						Depth to Liquid: NA				
						Total Depth: 5'				
						Depth to Water:				
Penetration Resistance	Moisture Content	Vapor (ppm)	HC Staining?	Sample #	Depth (ft. bgs.)	Sample Run	Recovery	Soil/Rock Type	Lithology/Remarks	Well Completion
	m	6.6	N		0			SM	moist, red brown silty sand	
					1				CI⁻ = 0.4 < 124

2					
					3			SM	SAA	
					4				CI⁻ = 0.4 < 124	
					5			SC	moist brown, sand, some silt and clay cohesive	
					6				CI⁻ = 0.4 < 124	
					7					
					8					
					9					
					10					
					11					
					12					
					13					
					14					
					15

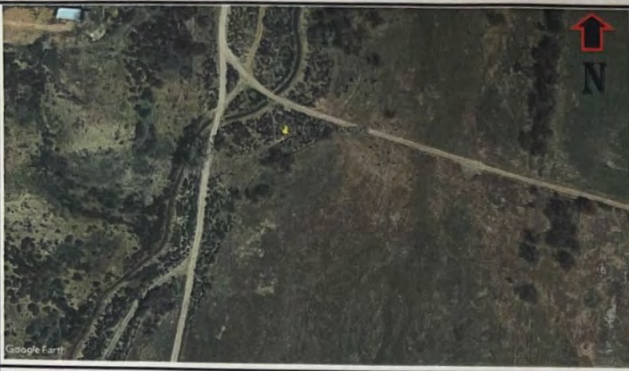
WSP USA INC								
		848 East 2nd Avenue								
		Durango, CO 81301								
		BORING LOG/MONITORING WELL COMPLETION DIAGRAM								
Boring/Well Number: BH05		Project: Sandrock Water Gathering								
Date: 4/7/2021		Project Number:								
Logged By: Eric Carroll		Drilled By: Hilcorp								
Drilling Method: Hollow Stem		Sampling Method: Continuous								
Elevation: 6,000	Detector: PID	Seal: Bentonite								
Gravel Pack: 10-20 Silica Sand		Grout: Bentonite								
Casing Type: Schedule 40 PVC		Diameter: 2"	Length: NA							
Screen Type: Schedule 40 PVC		Diameter: 2"	Length: NA							
Slot: 0.010"		Total Depth: 5'	Depth to Liquid: NA							
Depth to Water: NA										
Penetration Resistance	Moisture Content	Vapor (ppm)	HC Staining?	Sample #	Depth (ft. bgs.)	Sample Run	Recovery	Soil/Rock Type	Lithology/Remarks	Well Completion
	m	4.7	N	BH05 0-2	0			SM	moist, red brown, silty sand	
					1	1			CI- 0.4 <124

2					
	m	3.1	N		3	2		SM	SAA	
					4				CI- 0.4 <124	
	m	2.8	N	BH05 4-5	5	3		SC	moist brown, sand, some silt & clay cohesive	
					6				CI- 0.2 <124	
					7					
					8					
					9					
					10					
					11					
					12					
					13					
					14					
					15

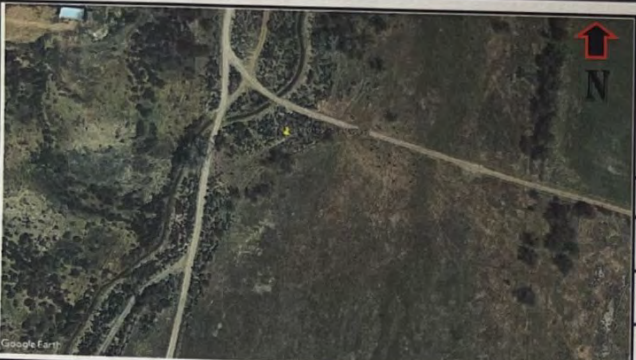
WSP USA INC																																																																																																																																																																																												
		848 East 2nd Avenue																																																																																																																																																																																												
		Durango, CO 81301																																																																																																																																																																																												
		BORING LOG/MONITORING WELL COMPLETION DIAGRAM																																																																																																																																																																																												
Boring/Well Number: BH06		Project: Sandrock Water Gathering																																																																																																																																																																																												
Date: 4/7/2021		Project Number:																																																																																																																																																																																												
Logged By: Eric Carroll		Drilled By: Hilcorp																																																																																																																																																																																												
Drilling Method: Hollow Stem		Sampling Method: Continuous																																																																																																																																																																																												
Seal: Bentonite		Grout: Bentonite																																																																																																																																																																																												
Diameter: 2" Length: NA		Hole Diameter: 6"	Depth to Liquid: NA																																																																																																																																																																																											
Diameter: 2" Length: NA		Total Depth: 5'	Depth to Water:

Penetration Resistance	Moisture Content	Vapor (ppm)	HC Staining?	Sample #	Depth (ft. bgs.)	Sample Run	Recovery	Soil/Rock Type	Lithology/Remarks	Well Completion		m	3.6	N	BH06 0-2	0			SM	moist, red brown, silty sand							1	1			CI ⁻ = 4.0 580							2							m	3.4	N		3	2			SAA							4				CI ⁻ = 2.8 312			m	3.1	N	BH06 4-5	5	3			moist, brown, sand, some clay & silt, cohesive							6				CI ⁻ = 1.4 < 124							7											8											9											10											11											12											13											14											15					
Penetration Resistance	Moisture Content	Vapor (ppm)	HC Staining?	Sample #	Depth (ft. bgs.)	Sample Run	Recovery	Soil/Rock Type	Lithology/Remarks	Well Completion																																																																																																																																																																																				
	m	3.6	N	BH06 0-2	0			SM	moist, red brown, silty sand																																																																																																																																																																																					
					1	1			CI ⁻ = 4.0 580																																																																																																																																																																																					
					2																																																																																																																																																																																									
	m	3.4	N		3	2			SAA																																																																																																																																																																																					
					4				CI ⁻ = 2.8 312																																																																																																																																																																																					
	m	3.1	N	BH06 4-5	5	3			moist, brown, sand, some clay & silt, cohesive																																																																																																																																																																																					
					6				CI ⁻ = 1.4 < 124																																																																																																																																																																																					
					7																																																																																																																																																																																									
					8																																																																																																																																																																																									
					9																																																																																																																																																																																									
					10																																																																																																																																																																																									
					11																																																																																																																																																																																									
					12																																																																																																																																																																																									
					13																																																																																																																																																																																									
					14																																																																																																																																																																																									
					15

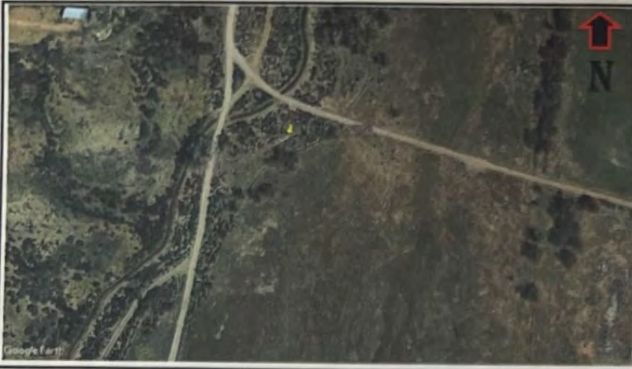
WSP USA INC								
		848 East 2nd Avenue								
		Durango, CO 81301								
		BORING LOG/MONITORING WELL COMPLETION DIAGRAM								
Boring/Well Number: BH07		Project: Sandrock Water Gathering								
Date: 4/7/2021		Project Number:								
Logged By: Eric Carroll		Drilled By: Hilcorp								
Elevation: 6,000	Detector: PID	Drilling Method: Hollow Stem	Sampling Method: Continuous							
Gravel Pack: 10-20 Silica Sand		Seal: Bentonite	Grout: Bentonite							
Casing Type: Schedule 40 PVC	Diameter: 2"	Length: NA	Hole Diameter: 6"							
Screen Type: Schedule 40 PVC	Slot: 0.010"	Diameter: 2"	Length: NA							
		Total Depth: 5'	Depth to Water:							
Penetration Resistance	Moisture Content	Vapor (ppm)	HC Staining?	Sample #	Depth (ft. bgs.)	Sample Run	Recovery	Soil/Rock Type	Lithology/Remarks	Well Completion
	m	1.7	N	BH07 0-2	0				moist, red brown, silty sand	
					1				CI ⁻ = 1.8 152	
					2	1				
	m	1.1	N		3	2			SAA =

4				CI ⁻ = 1.6 124	
	m	0.8	N	BH07 4-5	5	3			moist, brown, sand, some clay & silt, cohesive	
					6				CI ⁻ = 0.8 < 124	
					7					
					8					
					9					
					10					
					11					
					12					
					13					
					14					
					15

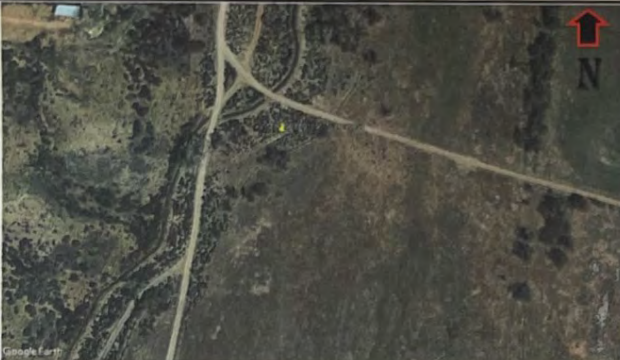
WSP USA INC						
				848 East 2nd Avenue						
				Durango, CO 81301						
				BORING LOG/MONITORING WELL COMPLETION DIAGRAM						
Boring/Well Number: B408				Project: Sandrock Water Gathering						
Date: 4/7/2021				Project Number:						
Logged By: Eric Carroll				Drilled By: Hilcorp						
Drilling Method: Hollow Stem				Sampling Method: Continuous						
Gravel Pack: 10-20 Silica Sand				Seal: Bentonite						
Grout: Bentonite										
Casing Type: Schedule 40 PVC				Diameter: 2"	Length: NA	Hole Diameter: 6"	Depth to Liquid: NA			
Screen Type: Schedule 40 PVC				Slot: 0.010"	Diameter: 2"	Length: NA	Total Depth: 5'			
				Depth to Water:						
Penetration Resistance	Moisture Content	Vapor (ppm)	HC Staining?	Sample #	Depth (ft. bgs.)	Sample Run	Recovery	Soil/Rock Type	Lithology/Remarks	Well Completion
	m	3.9	N	B408 0-2	0				moist, red brown, silty sand	
					1	1			CI = 1.6 < 124	
					2					
	m	2.7	N		3	2			SAA

4				CI = 1.2 < 124	
	m	2.4	N	B408 4-5	5	3			moist, brown, cohesive, sand	
					6				some clay & silt	
					7				CI = 0.6 < 124	
					8					
					9					
					10					
					11					
					12					
					13					
					14					
					15

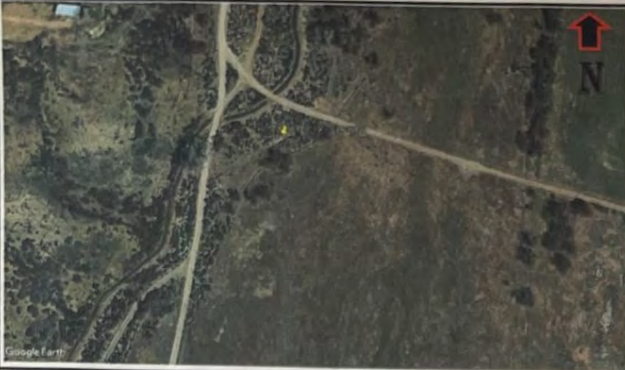
WSP USA INC								
		848 East 2nd Avenue								
		Durango, CO 81301								
		BORING LOG/MONITORING WELL COMPLETION DIAGRAM								
Boring/Well Number: BH09		Project: Sandrock Water Gathering								
Date: 4/7/2021		Project Number:								
Logged By: Eric Carroll		Drilled By: Hilcorp								
Elevation: 6,000	Detector: PID	Drilling Method: Hollow Stem	Sampling Method: Continuous							
Gravel Pack: 10-20 Silica Sand		Seal: Bentonite	Grout: Bentonite							
Casing Type: Schedule 40 PVC		Diameter: 2"	Length: NA							
Screen Type: Schedule 40 PVC		Diameter: 2"	Length: NA							
Slot: 0.010"		Total Depth: 5'	Depth to Liquid: NA							
Depth to Water: 5'										
Penetration Resistance	Moisture Content	Vapor (ppm)	HC Staining?	Sample #	Depth (ft. bgs.)	Sample Run	Recovery	Soil/Rock Type	Lithology/Remarks	Well Completion
	m	6.9	N	BH09 0-2	0				moist, red brown, loose sand	
					1	1			CI = 1.8 152	
					2

m	4.9	N		3	2			moist, red brown, loose, sand	
					4				CI = 1.4 <124	
					5	3			moist, brown, cohesive, sand	
	m	4.7	N	BH09 4-5	6				Some clay & silt	
					7				CI = 0.8 <124	
					8					
					9					
					10					
					11					
					12					
					13					
					14					
					15

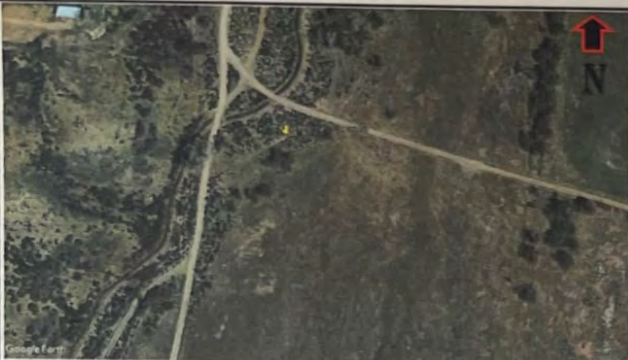
WSP USA INC						
				848 East 2nd Avenue						
				Durango, CO 81301						
				BORING LOG/MONITORING WELL COMPLETION DIAGRAM						
Boring/Well Number: BH10				Project: Sandrock Water Gathering						
Date: 4/7/2021				Project Number:						
Logged By: Eric Carroll				Drilled By: Hilcorp						
Elevation: 6,000		Detector: PID		Drilling Method: Hollow Stem		Sampling Method: Continuous				
Gravel Pack: 10-20 Silica Sand				Seal: Bentonite		Grout: Bentonite				
Casing Type: Schedule 40 PVC				Diameter: 2"		Length: NA				
Screen Type: Schedule 40 PVC				Slot: 0.010"		Diameter: 2"				
				Length: NA		Total Depth: 5'				
						Depth to Liquid: NA				
						Depth to Water:				
Penetration Resistance	Moisture Content	Vapor (ppm)	HC Staining?	Sample #	Depth (ft. bgs.)	Sample Run	Recovery	Soil/Rock Type	Lithology/Remarks	Well Completion
	m	8.7	N	BH10 0-2	0	1		SM	moist, red brown, loose, silty sand	
					1				CI ⁻ = 2.0 180

2					
	m	7.6	N		3	2		SM	SAA CI ⁻ = 1.6 124	
					4					
	m	5.11	N	BH10 4-5	5	3		SC	moist, brown, cohesive, sand some silt & clay	
					6				CI ⁻ = 0.8 < 124	
					7					
					8					
					9					
					10					
					11					
					12					
					13					
					14					
					15

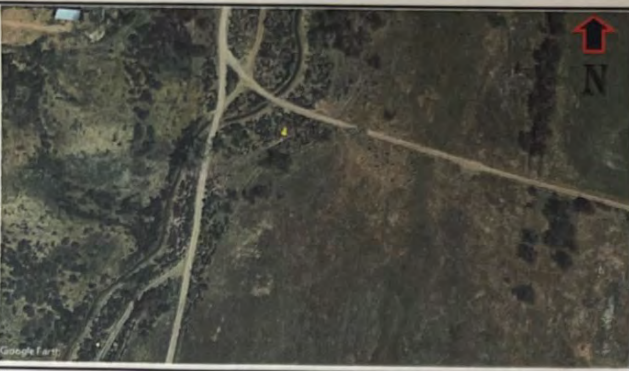
WSP USA INC						
				848 East 2nd Avenue						
				Durango, CO 81301						
				BORING LOG/MONITORING WELL COMPLETION DIAGRAM						
Boring/Well Number: <i>BH11</i>				Project: <i>Sandrock Water Gathering</i>						
Date: <i>4/7/2021</i>				Project Number:						
Logged By: <i>Eric Carroll</i>				Drilled By: <i>Hilcorp</i>						
Elevation: <i>6,000</i>				Detector: <i>PID</i>						
Gravel Pack: <i>10-20 Silica Sand</i>				Seal: <i>Bentonite</i>						
Casing Type: <i>Schedule 40 PVC</i>				Grout: <i>Bentonite</i>						
Screen Type: <i>Schedule 40 PVC</i>				Diameter: <i>2"</i>						
Slot: <i>0.010"</i>				Length: <i>NA</i>						
Diameter: <i>2"</i>				Hole Diameter: <i>6"</i>						
Length: <i>NA</i>				Depth to Liquid: <i>NA</i>						
Total Depth: <i>5'</i>				Depth to Water:						
Penetration Resistance	Moisture Content	Vapor (ppm)	HC Staining?	Sample #	Depth (ft. bgs.)	Sample Run	Recovery	Soil/Rock Type	Lithology/Remarks	Well Completion

<i>m</i>	<i>0.2</i>	<i>N</i>		<i>0</i>				<i>moist, red brown, loose, sand</i>	
					<i>1</i>				<i>CI⁻ = 0.2 <124</i>	
					<i>2</i>					
	<i>m</i>	<i>0.1</i>	<i>N</i>		<i>3</i>				<i>SAA</i>	
					<i>4</i>				<i>CI⁻ = 0.2 <124</i>	
	<i>m</i>	<i>0.1</i>	<i>N</i>		<i>5</i>				<i>SAA</i>	
					<i>6</i>				<i>CI⁻ = 0.2 <124</i>	
					<i>7</i>					
					<i>8</i>					
					<i>9</i>					
					<i>10</i>					
					<i>11</i>					
					<i>12</i>					
					<i>13</i>					
					<i>14</i>					
					<i>15</i>
