Re: Site Assessment, Remediation, Reclamation, and Closure Report
JG State 16 #5 Tank Battery
API No. 30-025-39799
GPS: Latitude 32.8355103 Longitude -103.7734222
UL "F", Sec. 16, T17S, R32E
Lea County, NM
NMOCD Ref. No. NAPP2122152433

Paragon Environmental, LLC (Paragon) has been contracted by Spur Energy Partners (Spur) to perform a spill assessment, conduct remediation activities, and reclaim the old containment area for the release site known as the JG State 16 #5 Tank Battery (JG). Details of the release are summarized below:

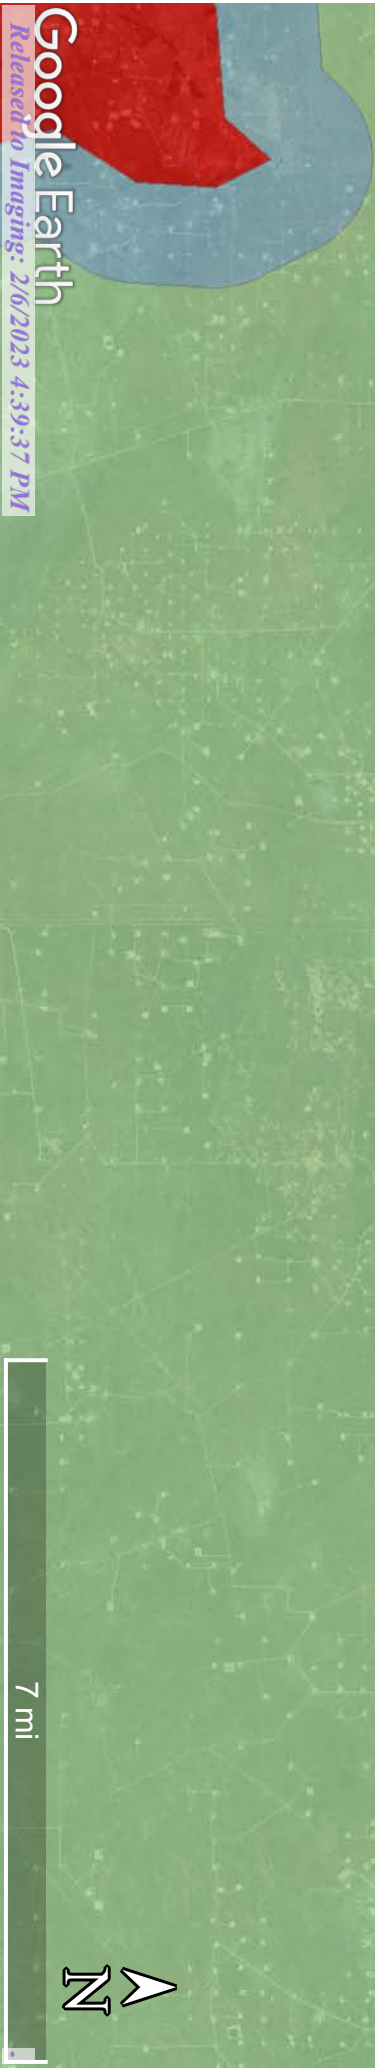
JG State 16 #5 Tank Battery
AP# 30-024-39799
Lea County, NM
Karst Map

The Soil Survey and FEMA Flood Map are provided in Appendix B. A Karst Map is provided in Figure #3.

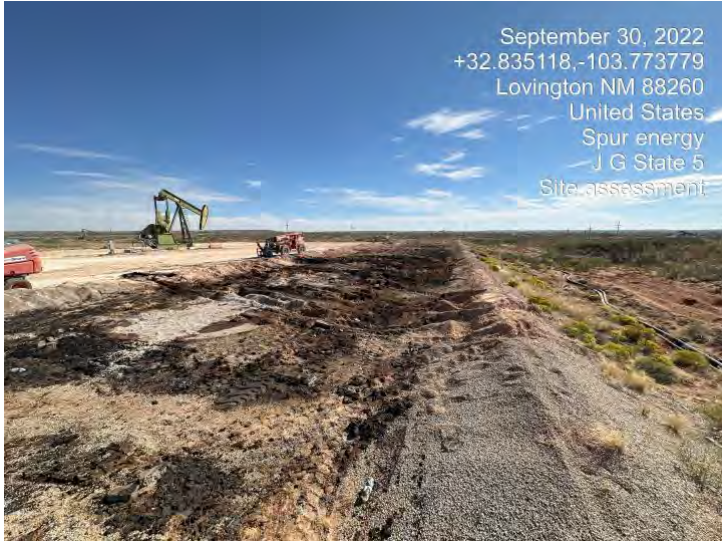
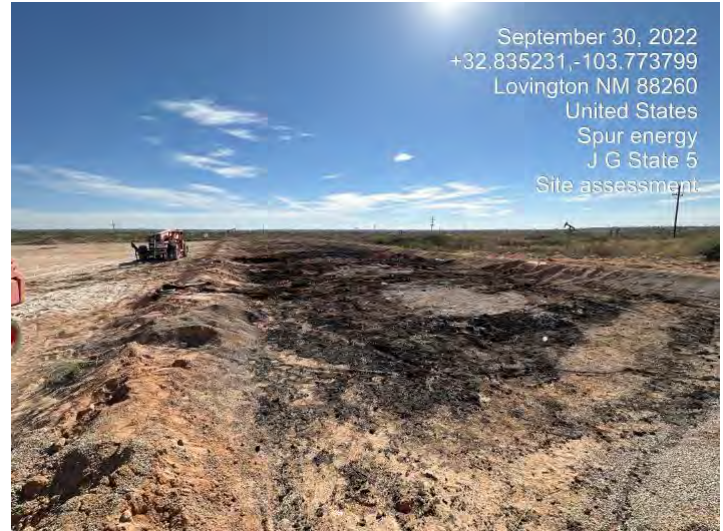
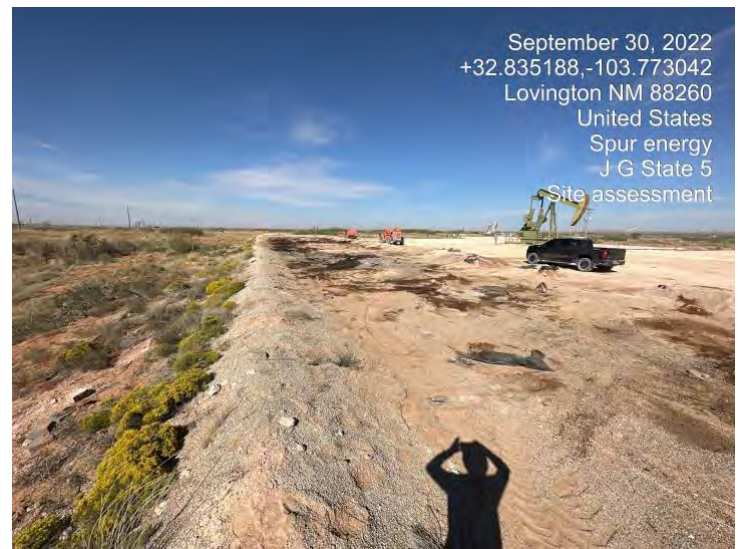
Photographic Documentation
Before Remediation

On August 16, 2022, Paragon conducted a site visit to evaluate the site. There was no evidence that any fluids had breached the containment. The liner was not visible due to the gravel and dirt covering it as much as 1-foot in much of the containment. Much of the infrastructure was still on site though was burned and not operable. Initial samples were not obtained at this point because we wanted to remove the old material and liner to expose what was underneath.

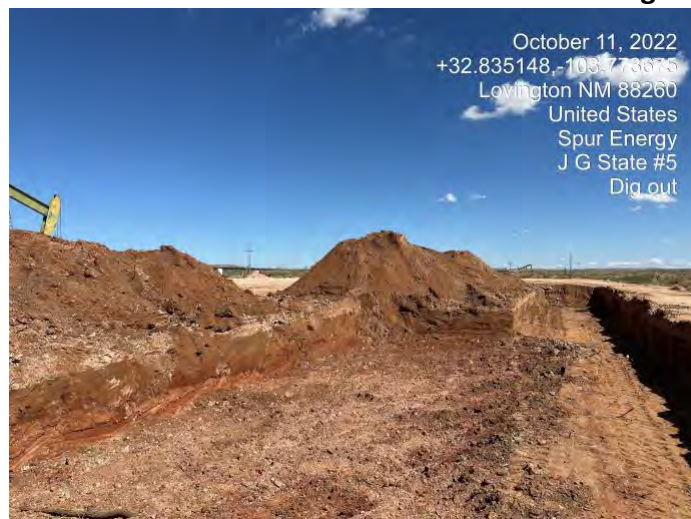
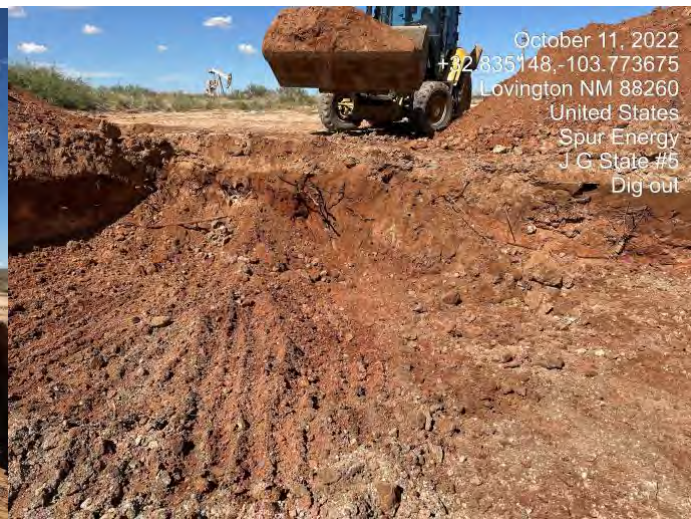
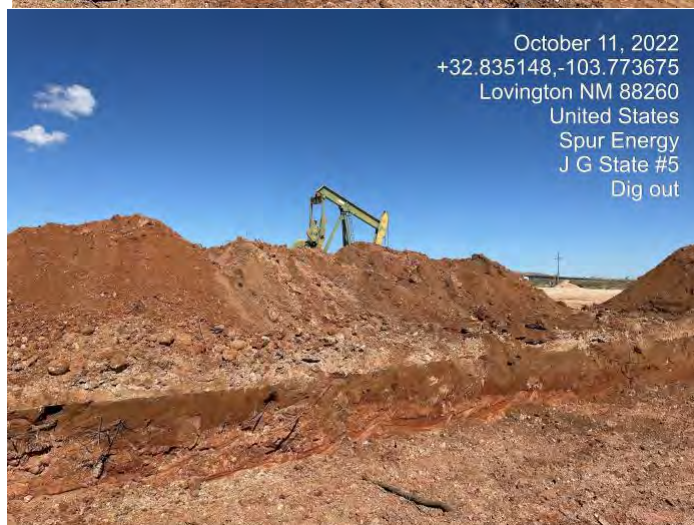
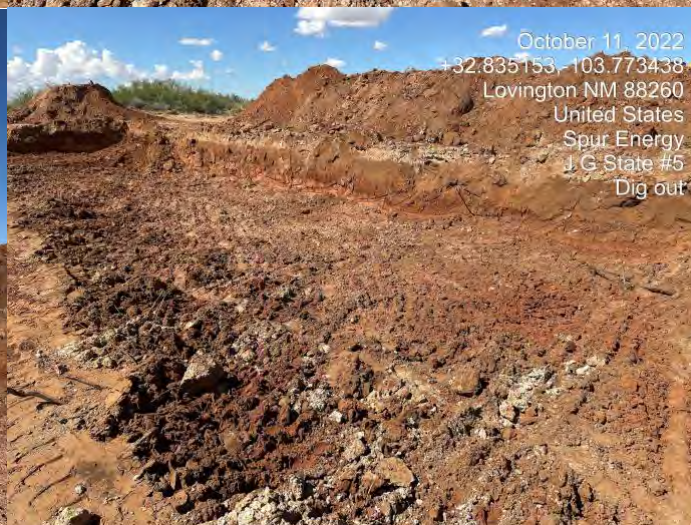
Photographic Documentation
During Remediation

Once the rest of the battery was excavated, we found heavy staining below where the tanks were located. We dug several test holes throughout the battery to determine the vertical extent of the contamination. Once we found clean soil, we ran field titrations for
